| 29 Red Lion Street<br>Chesham Bucks<br>HP5 1EJ | Phase 1 Only<br>Grimshaw Lane<br>Manchester | |

PIPELINE SCHEDULES for 9762 - SW

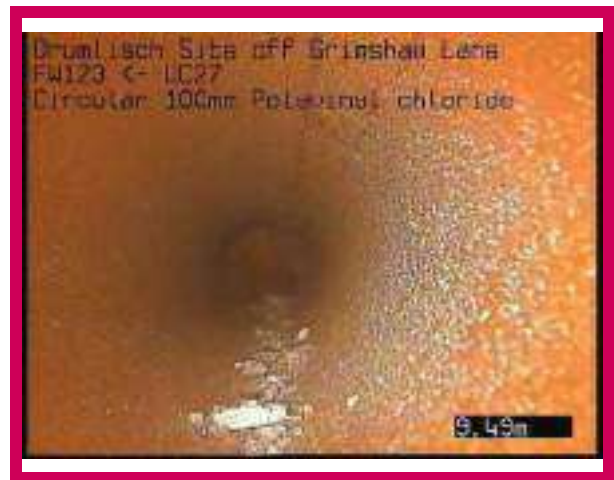
2, 00:00:51, 9.41 m  
Settled deposits, fine, 5% cross-sectional area loss

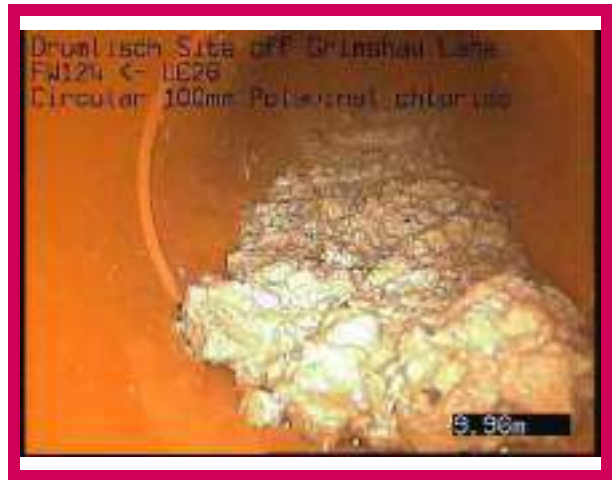
2, 00:00:56, 9.94 m  
Settled deposits, coarse, 20% cross-sectional area loss

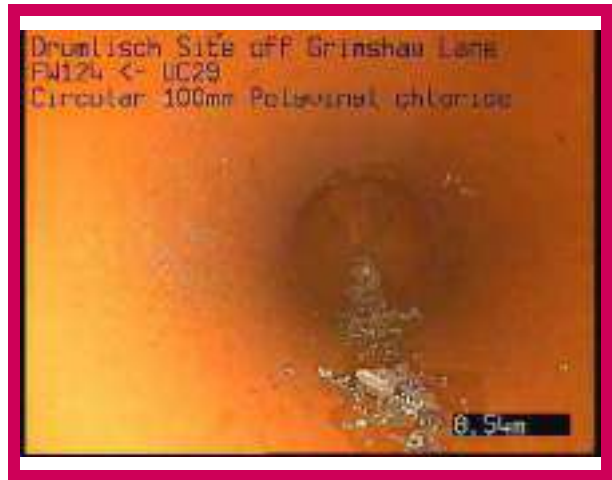
2, 00:00:47, 8.50 m  
Settled deposits, fine, 5% cross-sectional area loss

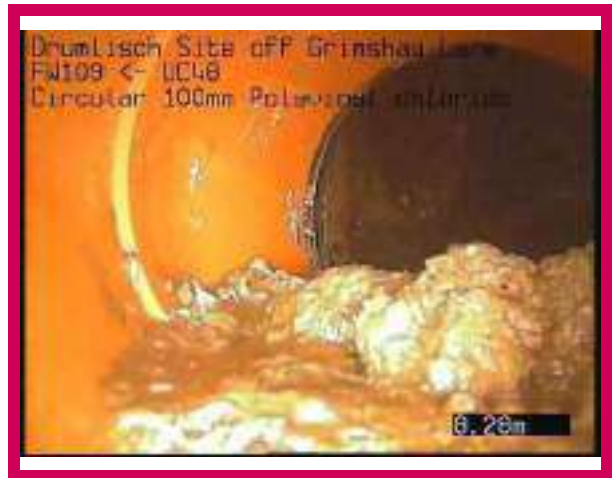
2, 00:00:20, 8.28 m  
Settled deposits, fine, 20% cross-sectional area loss

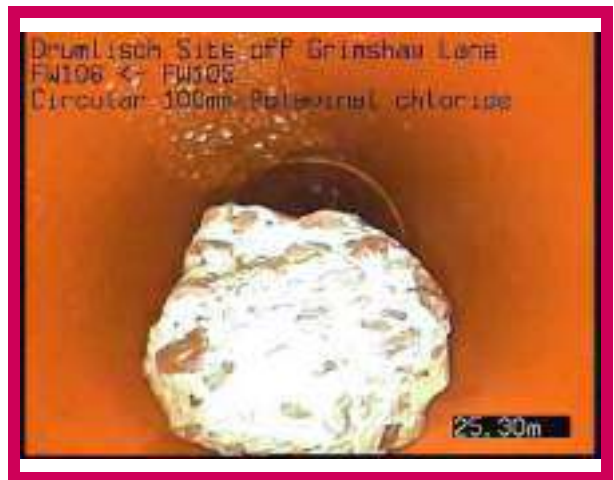
2, 00:02:32, 25.30 m  
Settled deposits, coarse, 80% cross-sectional area loss

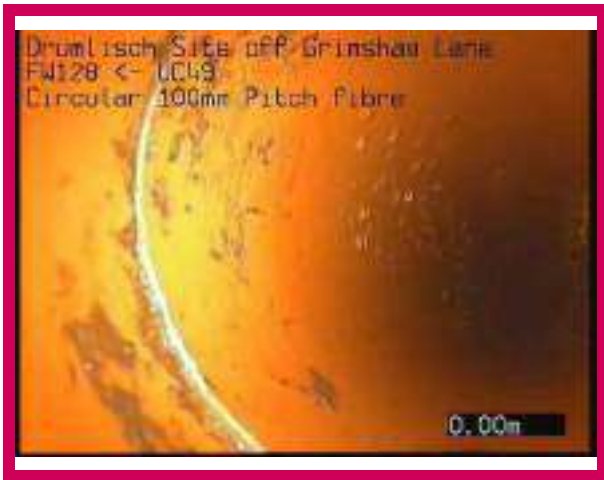
1, 00:00:00, 0.00 m  
Start node, manhole, reference: FW128

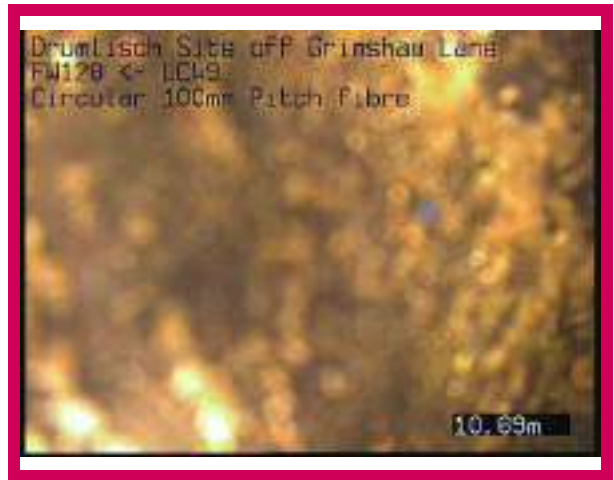
2, 00:00:52, 10.69 m  
Finish node, gully, reference: UC49

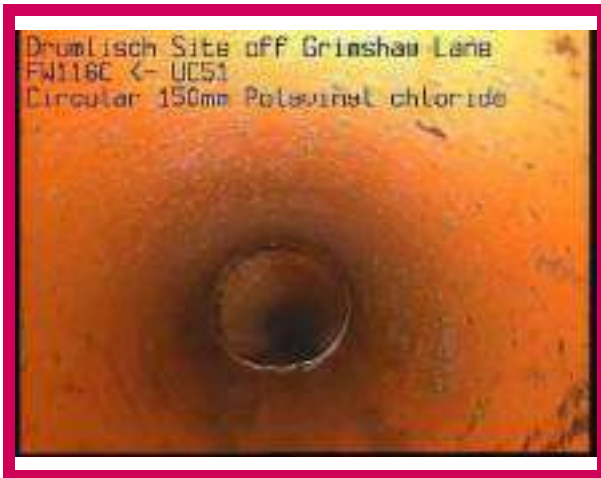
1, 00:00:00, 0.00 m  
Start node, manhole, reference: FW116C

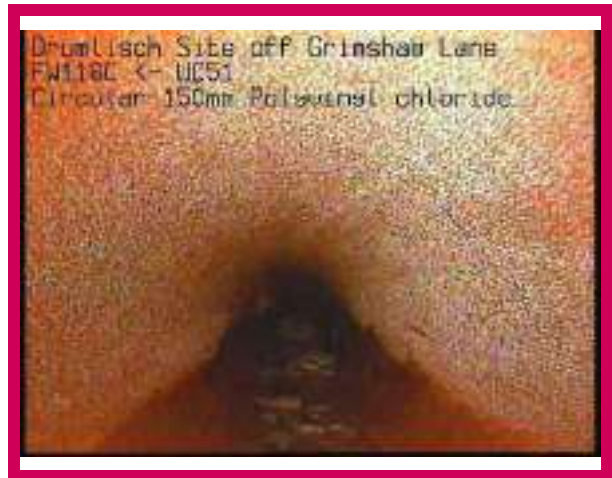
2, 00:00:41, 3.67 m  
Settled deposits, hard or compacted, 5% cross-sectional area loss

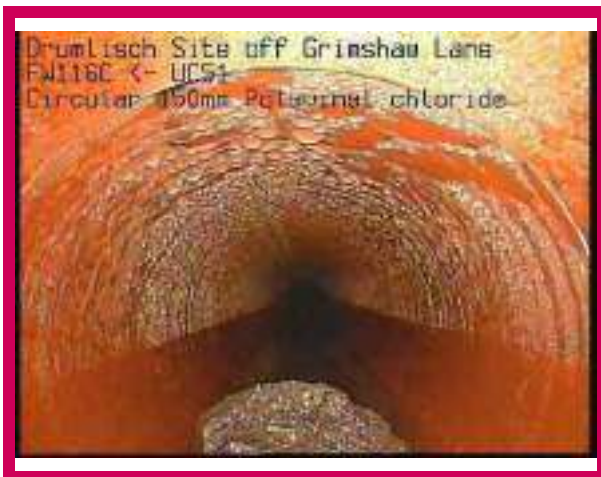
3, 00:00:47, 4.65 m  
Settled deposits, coarse, 10% cross-sectional area loss

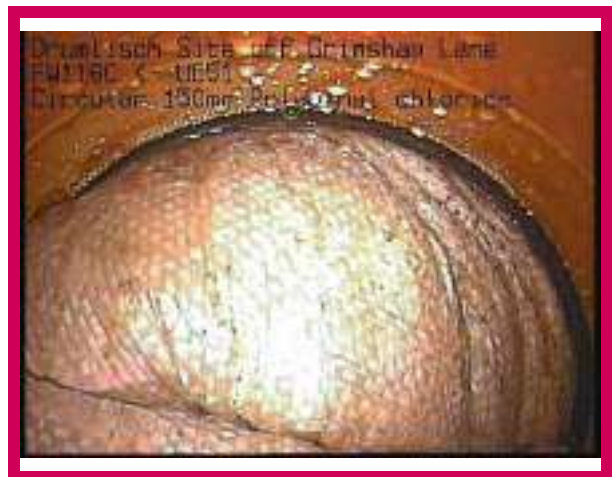
4, 00:01:45, 12.74 m  
Finish node, other special chamber, reference: UC51, Capped

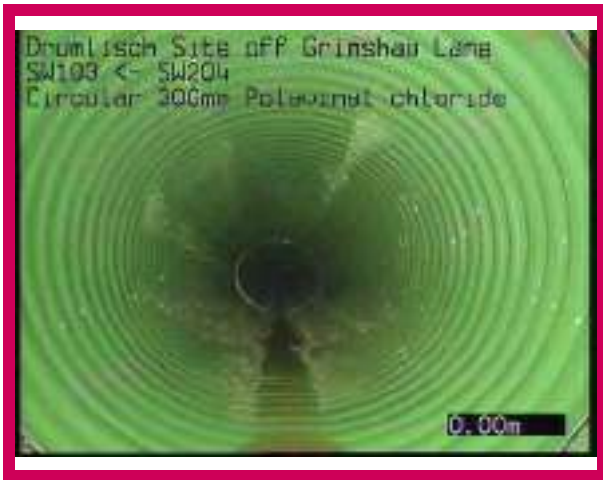
1, 00:00:00, 0.00 m  
Start node, manhole, reference: SW103

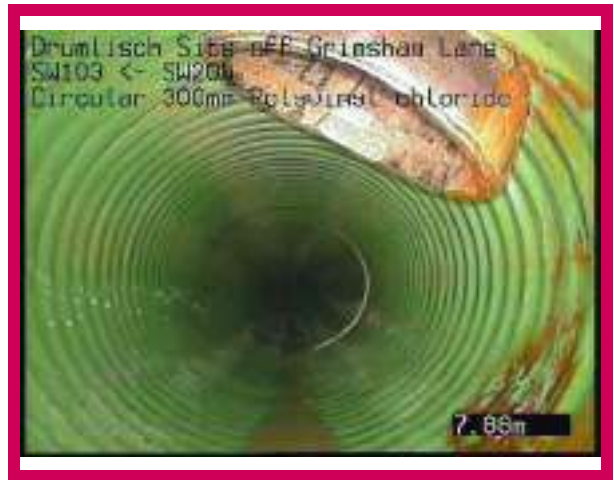
2, 00:00:57, 7.88 m  
Connection defective, connecting pipe is intruding at 01 o'clock, 150mm dia, intrusion: 10%

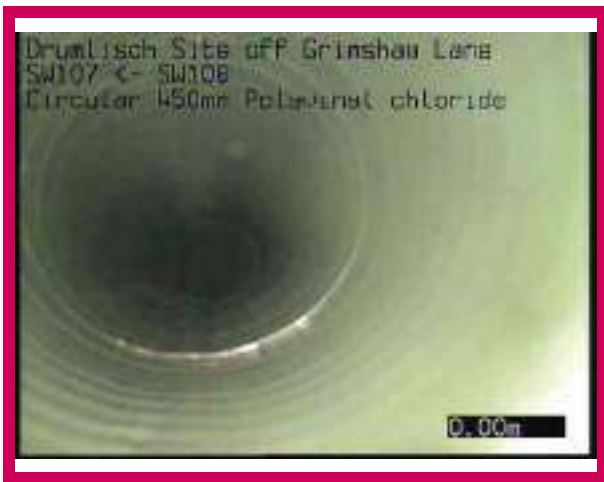
1, 00:00:00, 0.00 m  
Start node, manhole, reference: SW107

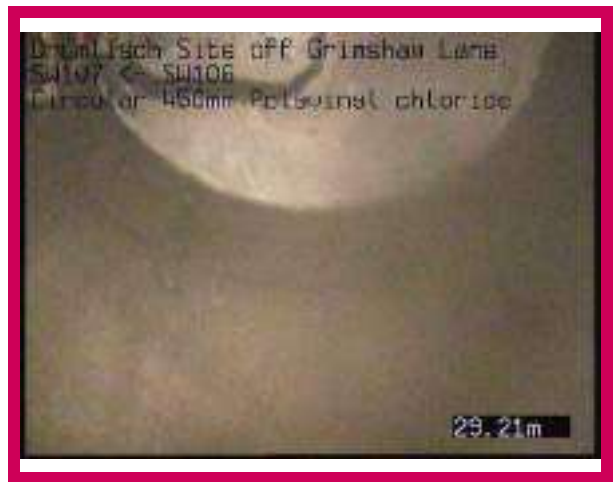
2, 00:02:48, 29.21 m  
Finish node, manhole, reference: SW106

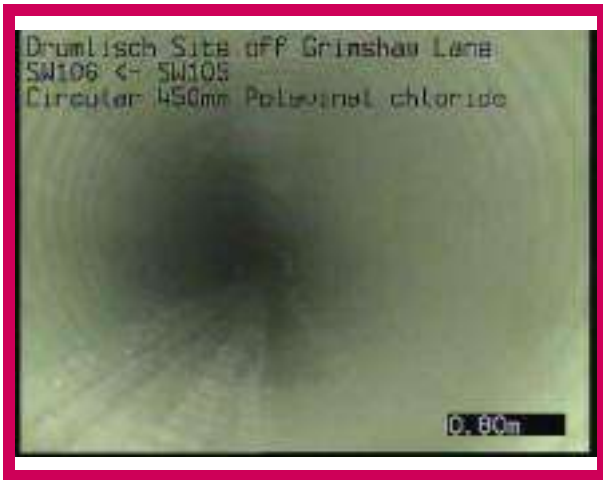
1, 00:00:00, 0.00 m  
Start node, manhole, reference: SW106

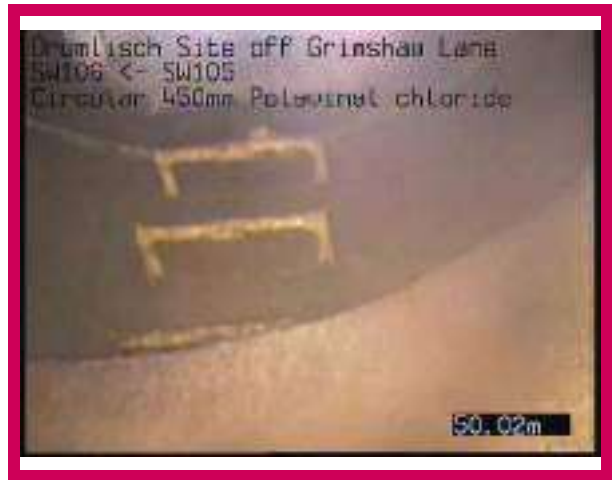
2, 00:03:17, 50.02 m  
Finish node, manhole, reference: SW105

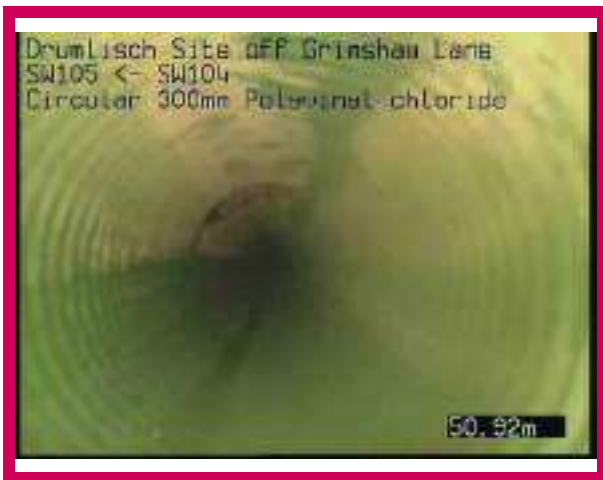
1, 00:00:00, 0.00 m  
Start node, manhole, reference: SW105

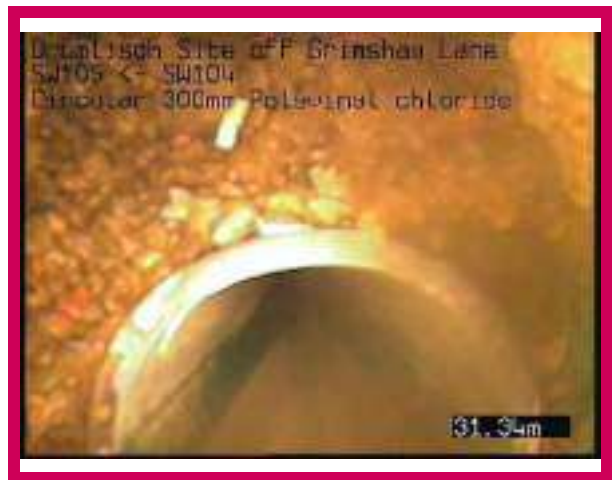
2, 00:07:04, 31.34 m  
Finish node, manhole, reference: SW104

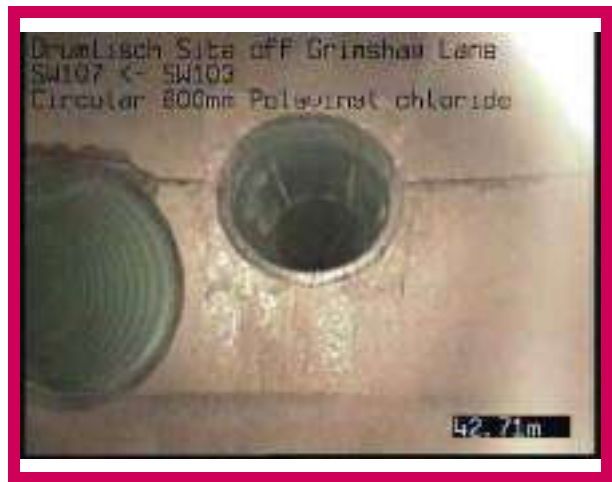
2, 00:02:39, 42.71 m  
Finish node, catchpit, reference: SW103

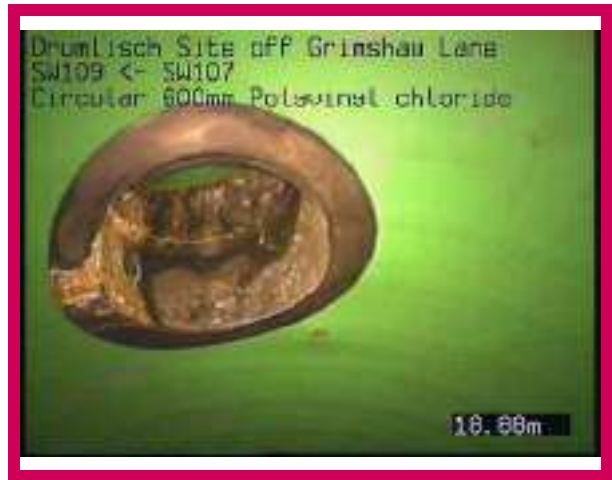
2, 00:01:29, 18.88 m  
Connection other than junction at 11 o'clock, 150mm dia

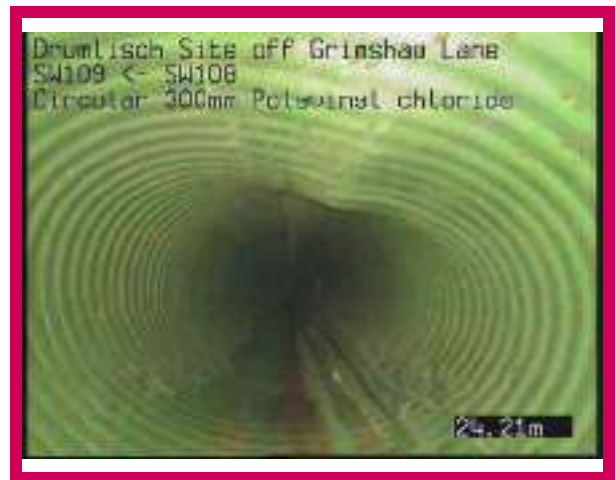
2, 00:02:32, 24.21 m  
Deformed sewer or drain, 10%

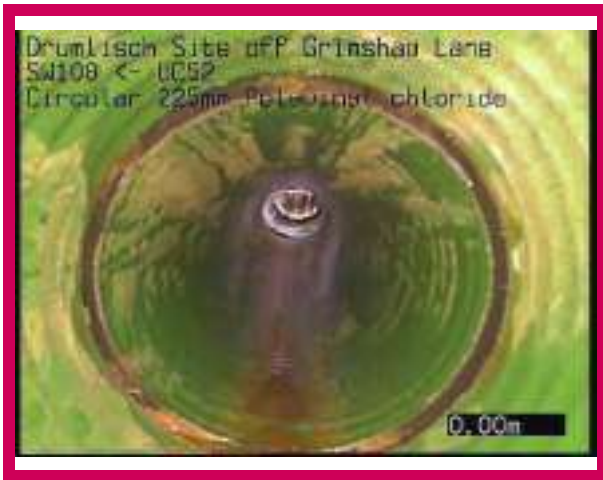
1, 00:00:00, 0.00 m  
Start node, manhole, reference: SW108

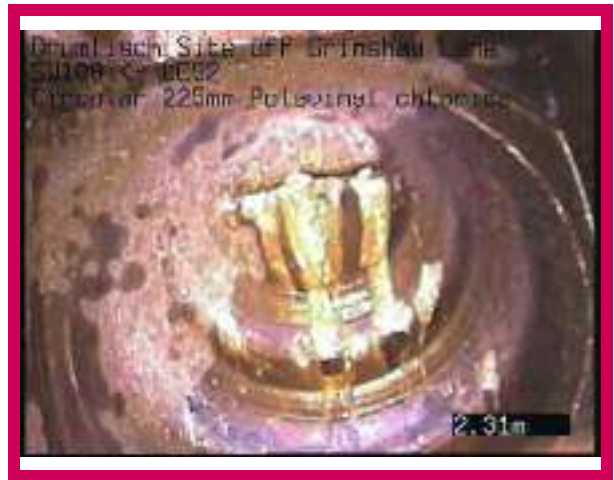
2, 00:00:31, 2.31 m  
Finish node, gully, reference: UC52, Gully

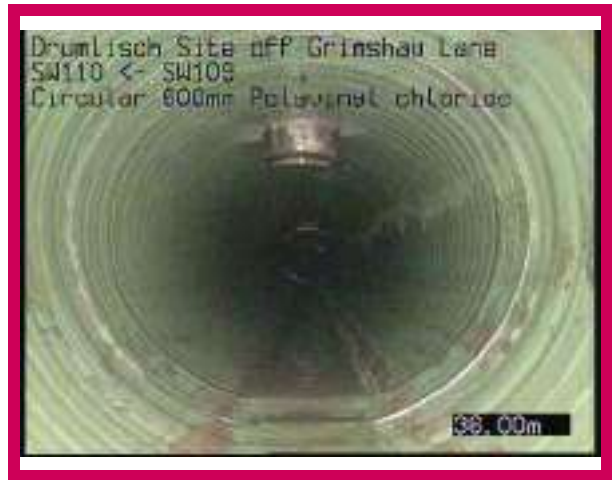
| Scale: 1:536 | Position [m] | Code | Observation | Grade |
|---|---|---|---|---|
| | 36.09 | CXI | Connection defective, connecting pipe is intruding at 12 o'clock, 150mm dia, intrusion: 5% | 3 |

2, 00:02:34, 36.09 m  
Connection defective, connecting pipe is intruding at 12 o'clock, 150mm dia, intrusion: 5%

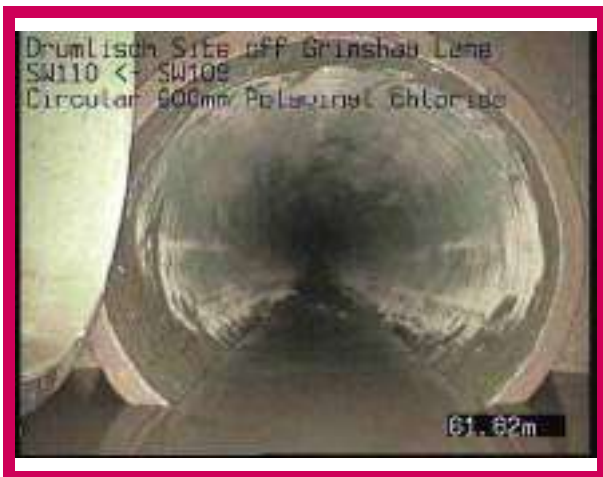
3, 00:04:32, 61.82 m  
Finish node, catchpit, reference: SW109
