# Structural Report

79-87 Cheetham Hill Road, Manchester, M4 4ER

2919-430\_L01

03 June 2024

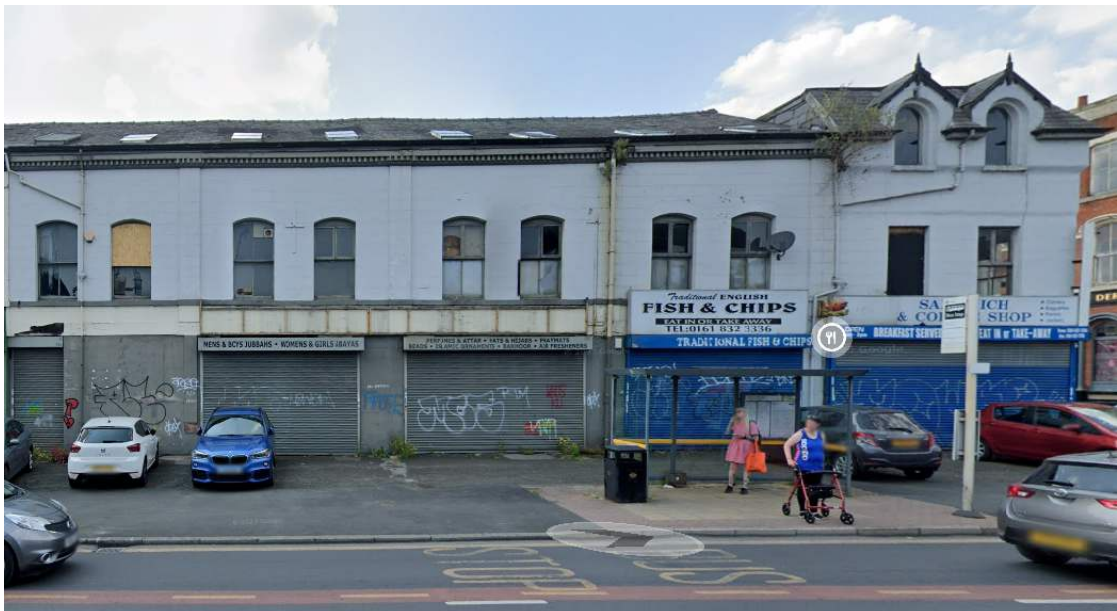
*Front Elevation*

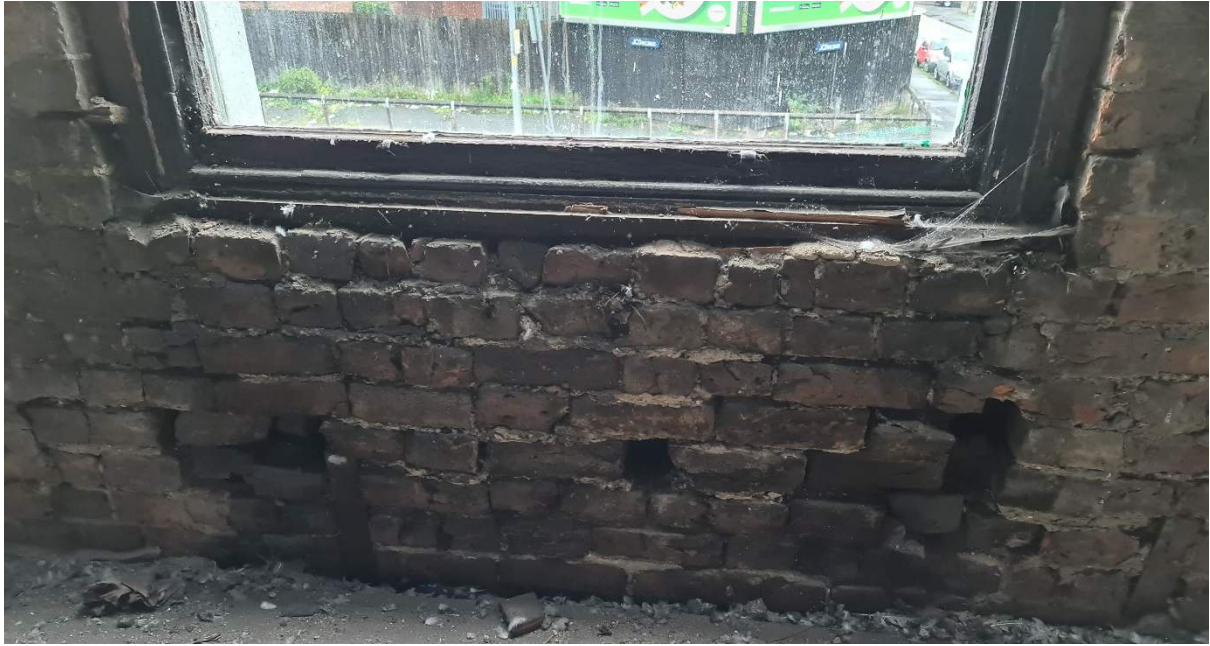
*Photograph 10*

- 4.6.2 The inside face of the external walls at first floor are riddled with extensive cracks and damage to the brickwork which are beyond practical repair. There are pockets of brickwork in more than a dozen areas that have collapsed into the cavity. Most of these defects are present around the window openings and brick piers where the original party walls would have been. See Photographs 10 to 14. The most likely cause of this is the rebuilding of the solid wall into a cavity wall, and from past experiences, wall ties are rarely used to tie the two leaves together considering the age of the building.

- 4.6.3 The front and side elevations have lost half their compressive and flexural strength as they have gone from 215mm wide walls to 100mm wide walls but are still supporting the same dead, live and wind loads. This, coupled with the fact that the buttressing party and spine walls have been removed and the lack of lateral restraints/ties provided to the masonry at floor and eaves levels, there are very little structural elements restraining the masonry horizontally which has caused the failures noted in the building envelope.

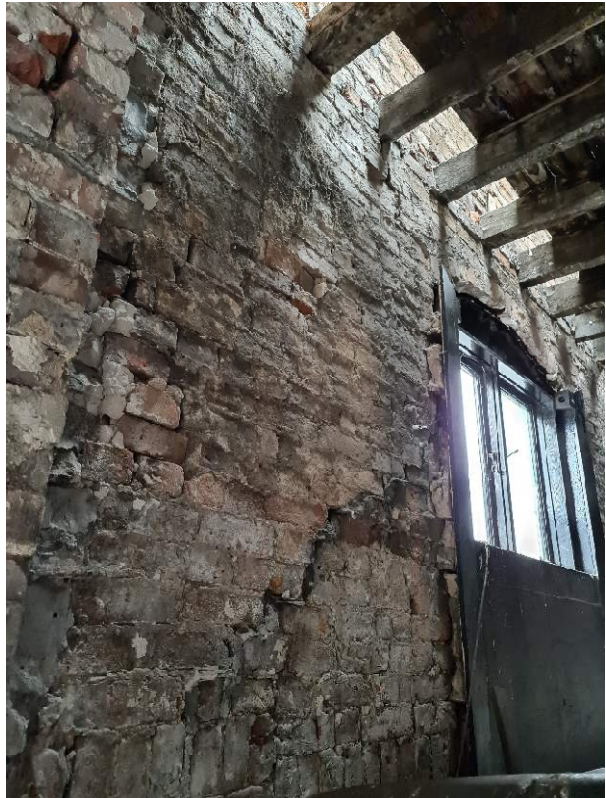
*Photograph 12*

- 4.6.4 The party and spine walls have been removed and replaced with steel beams that have inadequate bearings on to brick piers. The piers to the external walls have been poorly built and have not been tied into the external walls using starter kits or ties. This has caused the brick piers to buckle and come away from the adjoining walls under the eccentric bearing loads from the beams.
