**UNDERWATER TACTILE INSPECTION OF ROCHDALE CANAL WALL –  
MANCHESTER**

**October 2023**

**DOCUMENT REF: 2345874-R-01(01)**

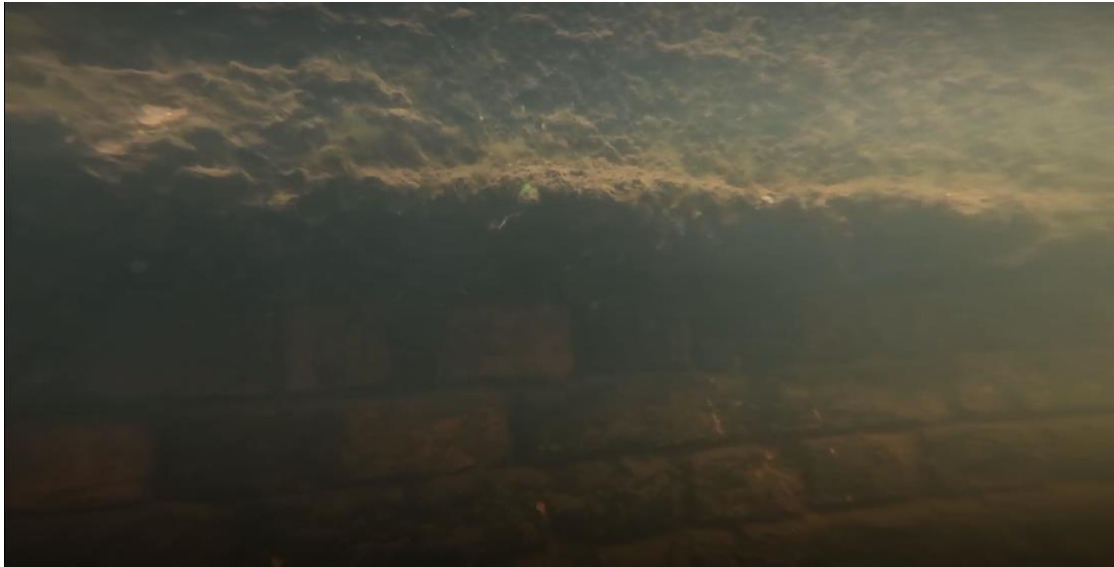
- 5.3 There is typically frost and environmental weathering to the brick and masonry faces along the wall.
- 5.4 All sections of the wall below water level were probed with a ranging rod and underwater camera footage was gathered where possible, no significant areas of erosion or missing masonry were found below water level at the time of inspection.

Photo 46: General underwater view of brickwork and concrete plinth below water level at chainage 44m.
