DESIGN + ACCESS STATEMENT

KING STREET CHAMBERS

| PROJECT REF. | 2050 |

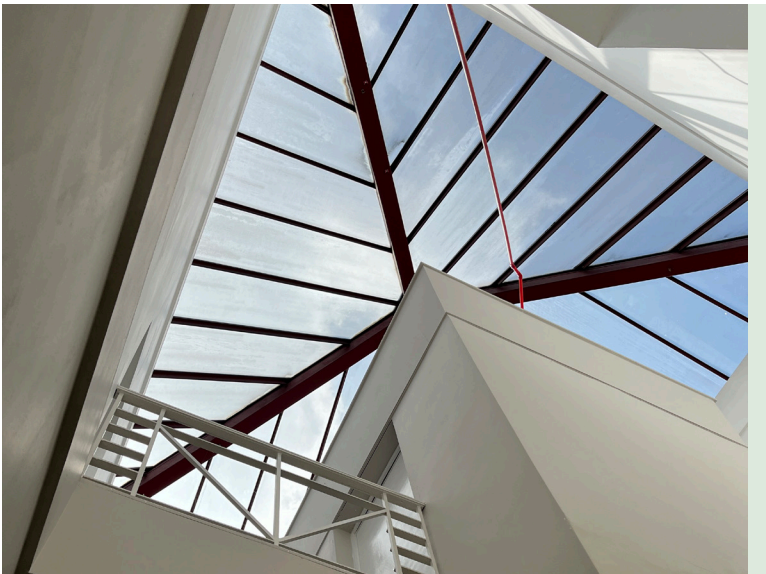
INTERNAL VIEW OF LANTERN

Central to the roof apex is a contemporary aluminum framed roof light which sits above the line of the top ridges. This is double glazed and

allows natural light to penetrate into the central section of the building atrium. The top floor of the common parts benefits from natural daylight through this modern intervention. The rooflight has some small cracks in one of the double glazed units, but no reports of water penetration are noted in this location.

| Item Ref | Heading | Description of Condition |
|---|---|---|
| 9.10 | | Allow for inspection and replacement of failed seals, glazing units and gaskets. |

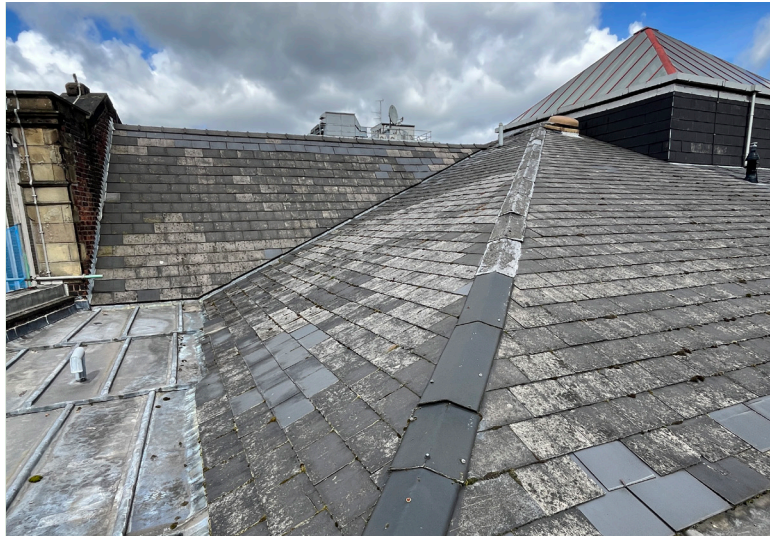
HIP MEMBERS AND LANTERN

Hips and ridges are also made up from a composite material, many of which have been replaced presumably because they have failed in the past. These replaced hips are also failing as they have been replaced with bolted fastenings which in some cases have failed again and resulting in numerous cracked tiles.

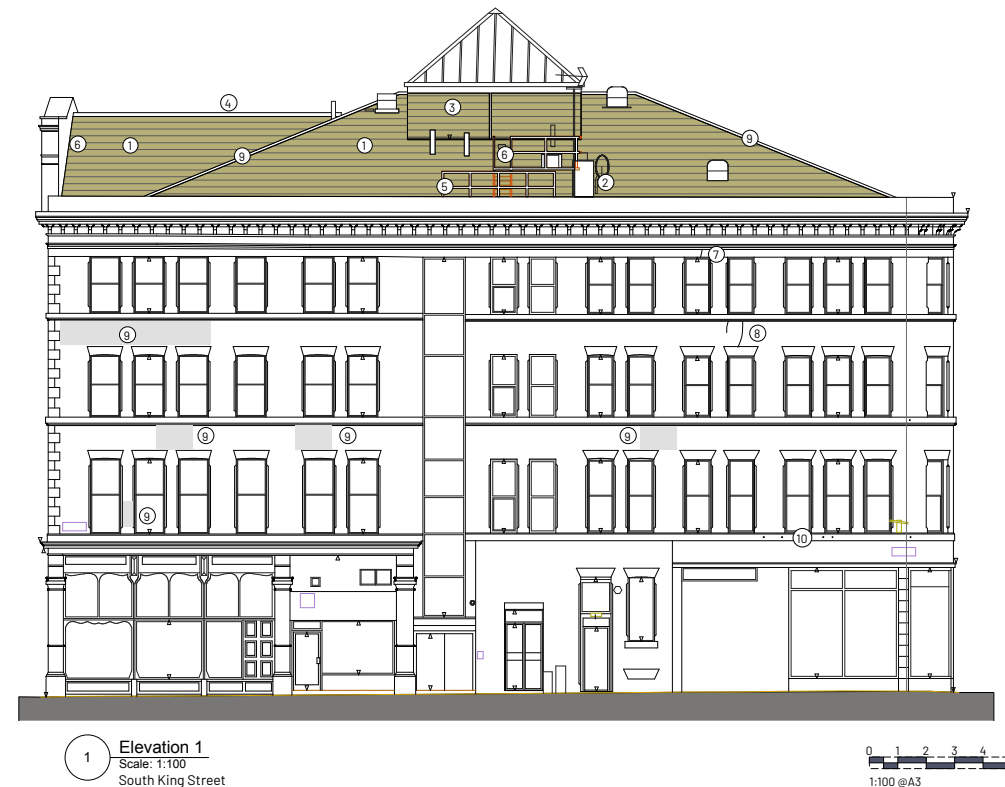
AREAS OF DELAMINATION

These defects include areas of brickwork that require re-pointing, delamination of stonework which may require re-facing and areas of obvious water infiltration on the top parapet stone course evidenced by the whitening of the stonework in those areas. Elevation intent drawings will be updated and full specifications made available and presented as part of a condition discharge.

| Item Ref | Heading | Description of Condition |
|---|---|---|
| 8.10 | | Repair/replace eroded and friable/otherwise damaged stone pieces. (to be agreed once scaffold is erected) |
