# Design Note

Project SIM - Gantry Conservation  
 Subject Conservation Philosophy  
 Project no 054704  
 Date 28 June 2023

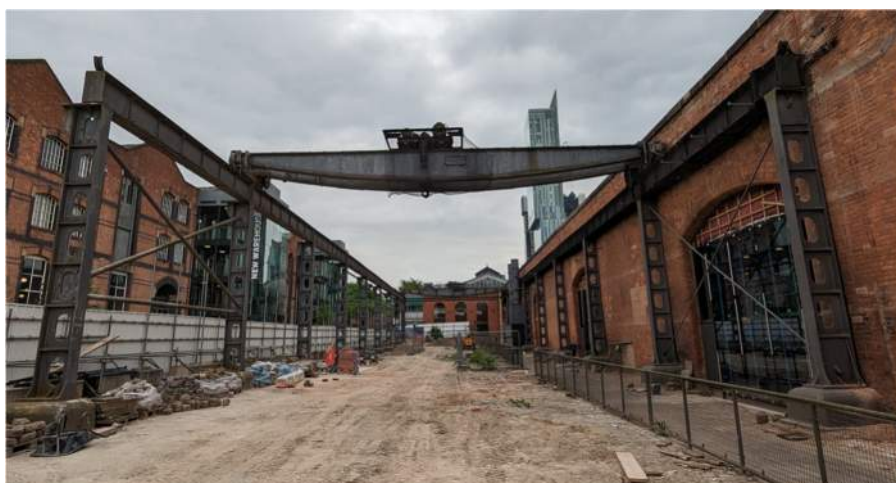
**Figure 1-1 SIM Gantry viewed from west**

The current protective coatings to the Gantry have failed in many locations, leading to widespread corrosion of the existing structures. Based on recent inspections the Gantry needs conservation works to stop the progressive deterioration and corrosion of the superstructure and safeguard its future.

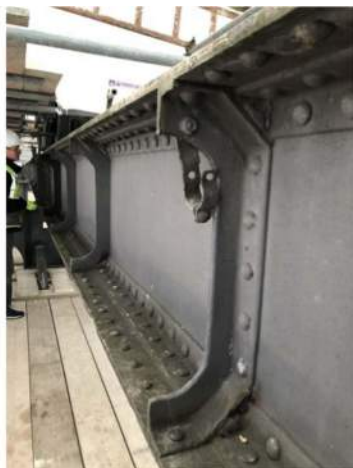
A properly installed, appropriately specified paint finish is the Gantry structure’s most important line of defence against corrosion and future decay. Failure of the current paint finish is the primary reason for the widespread corrosion present on the Gantry. It is understood that the last re-painting took place in the 1980’s, and as such it is not surprising that the existing paint covering has failed. Properly applied paint finishes typically have a design life of 20-25years, meaning that the finish applied in the 1980’s is c. 20 years beyond its anticipated design life. Paint sampling carried out for the Gantry shows that the 1980’s finish was also applied directly over the top of the previous paint layers which was likely detrimental to its longevity (see Figure 3-1).

All of the Crane Gantry samples showed the same surviving history or traces of, that tie in with the representative sample shown here.

To safeguard the Gantry superstructure against future deterioration a new paint coating is required. To achieve the maximum design life and reduce the risk of failures it is proposed that this should be applied onto the prepared bare metal of the Gantry, rather than over existing coatings. Failure to properly prepare the surface is likely to have a detrimental effect on the life of any applied coating, and it is unlikely that an adequate warranty could be provided for coatings applied over existing paint finishes.

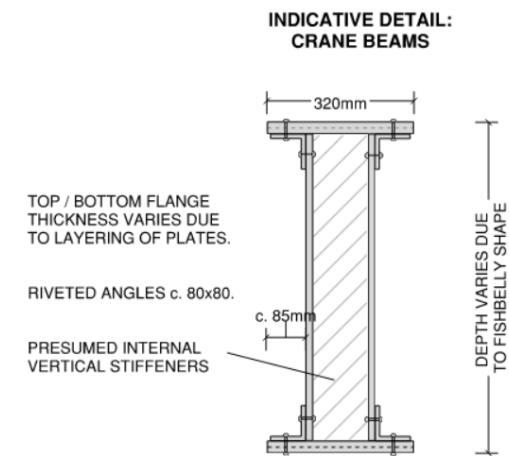
Figure 2-45 Crane beam details

- The 4 no. crane beams also show widespread corrosion, ranging from minor to localised severe cases, which can be categorised into 3 types:
  - Moderate/severe corrosion to the lower section of the beams along their full length. Similar to the Gantry beams this typically affects the angle which connects the web to the bottom flange, but also includes corrosion of the web and flange themselves.

- Crane beams are constructed as per the Gantry beams, but appear to be hollow with two separate webs. It is assumed that internal vertical stiffeners are present due to vertical lines of rivets being visible on the beam faces. Crane beams are c. 320mm wide with a fish belly profile meaning that the depth increases towards the midspan (Figure 2-45).

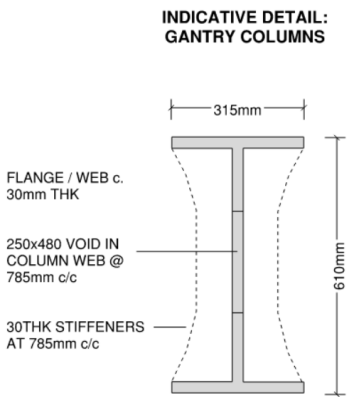
Figure 2-43 Gantry column details

- Gantry columns and plinth bases appear to be in good condition throughout, although there is some evidence of localised failure of paint finishes and associated minor corrosion.

- Gantry columns are c. 7m tall and measure c. 610 x 315mm with intermediate web stiffeners and penetrations through the web (Figure 2-43). Columns appear to be single-piece cast elements.

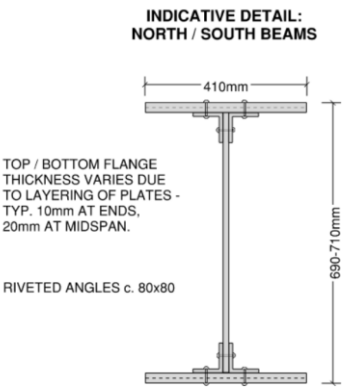
Figure 2-44 Gantry beam details

- Longitudinal Gantry beams show widespread evidence of corrosion, ranging from minor surface corrosion to localised severe corrosion and loss of structural capacity. Corrosion can generally be grouped into 3 types:

- Gantry beams vary in depth due to the plated construction, but measure c. 410mm wide x 700mm deep. The Gantry beams are compound sections – formed from separate plates held together with angle sections and rivets (Figure 2-44). Where beams meet at the column heads, they appear to be bolted to each other via end plates as well as being bolted into column heads.
