Project Title  
Castlefield Viaduct  
Phase 2

Drawing Title  
Remedials  
Transverse Beams  
Bearing Stiffeners

| ID | CVI-ARUP-ZZ-ZZ-DR-S-4001 | | |

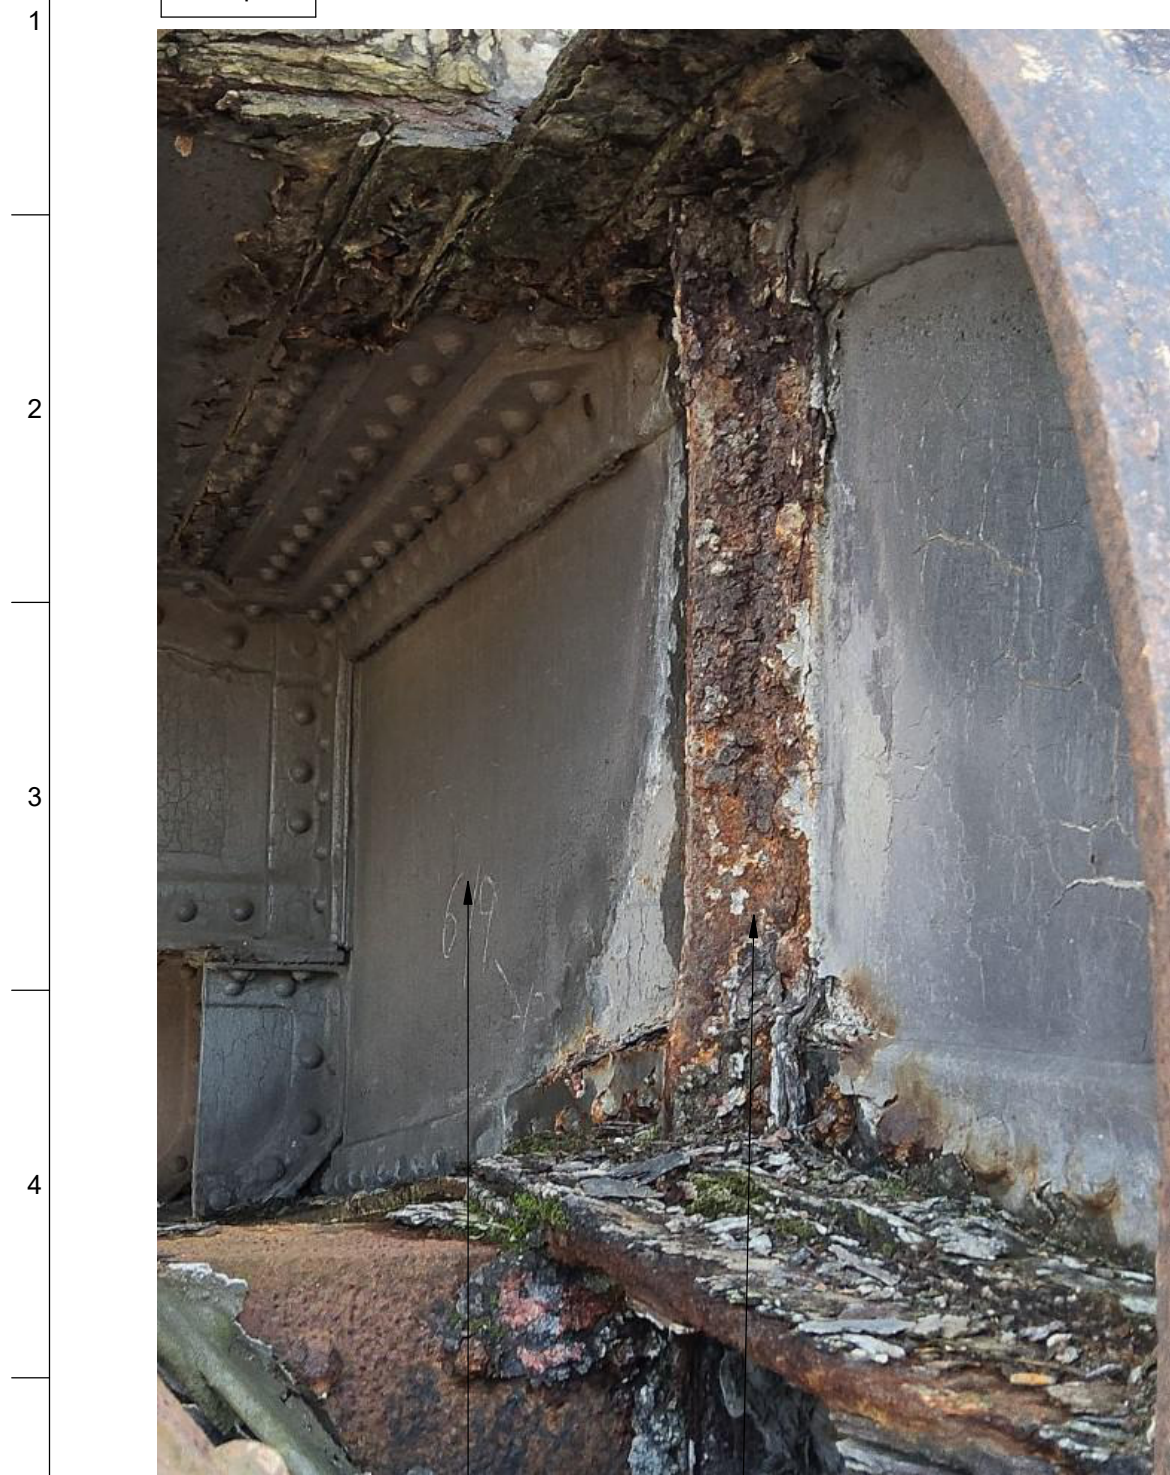
Transverse beam  
- 1/2" thick web plate

Bearing stiffener  
- 6" x 3" x 1/2" Tee  
each side of web

Lattice girder  
bottom chord

Corrosion typically where  
transverse beam extends  
beyond weathering  
protection of deck plate

Remedial stiffeners installed  
during Ph1, to transverse  
beam (TB) ends as follows:  
- TB 25 - north and south  
- TB 27 - north and south  
- TB 29 - north  
- TB 35 - north  
- TB 36 - north  
- TB 37 - north  
- TB 38 - north  
- TB 39 - north  
- TB 40 - north  
(11No. total)

Air gap between stiffener  
and web plate  
- not as per 2022 detail  
which showed contact  
required)

Washers as packers  
across top flange of  
bottom chord
