# Historic Building Watching Brief

33 Thomas Street  
Manchester  
M4 1NA

Conducted and written by Hannah Kernychnyj  
February 2024

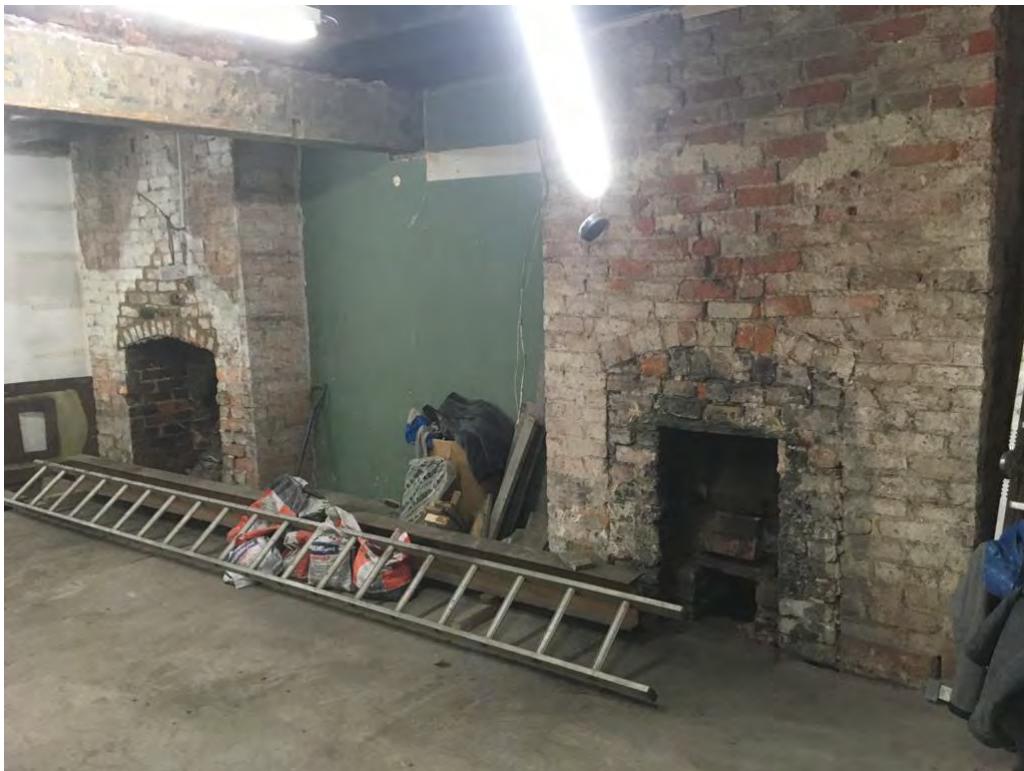
Fig 13. Ground floor aspect now fireplaces are open.

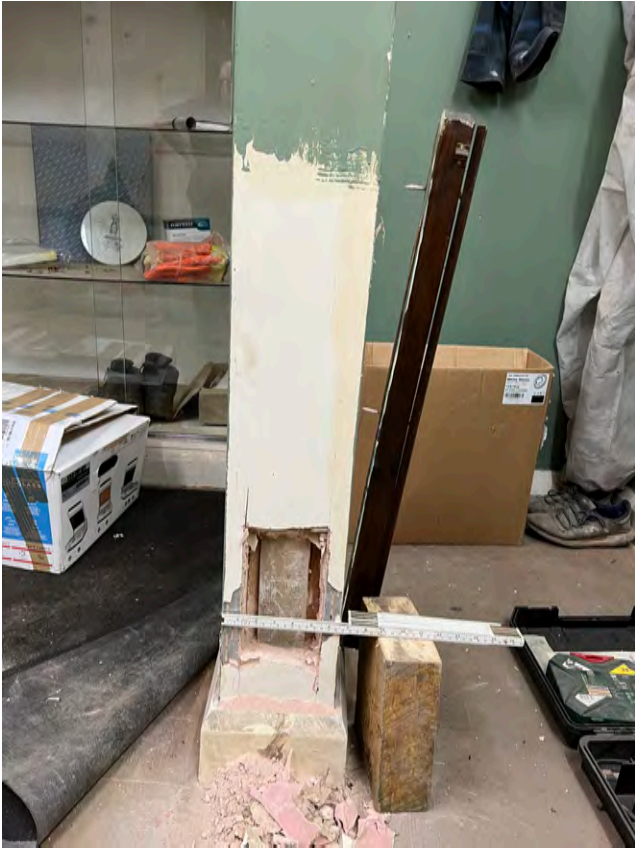
An investigation into the pillar revealed a boxed in metal column holding the beam above. Exposing the original wooden beam, which had also been boxed in, revealed that perhaps it had been recycled from another building as the hand painted lettering on the front of the beam

Fig 14. Exploring pillar

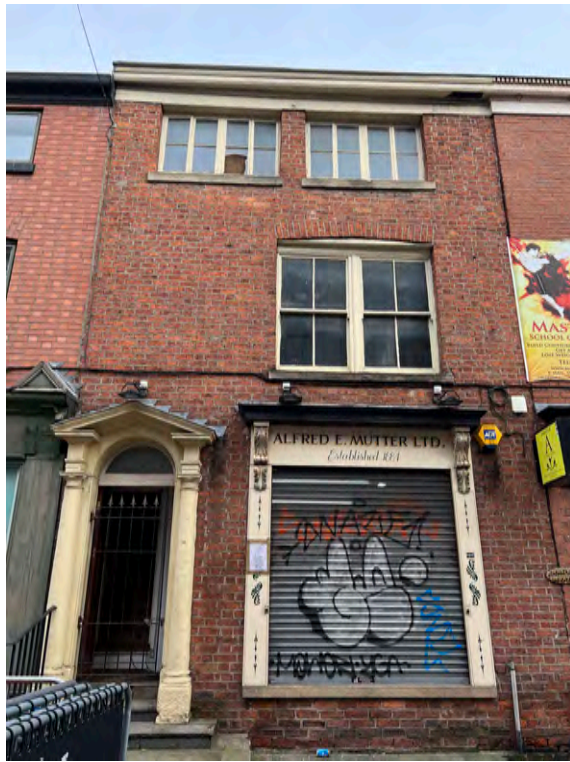
It was suggested by the previous owner that the original signage was under the current facade, but exploration only uncovered the metal box which houses the roller shutter mechanism and a steel beam.

Fig 17. Shop Front

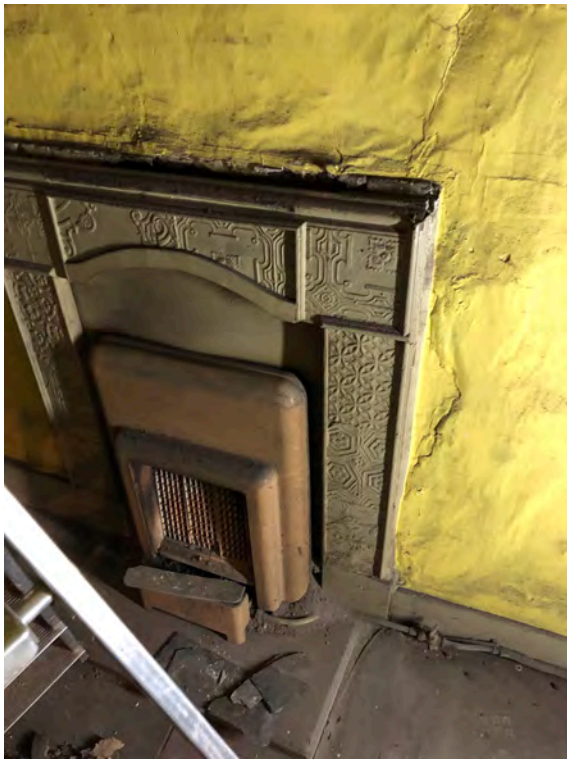
Opening this fireplace revealed a brick arch and the original cast iron grate, part of which is broken.

Fig 20. Rear fireplace with 1950's fire surround.

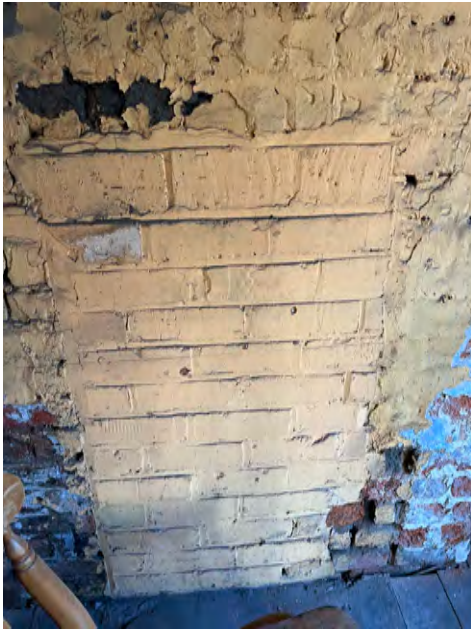
Small Fireplace opened to find original broken cast iron grate and slate tiles. An angle iron was placed below the brick arch.

Fig 25. Rear Fireplace behind Painted brickwork.

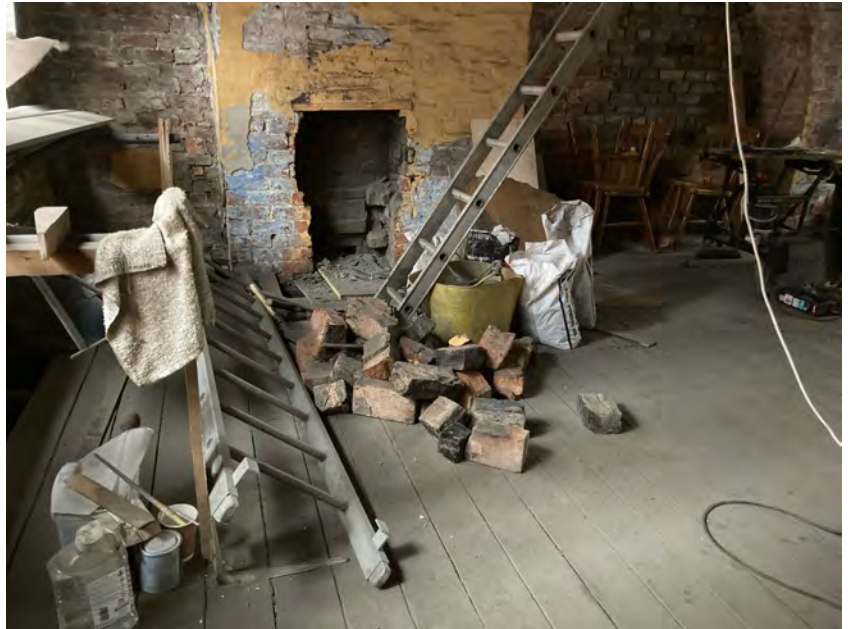
Fig 26. opening up of rear Fireplace

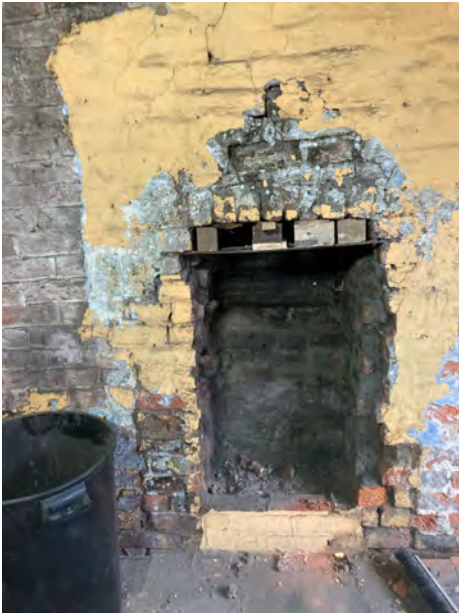
Small Fireplace only revealed the chimney breast full of bricks and slate.

Fig 29. Front Fireplace
