Client  
The National Trust

Project Title  
Castlefield Viaduct  
Phase 2

Drawing Title  
Remedials  
Piers

| ID | CVI-ARUP-ZZ-ZZ-DR-S-4021 | | |

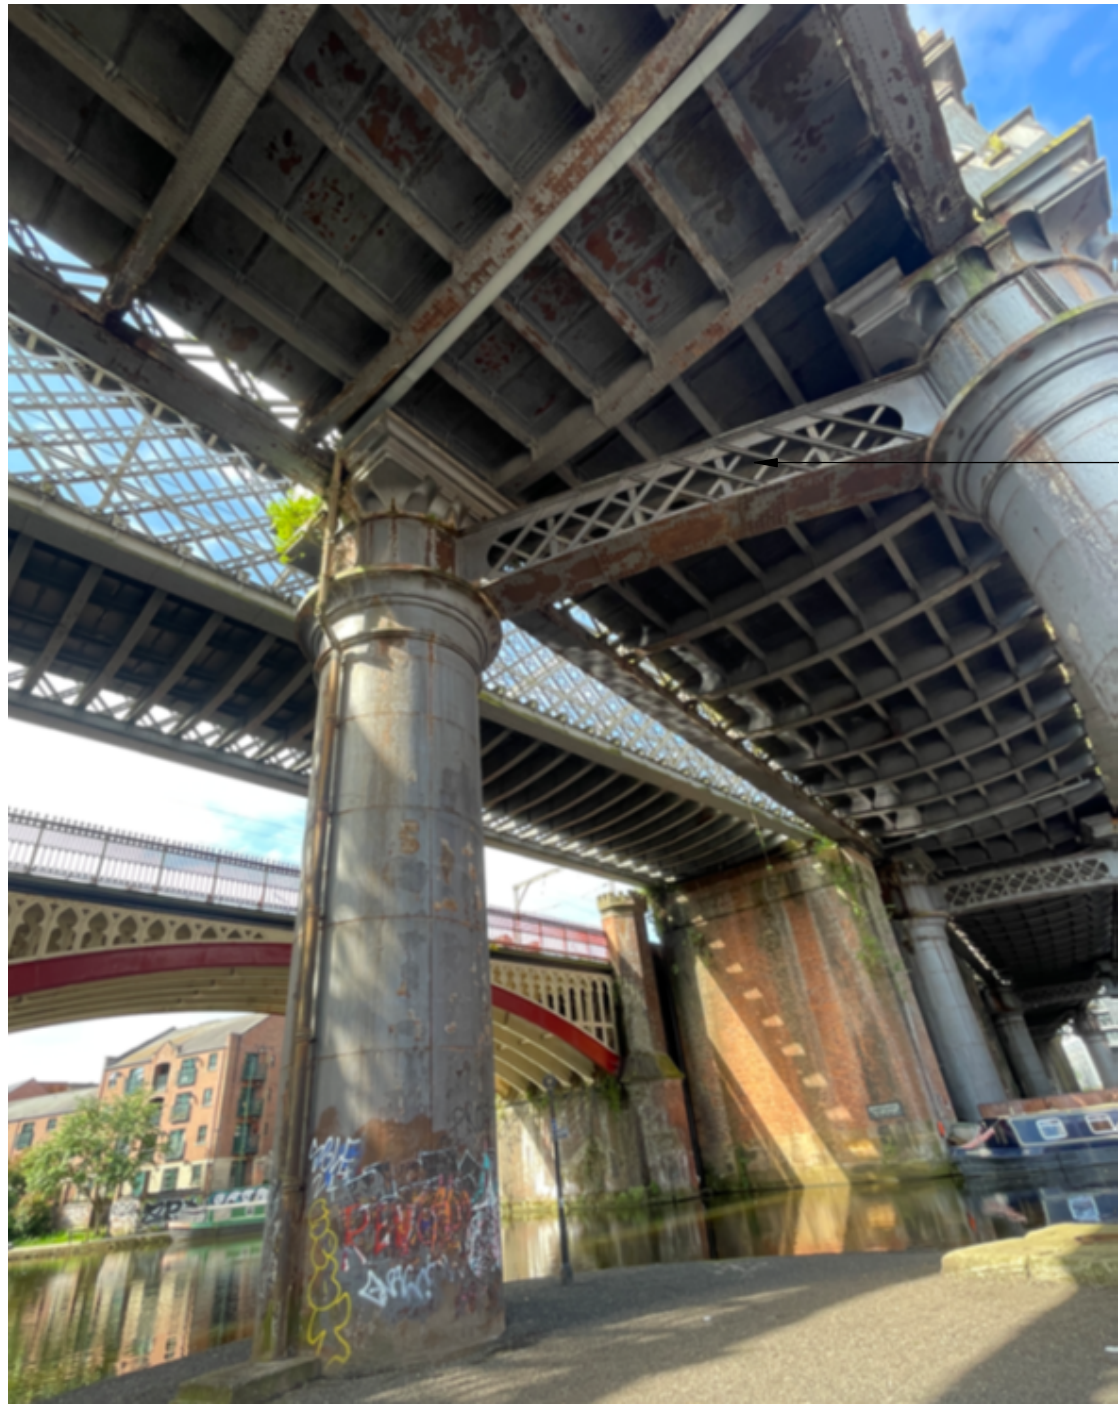
Decorative castellations  
at column interface with  
lattice girders

Cross pier beam

Flarings at column head

Cast iron casings to  
main column shaft

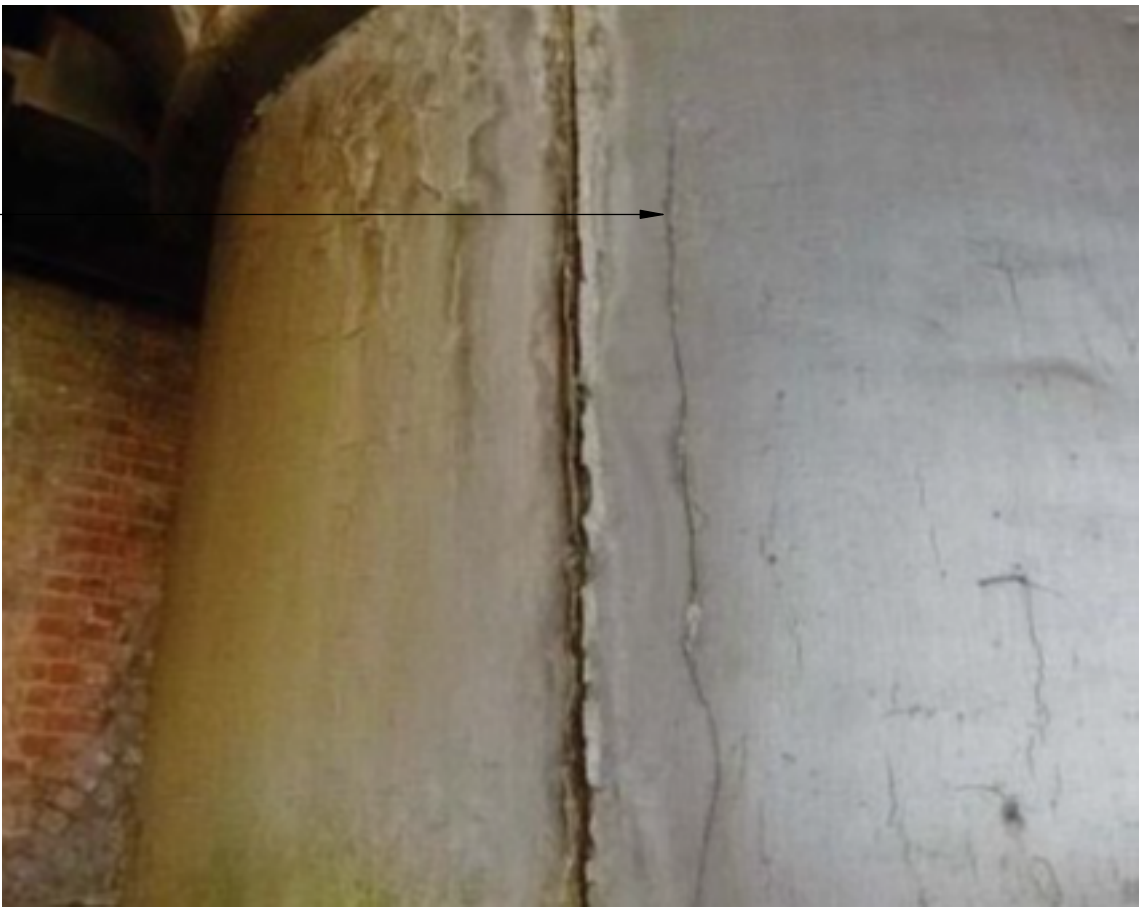
## DEFECT EXAMPLES

Vertical fracture to column head  
flaring

Vertical corrosion  
- no fracture
