# Outline Shopfront & Elevation Specification

Installation of new external shop front with local elevational repairs and cleaning.

Address: 28-30 Oldham Street, Manchester,

Issue Date: 25 July 2024

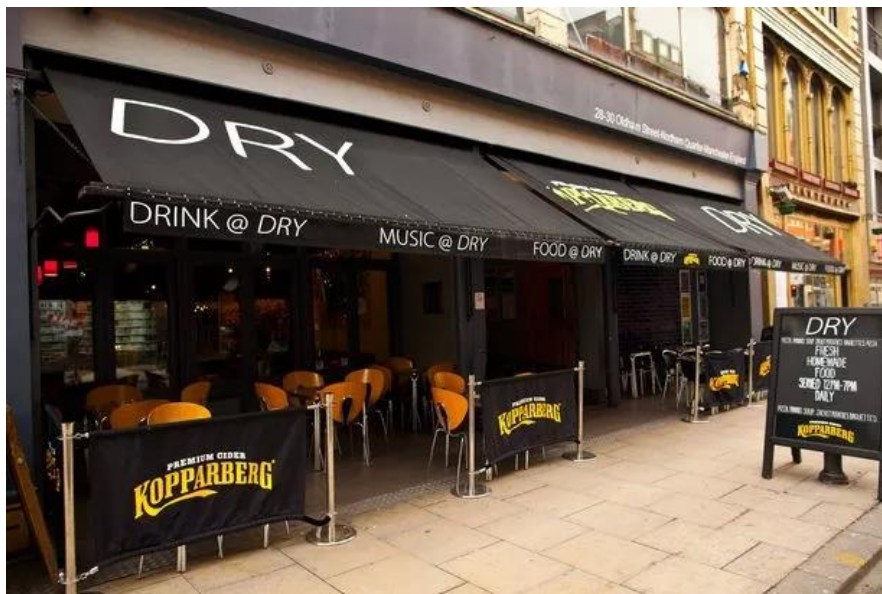
Overall design to match existing- see photograph below indicating assumed existing awning arrangement.

- Structure: The replacement awning will feature a robust and durable three-piece design, providing optimal shading and weather protection for the shopfront. The traditional style will complement the overall aesthetic of the refurbished shopfront, adding a touch of classic charm.
- Size / extent: to match existing size.
