## 48 King Street Planning Comments – 140293/LO/2024

Project: 48 King Street,  
Manchester.

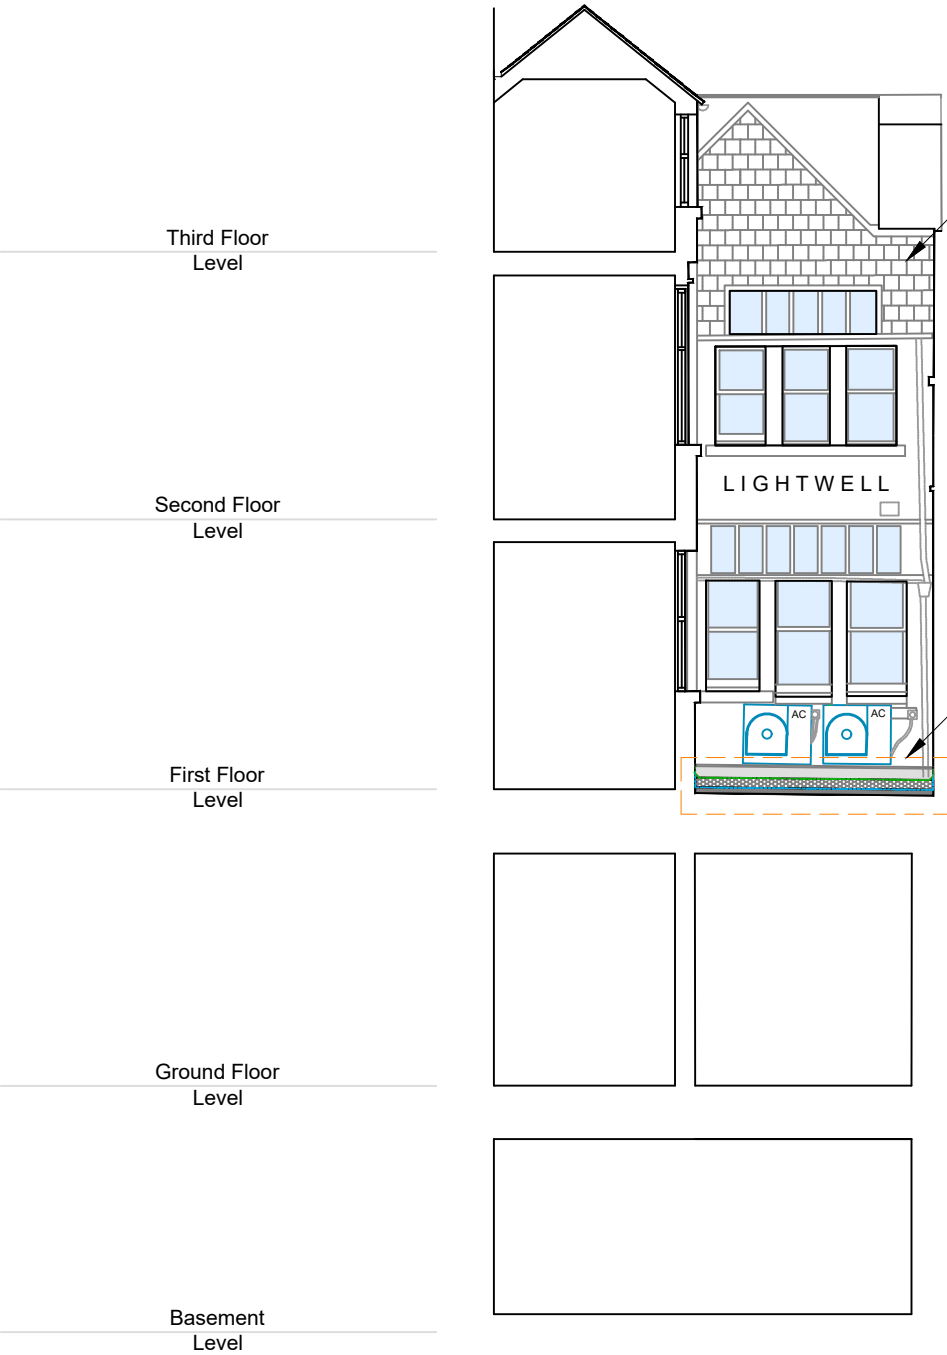
Pitched Slate Roofs:

Remove all ridge & verge slate tiles and set aside for re-use.

Remove battens and underlay and replace with new breathable  
breathable roofing membrane (Permavent Red) and treated  
battens.

Re-fit retained slates and utilise previously removed ridge &  
verge slate tiles. Allow for the replacement of damaged tiles with  
new to match (Welsh / Cambrian slate).

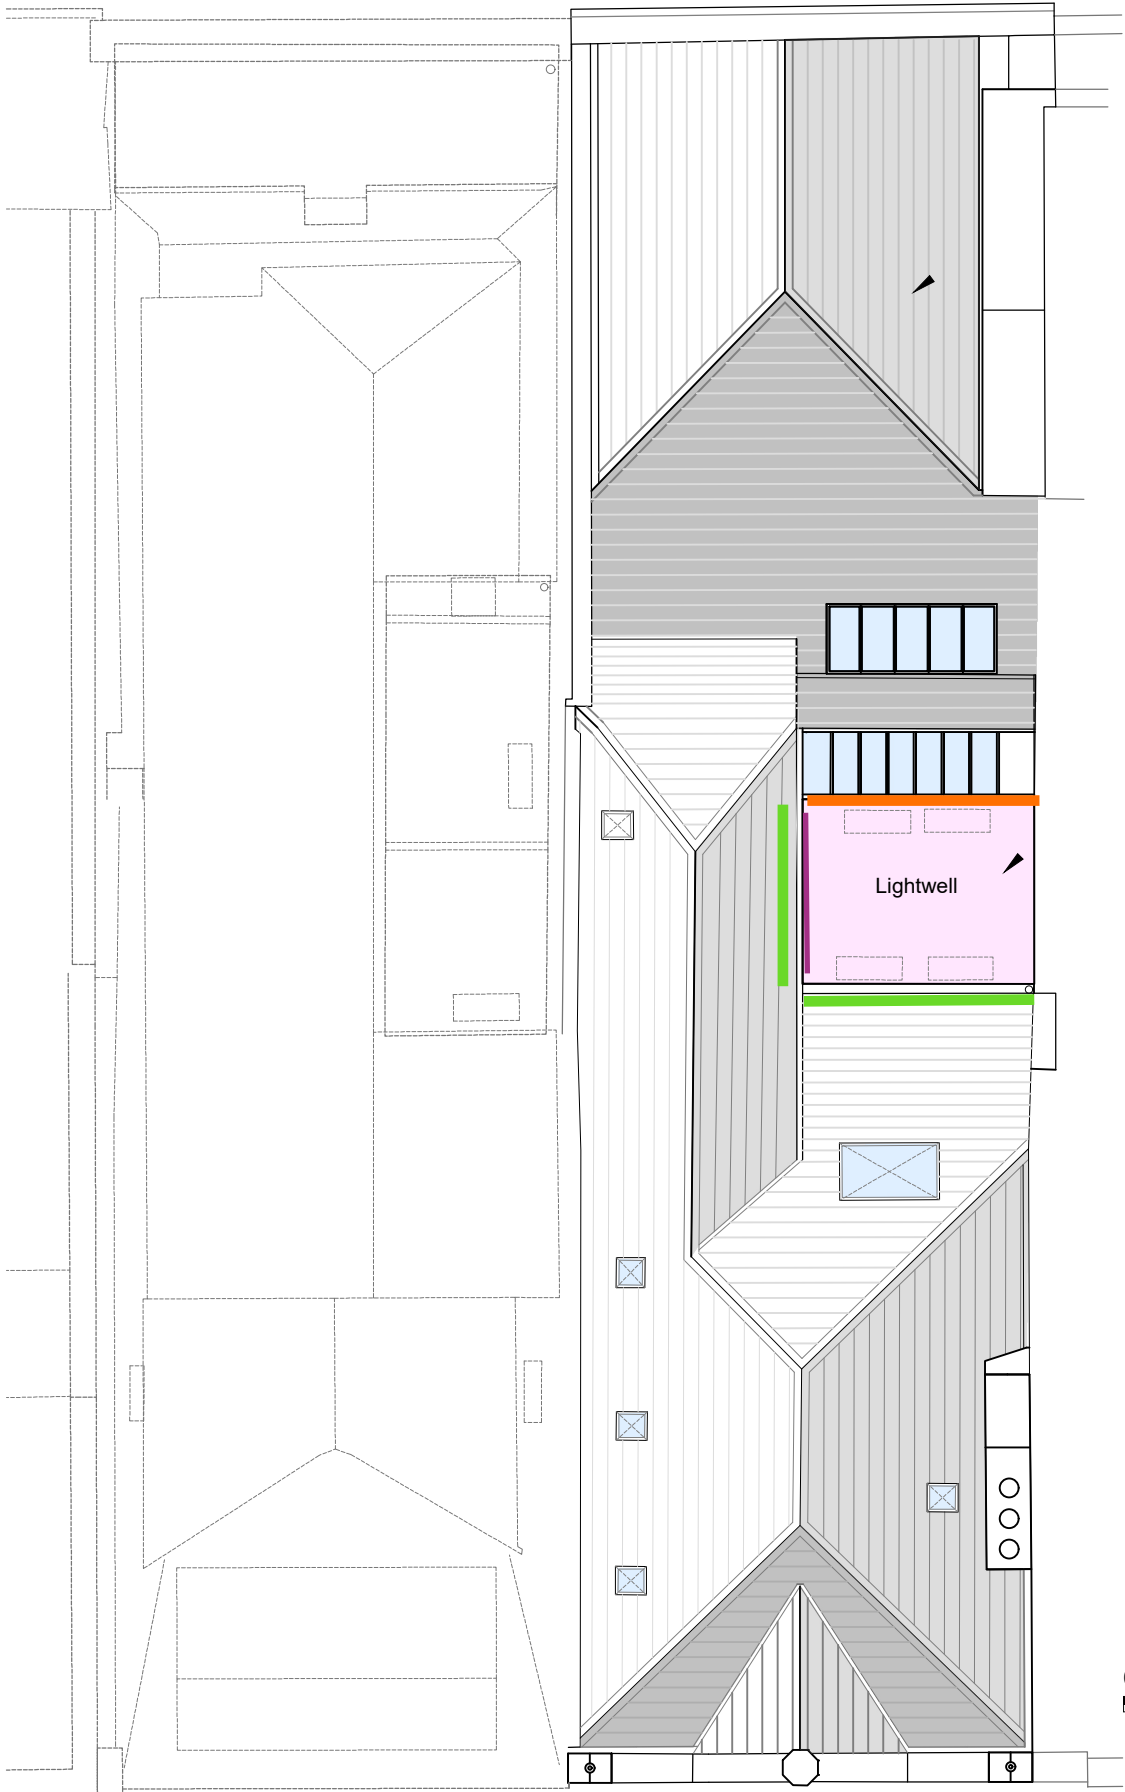
50 King Street  
**PROPOSED -**  
SCHEMATIC ROOF PLAN:  
48 King Street

Replacement cast iron gutter
-

uPVC gutter in repair. No works planned
