# Chetham's School of Music, Manchester

## Results of Architectural Paint Research

31/01/2024

| Nature of Project | Architectural Paint Research to selected interior facets within the fire damaged music hall. |

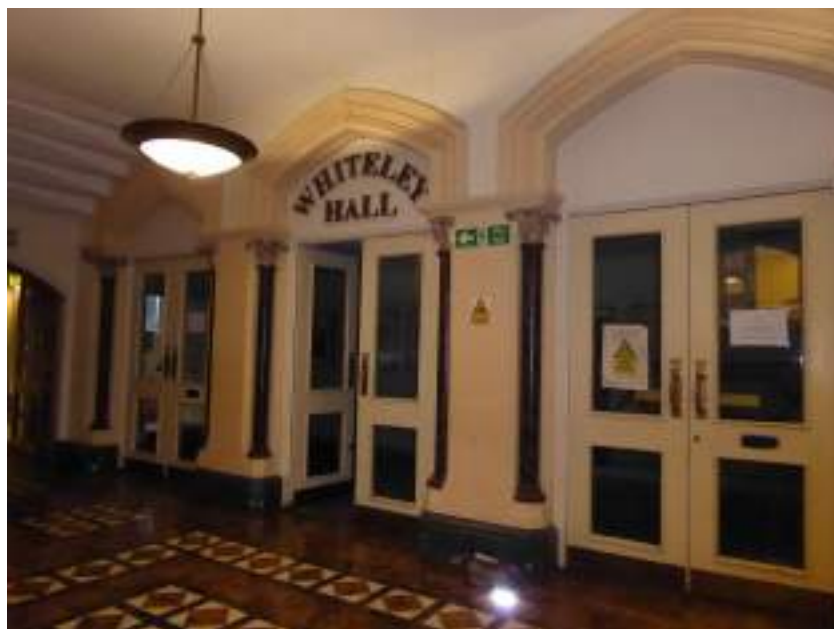
*Figure 20: entrance hall showing doors into the Whiteley Hall on the day of sampling.*

The base of the columns to the entrance hall are painted with a dark brown colour paint and the stone columns are finished with an imitation marble paint scheme. It was noted that the floor finish in this area was

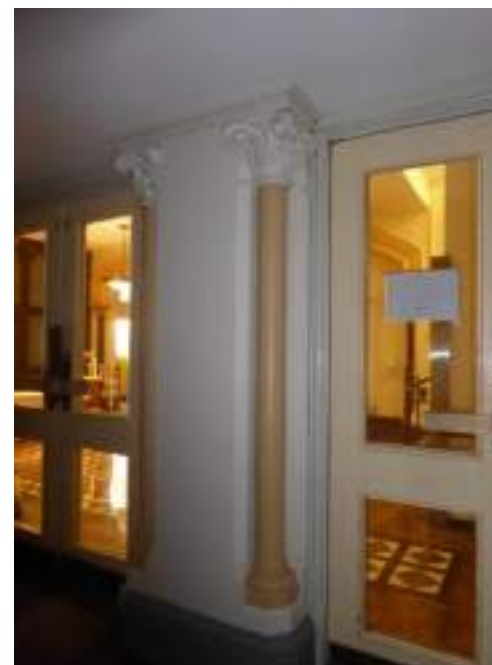
made up of a number of brown and cream colour floor tiles. By contrast the area within the vestibule has been painted white to the wall with a cream-yellow colour to the retained columns and a grey colour to the skirting. In this area the carved stone capitals have been painted white.

*Figure 21: image of the entrance vestibule to the main entrance foyer as seen on the day of sampling.*

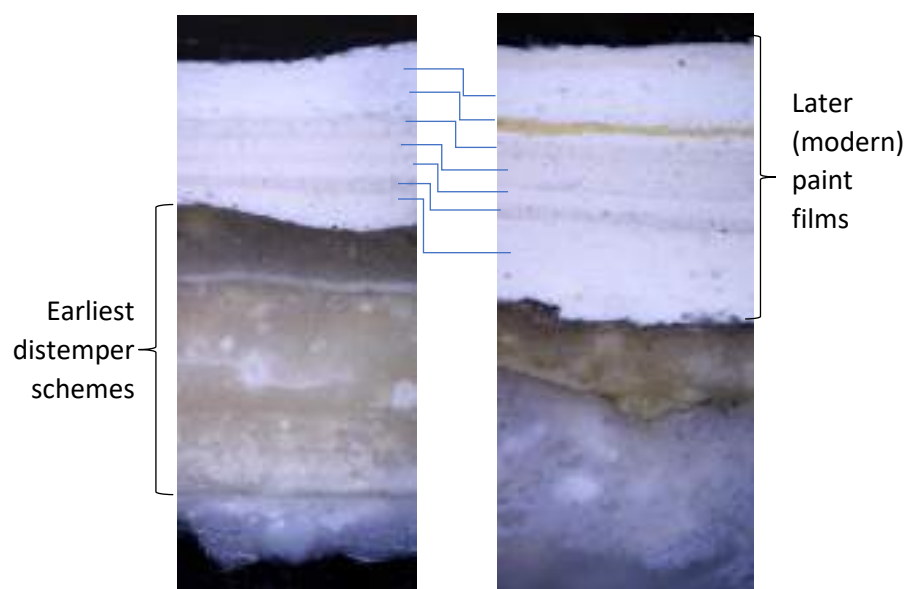
Analysis of samples taken from the ceiling and cornice would indicate initial use of distemper applied to the plaster. In the most part these have been applied without any apparent addition of any pigments so would appear as an off-white colour to the plaster due to the natural appearance of the distemper. Further analysis may indicate use of distemper or whiting, but both were a common method employed where decoration of a plaster ceiling could be undertaken whilst allowing lime plaster to continue to carbonate, a process that could take up to two years to complete. This type of paint was also relatively cheap to make and renew with the ability to wash off the existing scheme prior to the application of a new paint film. There appears to be in the region of five schemes of distemper seen in samples to the ceiling facets (Figure 22).

Figure 22: sample 26 (left) and sample 23 (right) taken from the ceiling.

There is evidence of dirt films between some of the schemes with some apparent yellowing of the distemper (see Figure 22). This would suggest perhaps that there was some tonal variation across the ceiling though there is no evidence of polychromy often employed with the picking in of facets in the Victorian period. It may be that the functional nature of this space within the grammar school required a simple and easy to maintain scheme of decoration to the ceiling. Dirt films between schemes can also be evidence of pollutants (such as from gas lighting) or an indication of the length of time between redecoration.

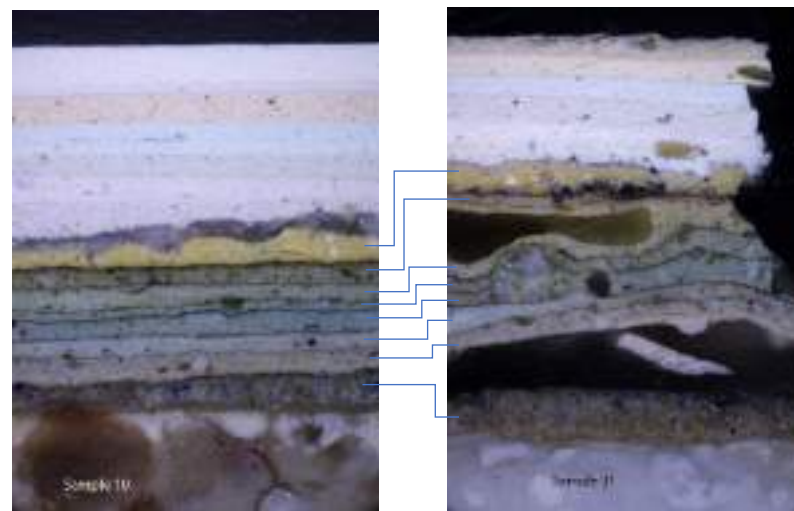
The images shown in Figure 28 illustrate the comparable treatment of the upper section of the wall with the middle section. There is a slight variation in the last green colour scheme with a stone colour seen preceding the yellow in the right-hand sample but generally the treatment of the wall varied at the lower level during the use of the dark red colour.

*Figure 28: comparison of sample 10 from the mid-wall height and sample 31 from upper wall.*

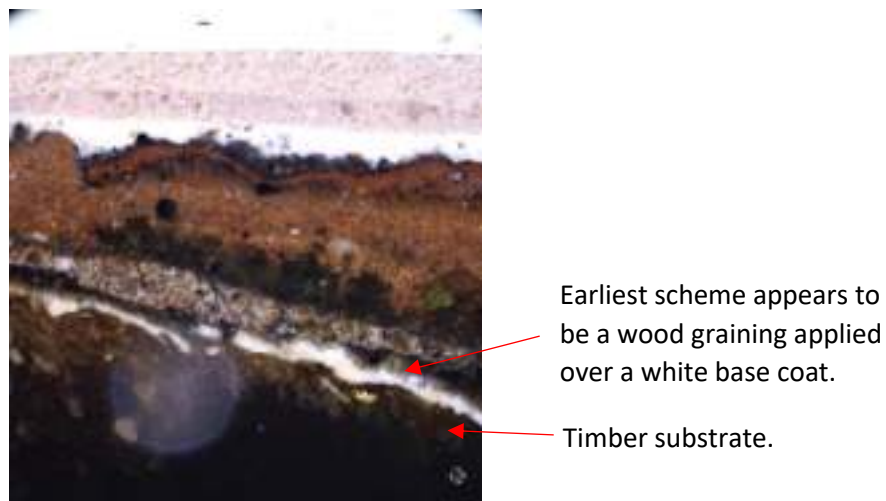
*Figure 31: detail of sample 01 taken at 200x magnification.*

Evidence of a brown colour applied to the skirting. There is an initial cream colour seen in the samples with a darker film apparent as shown in Figure 31 this would suggest the use of a graining scheme however this was extremely difficult to expose, and a colour reference couldn't be recorded. It is not conclusive that this early scheme to the skirting is coeval with scheme three to the walls.

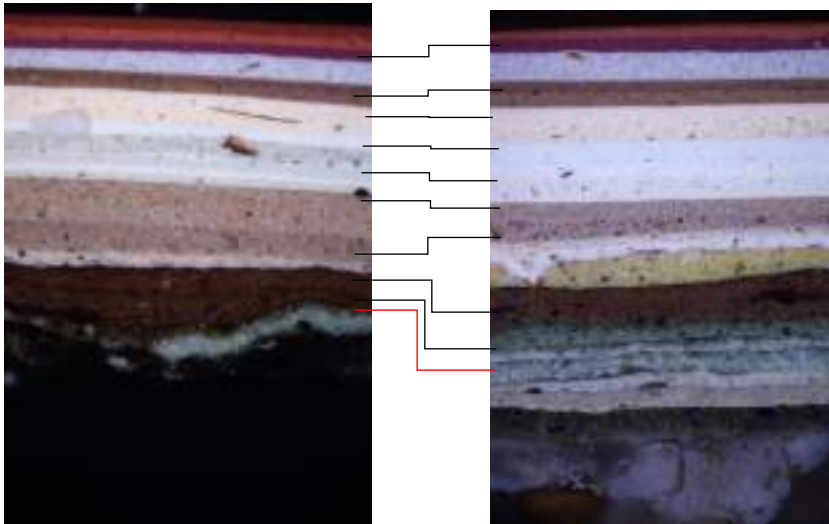
appears almost off-white in cross section as seen to the right-hand image in Figure 32, however when exposed the effect is a soft pale green colour.

*Figure 32: Sample 03 (left) and 04 (right) taken at 200x magnification showing treatment of lower wall and skirting timber.*

Renewed use of brown colour to the skirting and sample 03 contains evidence of the blue-grey colour from the walls within this sample indicating that the decorator likely painted over the top edge of the skirting when painting the wall before returning and painting the skirting. This evidence was only seen in this sample and corresponded to the same colour seen in sample 04 from the lower portion of the wall that was later incorporated into an extension of the height of the skirting (see Figure 32).

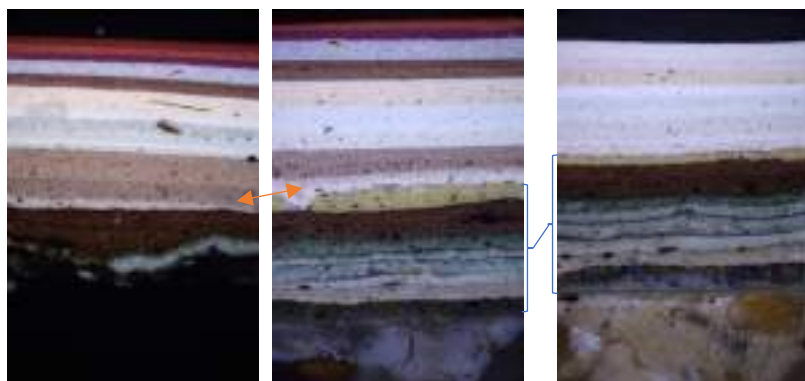
More concise use of an orange-brown colour to the three lower samples from the skirting indicating that at this point the timber moulding (sample 03) was the top of the skirting and sample 04 from the lower wall was not yet incorporated into the line of skirting (see Figure 34 below) .

The orange arrow indicates where the lower section of the wall (sample 4) starts to be treated as part of the skirting rather than section of the wall.

*Figure 34: Comparison of sample 03(left), sample 04 (centre) and sample 06 (right)*

Pink colour seen in samples taken from the skirting timbers. This colour is seen in sample 04 indicating that this was now treated as part of the skirting rather than the wall (refer Figure 34). This scheme shows the first paint films to sample 05 and sample 14 further indicating that the timber baton was now applied to the wall to provide the impression of a deeper skirting than previously seen in the space. The paint appears to have been applied in an oil alkyd type paint (not tested) suggesting this scheme post-dates the Second World War.

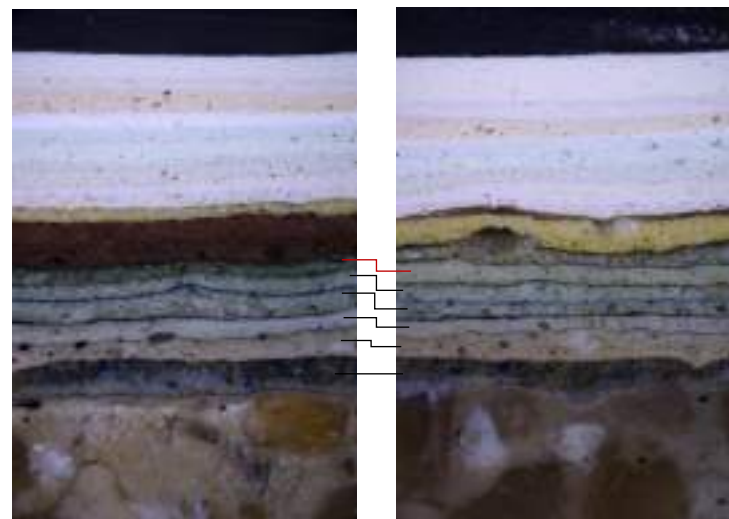
The samples shown in Figure 35 below illustrate the correlation of paint films with scheme six identified by a red line to show the colour change seen.

*Figure 35: Comparison of samples 06 & 08 from the wall (at 200x magnification)*

Continuation of the use of green colour scheme though the appearance of the colour varies with a blue-green used to much of the lower wall and a more vibrant green colour seen to the mid-section (see Figure 35). The paint films at the upper level are disrupted though fragmentary evidence of the paint films does not indicate the vibrant green colour seen to the mid height walls. Evidence suggests this there may have been a cream (stone) colour used to the upper level.

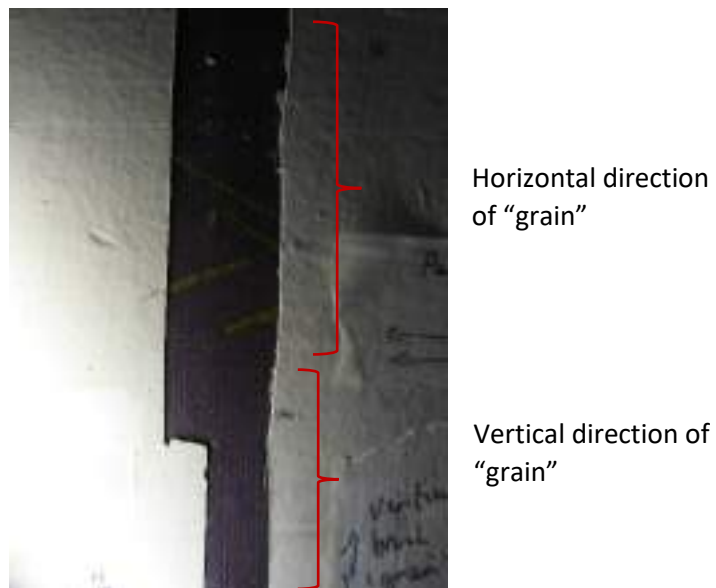
Figure 37: image of scheme 7 showing "grain" effect in the brush strokes.

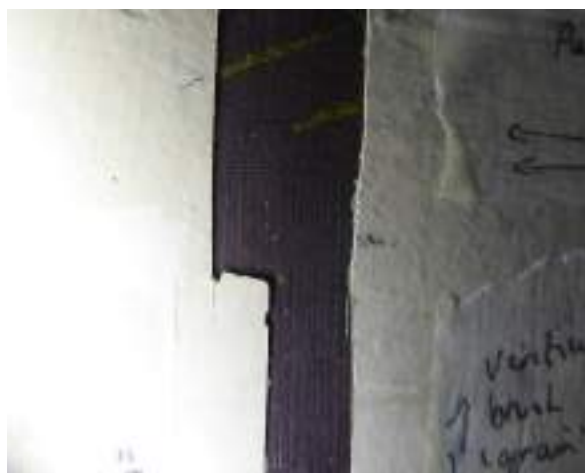
Figure 38: detail of textured paint finish shown in previous image.

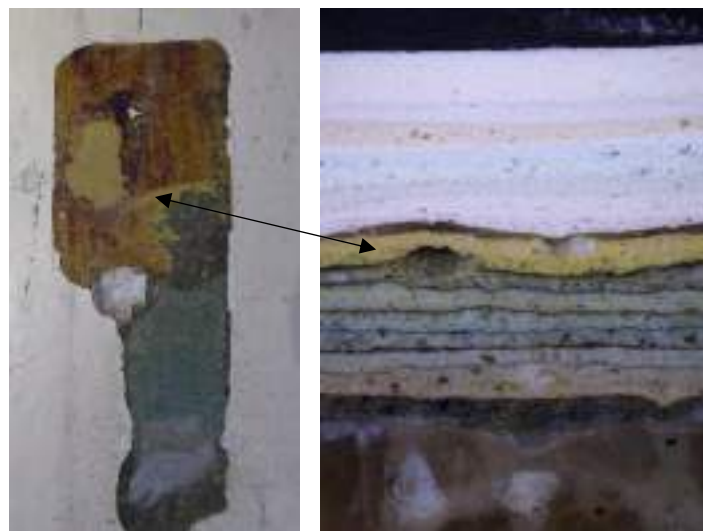
Figure 39: detail of the exposed yellow scheme (08) shown alongside a paint cross section.

colour would suggest that the room is now painted with a single colour to the walls though the paint films in samples taken from the window arch are disrupted and the treatment cannot be determined. Oil based varnish film noted in one sample but also recorded in exposure of paint films as illustrated in Figure 39.

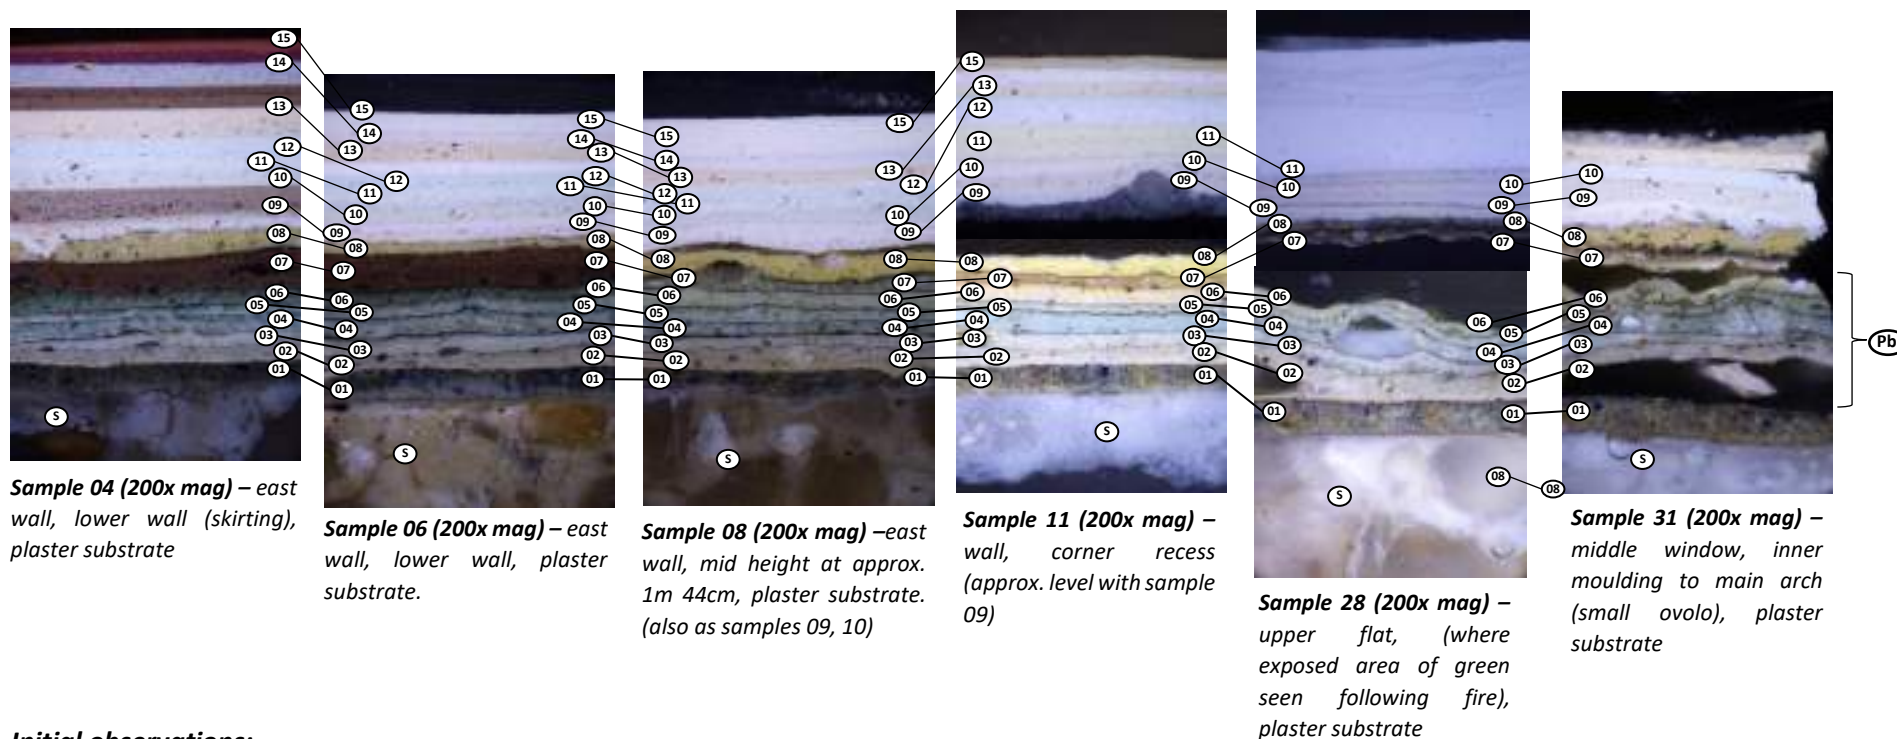
- Samples taken from wall show a comparable use of colour from the earliest grey distemper-based scheme through use of green and then red in samples taken from the lower wall. Sample 08 taken from the mid-height of the wall shows the upper section of wall was not treated in the same manner at this stage.
- A strong yellow colour is seen at scheme 08 applied to samples except that taken from upper wall section.
- Later schemes of decoration have largely been applied in pastel / off-white schemes in twentieth century modern paint films.
- Strong colour seen in samples to the skirting section of the lower wall (sample 04) where brown, purple and red are seen.
- Schemes 02 – 07 test positive for the presence of lead.

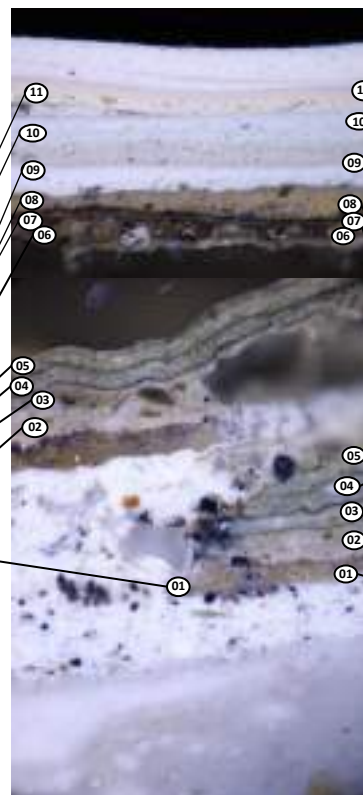
**Sample 32 (200x mag)**– upper wall, centre window, main inner arch, vertical flat, plaster substrate.

- Samples taken from upper section of west elevation include samples from around the window arch.
- All samples contain the earliest grey colour seen in samples from the lower wall.
- Sample 32 shows a fracture in the paint films that has allowed later (modern) paint film to bleed through the schemes.
- Samples indicate that there was little variation in the scheme from the lower wall up to the cornice with the exception of the bevel edge of the window arch which was repeatedly painted a stone colour rather than green.
- No dark red seen in the samples taken from the upper wall.

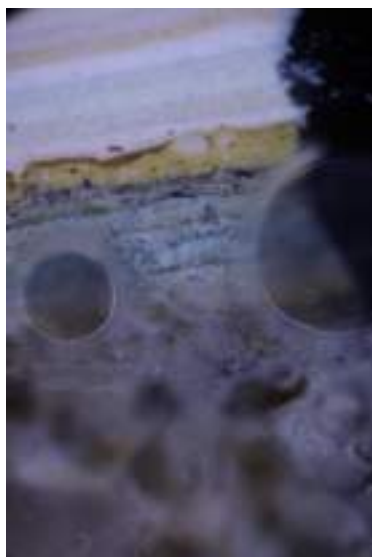
**Sample 08 (200x) Hcl**

*Test with dilute hydrochloric acid tests for the presence of carbonates found both in lead-based paints (lead carbonate) and in distempers and limewashes. Strong effervescence in the earliest grey colour confirms presence of carbonates.*

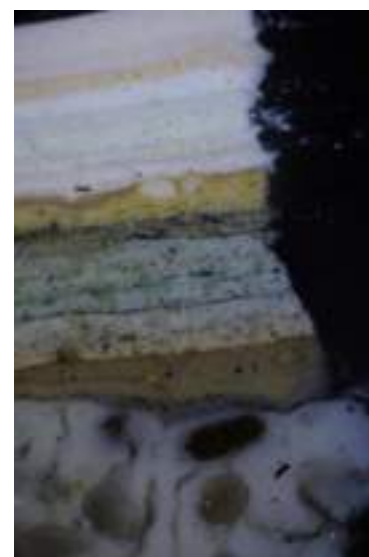
**Sample 08 (200x mag) – after Hcl**

*Test with dilute hydrochloric acid to the blue pigments in the earliest grey paint film indicates artificial ultramarine. Note bleaching of the blue to leave the yellow pigment.*
