# Arboricultural Appraisal Report

## Subsidence Damage Investigation at:

6 Scarsdale Road  
Manchester  
M14 5PS

| REPORT DATE: | 15/03/2024 |

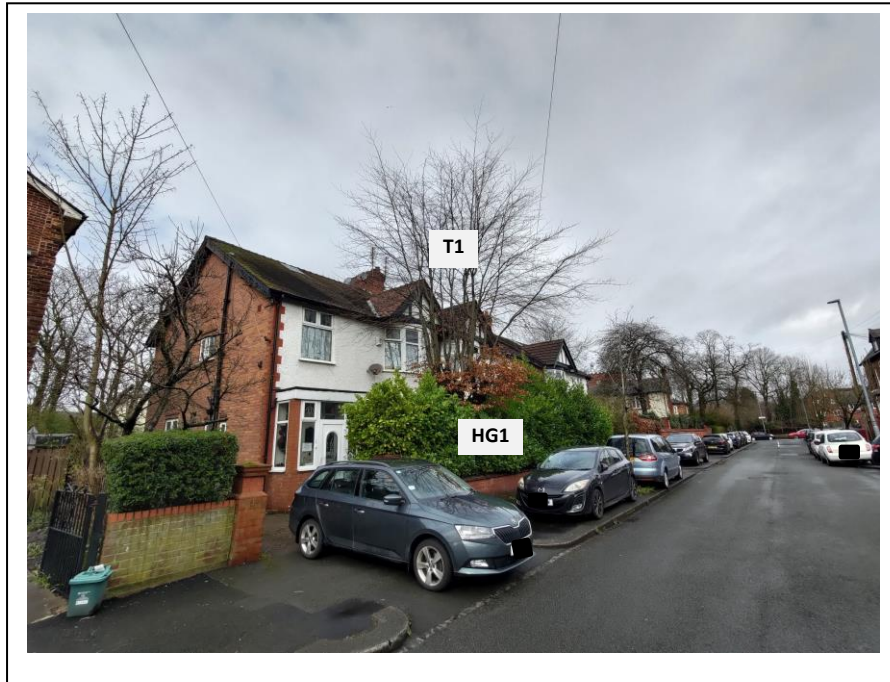
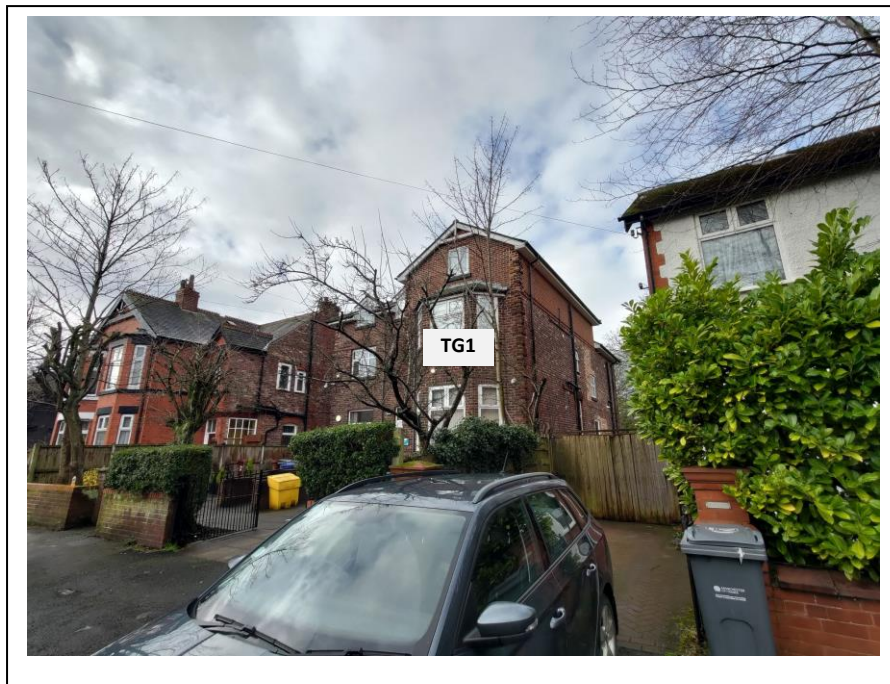
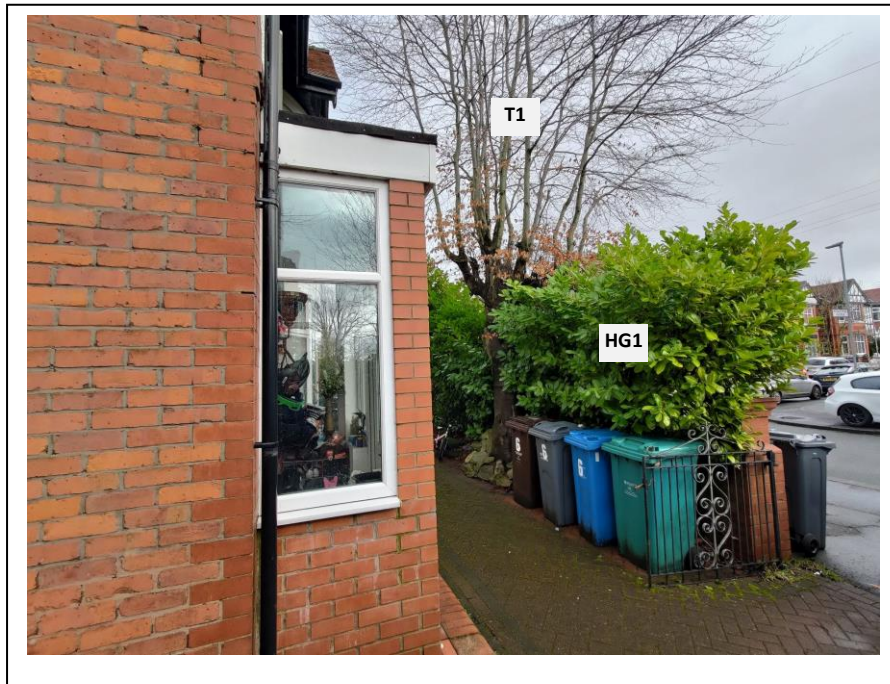
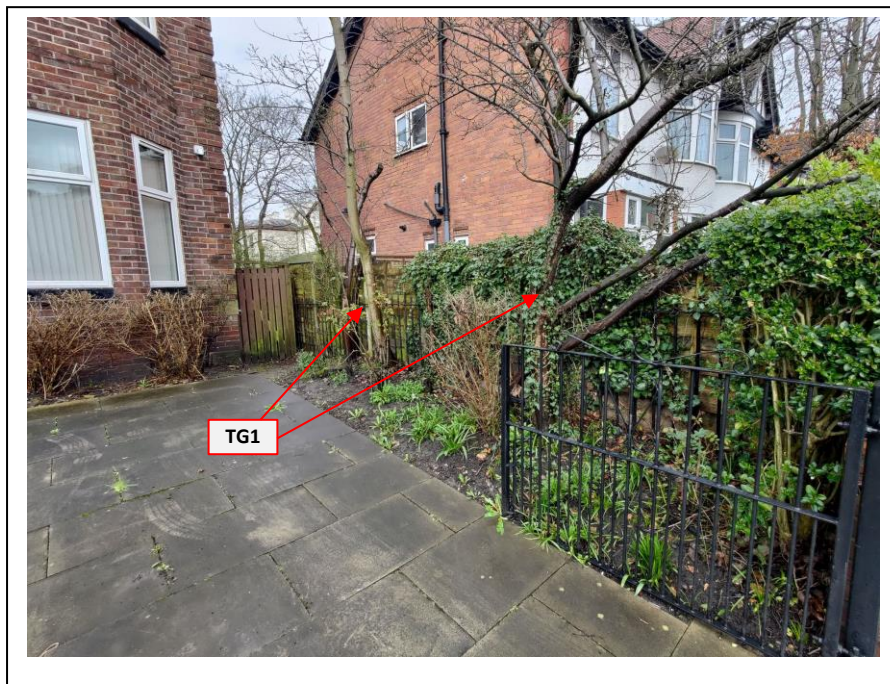
Samples recovered from TP/BH1 have been positively identified (using anatomical analysis) as *Fagus*, *Prunus* and *Acer*, the origin of which will be T1, HG1 and the associated elements of TG1 confirming their influence on the soils below the foundations.

Based on the information currently available, engineering opinion and our own site assessment we conclude there is damage consistent with shrinkage of the clay fraction exacerbated by the soil drying effects of vegetation.

If an arboricultural solution is to be implemented to mitigate the influence of the trees/vegetation considered to be responsible for the movement/damage, works set out at Table 1 below are recommended.
