# Investigative Works Findings

35 King Street

March 2024

**Mark Pinney**  
ASSOCIATES

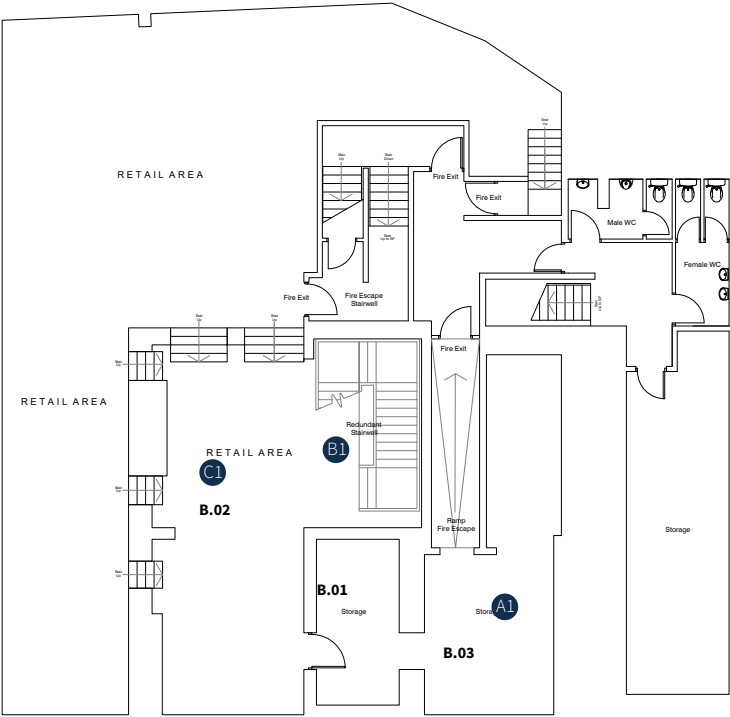
| TAG | CATEGORY | LOCATION | PURPOSE AND EXPECTATION | METHOD | FINDINGS |
|---|---|---|---|---|---|
| A1 | Opening into the ceiling above | B.03<br> | To understand the ground floor build up.<br><br>We are expecting to find a concrete deck. | Firstly a 10mm hole will be drilled in the ceiling to ascertain the build up. If the build up cannot be ascertained from the hole then a 300x300mm section of the ceiling will be carefully removed to reveal the construction above and closed up after investigation.<br><br>Opening to be located in the east side of the storage area. | Non-original concrete deck found. |

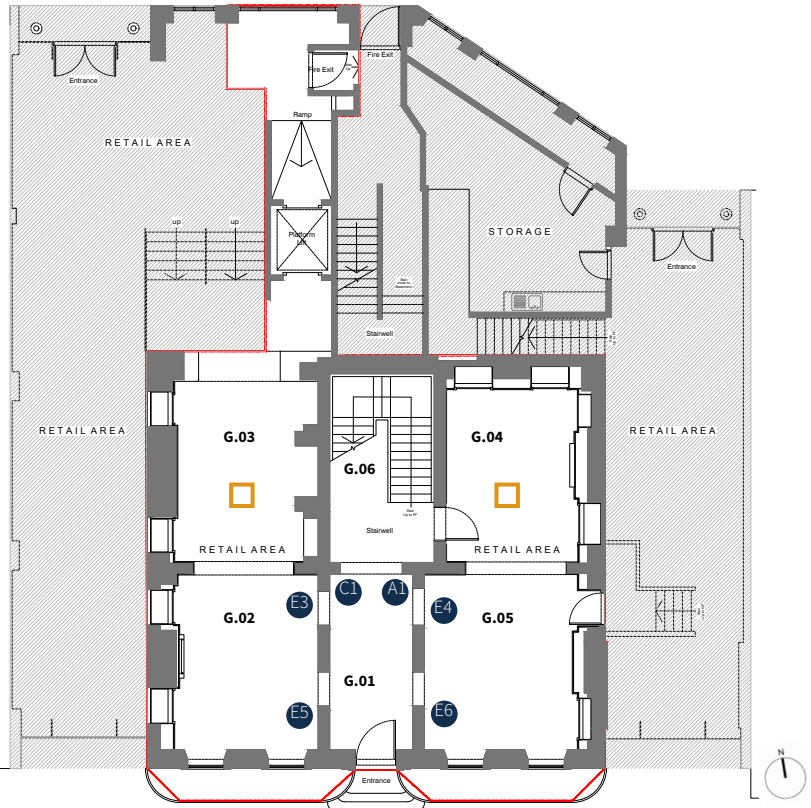
| TAG | CATEGORY | LOCATION | PURPOSE AND EXPECTATION | METHOD | FINDINGS |
|---|---|---|---|---|---|
| E5 | Opening into the ceiling above | G.02<br> | To understand if there is any steelwork or lintels in this area and to find out if services can run horizontally within the ceiling void. We are expecting to find a concrete beam. | Firstly a 10mm hole will be drilled in the ceiling to ascertain the build up. If the build up cannot be ascertained from the hole then a 300x300mm section of the ceiling will be carefully removed to reveal the construction above and closed up after investigation.<br>Opening to be located above the doorway at the south east end of the room. | Non-original plasterboard ceiling suspended under concrete slab found. |
| E6 | Opening into the ceiling above | G.05<br> | To understand if there is any steelwork or lintels in this area and to find out if services can run horizontally within the ceiling void. We are expecting to find a concrete beam. | Firstly a 10mm hole will be drilled in the ceiling to ascertain the build up. If the build up cannot be ascertained from the hole then a 300x300mm section of the ceiling will be carefully removed to reveal the construction above and closed up after investigation.<br>Opening to be located above the doorway at the south west end of the room. | Non-original plasterboard ceiling suspended under concrete slab found. |

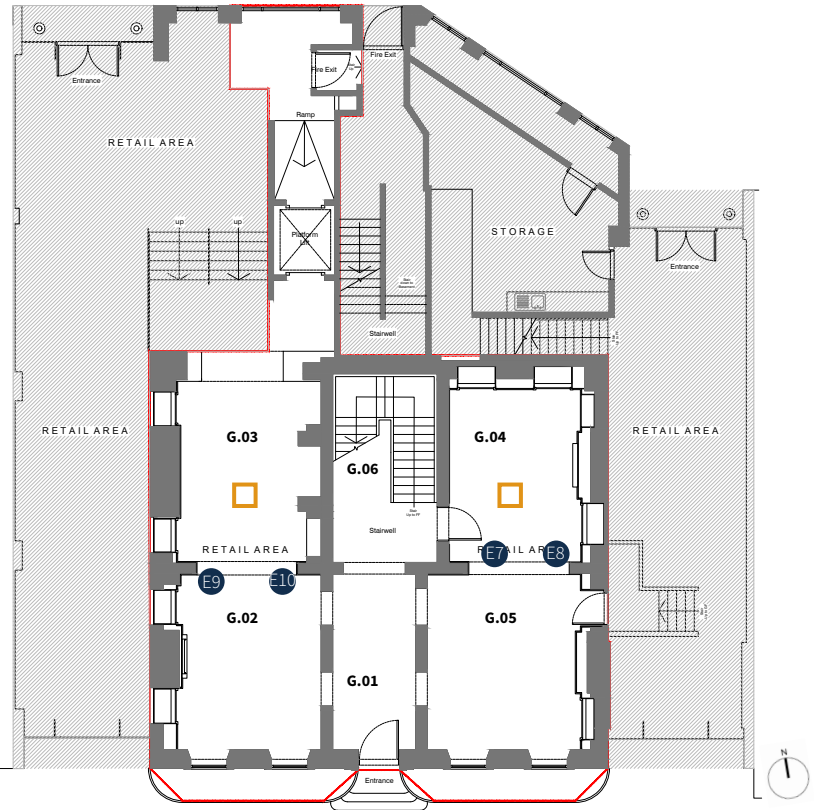
| TAG | CATEGORY | LOCATION | PURPOSE AND EXPECTATION | METHOD | FINDINGS |
|---|---|---|---|---|---|
| E9 | Opening into the ceiling above | G.02<br> | To understand if there is any steelwork or lintels in this area and to find out if services can run horizontally within the ceiling void.<br><br>We are expecting to find a concrete beam. | Firstly a 10mm hole will be drilled in the ceiling to ascertain the build up. If the build up cannot be ascertained from the hole then a 300x300mm section of the ceiling will be carefully removed to reveal the construction above and closed up after investigation.<br><br>Opening to be located in the corner at the north west of the room. | Non-original plasterboard ceiling<br>suspended under concrete slab found. |
| E10 | Opening into the ceiling above | G.02<br> | To understand if there is any steelwork or lintels in this area and to find out if services can run horizontally within the ceiling void.<br><br>We are expecting to find a concrete beam. | Firstly a 10mm hole will be drilled in the ceiling to ascertain the build up. If the build up cannot be ascertained from the hole then a 300x300mm section of the ceiling will be carefully removed to reveal the construction above and closed up after investigation.<br><br>Opening to be located in the corner at the north east of the room. | Non-original plasterboard ceiling<br>suspended under concrete slab found. |

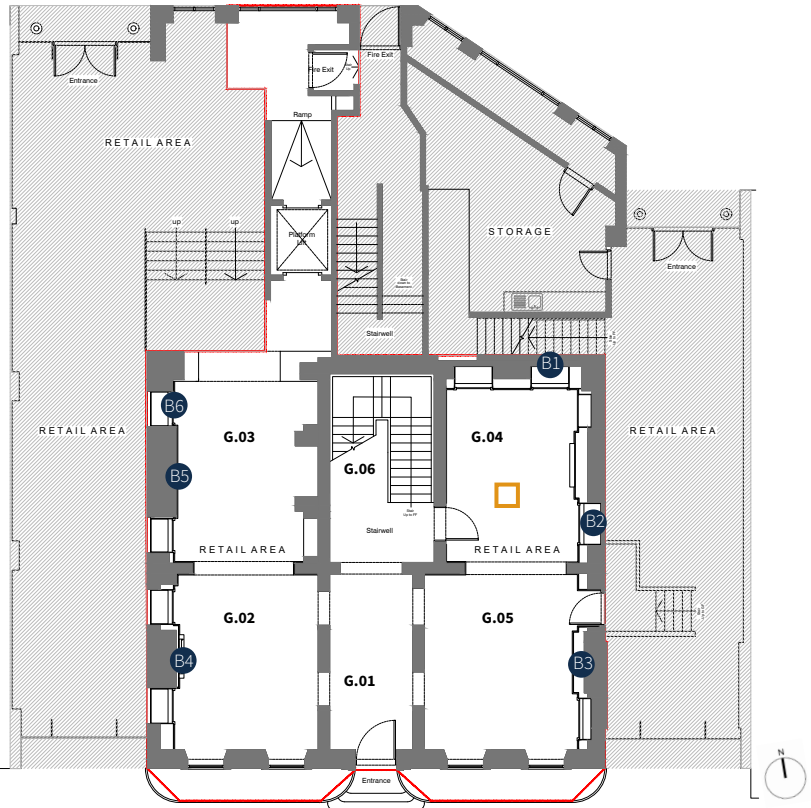
| TAG | CATEGORY | LOCATION | PURPOSE AND EXPECTATION | METHOD | FINDINGS |
|---|---|---|---|---|---|
| B1 | Opening into the wall | G.04<br> | To determine whether the wall is made of brick and examine the condition of the brick.<br><br>We are expecting to find brick-work. | Firstly a 10mm hole will be drilled in the wall to ascertain the wall build up. If the build up cannot be ascertained from the hole then a 300x300mm section of the plasterboard/panelling will be carefully removed to reveal the wall construction behind and closed up after investigation. | Non-original wall lining to brick wall found. |
| B2 | Opening into the wall | G.04<br> | To examine the wall build up and wall finish.<br><br>We are expecting to find brick-work. | Firstly a 10mm hole will be drilled in the wall to ascertain the wall build up. If the build up cannot be ascertained from the hole then a 300x300mm section of the plasterboard/panelling will be carefully removed to reveal the wall construction behind and closed up after investigation. | Non-original wall lining to brick wall found. |
| B3 | Opening into the wall | G.05<br> | To examine the wall build up and wall finish.<br><br>We are expecting to find brick-work or stud wall. | Firstly a 10mm hole will be drilled in the wall to ascertain the wall build up. If the build up cannot be ascertained from the hole then a 300x300mm section of the plasterboard/panelling will be carefully removed to reveal the wall construction behind and closed up after investigation. | Non-original wall lining to brick wall found. |
| B4 | Opening into the wall | G.02<br> | To determine whether the wall is made of brick and examine the condition of the brick.<br><br>We are expecting to find brick-work. | Firstly a 10mm hole will be drilled in the wall to ascertain the wall build up. If the build up cannot be ascertained from the hole then a 300x300mm section of the plasterboard/panelling will be carefully removed to reveal the wall construction behind and closed up after investigation. | Non-original wall lining to brick wall found. |
| B5 | Opening into the wall | G.03<br> | To determine whether the wall is made of brick and examine the condition of the brick.<br><br>We are expecting to find brick-work. | Firstly a 10mm hole will be drilled in the wall to ascertain the wall build up. If the build up cannot be ascertained from the hole then a 300x300mm section of the plasterboard/panelling will be carefully removed to reveal the wall construction behind and closed up after investigation. | Non-original wall lining to brick wall found. |
| B6 | Opening into the wall | G.03<br> | To determine whether the wall is made of brick and examine the condition of the brick.<br><br>We are expecting to find brick-work. | Firstly a 10mm hole will be drilled in the wall to ascertain the wall build up. If the build up cannot be ascertained from the hole then a 300x300mm section of the plasterboard/panelling will be carefully removed to reveal the wall construction behind and closed up after investigation. | Non-original wall lining to brick wall found. |

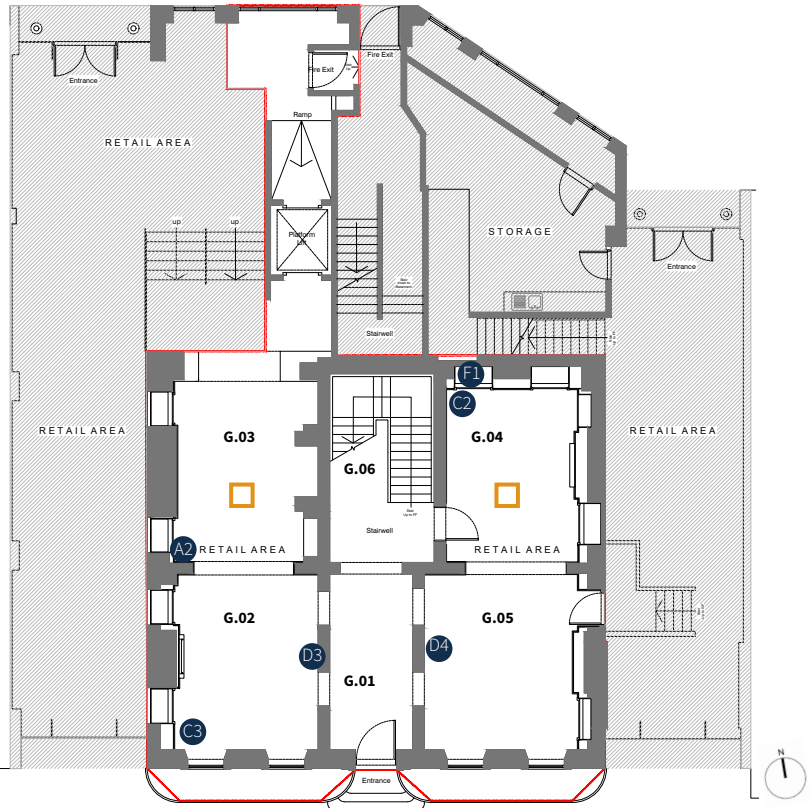
| TAG | CATEGORY | LOCATION | PURPOSE AND EXPECTATION | METHOD | FINDINGS |
|---|---|---|---|---|---|
| D3 | Opening into the wall | G.02<br> | Determine whether the wall is made of brick and examine the condition of the brick.<br><br>We are expecting to find a brick wall or stud wall. | Firstly a 10mm hole will be drilled in the wall to ascertain the wall build up. If the build up cannot be ascertained from the hole then a 300x300mm section of the plasterboard/panelling will be carefully removed to reveal the wall construction behind and closed up after investigation. | Non-original wall lining to brick wall found. |
| D4 | Opening into the wall | G.05<br> | Determine whether the wall is made of brick and examine the condition of the brick.<br><br>We are expecting to find a brick wall or stud wall. | Firstly a 10mm hole will be drilled in the wall to ascertain the wall build up. If the build up cannot be ascertained from the hole then a 300x300mm section of the plasterboard/panelling will be carefully removed to reveal the wall construction behind and closed up after investigation. | Non-original wall lining to brick wall found. |
| F1 | Opening into the ceiling above | G.04<br> | To understand if services can run to the floor above and to see if there is any historic material above the suspended ceiling.<br><br>We are expecting to find a brick wall. | First we would use the existing ceiling hatch for our investigation. If the existing hatch isn't sufficient for the investigation, we would then drill a 10mm hole. If the build up cannot be ascertained from the hole, then we would open up a 300mmx300mm hole for visual structural survey that would be closed up after the investigation.<br><br>Opening to be located in the corner at the north west of the room. | Non-original plasterboard ceiling<br>suspended under concrete slab found. |

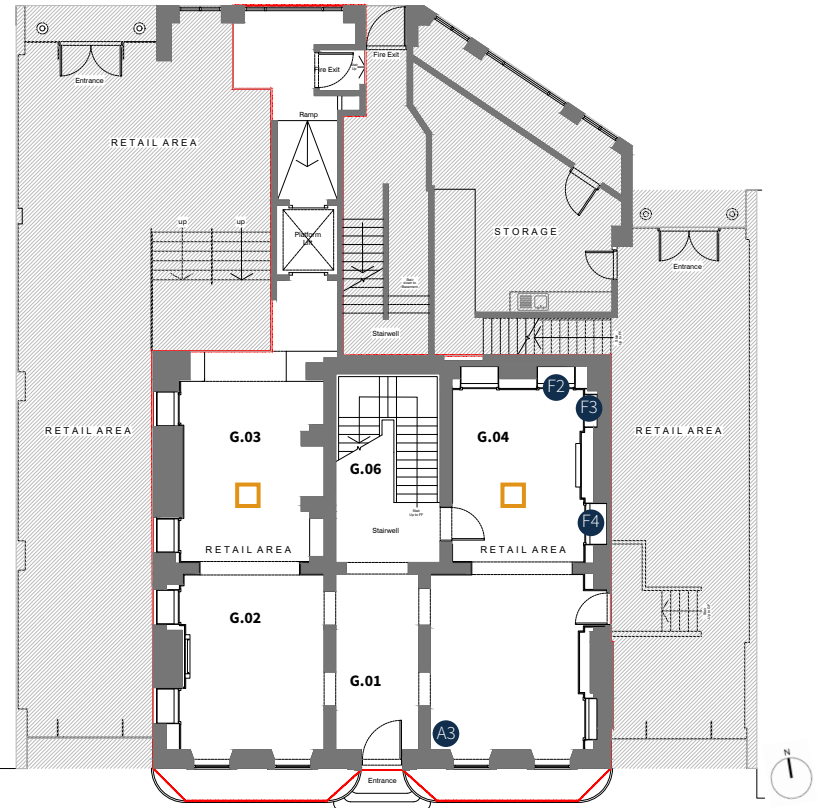
| TAG | CATEGORY | LOCATION | PURPOSE AND EXPECTATION | METHOD | FINDINGS |
|---|---|---|---|---|---|
| F4 | Opening into the ceiling above | G.04<br> | To understand if services can run to the floor above and to see if there is any historic material above the suspended ceiling.<br><br>We are expecting to find a brick wall and concrete beam. | First we would use the existing ceiling hatch for our investigation.<br>If the existing hatch isn't sufficient for the investigation , we would then drill a 10mm hole. If the build up cannot be ascertained from the hole, then we would open up a 300mmx300mm hole for visual structural survey that would be closed up after the investigation.<br><br>Opening to be located in the corner at the south east of the room. | Non-original plasterboard ceiling<br>suspended under concrete slab found. |
| A3 | Opening into the floor | G.05<br> | To understand the structural makeup and thickness of the floor.<br><br>Investigation to be done in multiple locations on ground floor to determine whether there is a consistent floor buildup.<br><br>We are expecting to find a concrete slab. | Determine the installation method of the parquet flooring, whether glued or nailed. For glued parquet, use a heat gun to soften the adhesive and a putty knife to gently pry up the tiles. If nailed, employ a pry bar to carefully lever the tiles up. After removal, clean the backs of the tiles to eliminate any residual adhesive or wood.<br><br>Then we would use 60mm diameter core drilled hole in the south east corner of the room to investigate the concrete. We would the fill the hole and reinstate the parquet. | Non-original modern timber floor on concrete slab found. |

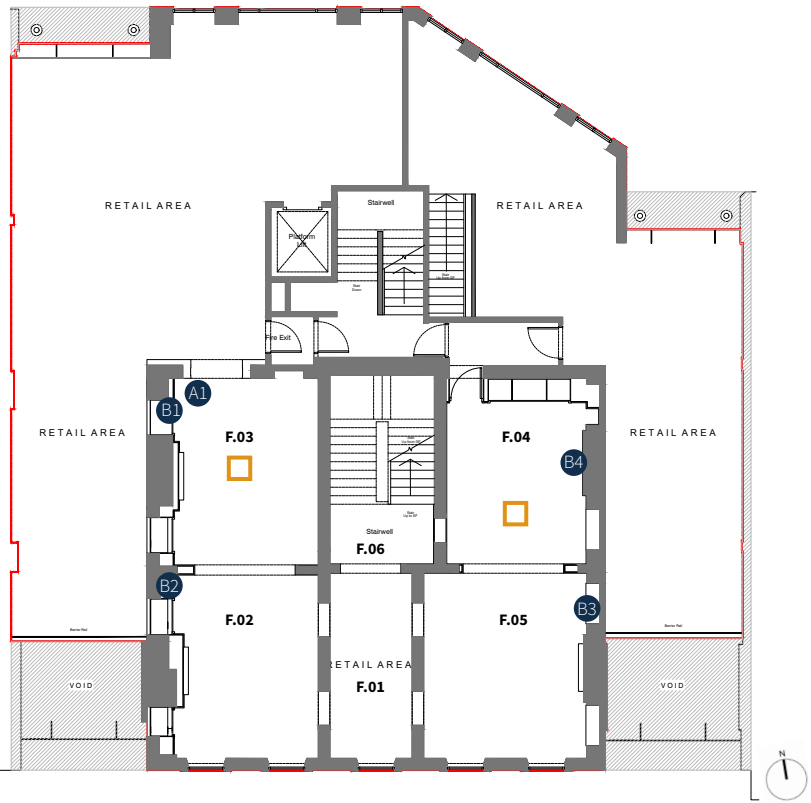
| TAG | CATEGORY | LOCATION | PURPOSE AND EXPECTATION | METHOD | FINDINGS |
|---|---|---|---|---|---|
| B1 | Opening into the wall | F.03<br> | To determine whether the wall is made of brick and examine the condition of the brick.<br><br>We are expecting to find brick-work. | Recommended phased approach to testing existing plasterboard to determine heritage significance through three steps:<br>- If possible, look into the wall build up by removing existing elements chased into the plasterboard (light switches etc.)<br>- If this does not work, or isn't possible, a small hole will be drilled in the wall to see if the wall build up can be seen.<br>- If it is just plasterboard, the full opening up can be completed. If it is historic plaster an agreement will be made with the CO on how to approach it. | Plastered brick wall found. Proposed works will line over existing plaster where wall lining not present. |
| B2 | Opening into the wall | F.02<br> | To determine whether the wall is made of brick and examine the condition of the brick.<br><br>We are expecting to find brick-work. | Firstly a 10mm hole will be drilled in the wall to ascertain the wall build up. If the build up cannot be ascertained from the hole then a 300x300mm section of the plasterboard/panelling will be carefully removed to reveal the wall construction behind and closed up after investigation. | Plastered brick wall found. Proposed works will line over existing plaster where wall lining not present. |
| B3 | Opening into the wall | F.05<br> | To determine whether the wall is made of brick and examine the condition of the brick.<br><br>We are expecting to find brick-work. | Recommended phased approach to testing existing plasterboard to determine heritage significance through three steps:<br>- If possible, look into the wall build up by removing existing elements chased into the plasterboard (light switches etc.)<br>- If this does not work, or isn't possible, a small hole will be drilled in the wall to see if the wall build up can be seen.<br>- If it is just plasterboard, the full opening up can be completed. If it is historic plaster an agreement will be made with the CO on how to approach it. | Plastered brick wall found. Proposed works will line over existing plaster where wall lining not present. |
| B4 | Opening into the wall | F.04<br> | To determine whether the wall is made of brick and examine the condition of the brick.<br><br>We are expecting to find brick-work. | Recommended phased approach to testing existing wall to determine heritage significance through three steps:<br>- If possible, look into the wall build up by removing existing elements chased into the tiles (light switches etc.)<br>- If this does not work, or isn't possible, one glazed tile will be removed to see if the wall build up can be seen.<br>- If it is just plasterboard, the full opening up can be completed. If it is historic plaster an agreement will be made with the CO on how to approach it. | Plastered brick wall found. Proposed works will line over existing plaster where wall lining not present. |

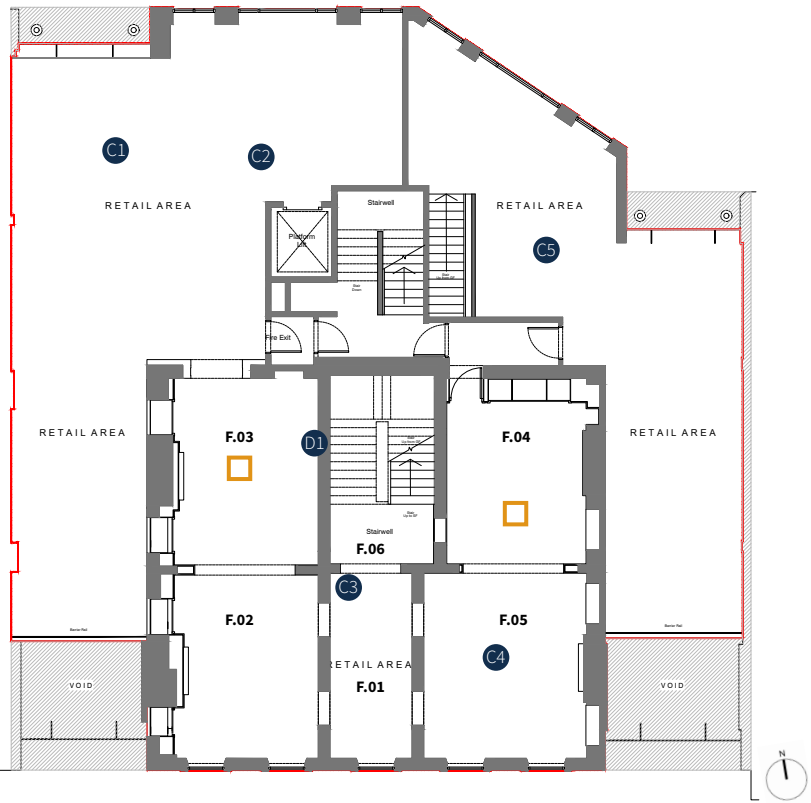
| TAG | CATEGORY | LOCATION | PURPOSE AND EXPECTATION | METHOD | FINDINGS |
|---|---|---|---|---|---|
| C1 | Opening into the ceiling above | | To understand the construction of the roof deck.<br>We are expecting to find concrete slab. We do not believe this is a suspended ceiling, investigative works necessary to understand structural soffit condition and buildup. | First we would use the existing ceiling panel for our investigation. If the existing hatch isn't sufficient for the investigation , we would then drill a 10mm hole. If the build up cannot be ascertained from the hole, then we would open up a 300mmx300mm hole for visual structural survey that would be closed up after the investigation.<br><br>Opening to be located in the corner at the north west of the room. | Non-original composite flat roof profile found. |
| C2 | Opening into the ceiling above | | To understand the construction of the roof deck.<br>We are expecting to find concrete slab. We do not believe this is a suspended ceiling, investigative works necessary to understand structural soffit condition and buildup. | First we would use the existing ceiling panel for our investigation. If the existing hatch isn't sufficient for the investigation , we would then drill a 10mm hole. If the build up cannot be ascertained from the hole, then we would open up a 300mmx300mm hole for visual structural survey that would be closed up after the investigation.<br><br>Opening to be located in the corner at the south east of the room. | Non-original composite flat roof profile found. |
| C5 | Opening into the ceiling above | East retail area | To understand the construction of the roof deck.<br>We are expecting to find concrete slab. We do not believe this is a suspended ceiling, investigative works necessary to understand structural soffit condition and buildup. | First we would use the existing ceiling panel for our investigation. If the existing hatch isn't sufficient for the investigation , we would then drill a 10mm hole. If the build up cannot be ascertained from the hole, then we would open up a 300mmx300mm hole for visual structural survey that would be closed up after the investigation.<br><br>Opening to be located in the corner at the south west of the room. | Non-original composite flat roof profile found. |
| D1 | Opening into the wall | F.03 | To determine whether the wall is made of brick and examine the condition of the brick.<br>We are expecting to find brick or stud wall. | Firstly a 10mm hole will be drilled in the wall to ascertain the wall build up. If the build up cannot be ascertained from the hole then a 300x300mm section of the plasterboard/panelling will be carefully removed to reveal the wall construction behind and closed up after investigation. | Plastered brick wall found. Proposed works will line over existing plaster where wall lining not present. |

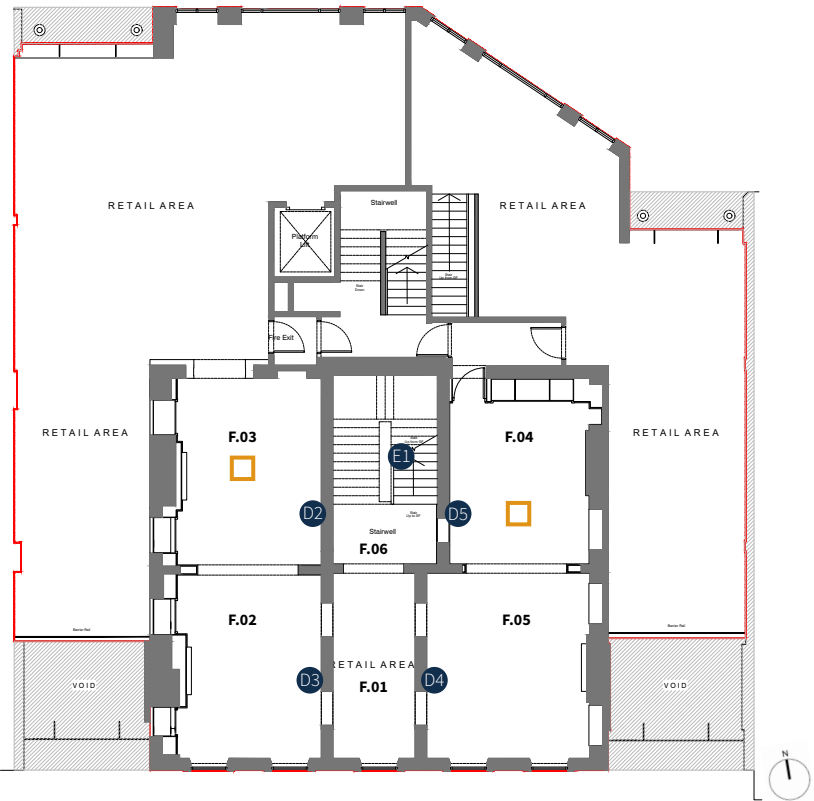
| TAG | CATEGORY | LOCATION | PURPOSE AND EXPECTATION | METHOD | FINDINGS |
|---|---|---|---|---|---|
| D2 | Opening into the wall | F.03<br> | To determine whether the wall is made of brick and examine the condition of the brick.<br><br>We are expecting to find brick or stud wall. | Firstly a 10mm hole will be drilled in the wall to ascertain the wall build up. If the build up cannot be ascertained from the hole then a 300x300mm section of the plasterboard/panelling will be carefully removed to reveal the wall construction behind and closed up after investigation. | Plastered brick wall found.<br>Proposed works will line over existing plaster where wall lining not present. |
| D3 | Opening into the wall | F.02<br> | To determine whether the wall is made of brick and examine the condition of the brick.<br><br>We are expecting to find brick or stud wall. | Firstly a 10mm hole will be drilled in the wall to ascertain the wall build up. If the build up cannot be ascertained from the hole then a 300x300mm section of the plasterboard/panelling will be carefully removed to reveal the wall construction behind and closed up after investigation. | Plastered brick wall found.<br>Proposed works will line over existing plaster where wall lining not present. |
| D4 | Opening into the wall | F.05<br> | To examine the wall build up and wall finish.<br><br>We are expecting to find brick or stud wall. | Firstly a 10mm hole will be drilled in the wall to ascertain the wall build up. If the build up cannot be ascertained from the hole then a 300x300mm section of the plasterboard/panelling will be carefully removed to reveal the wall construction behind and closed up after investigation. | Plastered brick wall found.<br>Proposed works will line over existing plaster where wall lining not present. |
| D5 | Opening into the wall | F.04<br> | To examine the wall build up and wall finish.<br><br>We are expecting to find brick or stud wall. | Firstly a single tile will be carefully removed and a 10mm hole will be drilled in the wall to ascertain the wall build up. If the build up cannot be ascertained from the hole then a 300x300mm section of the tile and plasterboard will be carefully removed to reveal the wall construction behind and closed up after investigation. | Plastered brick wall found.<br>Proposed works will line over existing plaster where wall lining not present. |
| E1 | Expose area of existing stair | F.06<br> | To understand how the stair has been constructed, its condition and load bearing capacity.<br><br>We are expecting to find a steel staircase construction. | Carefully removing a tread board and a section of the perimeter string detail to expose the construction beneath and putting it back in place after the inspection. | Non-original metal staircase with timber finishes. |

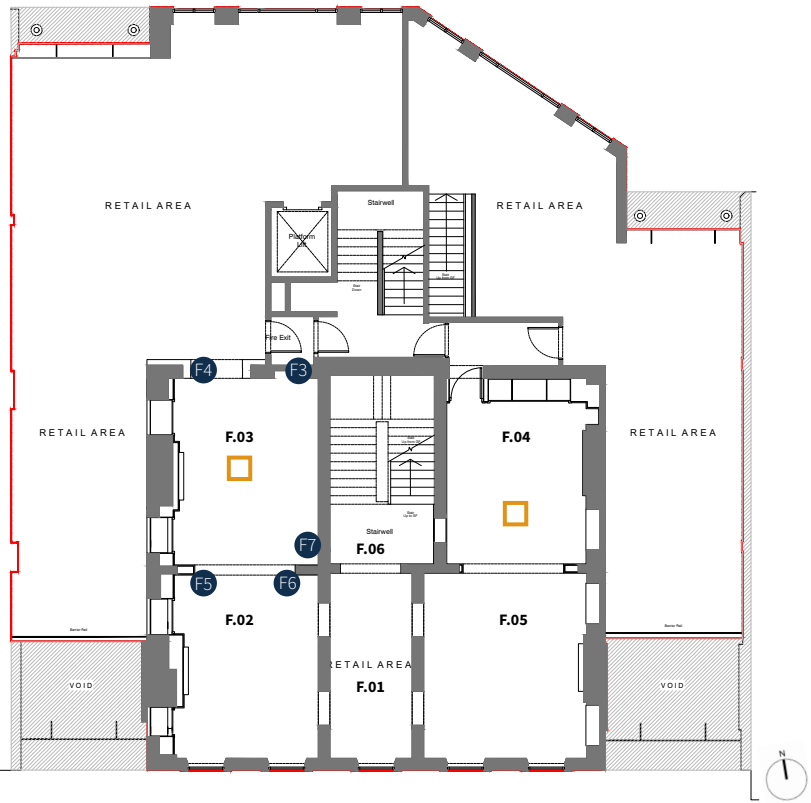
| TAG | CATEGORY | LOCATION | PURPOSE AND EXPECTATION | METHOD | FINDINGS |
|---|---|---|---|---|---|
| F6 | Opening into the ceiling above | F.02<br> | To understand if there is any steelwork or lintels in this area, their size and to find out if services can run horizontally within the ceiling void.<br><br>We are expecting to find a concrete beam. | Firstly a 10mm hole will be drilled in the ceiling to ascertain the build up. If the build up cannot be ascertained from the hole then a 300x300mm section of the ceiling will be carefully removed to reveal the construction above and closed up after investigation.<br><br>Opening to be located in the corner at the north east of the room. | Non-original plasterboard ceiling<br>suspended under concrete slab found. |
| F7 | Opening into the ceiling above | F.03<br> | To understand if there is any steelwork or lintels in this area, their size and to find out if services can run horizontally within the ceiling void.<br><br>We are expecting to find a concrete beam. | First we would use the existing ceiling hatch for our investigation. If the existing hatch isn't sufficient for the investigation , we would then drill a 10mm hole. If the build up cannot be ascertained from the hole, then we would open up a 300mmx300mm hole for visual structural survey that would be closed up after the investigation.<br><br>Opening to be located in the corner at the south east of the room. | Non-original plasterboard ceiling<br>suspended under concrete slab found. |

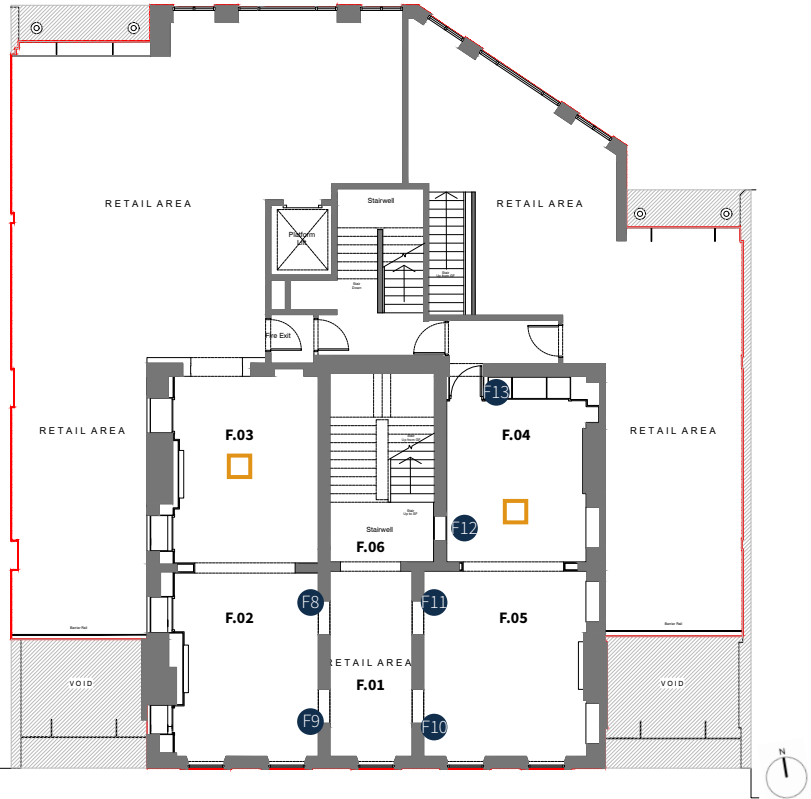
| TAG | CATEGORY | LOCATION | PURPOSE AND EXPECTATION | METHOD | FINDINGS |
|---|---|---|---|---|---|
| F12 | Opening into the ceiling above | F.04<br> | To understand if there is any steelwork or lintels in this area, their size and to find out if services can run horizontally within the ceiling void. We are expecting to find a concrete beam. | First we would use the existing ceiling hatch for our investigation. If the existing hatch isn't sufficient for the investigation , we would then drill a 10mm hole. If the build up cannot be ascertained from the hole, then we would open up a 300mmx300mm hole for visual structural survey that would be closed up after the investigation.<br>Opening to be located in the south west corner of the room. | Non-original plasterboard ceiling suspended under concrete slab found. |
| F13 | Opening into the ceiling above | F.04<br> | To understand if there is any steelwork or lintels in this area, their size and to find out if services can run horizontally within the ceiling void and if the services can run to the floor above. We are expecting to find a concrete beam or brickwork. | First we would use the existing ceiling hatch for our investigation. If the existing hatch isn't sufficient for the investigation , we would then drill a 10mm hole. If the build up cannot be ascertained from the hole, then we would open up a 300mmx300mm hole for visual structural survey that would be closed up after the investigation.<br>Opening to be located in the north west corner of the room. | Non-original plasterboard ceiling suspended under concrete slab found. |

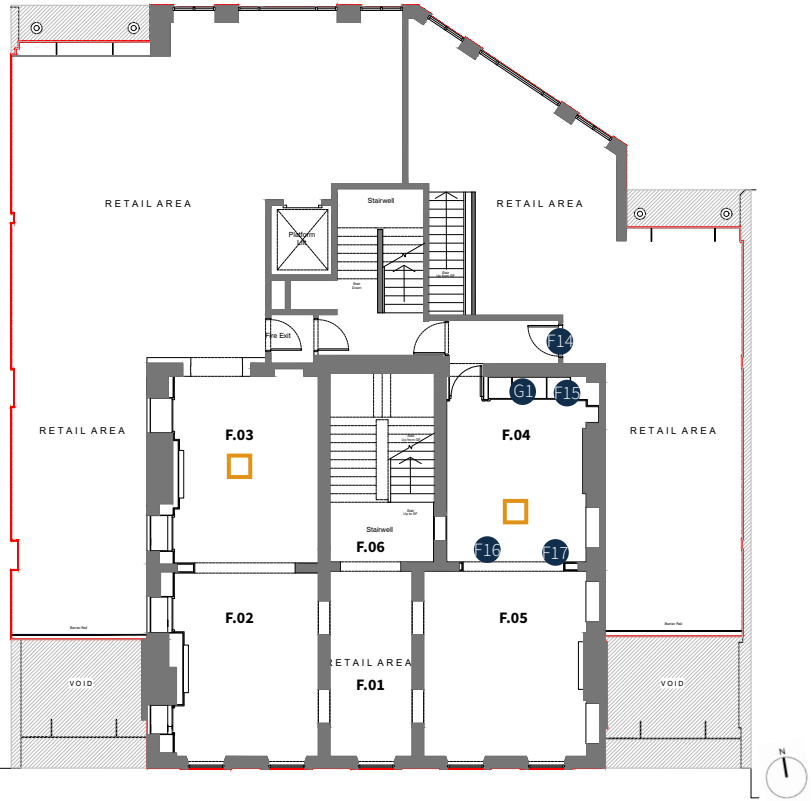
| TAG | CATEGORY | LOCATION | PURPOSE AND EXPECTATION | METHOD | FINDINGS |
|---|---|---|---|---|---|
| F17 | Opening into the ceiling above | F.04<br> | To understand if there is any steelwork or lintels in this area, their size and to find out if services can run horizontally within the ceiling void.<br><br>We are expecting to find a concrete beam. | First we would use the existing ceiling hatch for our investigation.<br>If the existing hatch isn't sufficient for the investigation , we would then drill a 10mm hole. If the build up cannot be ascertained from the hole, then we would open up a 300mmx300mm hole for visual structural survey that would be closed up after the investigation.<br>Opening to be located in the south east corner of the room. | Non-original plasterboard ceiling suspended under concrete slab found. |
| G1 | Opening into the ceiling above | F.04<br> | To understand if services can run to the floor above or if there is structure that will cause issues.<br><br>We are expecting to find concrete beam or brickwork. | First we would use the existing ceiling hatch for our investigation.<br>If the existing hatch isn't sufficient for the investigation , we would then drill a 10mm hole. If the build up cannot be ascertained from the hole, then we would open up a 300mmx300mm hole for visual structural survey that would be closed up after the investigation.<br>Opening to be located in the north side of the room. | Non-original plasterboard ceiling suspended under concrete slab found. |

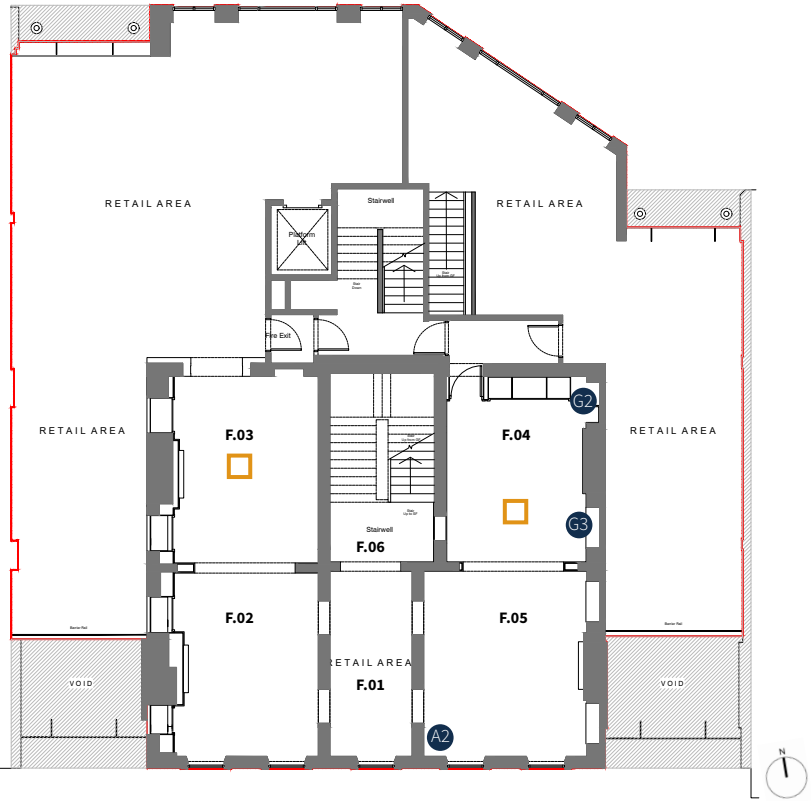
| TAG | CATEGORY | LOCATION | PURPOSE AND EXPECTATION | METHOD | FINDINGS |
|---|---|---|---|---|---|
| G2 | Opening into the floor | F.04<br> | To understand if services can run to the floor above or if there is structure in the way that will cause issues. Investigation to be done in multiple locations on first floor to determine whether there is a consistent floor buildup.<br><br>We are expecting to find concrete beam or brickwork. | Floor board to be taken out, 60mm diameter hole in the north east corner of the room to be core drilled. After inspection has been carried out, hole to be refilled and floor board put back into place. | Non-original modern timber floor on concrete slab found. |
| G3 | Opening into the ceiling above | F.04<br> | To understand if services can run to the floor above or if there is structure in the way that will cause issues.<br><br>We are expecting to find concrete beam or brickwork. | First we would use the existing ceiling hatch for our investigation. If the existing hatch isn't sufficient for the investigation, we would then drill a 10mm hole. If the build up cannot be ascertained from the hole, then we would open up a 300mmx300mm hole for visual structural survey that would be closed up after the investigation.<br>Opening to be located in the north east corner of the room. | Non-original plasterboard ceiling suspended under concrete slab found. |
| A2 | Opening into the floor | F.05<br> | Determine the floor build up and thickness. Investigation to be done in two locations on first floor to determine whether there is a consistent floor buildup.<br><br>We expect to find concrete slab beneath the timber floor. | Floor board to be taken out, 60mm diameter hole in the south east corner of the room to be core drilled. After inspection has been carried out, hole to be refilled and floor board put back into place. | Non-original modern timber floor on concrete slab found. |

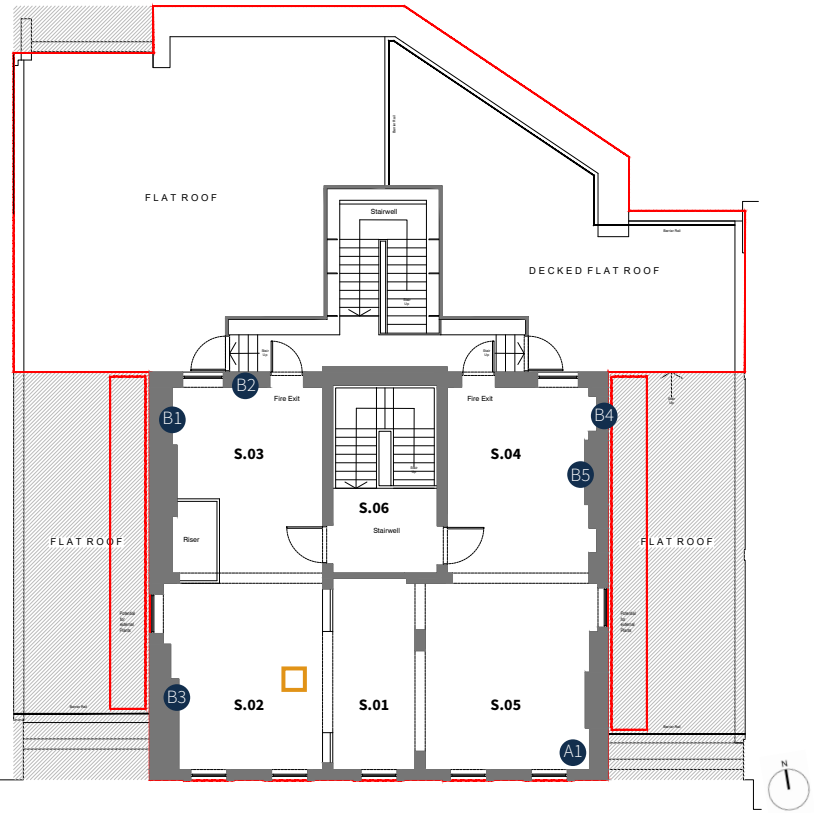
| TAG | CATEGORY | LOCATION | PURPOSE AND EXPECTATION | METHOD | FINDINGS |
|---|---|---|---|---|---|
| A1 | Opening into the floor | S.05<br> | Determine the floor build up and thickness.<br><br>We expect to find concrete slab beneath the carpet. | 60mm diameter hole in the south east corner of the room to be core drilled. After inspection has been carried out, hole to be closed up. | Non-original modern floor on concrete slab found. |
| B1 | Opening into the wall | S.03<br> | To examine the wall build up and wall finish.<br><br>We are expecting to find brick or stud wall. | Firstly a 10mm hole will be drilled in the wall to ascertain the wall build up. If the build up cannot be ascertained from the hole then a 300x300mm section of the plasterboard/panelling will be carefully removed to reveal the wall construction behind and closed up after investigation. | Plastered brick wall found. Proposed works will line over existing plaster where wall lining not present. |
| B2 | Opening into the wall | S.03<br> | To examine the wall build up and wall finish.<br><br>We are expecting to find brick or stud wall. | Firstly a 10mm hole will be drilled in the wall to ascertain the wall build up. If the build up cannot be ascertained from the hole then a 300x300mm section of the plasterboard/panelling will be carefully removed to reveal the wall construction behind and closed up after investigation. | Plastered brick wall found. Proposed works will line over existing plaster where wall lining not present. |
| B3 | Opening into the wall | S.02<br> | To examine the wall build up and wall finish.<br><br>We are expecting to find brick or stud wall. | Firstly a 10mm hole will be drilled in the wall to ascertain the wall build up. If the build up cannot be ascertained from the hole then a 300x300mm section of the plasterboard/panelling will be carefully removed to reveal the wall construction behind and closed up after investigation. | Plastered brick wall found. Proposed works will line over existing plaster where wall lining not present. |
| B4 | Opening into the wall | S.04<br> | To examine the wall build up and wall finish.<br><br>We are expecting to find brick or stud wall. | Firstly a 10mm hole will be drilled in the wall to ascertain the wall build up. If the build up cannot be ascertained from the hole then a 300x300mm section of the plasterboard/panelling will be carefully removed to reveal the wall construction behind and closed up after investigation. | Plastered brick wall found. Proposed works will line over existing plaster where wall lining not present. |
| B5 | Opening into the wall | S.04<br> | To examine the wall build up and wall finish.<br><br>We are expecting to find brick or stud wall. | Firstly a 10mm hole will be drilled in the wall to ascertain the wall build up. If the build up cannot be ascertained from the hole then a 300x300mm section of the plasterboard/panelling will be carefully removed to reveal the wall construction behind and closed up after investigation. | Plastered brick wall found. Proposed works will line over existing plaster where wall lining not present. |

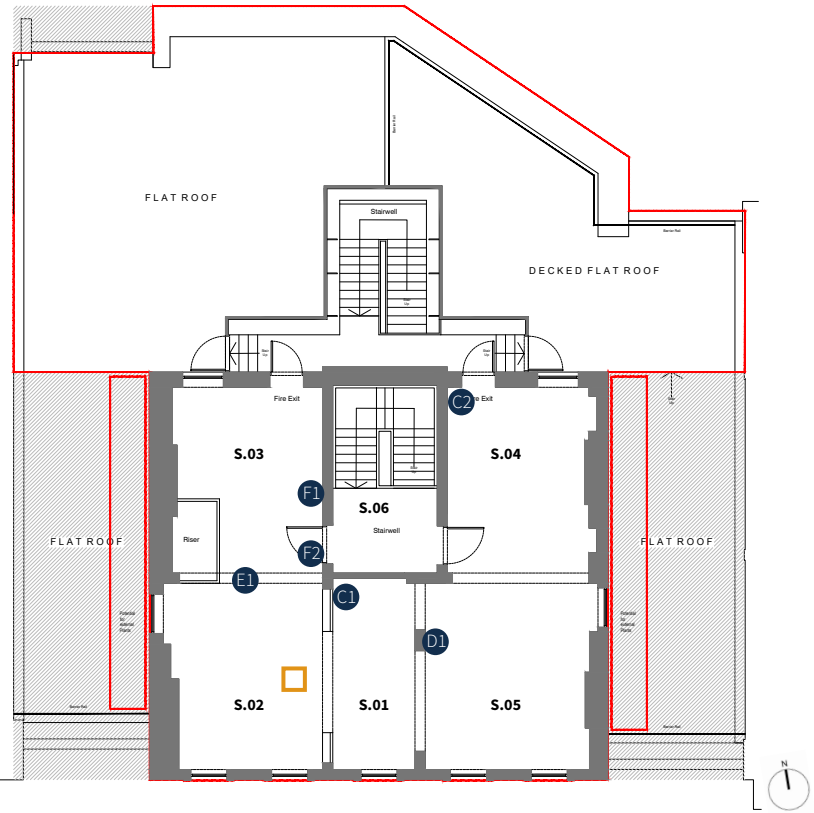
| TAG | CATEGORY | LOCATION | PURPOSE | METHOD | FINDINGS |
|---|---|---|---|---|---|
| C1 | Opening into the ceiling above | S.01<br> | Determine whether the wall is made of brick and examine the condition of the brick | Firstly a 10mm hole will be drilled in the ceiling to ascertain the build up. If the build up cannot be ascertained from the hole then a 300x300mm section of the ceiling will be carefully removed to reveal the construction above and closed up after investigation.<br><br>Opening to be located in the north west corner of the room. | Non-original plasterboard suspended ceiling found. |
| C2 | Opening into the ceiling above | S.04<br> | Determine whether the wall is made of brick and examine the condition of the brick | Firstly a 10mm hole will be drilled in the ceiling to ascertain the build up. If the build up cannot be ascertained from the hole then a 300x300mm section of the ceiling will be carefully removed to reveal the construction above and closed up after investigation.<br><br>Opening to be located in the north west corner of the room. | Non-original plasterboard suspended ceiling found. |
| F1 | Opening into the ceiling above | S.03<br> | To understand if there is any steelwork or lintels in this area and to find out if services can run horizontally within the ceiling void.<br><br>We are expecting to find a concrete beam. | Firstly a 10mm hole will be drilled in the ceiling to ascertain the build up. If the build up cannot be ascertained from the hole then a 300x300mm section of the ceiling will be carefully removed to reveal the construction above and closed up after investigation.<br><br>Opening to be located in the east side of the room. | Non-original plasterboard suspended ceiling found. |
| F2 | Opening into the ceiling above | S.03<br> | To understand if there is any steelwork or lintels in this area, their size and to find out if services can run horizontally within the ceiling void.<br><br>We are expecting to find a concrete beam. | Firstly a 10mm hole will be drilled in the ceiling to ascertain the build up. If the build up cannot be ascertained from the hole then a 300x300mm section of the ceiling will be carefully removed to reveal the construction above and closed up after investigation.<br><br>Opening to be located in the south east corner of the room. | Non-original plasterboard suspended ceiling found. |

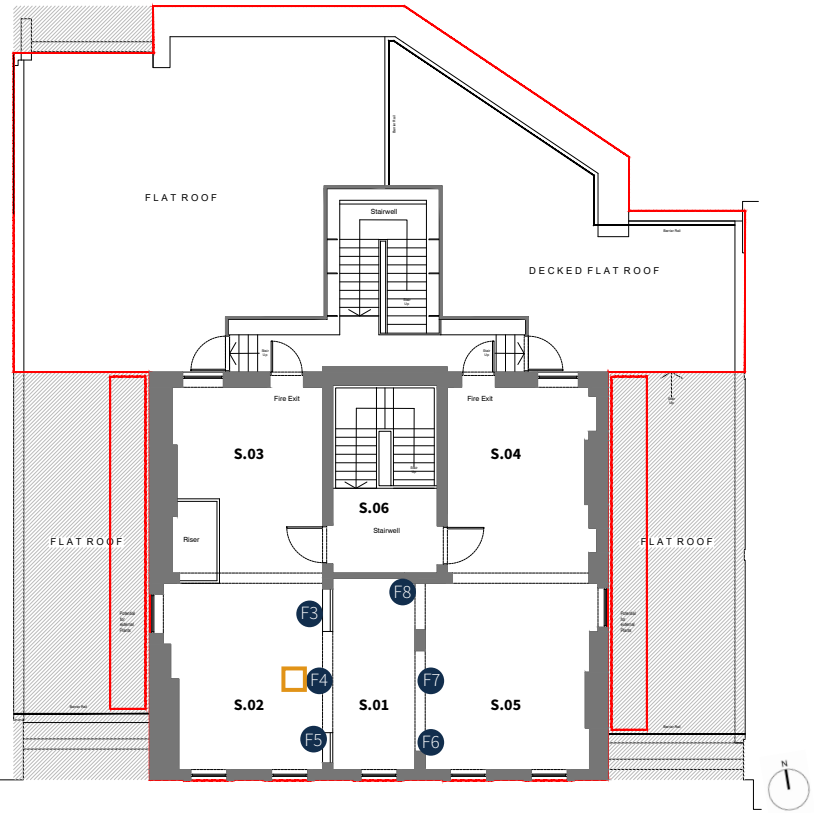
| TAG | CATEGORY | LOCATION | PURPOSE AND EXPECTATION | METHOD | FINDINGS |
|---|---|---|---|---|---|
| F7 | Opening into the ceiling above | S.05<br> | To understand if there is any steelwork or lintels in this area, their size and to find out if services can run horizontally within the ceiling void.<br><br>We are expecting to find a concrete beam. | Firstly a 10mm hole will be drilled in the ceiling to ascertain the build up. If the build up cannot be ascertained from the hole then a 300x300mm section of the ceiling will be carefully removed to reveal the construction above and closed up after investigation.<br><br>Opening to be located in the west side of the room. | Non-original plasterboard suspended ceiling found. |
| F8 | Opening into the ceiling above | S.01<br> | To understand if there is any steelwork or lintels in this area, their size and to find out if services can run horizontally within the ceiling void.<br><br>We are expecting to find a concrete beam. | Firstly a 10mm hole will be drilled in the ceiling to ascertain the build up. If the build up cannot be ascertained from the hole then a 300x300mm section of the ceiling will be carefully removed to reveal the construction above and closed up after investigation.<br><br>Opening to be located in the north east corner of the room. | Non-original plasterboard suspended ceiling found. |

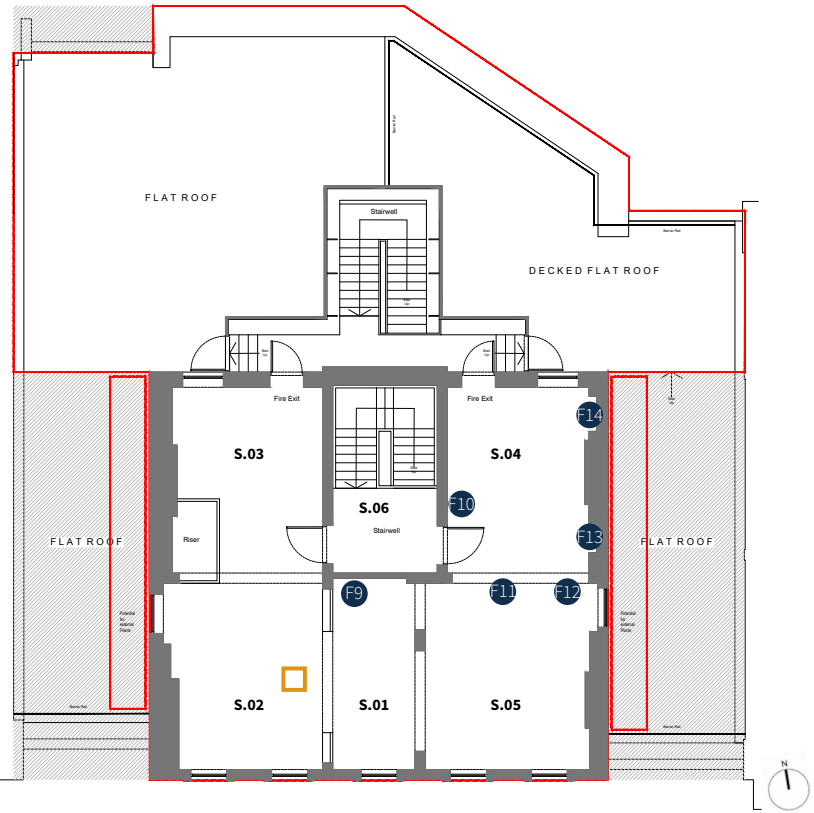
| TAG | CATEGORY | LOCATION | PURPOSE AND EXPECTATION | METHOD | FINDINGS |
|---|---|---|---|---|---|
| F13 | Opening into the ceiling above | S.04<br> | To understand if there is any steelwork or lintels in this area and to find out if services can run horizontally within the ceiling void.<br><br>We are expecting to find a concrete beam. | Firstly a 10mm hole will be drilled in the ceiling to ascertain the build up. If the build up cannot be ascertained from the hole then a 300x300mm section of the ceiling will be carefully removed to reveal the construction above and closed up after investigation.<br><br>Opening to be located in the south east corner of the room. | Non-original plasterboard suspended ceiling found. |
| F14 | Opening into the ceiling above | S.04<br> | To understand if there is any steelwork or lintels in this area and to find out if services can run horizontally within the ceiling void.<br><br>We are expecting to find a concrete beam. | Firstly a 10mm hole will be drilled in the ceiling to ascertain the build up. If the build up cannot be ascertained from the hole then a 300x300mm section of the ceiling will be carefully removed to reveal the construction above and closed up after investigation.<br><br>Opening to be located in the north east corner of the room. | Non-original plasterboard suspended ceiling found. |

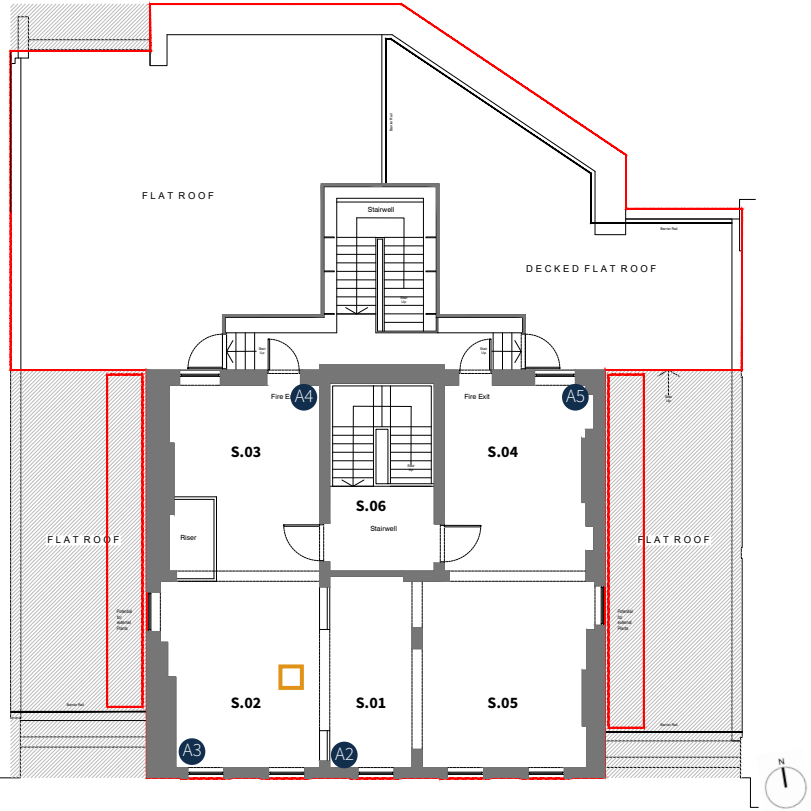
| TAG | CATEGORY | LOCATION | PURPOSE AND EXPECTATION | METHOD | FINDINGS |
|---|---|---|---|---|---|
| A2 | Opening into the floor | S.01<br> | Determine the floor build up and thickness.<br><br>We expect to find concrete slab beneath the carpet. | 60mm diameter hole in the south west corner of the room to be core drilled. After inspection has been carried out, hole to be closed up. | Non-original modern floor on concrete slab found. |
| A3 | Opening into the floor | S.02<br> | Determine the floor build up and thickness.<br><br>We expect to find concrete slab. | 60mm diameter hole in the south west corner of the room to be core drilled. After inspection has been carried out, hole to be closed up. | Non-original modern floor on concrete slab found. |
| A4 | Opening into the floor | S.03<br> | Determine the floor build up and thickness.<br><br>We expect to find concrete slab. | 60mm diameter hole in the north east corner of the room to be core drilled. After inspection has been carried out, hole to be closed up. | Non-original modern floor on concrete slab found. |
| A5 | Opening into the floor | S.04<br> | Determine the floor build up and thickness.<br><br>We expect to find concrete slab beneath the carpet. | 60mm diameter hole in the north east corner of the room to be core drilled. After inspection has been carried out, hole to be closed up. | Non-original modern floor on concrete slab found. |
