## 86 Cross Street, Manchester

15155-BKP-V1-XX-RP-S-001

Existing Building Condition Report

For  
Individual Restaurants

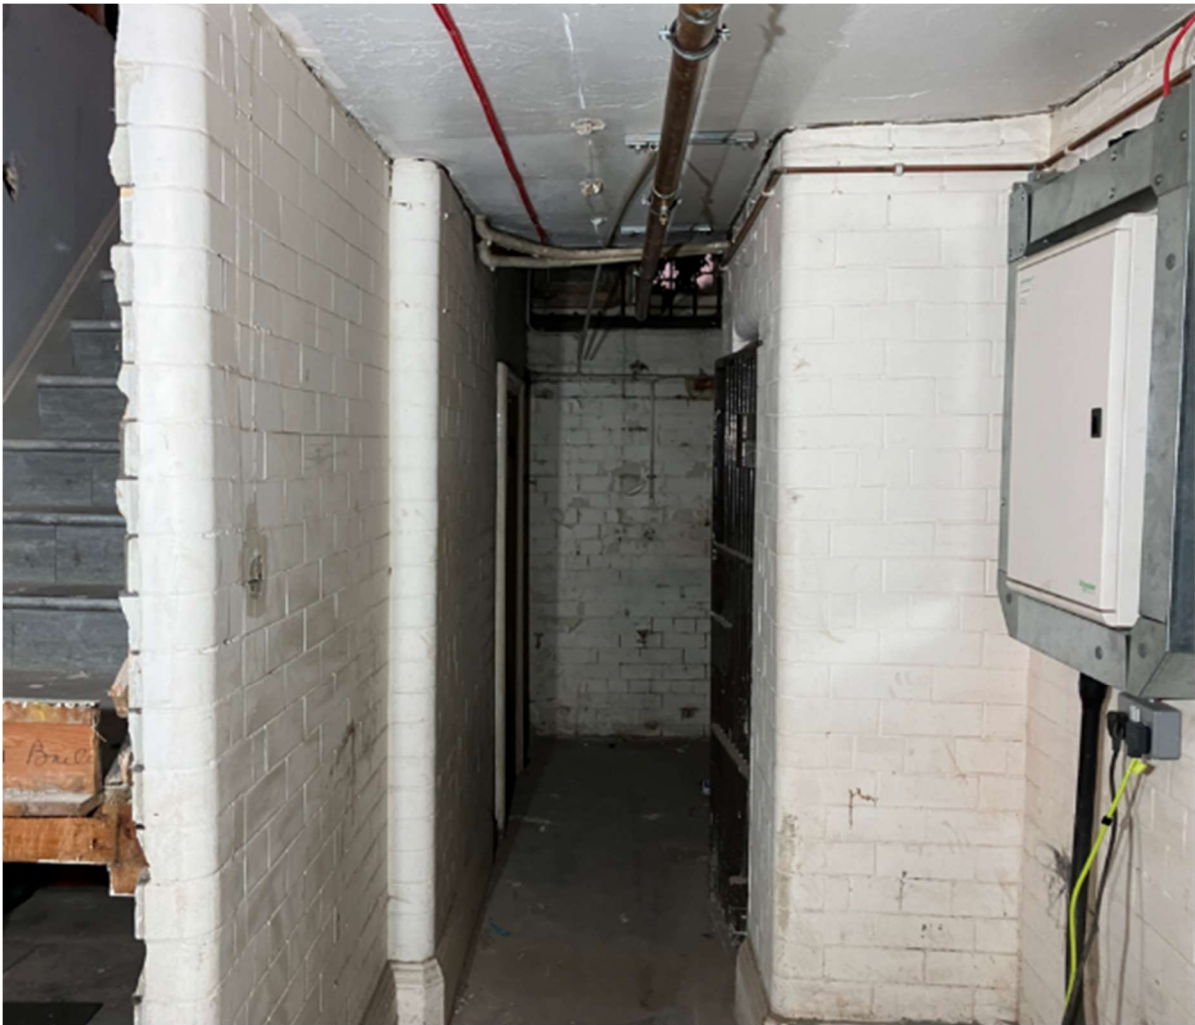
*Figure 5 – View in Existing Basement (Electrical Distribution Board and Ceiling Level Services Visible)*

Detailed internal services survey to the building is recommended prior to commencement of any works on site. For details of proposed internal building services alterations, refer to M+E consultant information.

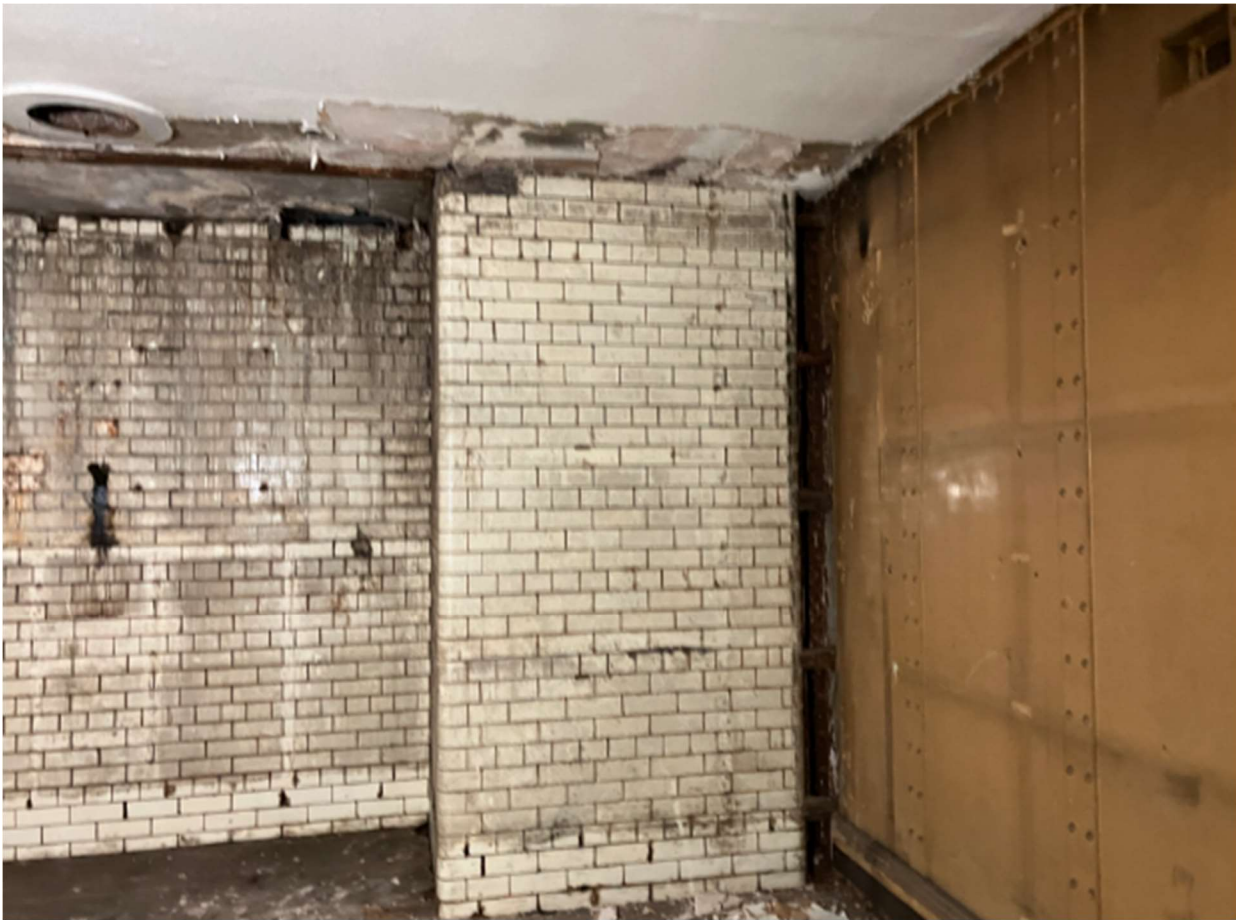
*Figure 6 – View on Existing Basement Walls to Front Elevation  
(Metal Panel Partition Wall Shown to Right-Hand Side)*

Masonry basement walls and internal basement partition walls (including metal panel sections) appeared to be in good condition generally, however the following related observations were recorded;

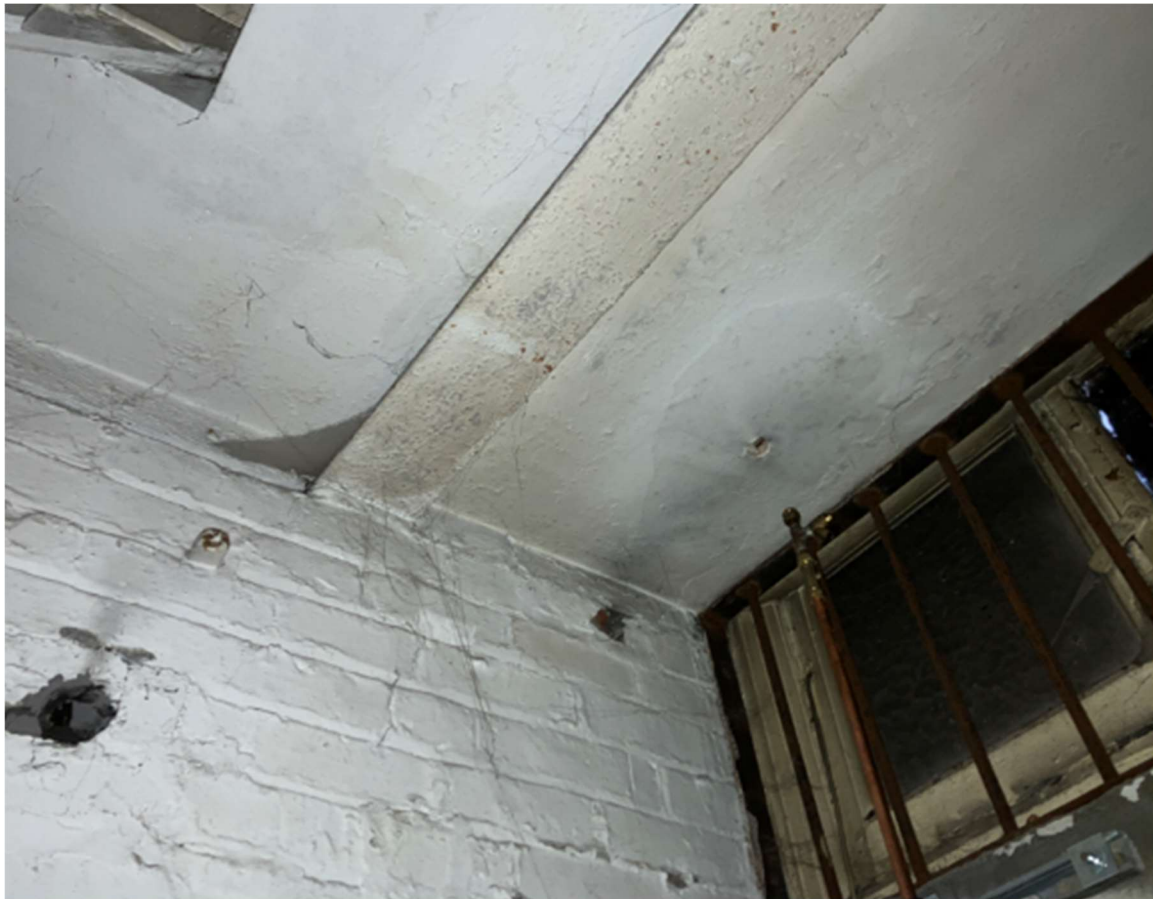
*Figure 11 – Primary Beam Bottom Flange with Filler Joist Floor Infill (as Witnessed from Basement Level)*

Filler joist floor and supporting primary beams witnessed on site appear to be in good condition generally, with no obvious signs of distortion or deterioration of floor structures generally, however the following related observations were recorded;

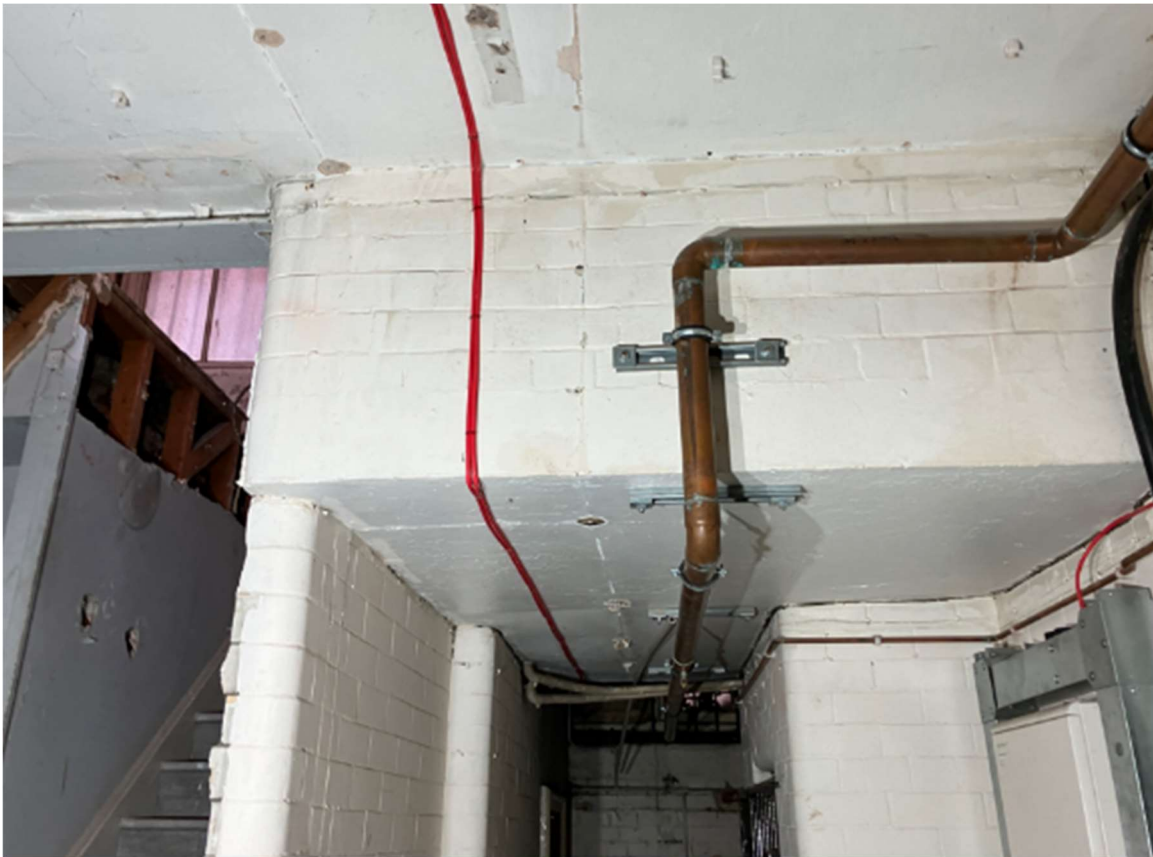
*Figure 12 – Reduced Level Concrete Slab to Proposed Staff Room / Toilets Area*

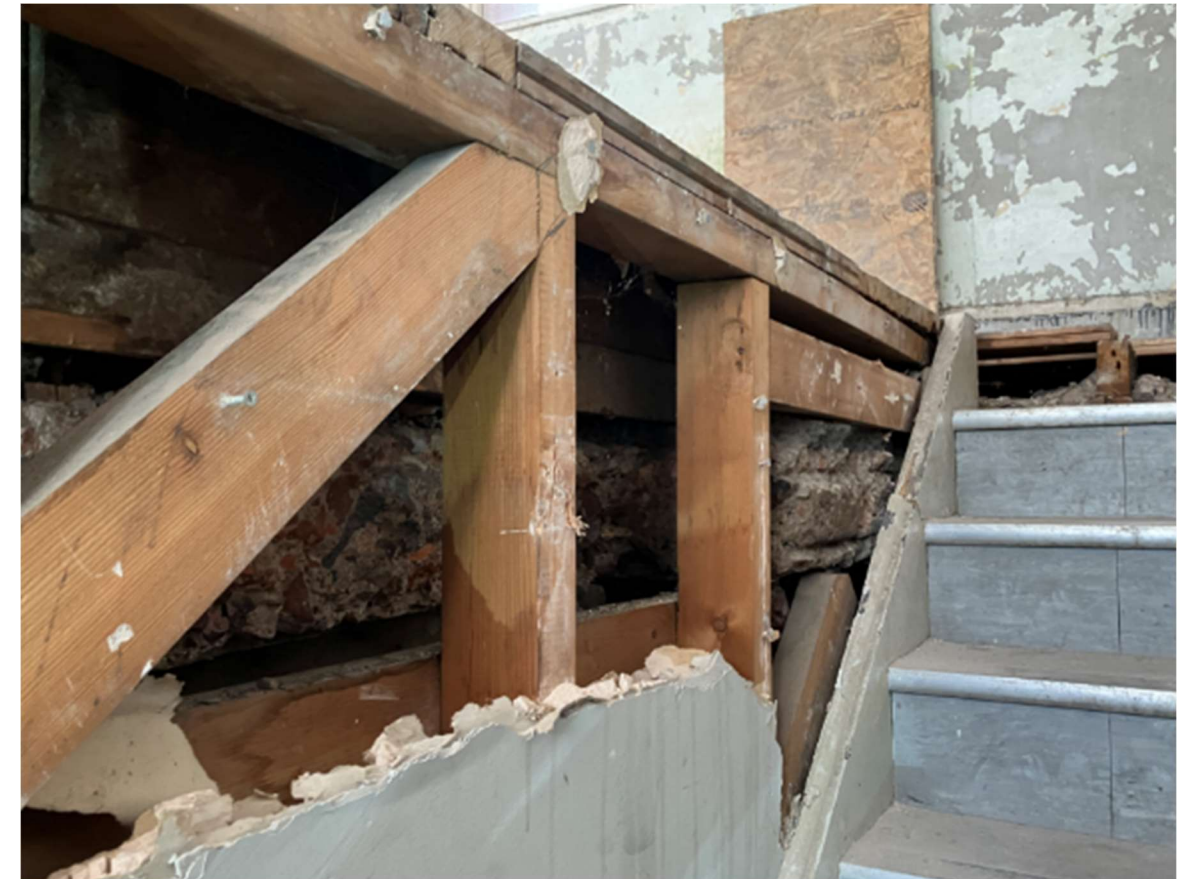
*Figure 14 – View on Filler Joist Floor Slab Edge at Basement Access Stair*

- Later addition of the basement access stair appears to be been coordinated with original primary steelwork beam members (to minimise requirements for additional supports to the filler joist floor).
- It is noted that where slab opening has been formed to the side of the stair, no structural support to the filler joist floor was witnessed on site (possible this is nominally embedded within filler joist floor and no visible without intrusive investigation works).

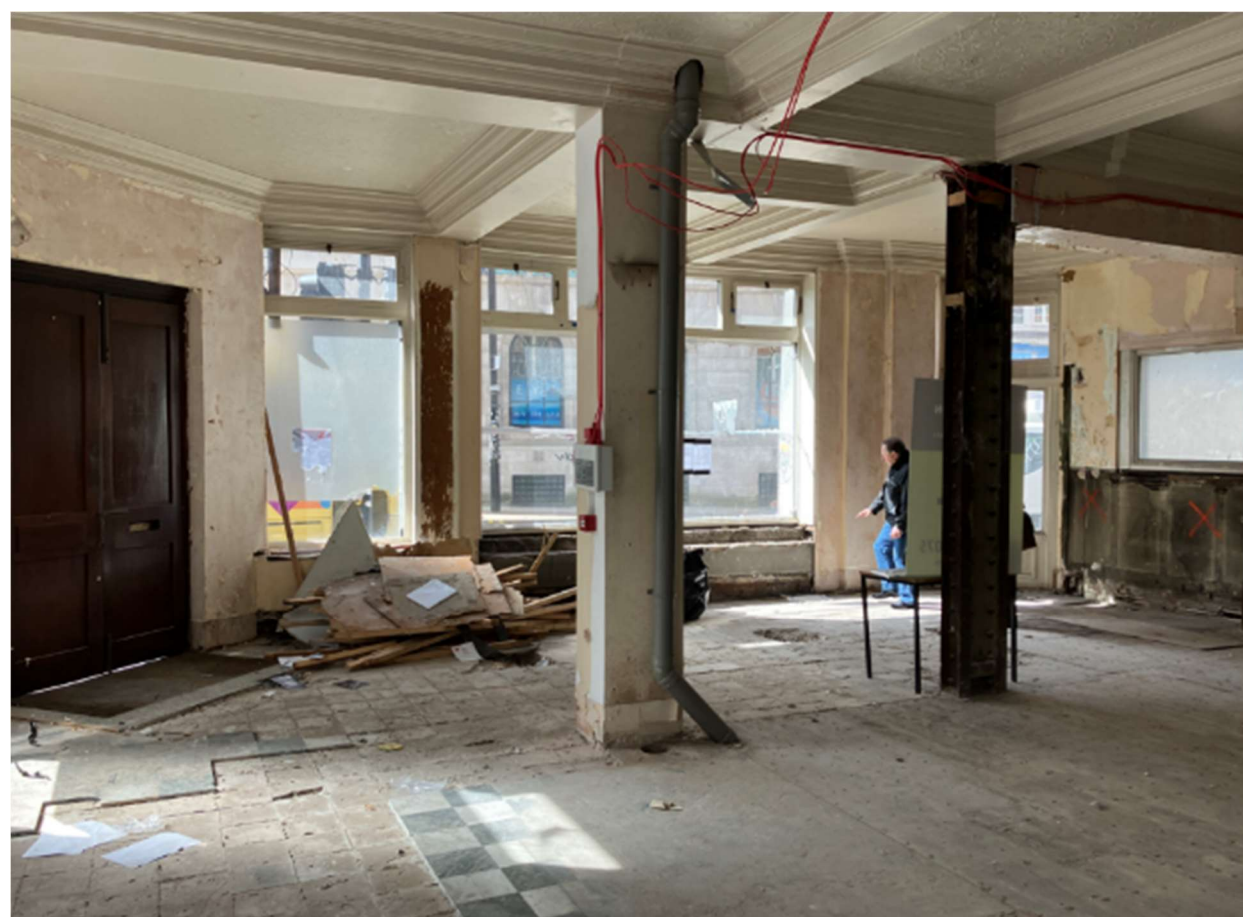
*Figure 15 – General Ground Floor View Looking onto John Dalton Street*

Ground floor walls and steel structural members were recorded as being in good condition, with no obvious signs of distortion or deterioration, however the following related observations were recorded;

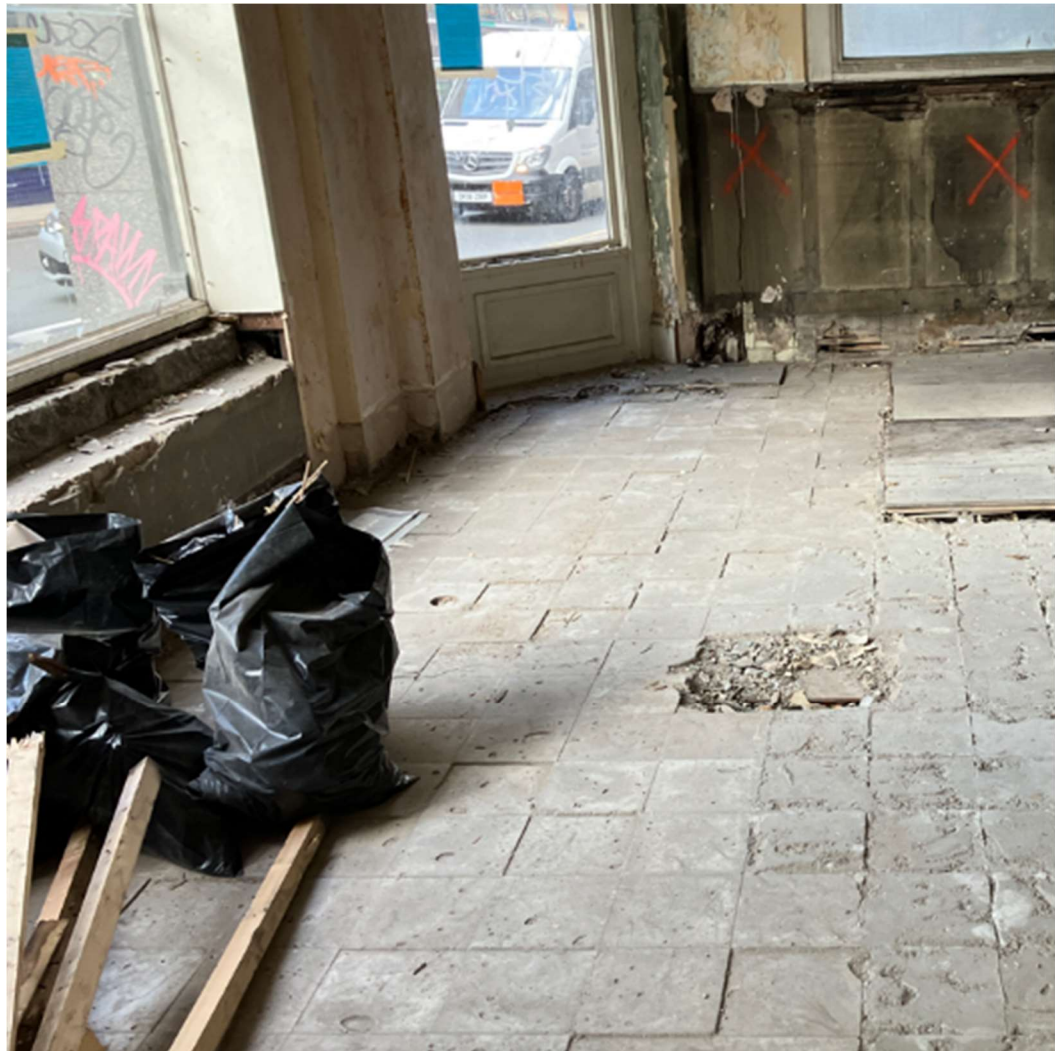
- 2No. localised intrusive investigation locations were witnessed on site close to elevation to John Dalton Street (not carried out as part of BKPL inspection, but likely present from previous investigation works). These indicated location of primary steelwork support member to the filler joist floor, along with smaller secondary support member and allowed for measurement of main structural floor members (refer to below Figure 22). Steel members witnessed were in good condition and unreinforced concrete infill slab was noted as being in good condition, formed generally in broken brick / stone (as opposed to containing significant clinker material)

Figure 21 – Previous Intrusive Investigation Location (Top Flange of Primary Steelwork Member Visible)

- Embedded steelwork supports to former pavement vents to be further exposed for inspection
- Ferroskan type survey recommended to allow detailed layout of steelwork support members within filler joist floor to be determined (including determination of beam locations / centres, sizes, slab details, etc. Particular attention is drawn to existing steelwork arrangements adjacent to existing basement access stairs

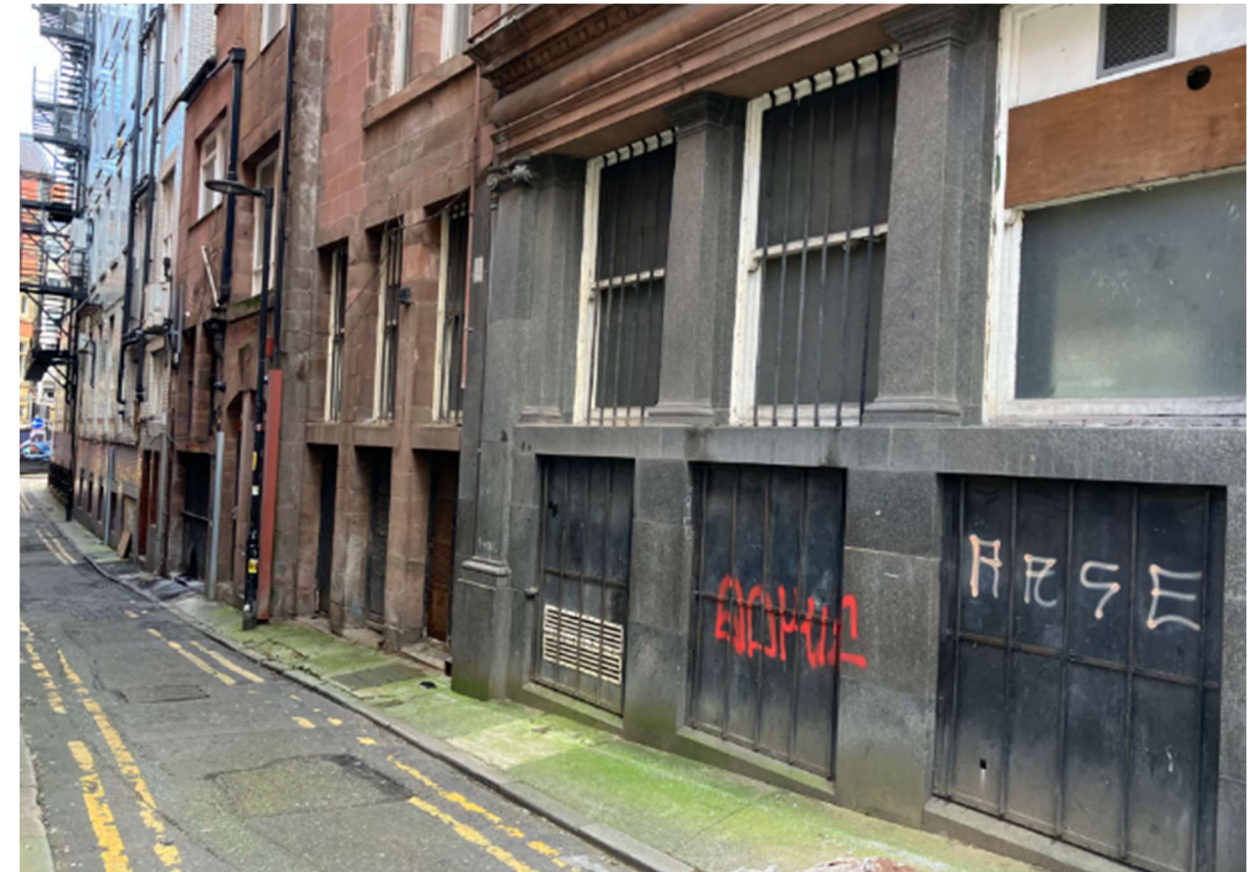
- Some loose electrical cabling noted to rear elevation of the building (onto Four Yards); it is unknown if cables are currently live
- Minor graffiti noted to rear elevation stonework and windows
- 2No. possible manhole chambers noted to rear of building in Four Yards

*Figure 24 – Rear Elevation of Building (Four Yards)*
