**Project Name:** Amspec Limited - Lower Campfield - LSO0373827 - merged  
**Project Status:** Complete  
**Project Date:** 27/06/2024  
**Lanes Division:** Manchester

As requested, we have recently carried out a drainage CCTV survey at the site location and our full and detailed findings are contained in the attached CCTV report which you can review at your leisure.

Section 2: Cracks, deposits coarse 10%, deposits fine 10%  
Section 3: Deposits fine 10-20%, hole in drain, joint displaced medium  
Section 4: Deposits fine 10%, deposits coarse 10%  
Section 5: Deposits fine 10-20%, deposits coarse 10%  
Section 6: Deposits coarse 10-20%  
Section 7: Deposits fine 10-20%, cracks, deposits hard 30%  
Section 8: Deposits fine 10%  
Section 10: Deposits fine 10%  
Section 11: Deposits fine 10-40%  
Section 12: Deposits hard 10%, deposits fine 10-20%  
Section 13: Deposits fine 10%, deposits hard 30%  
Section 14: Deposits fine 10-50%, deposits hard 10%  
Section 15: Crack longitudinal  
Section 16: Fracture longitudinal  
Section 17: Settled deposits 10%  
Section 18: Settled deposits 10%  
Section 19: Settled deposits up to 30%  
Section 20: Settled deposits 10% and crack circumferen

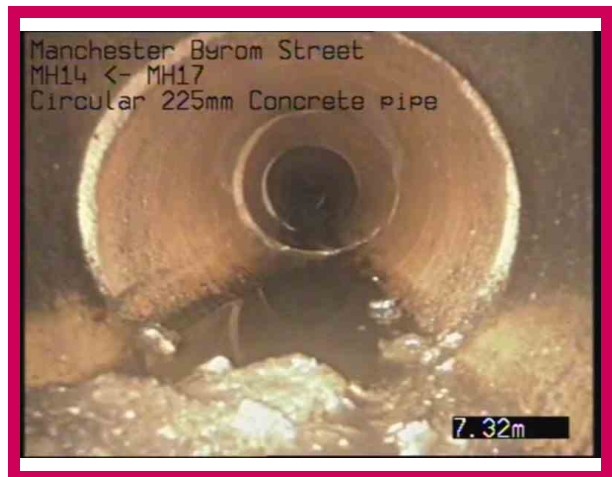
4, 00:00:47, 8.55 m  
Survey abandoned, Unable to survey past connection dropping debris while jetting. No access into line to flush or jet.

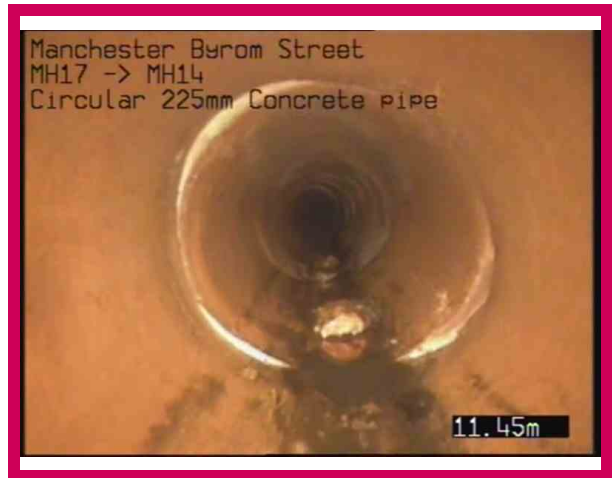
2, 00:00:53, 11.45 m  
Deformed drain or sewer, 5%

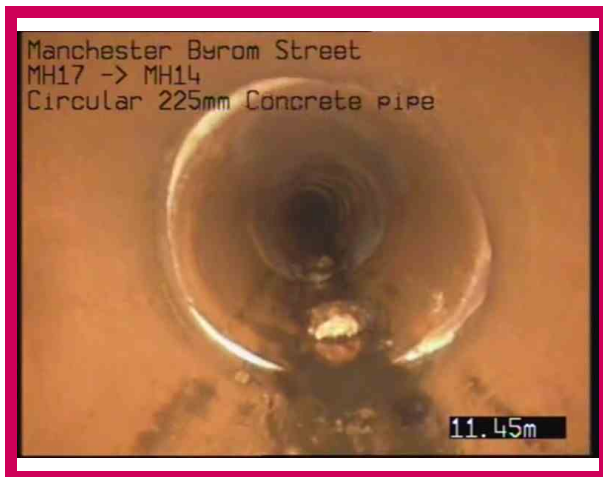
3, 00:00:54, 11.57 m  
Settled deposits, coarse, 5% cross-sectional area loss

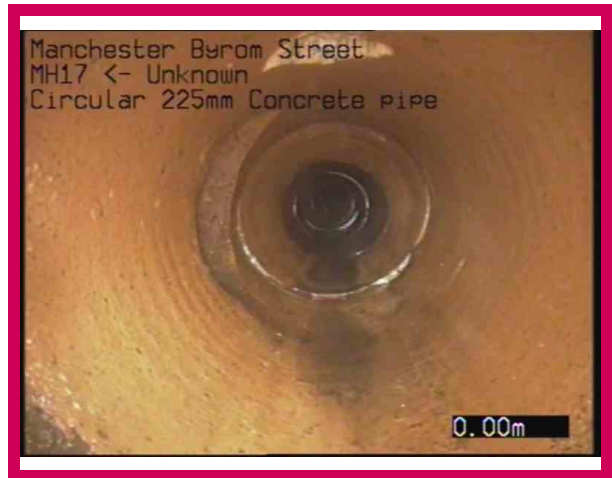
| Scale: 1:137 | Position [m] | Code | Observation | Grade |
|---|---|---|---|---|
| | 0.00 | SS | Surface damage, spalling at 12 o'clock | 2 |

2, 00:00:02, 0.00 m  
Surface damage, spalling at 12 o'clock

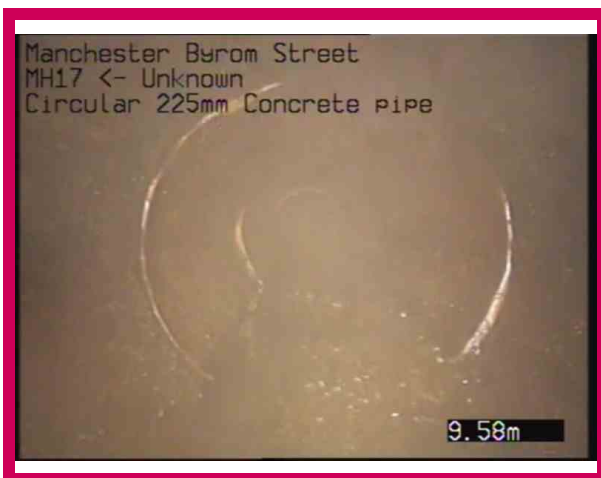
5, 00:00:47, 11.14 m  
Settled deposits, fine, 15% cross-sectional area loss, start

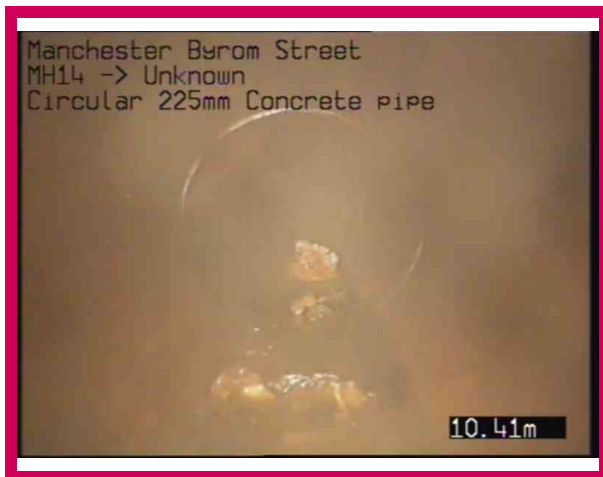
3, 00:00:46, 10.48 m  
Settled deposits, coarse, 10% cross-sectional area loss

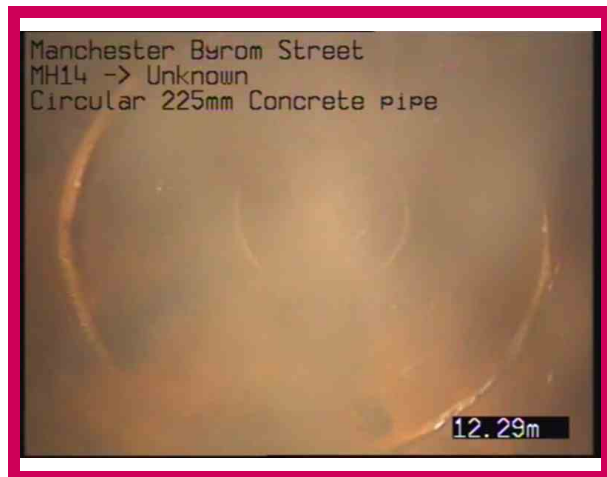
4, 00:00:55, 12.29 m  
Settled deposits, fine, 10% cross-sectional area loss, finish

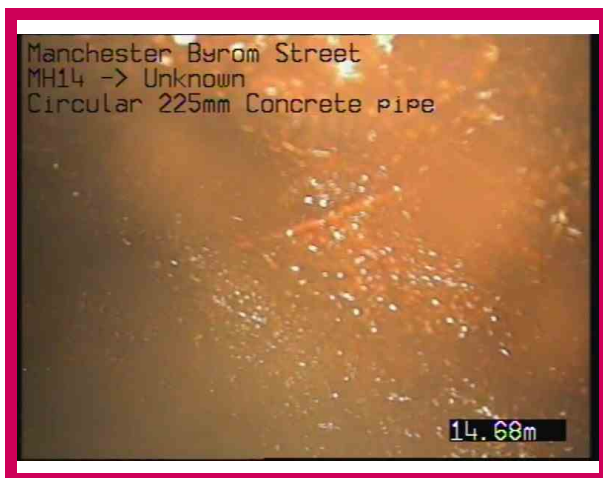
5, 00:01:09, 14.69 m  
Finish node, other special chamber, reference: Unknown, Line goes left into carrier

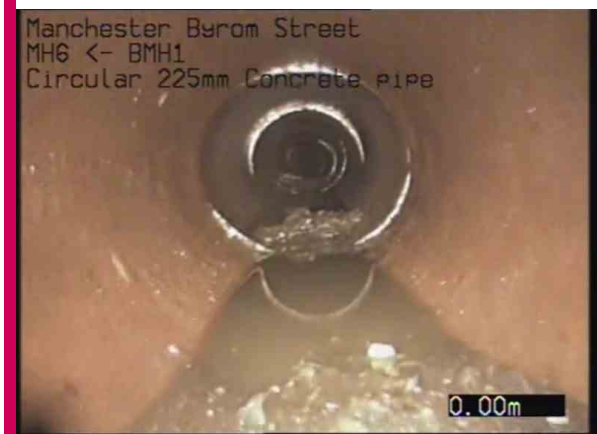
2, 00:00:04, 0.00 m  
Settled deposits, fine, 10% cross-sectional area loss

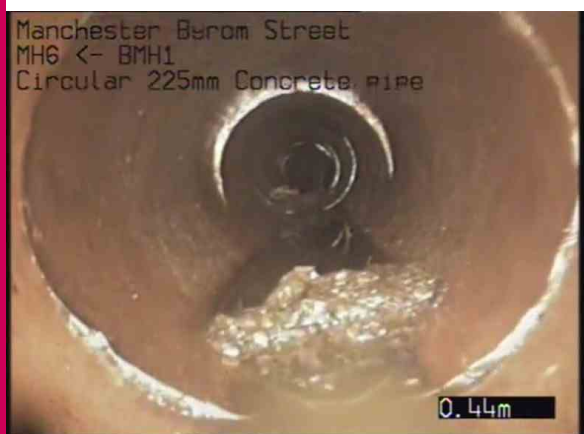
3, 00:00:06, 0.44 m  
Settled deposits, fine, 10% cross-sectional area loss

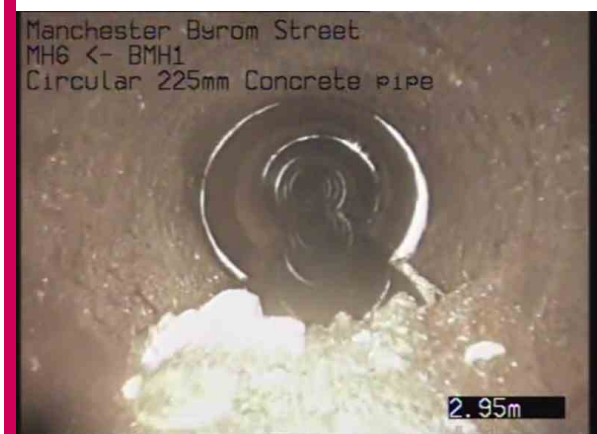
4, 00:00:13, 2.95 m  
Settled deposits, fine, 20% cross-sectional area loss

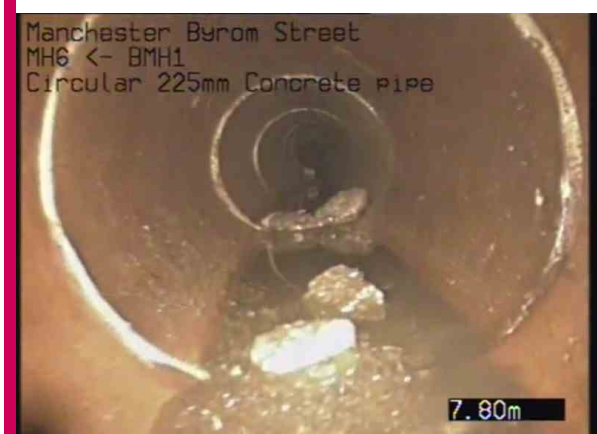
6, 00:00:30, 7.80 m  
Settled deposits, fine, 5% cross-sectional area loss

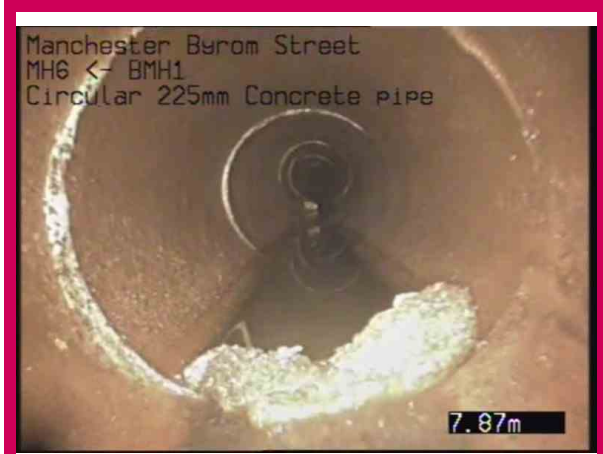
8, 00:00:33, 7.87 m  
Settled deposits, coarse at joint, 10% cross-sectional area loss

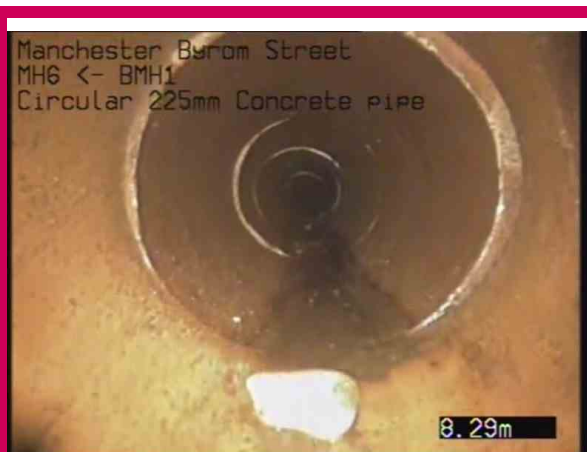
9, 00:00:41, 10.29 m  
Settled deposits, coarse, 10% cross-sectional area loss

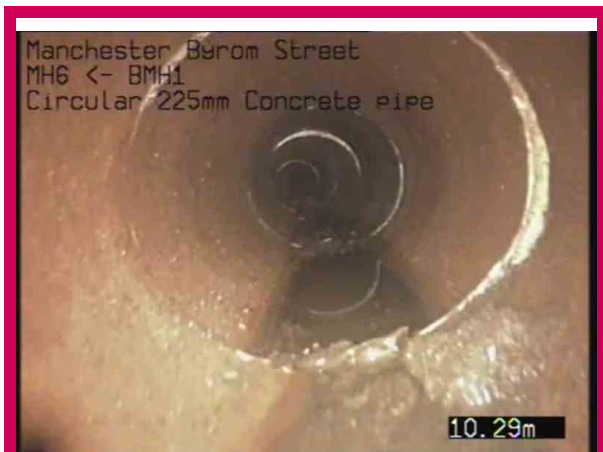
10, 00:00:49, 10.29 m  
Settled deposits, fine at joint, 5% cross-sectional area loss

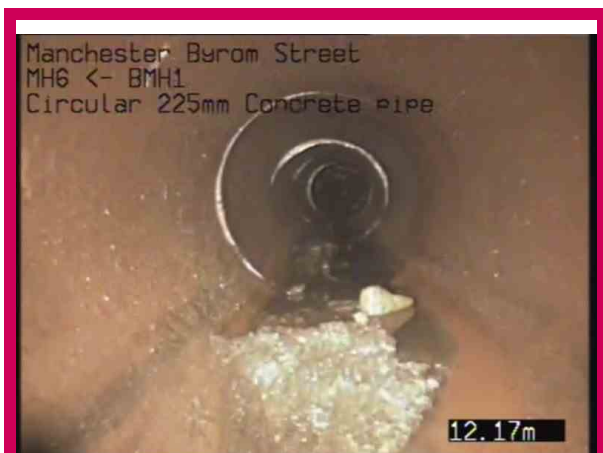
12, 00:00:59, 12.17 m  
Settled deposits, fine, 10% cross-sectional area loss

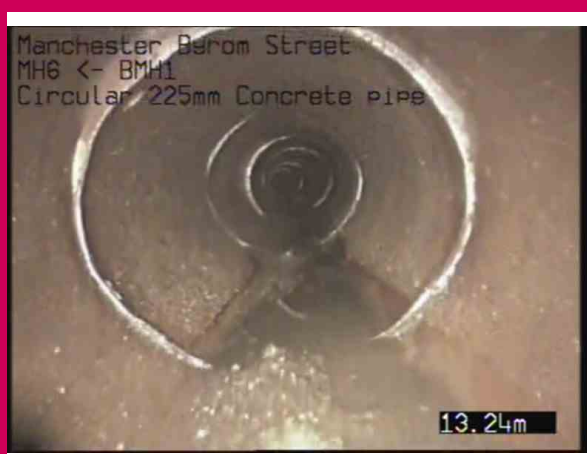
13, 00:01:03, 13.24 m  
Settled deposits, fine, 5% cross-sectional area loss

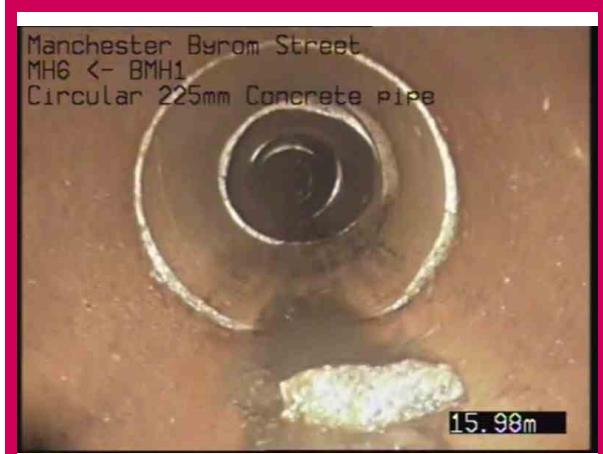
14, 00:01:16, 15.98 m  
Settled deposits, coarse, 5% cross-sectional area loss

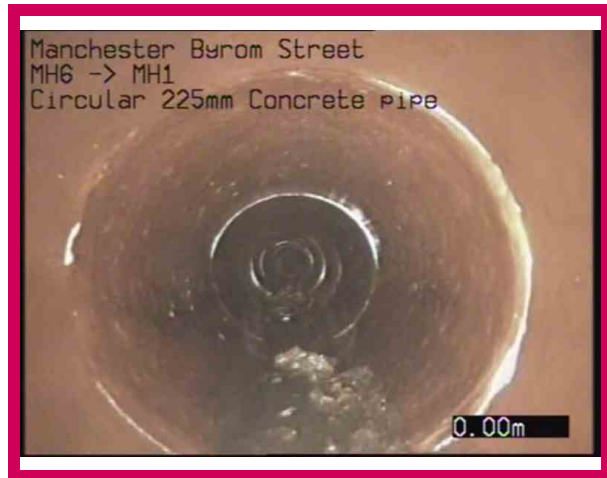
2, 00:00:05, 0.00 m  
Settled deposits, fine, 5% cross-sectional area loss

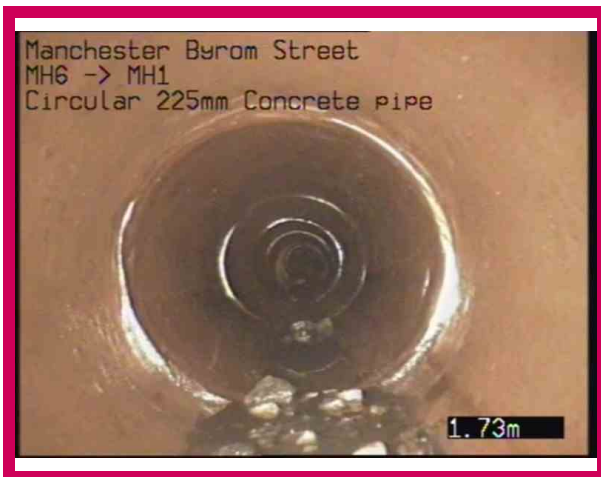
3, 00:00:13, 1.73 m  
Settled deposits, coarse, 5% cross-sectional area loss

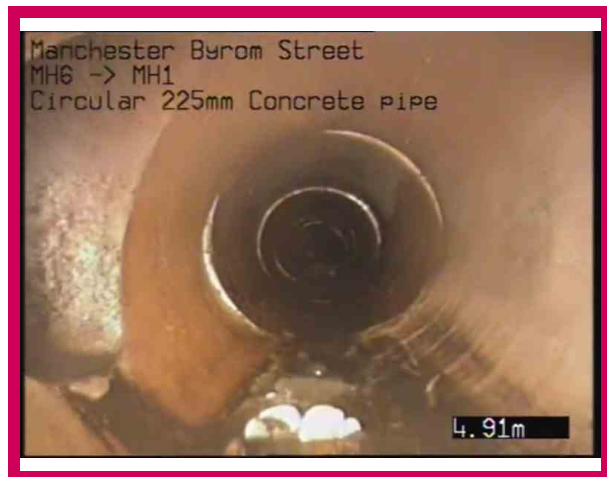
4, 00:00:26, 4.91 m  
Settled deposits, coarse, 5% cross-sectional area loss

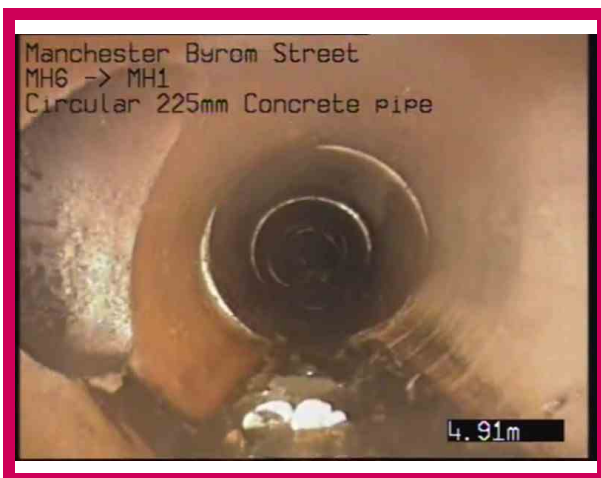
5, 00:00:25, 4.92 m  
Settled deposits, fine, 5% cross-sectional area loss

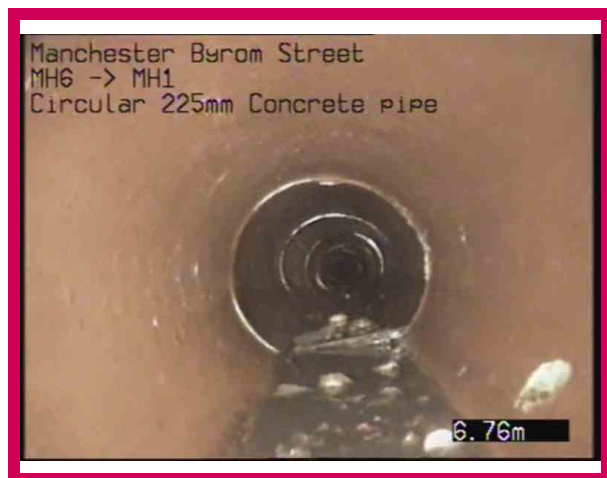
6, 00:00:33, 6.76 m  
Settled deposits, fine, 5% cross-sectional area loss

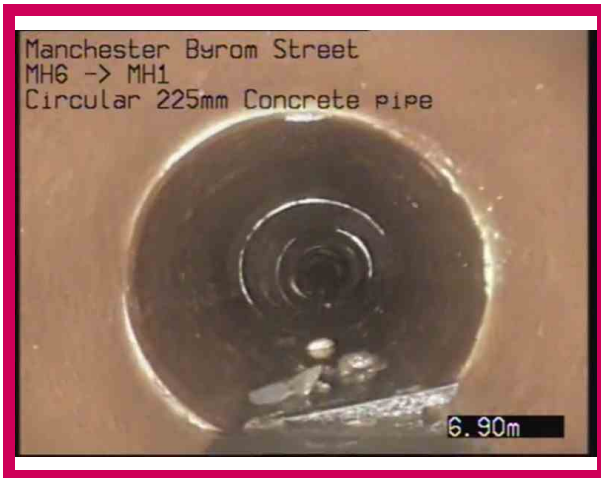
7, 00:00:35, 6.90 m  
Settled deposits, coarse at joint, 10% cross-sectional area loss

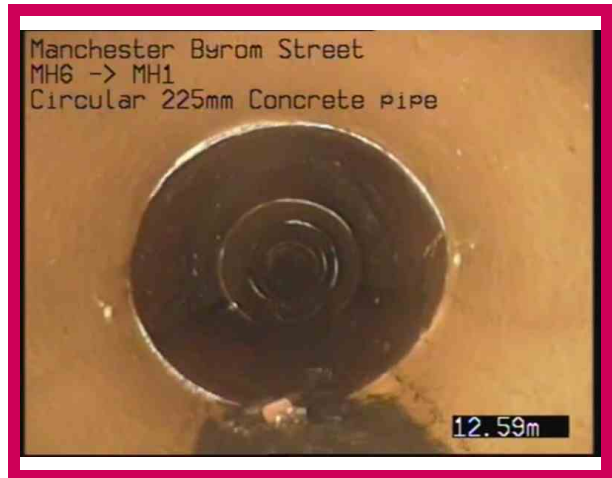
8, 00:00:56, 12.59 m  
Settled deposits, coarse, 5% cross-sectional area loss

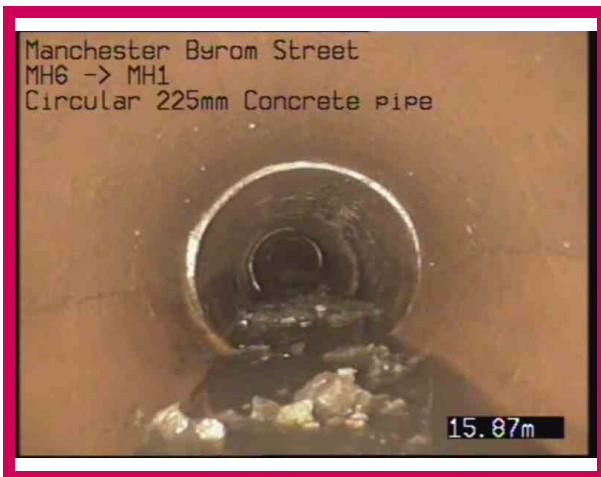
9, 00:01:11, 15.87 m  
Settled deposits, coarse, 15% cross-sectional area loss

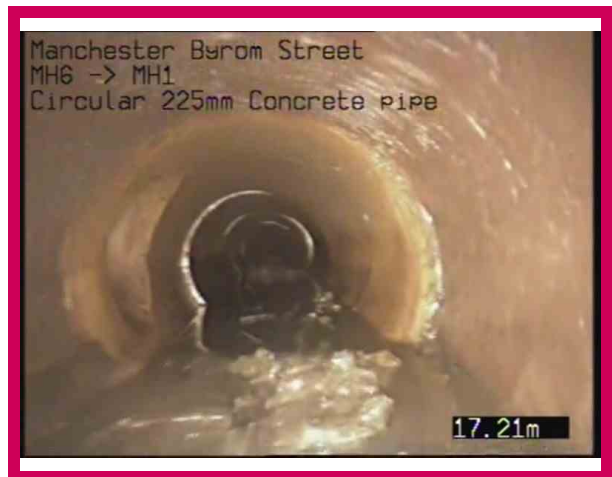
10, 00:01:15, 17.55 m  
Settled deposits, coarse, 20% cross-sectional area loss

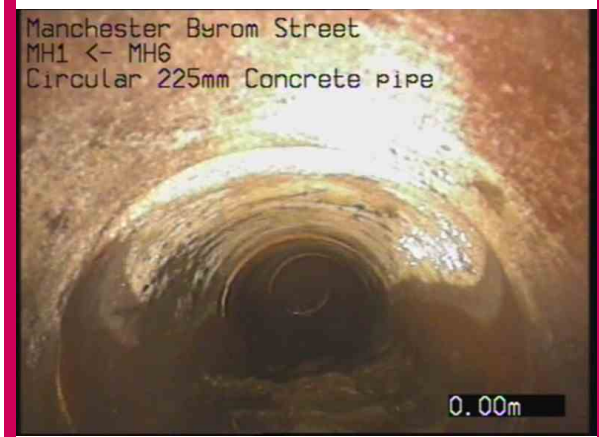
2, 00:00:06, 0.00 m  
Settled deposits, fine, 20% cross-sectional area loss

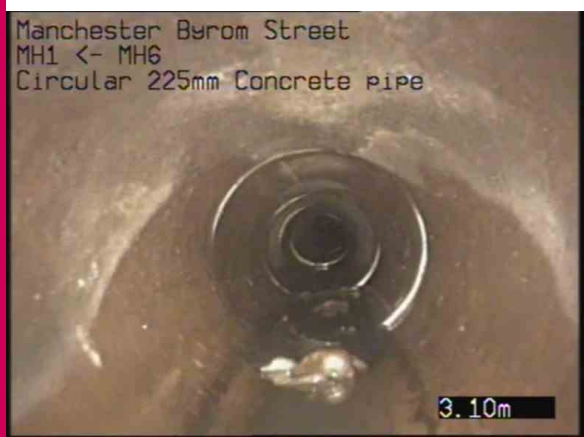
3, 00:00:22, 3.10 m  
Settled deposits, coarse, 5% cross-sectional area loss

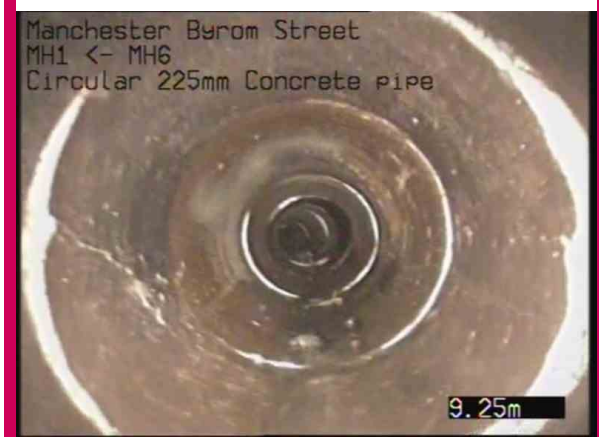
| Scale: 1:186 | Position [m] | Code | Observation | Grade |
|---|---|---|---|---|
| | 9.25 | CLJ | Crack, longitudinal at joint at 9 o'clock | 2 |

4, 00:00:45, 9.25 m  
Crack, longitudinal at joint at 9 o'clock

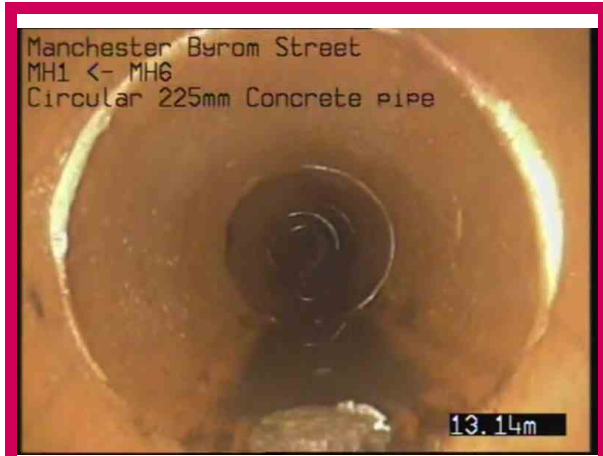
8, 00:00:57, 13.14 m  
Settled deposits, coarse at joint, 5% cross-sectional area loss

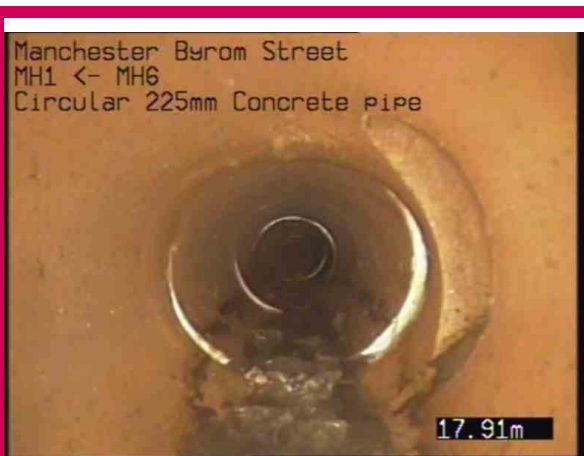
11, 00:01:23, 17.91 m  
Settled deposits, fine, 5% cross-sectional area loss

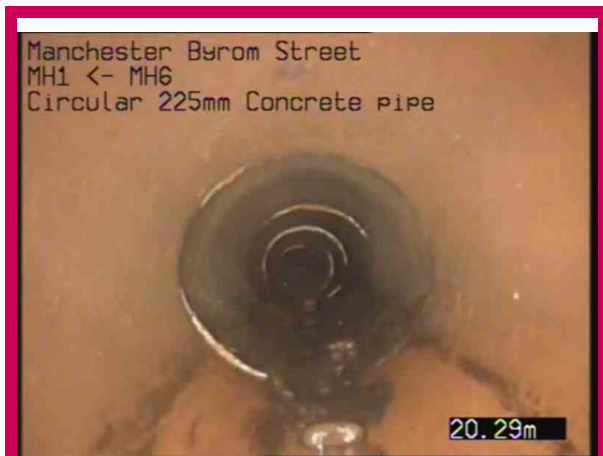
12, 00:01:34, 20.29 m  
Settled deposits, coarse, 5% cross-sectional area loss

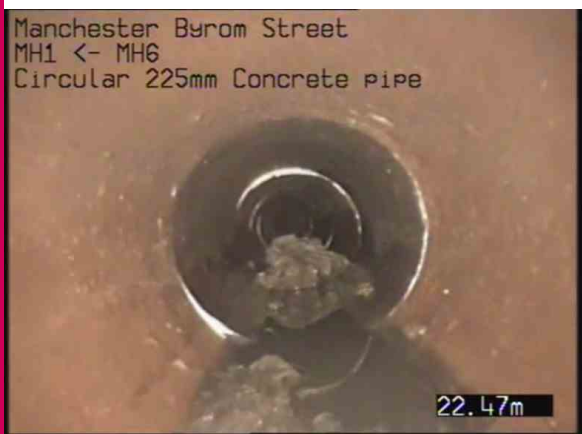
13, 00:01:45, 22.47 m  
Settled deposits, fine, 10% cross-sectional area loss

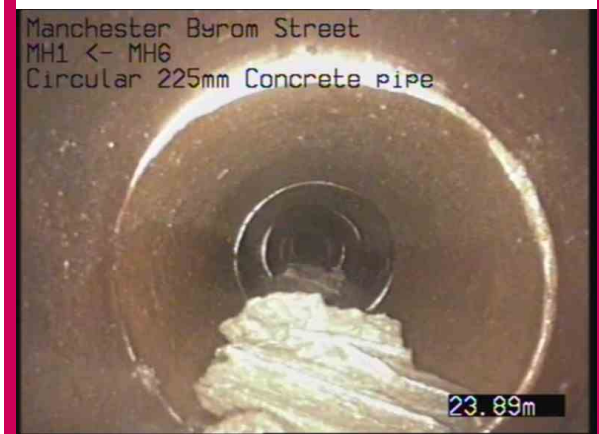
14, 00:01:55, 23.89 m  
Settled deposits, hard or compacted at joint, 30% cross-sectional area loss

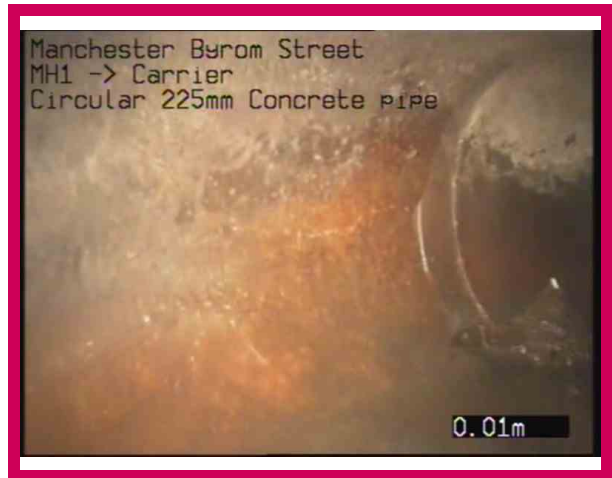
2, 00:00:07, 0.01 m  
Settled deposits, coarse at joint, 5% cross-sectional area loss

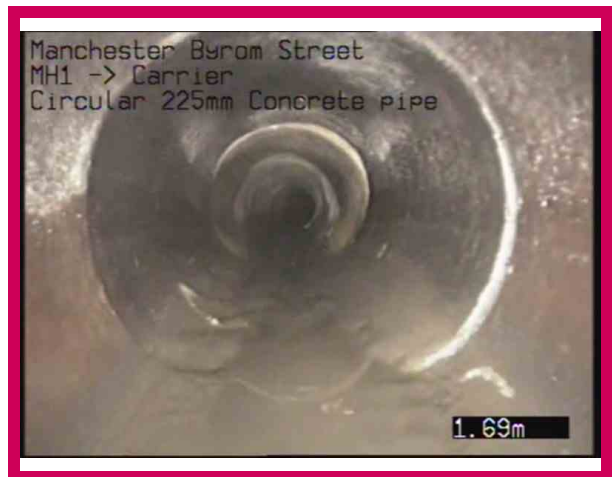
4, 00:00:15, 1.69 m  
Settled deposits, fine, 10% cross-sectional area loss

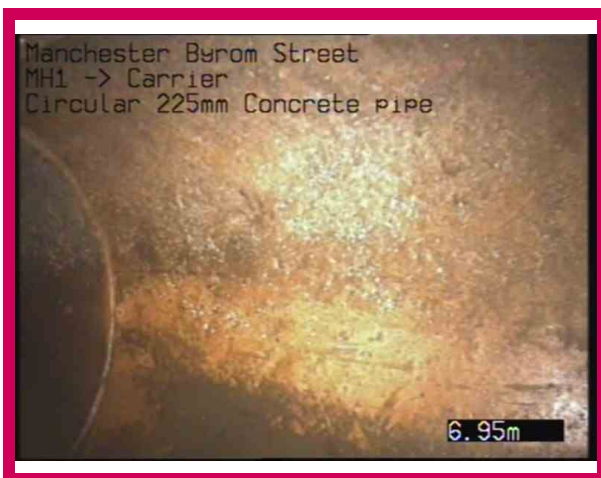
5, 00:00:48, 6.91 m  
Finish node, other special chamber, reference: Carrier, Line drops into carrier

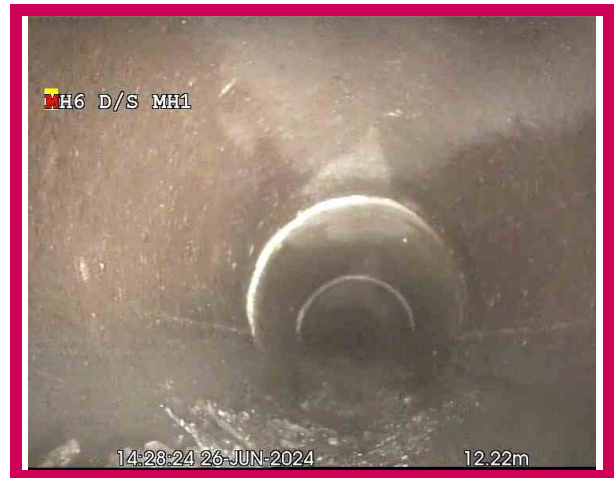
2, 00:01:14, 12.22 m  
Settled deposits, fine, 10% cross-sectional area loss

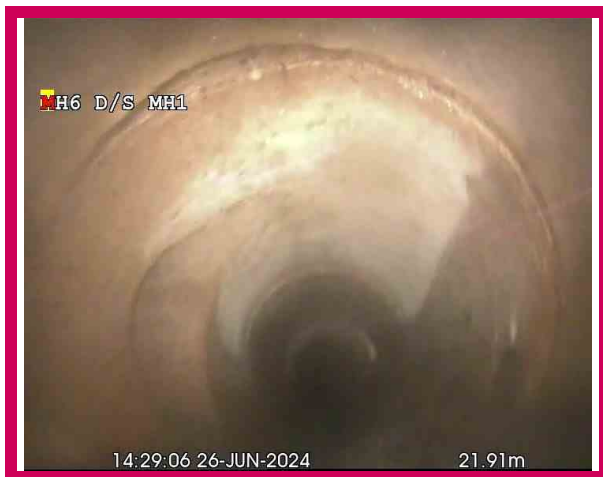
3, 00:01:55, 21.39 m  
Settled deposits, fine, 10% cross-sectional area loss

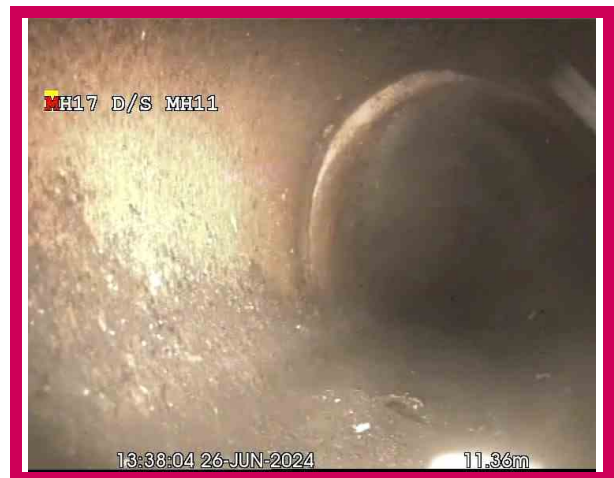
2, 00:00:35, 11.36 m  
Settled deposits, hard or compacted, 10% cross-sectional area loss

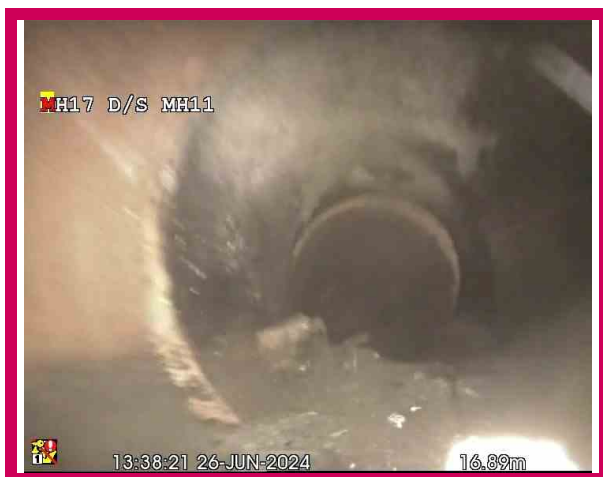
3, 00:00:52, 16.89 m  
Settled deposits, fine, 10% cross-sectional area loss

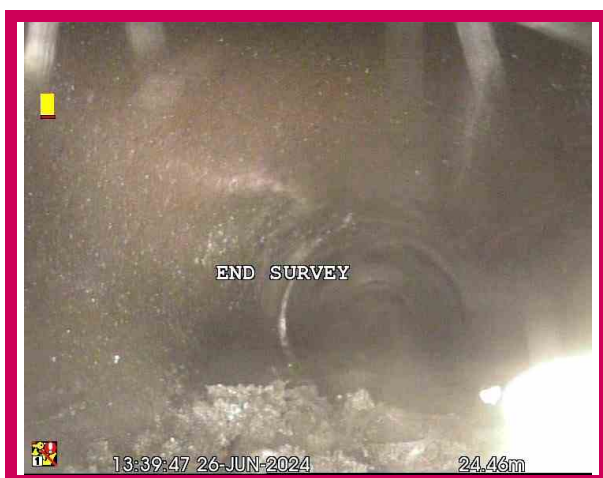
5, 00:02:17, 24.47 m  
Survey abandoned, Unable to survey further due to debris in line.

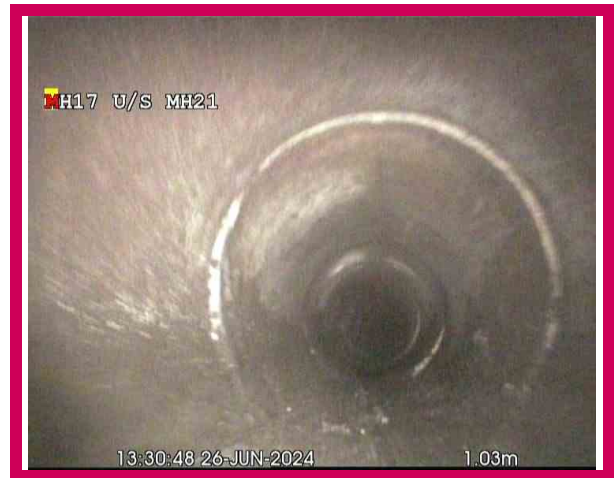
2, 00:00:09, 0.18 m  
Settled deposits, fine, 10% cross-sectional area loss, start

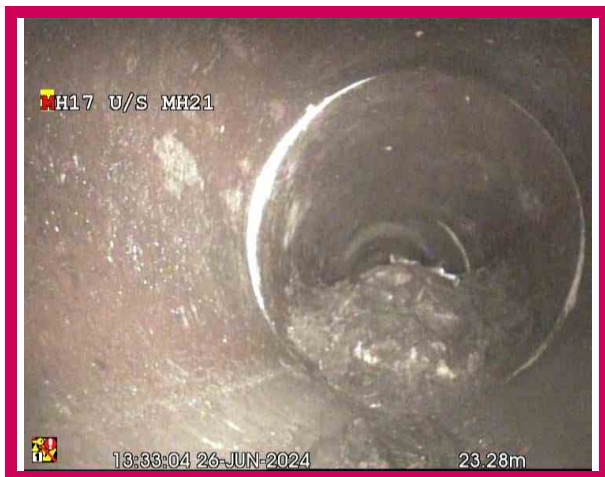
3, 00:02:23, 23.28 m  
Settled deposits, fine, 10% cross-sectional area loss, finish

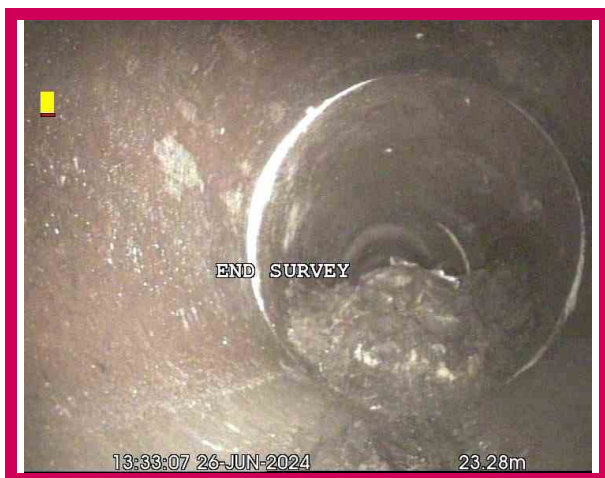
5, 00:02:29, 23.28 m  
Survey abandoned, Unable to survey further due to debris in line.

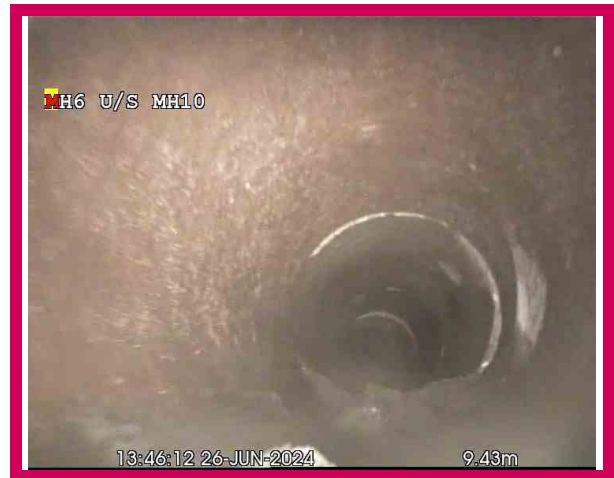
2, 00:00:37, 9.43 m  
Settled deposits, fine, 10% cross-sectional area loss

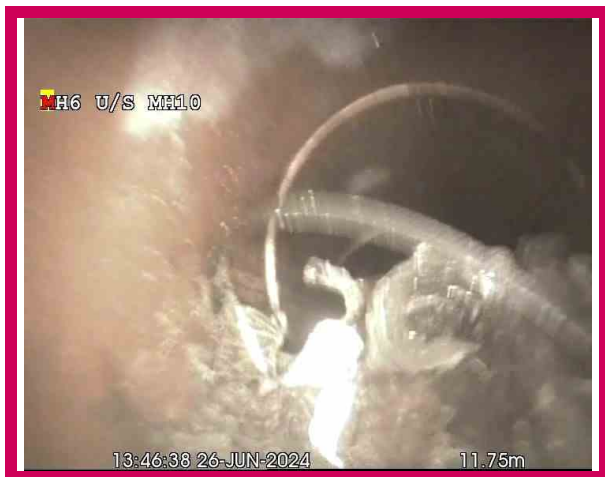
3, 00:01:03, 11.86 m  
Settled deposits, fine, 50% cross-sectional area loss

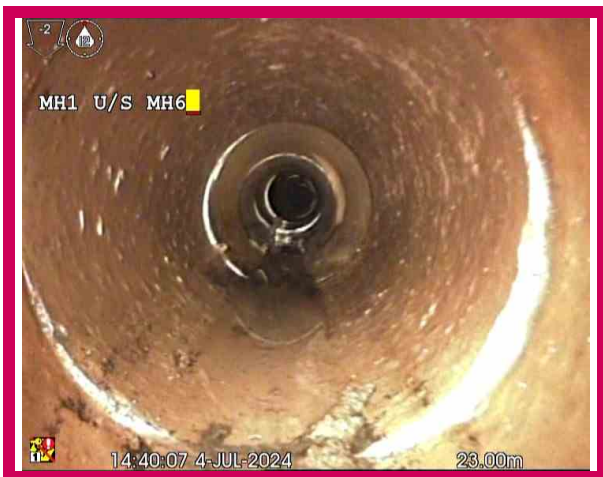
3, 00:02:36, 23.00 m  
Settled deposits, fine, 5% cross-sectional area loss

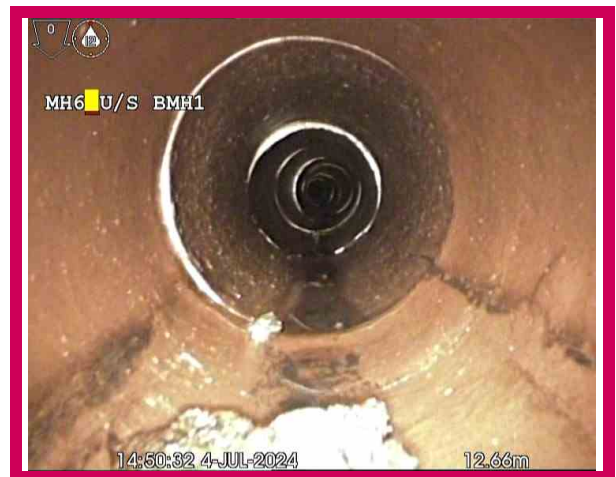
4, 00:01:23, 12.66 m  
Settled deposits, fine, 10% cross-sectional area loss

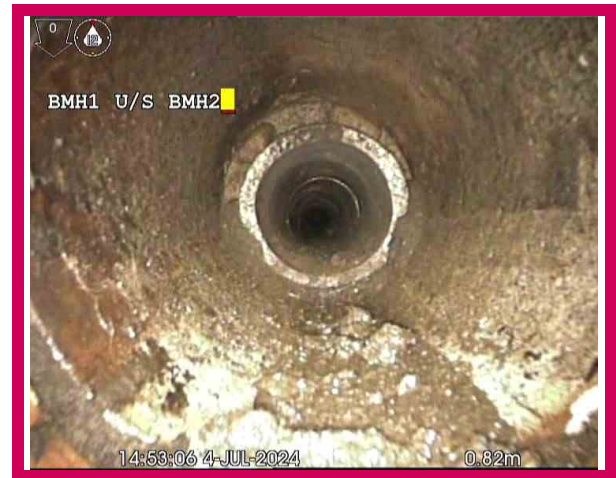
2, 00:00:07, 0.76 m  
Settled deposits, fine, 10% cross-sectional area loss

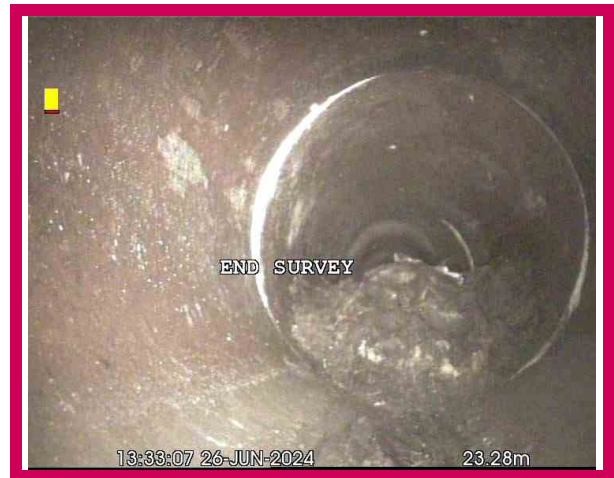
2, 00:02:29, 23.28 m  
Survey abandoned, Unable to survey further due to debris in line.

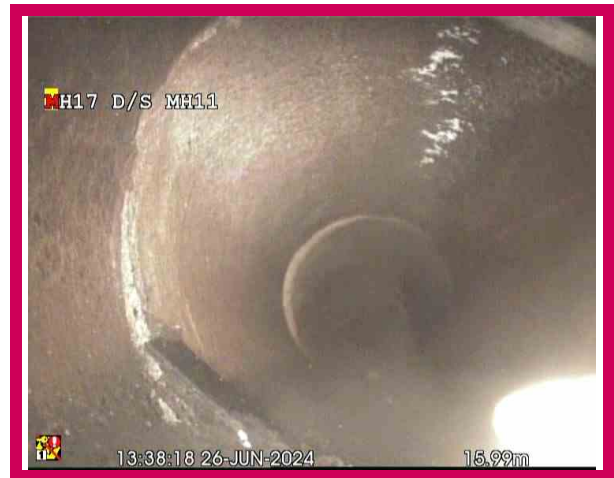
2, 00:00:48, 15.99 m  
Attached deposits, encrustation at joint from 6 o'clock to 8 o'clock, 5% cross-sectional area loss

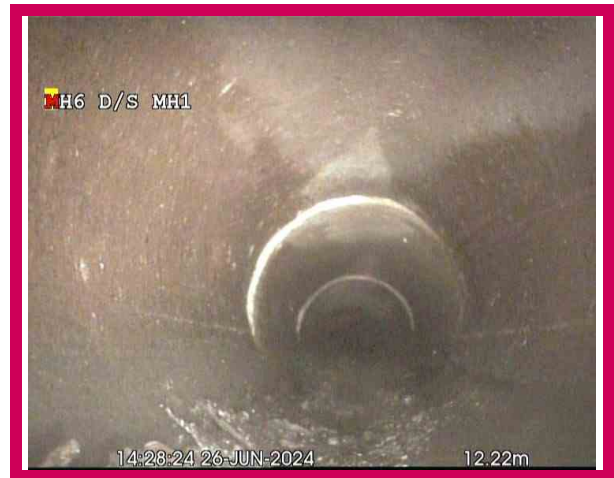
2, 00:01:14, 12.22 m  
Settled deposits, fine, 10% cross-sectional area loss

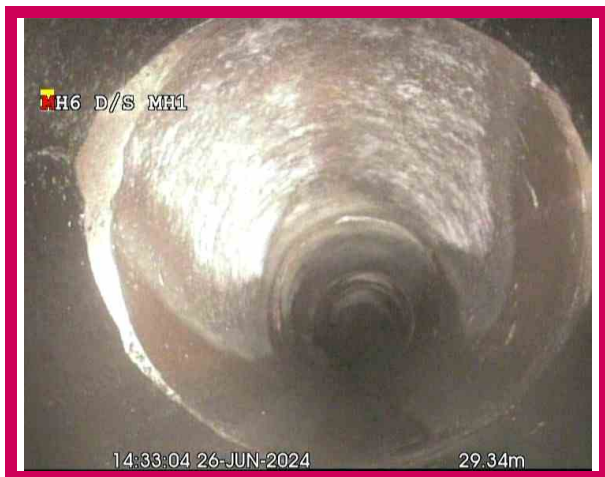
3, 00:05:53, 29.34 m  
Survey abandoned, Unable to survey due to debris in line.
