HOUGH HALL  
MOSTON

## STRUCTURAL CONDITION REPORT

Project No 2204-03  
August 2022  
Rev: P02  
HHM-REN-00-XX-RP-S-00001

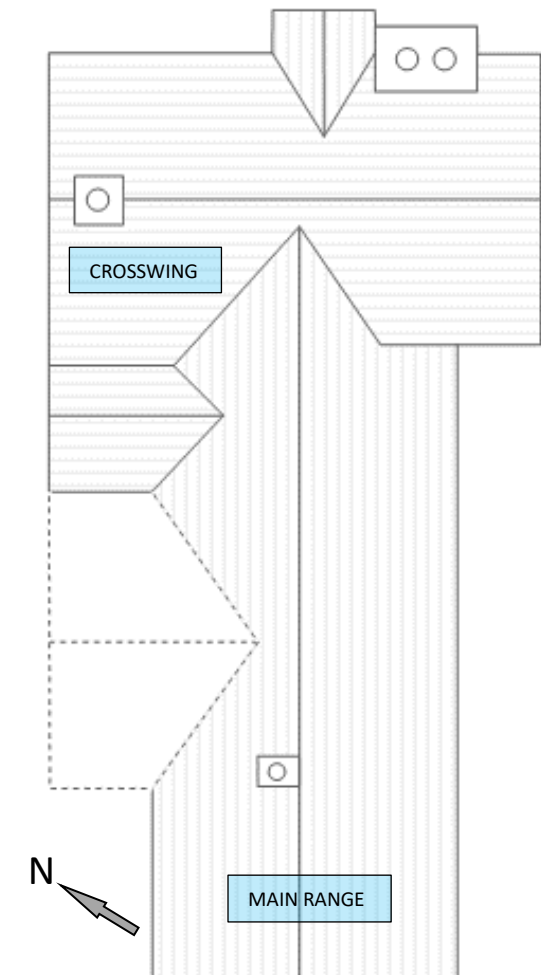
**Figure 1.2 – Indicative roof plan**

The indicative roof plan shown in Figure 1.2 below illustrates the current footprint and extent of the building. The dashed line indicates the extent of a now-demolished portion, which was taken down due to being in an unsafe condition.

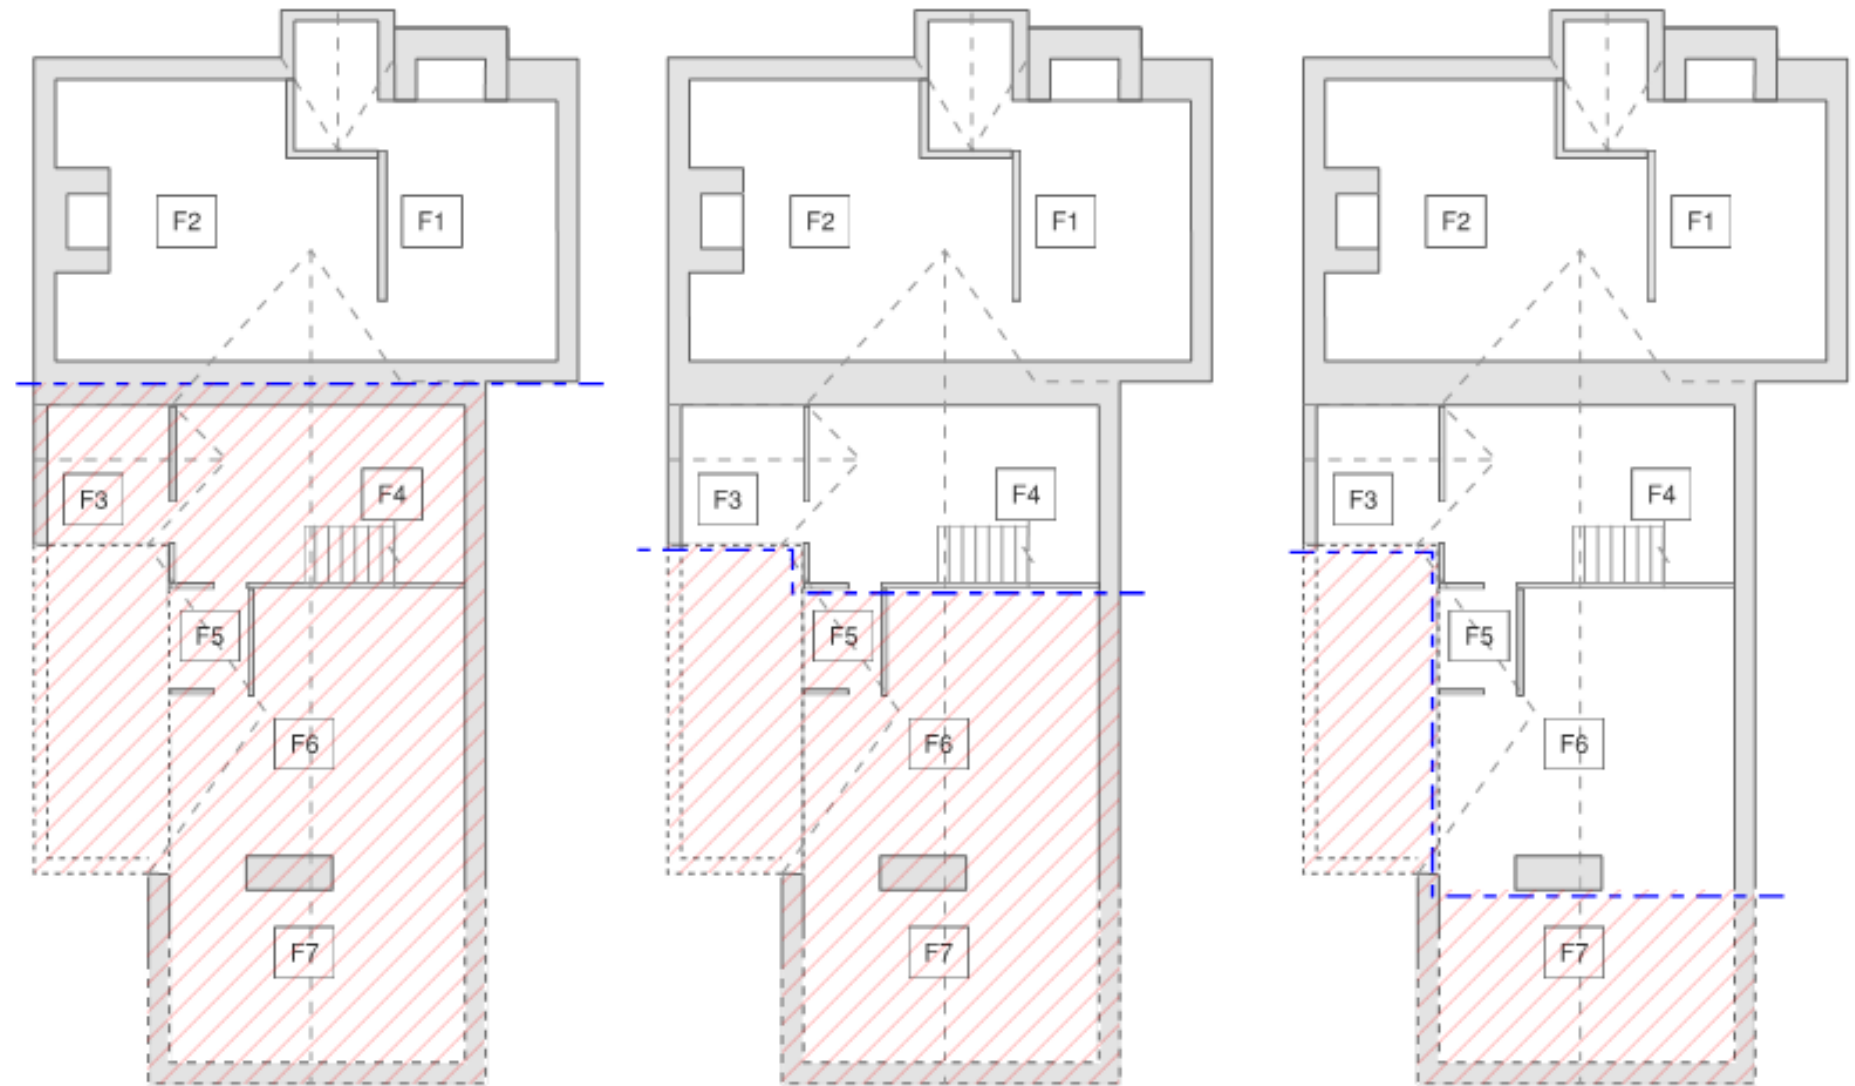
**Figure 4.1 – Retention and removal: Options 1, 2 & 3 (L-R)**

At first sight, the most obvious extent of possible retention and removal may be the interface between the main range and the crosswing, referred to here as 'Option 1'. However, it is considered that the crosswing on its own may be of insufficient size to allow viable reuse and would lead to the loss of an unnecessary amount of historic building fabric. A vertical circulation route would also need to be introduced within the space, significantly altering the internal layout, further reducing its viability for reuse and leading to further loss of historic building fabric. Introduction of a vertical circulation route would also entail significant structural interventions to support any members which may be trimmed to accommodate the necessary floor void(s) and to restrain walls where the adjacent floor is removed.

The main circulation route between ground and first floors of the building, in its current form, is apparently the staircase linking rooms G4 and F4 and it is considered that this circulation space would need to be maintained in order to make the crosswing viable as a usable space. The projection from the main range, enclosing rooms G3 / F3 could also form a valuable space for any future proposal for reuse. On this basis, a possible line demarking retention and removal can be considered, referred to here as 'Option 2'. This option would lead to less loss of historic building fabric than Option 1.

A further possible option, referred to here as 'Option 3' would be to retain the part of the main range enclosing rooms G5 / F5&F6, though the structural works required- both temporary and permanent- would be somewhat greater than those required to achieve Option 2 outlined above. Although this part of the main range is partly collapsed, the majority of primary structural elements in this area are extant, though failed in some instances due to the removal of vertical and / or lateral support. The brick wall / chimney at the western end of rooms G5 / F6, although largely collapsed above first floor level, presents a natural 'break line' within the main range which can be considered as an option for the demarcation between those areas to be retained and removed, as shown in Figure 4.1 above along with Options 1 and 2. This Option would lead to the retention of a larger amount of historic building fabric than Options 1 or 2 outlined above.

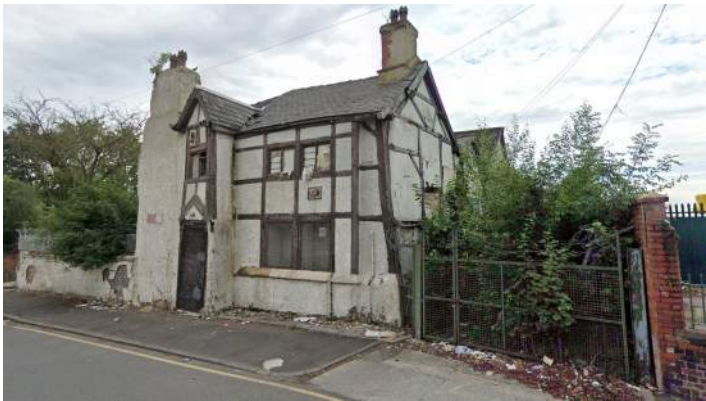
1. The infill panels between timber framing members and all stone / brick masonry walls on the east elevation appear to be covered with a cement-based render, largely obscuring the materials behind.
2. The render appears loose and has been lost in some places. Vegetation is visible.
3. The timber framing appears to be largely intact, though the condition of the timbers is unknown.
4. Some timber elements are suffering from decay; however, the extent is unknown.
5. The walls at ground to first floor adjacent to the door opening onto Hough Hall Road are of brick; likely having replaced timber posts.
6. Some items of vegetation are growing from the brickwork / stonework of the walls and chimneys.
7. A ventilation grille is visible in the plinth course, indicating a subfloor void below ground floor.

01: EAST ELEVATION, c.2019 (IMAGE © GOOGLE).

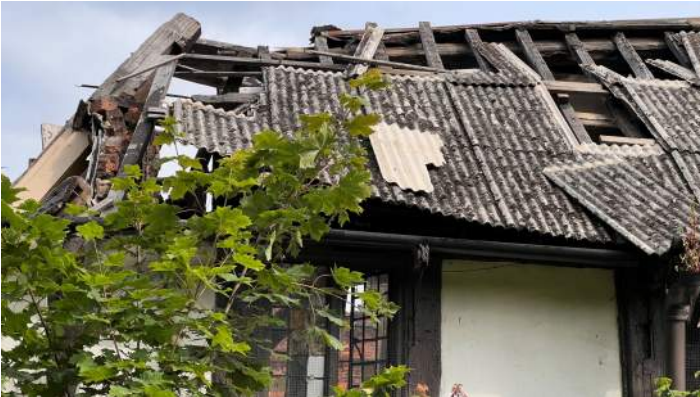
1. The roof of the main range is partially collapsed, at the west end.
2. The primary structure of the main range roof appears to be largely intact outside the area of collapse (approximately up to the location of the wall and chimney) however the roof members are unsupported at their north ends due to the effects of the emergency demolition.
3. It is likely that extant timber structural elements will require some degree of rectification, due to the deterioration caused by long term exposure to the elements.
4. Many of the asbestos sheets forming the roof covering of the main range are missing or displaced.
5. The primary structure of the roof of the crosswing (roof trusses, purlins) appears to be largely intact, based on observation from ground level.
6. Most of the roof coverings to the crosswing appear to be present, however some areas have been lost.

07: SOUTH ELEVATION. WEST END OF MAIN RANGE, ROOF LEVEL.

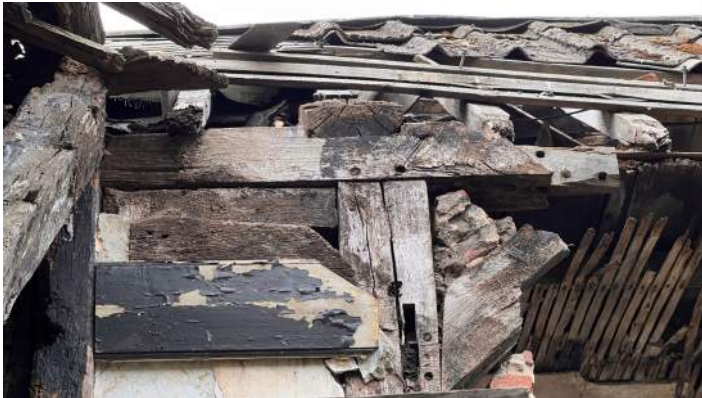
18: NORTH ELEVATION. CENTRAL BAY OF MAIN RANGE. EXAMPLE OF PEG JOINTS BETWEEN TIMBER MEMBERS.

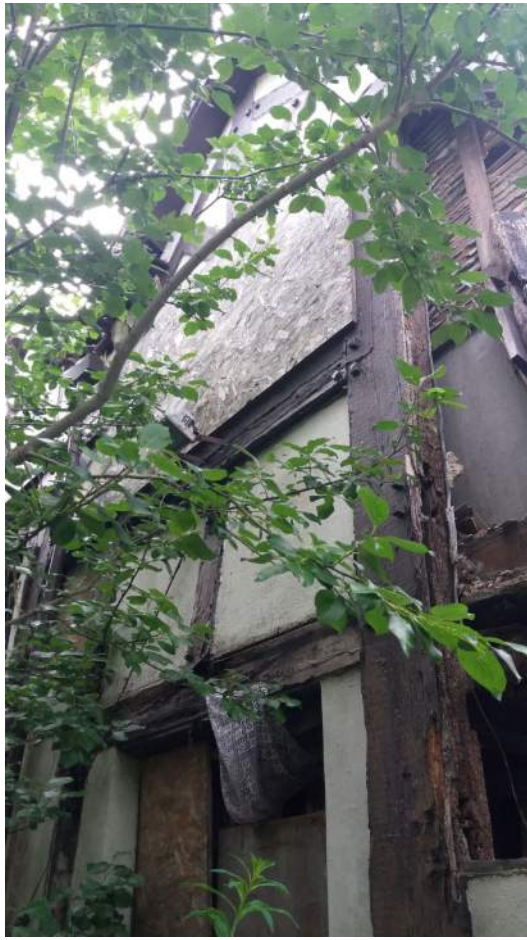
3. As above, the west side of the projection from the main range does not have an external wall due to formerly being part on an internal space.
4. The timber framing of the gable of the projection from the main range appears to be intact, though the condition of the timbers could not be assessed, and the material of the infill panels could not be determined. At eaves level, a kingpost roof truss is visible.

20: NORTH ELEVATION. GABLE OF PROJECTION FROM MAIN RANGE.

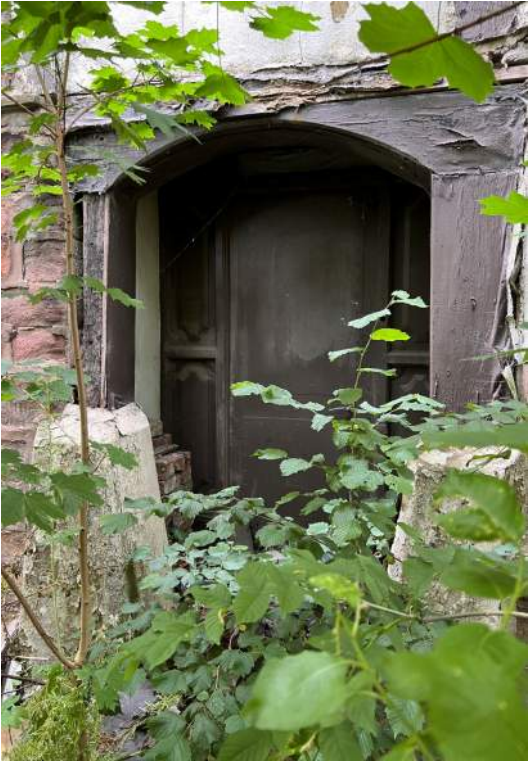
22: NORTH ELEVATION, CROSSWING. ENTRANCE INTO BUILDING. STONE MASONRY WALL EXTENDS TO FIRST FLOOR LEVEL IN THIS AREA.

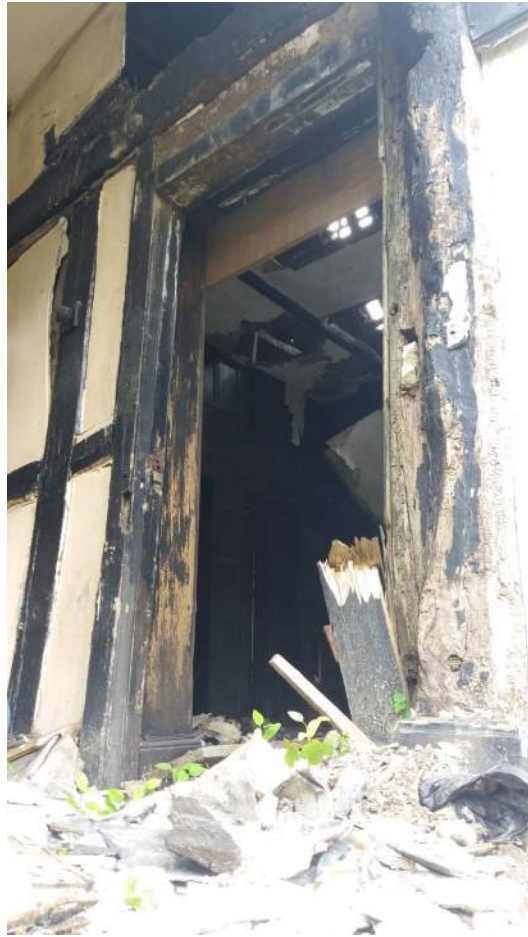
34: DOORWAY FROM ROOM F5 INTO ROOM F6.

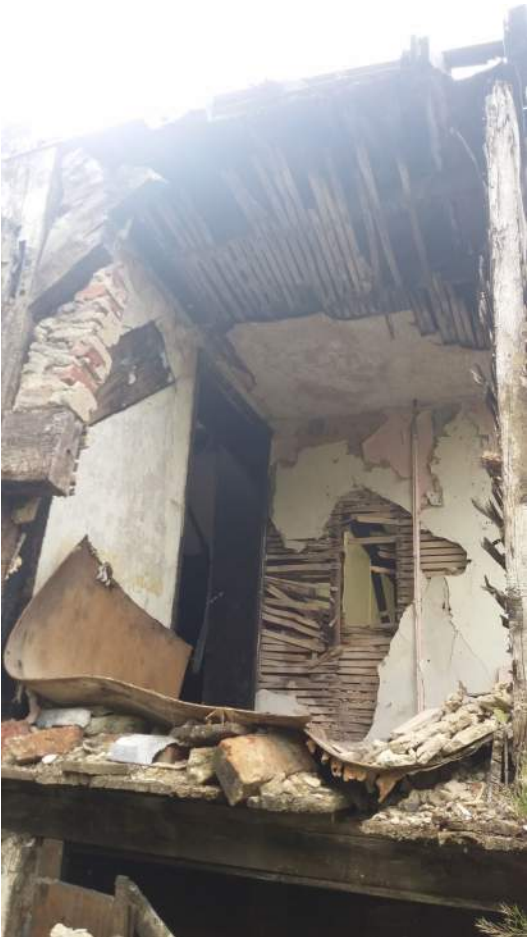
35: LOOKING INTO ROOM F5.
