| Site name: A&H Construction - Lowry Park,<br>Grimshaw Lane, Manchester. | | Units/ plots checked: : Unit 6 core area line outs | | | |
| Inspection by: Dan Squire | | Weather: 7°C Wet | | | |

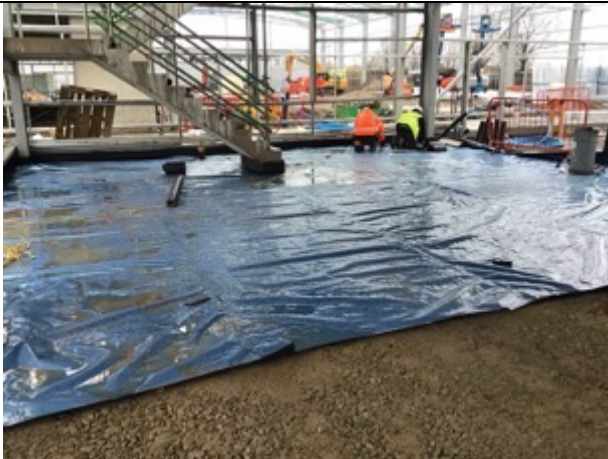
Stair core 2 overview

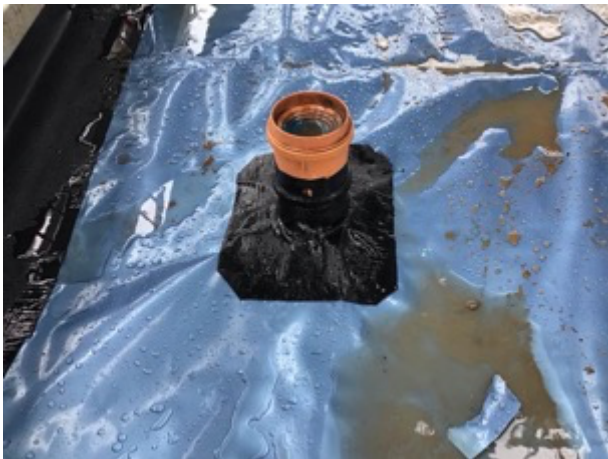
Stair core 2 pipe penetration

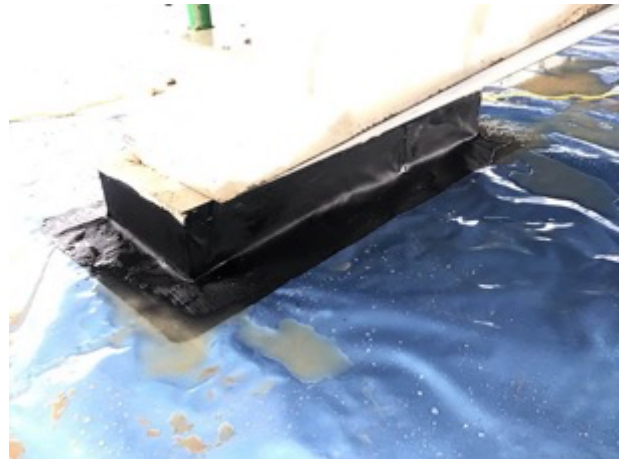
Stair core 2 detailing

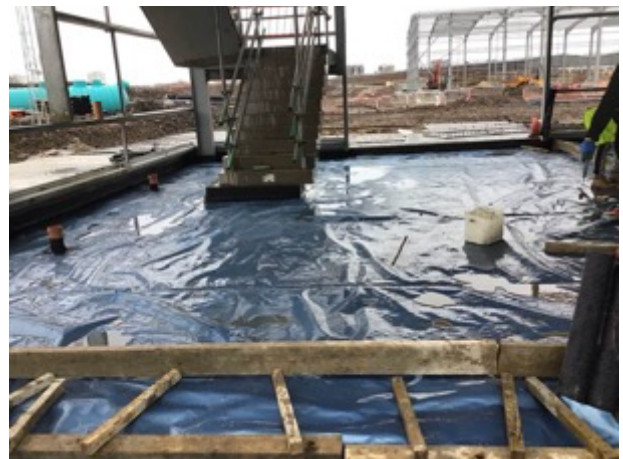
Stair core 3 overview

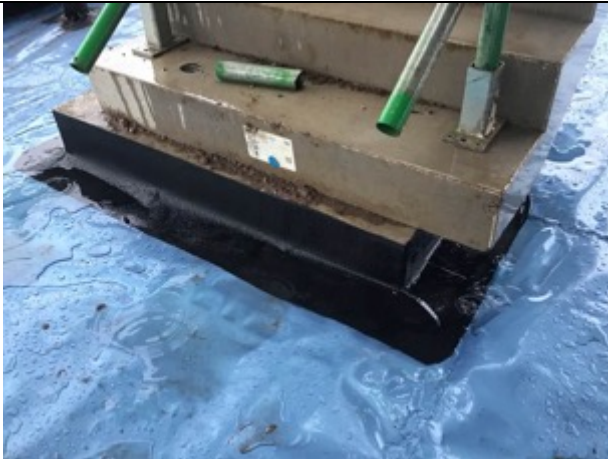
Stair core 3 detailing

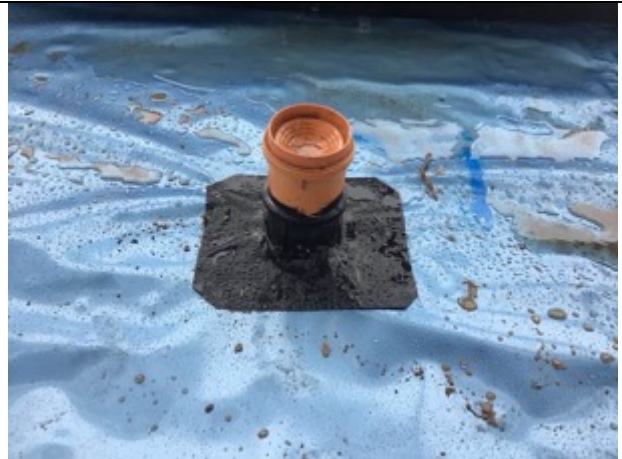
Stair core 3 pipe penetration

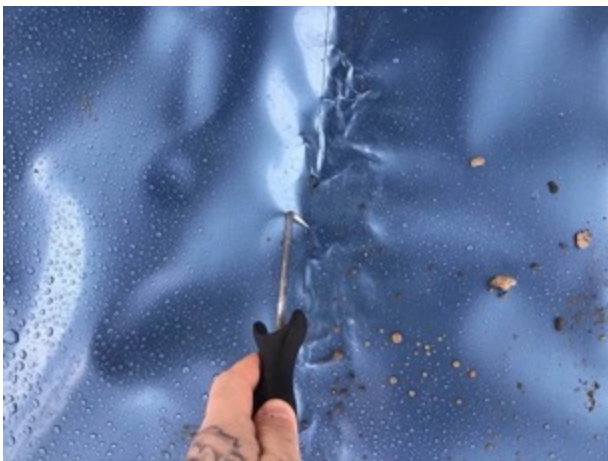
Probe testing hand welds

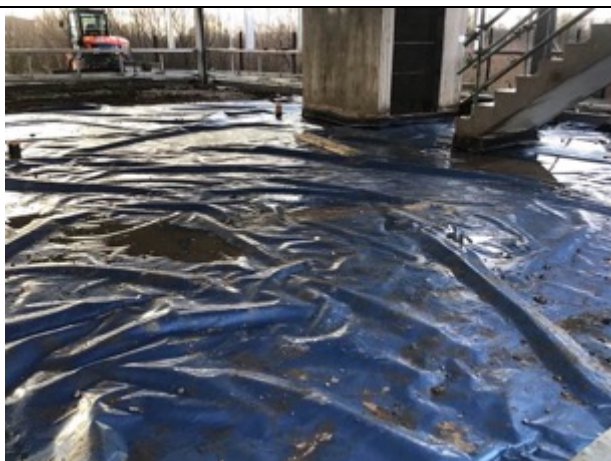
Unit 6 core area overview

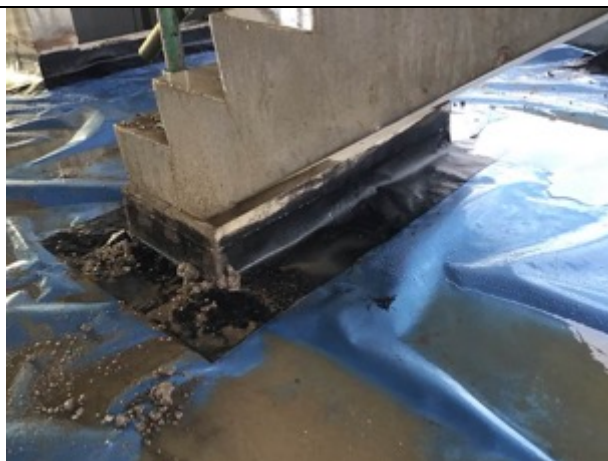
Sealed stair base

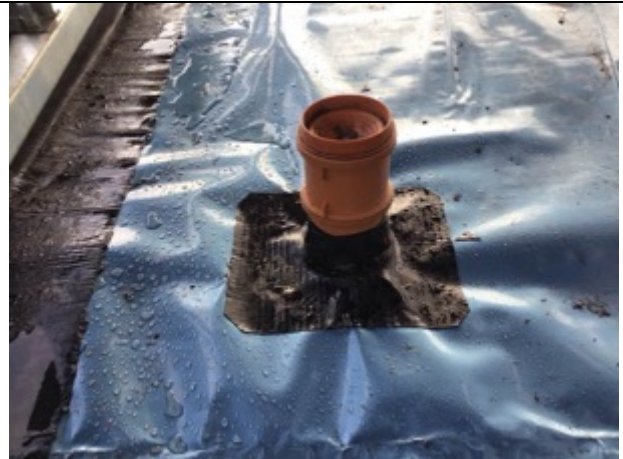
Sealed pipe penetration

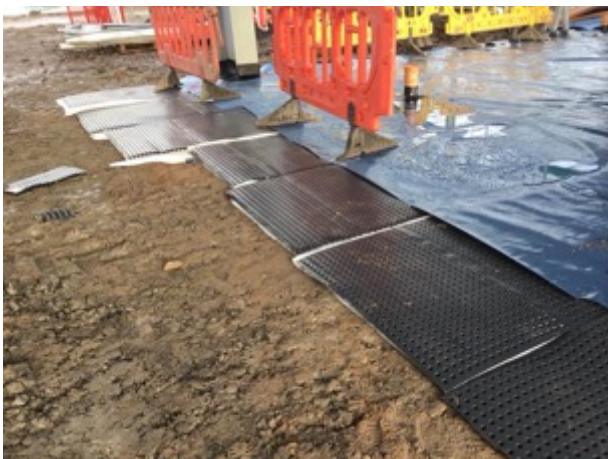
Vent mat installed under the membrane

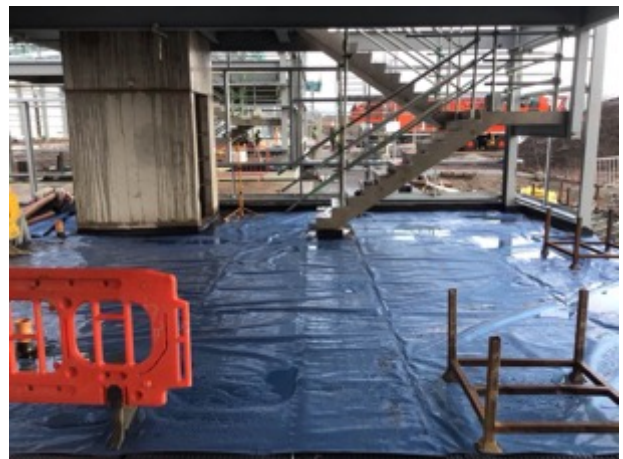
Unit 1 core area overview

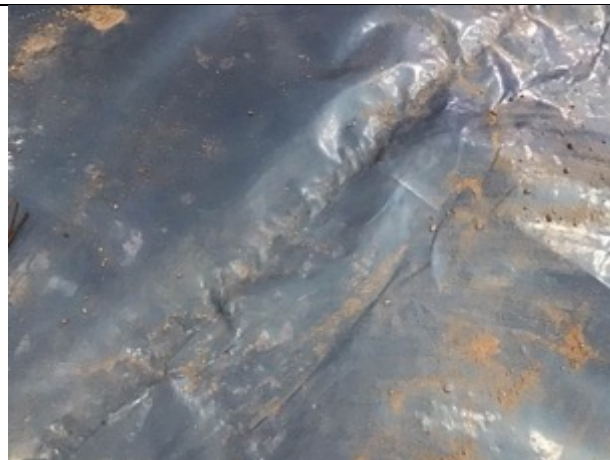
Membrane inspected after laser screed machine feet raised

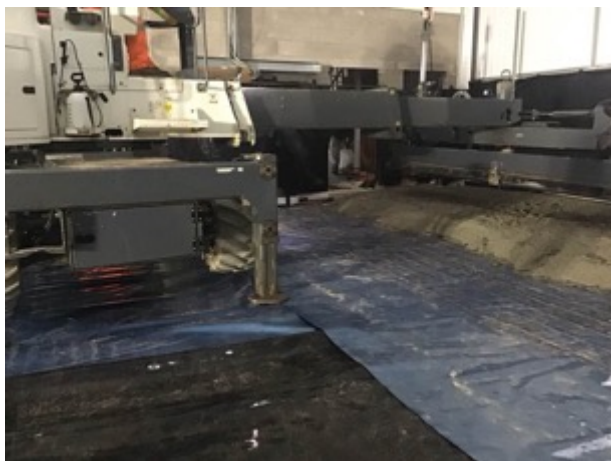
Laser screed machine keeping off the mesh on the membrane

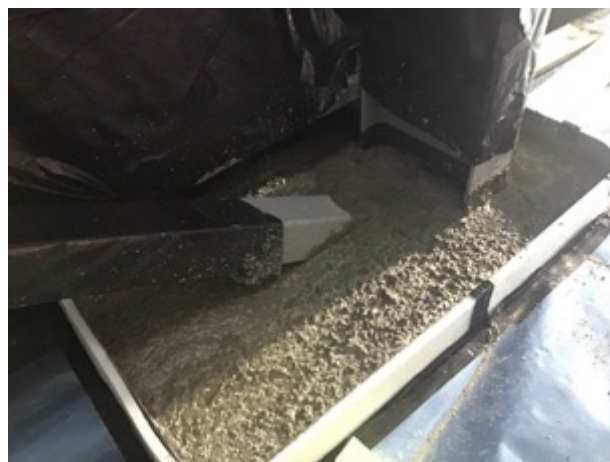
Stanchions encased prior to the pour inspection

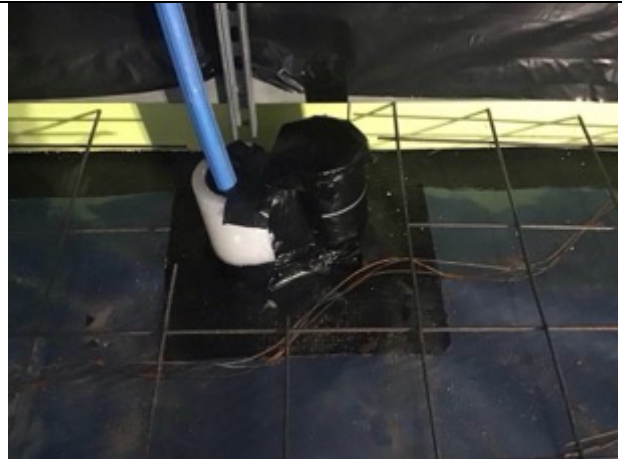
Sealed pipe penetrations with miothene installed by site

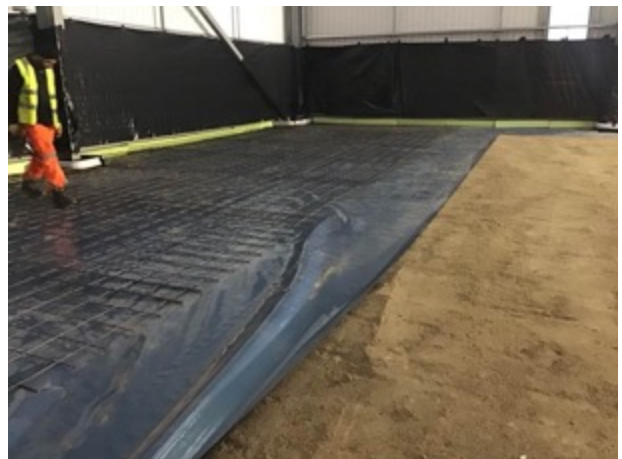
Membrane installed ahead of the first pour

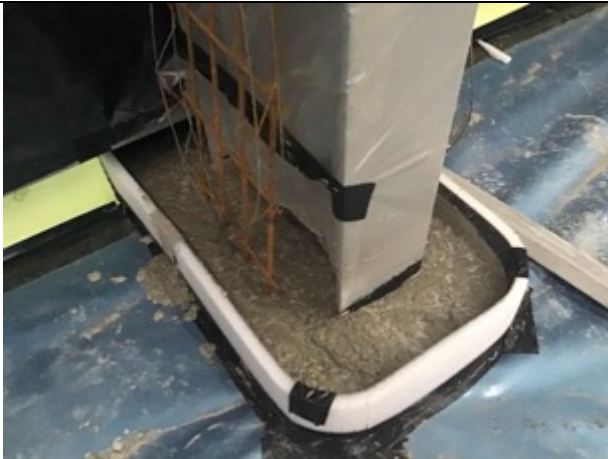
Sealed stanchions poured prior to the inspection

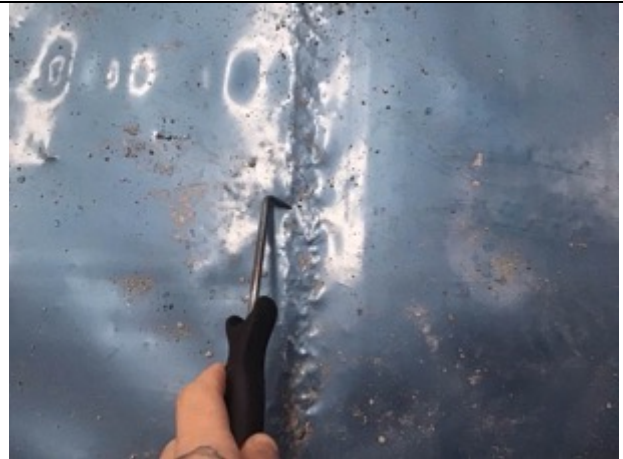
Probe test to hand weld joint

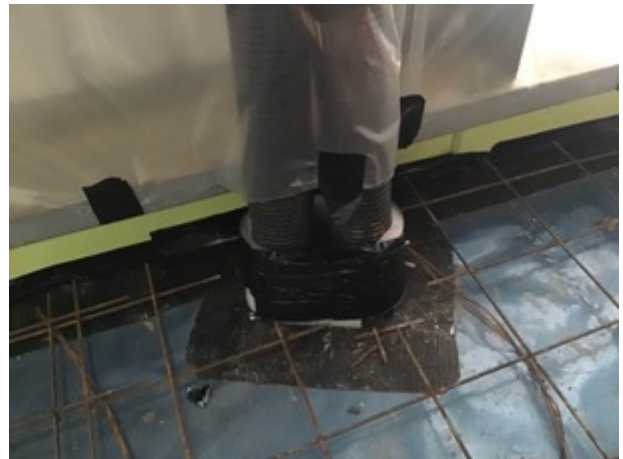
Restricted inspection to sealed pipe penetrations

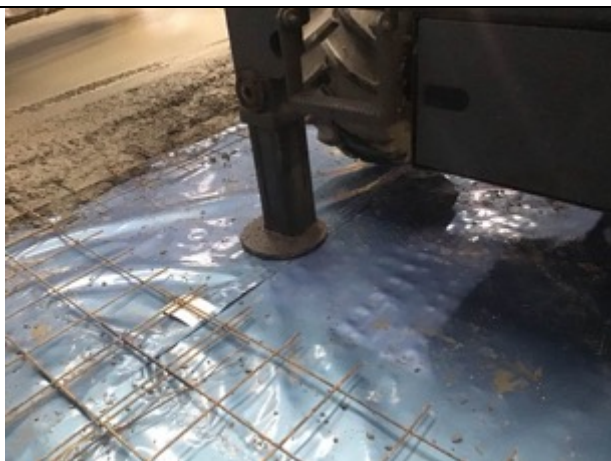
Plant keeping off the mesh on the membrane

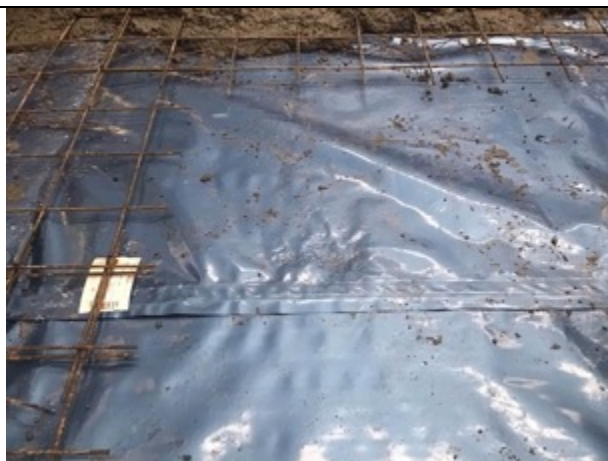
Membrane inspection after laser machine feet lifted

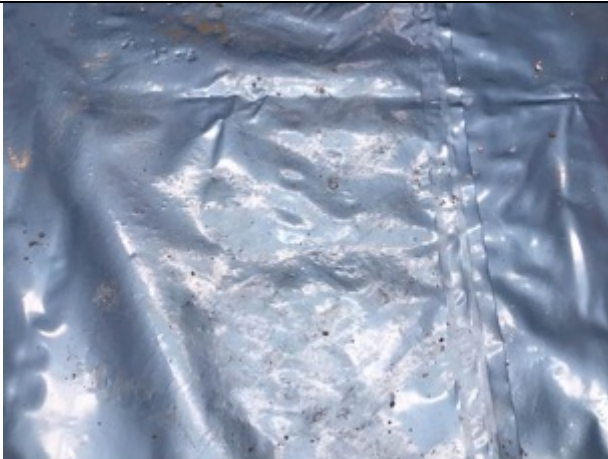
Membrane inspected after plant feet are raised

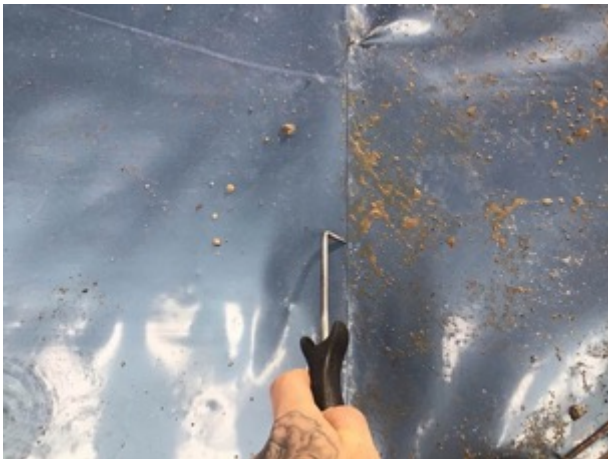
Probe test to sealed hand weld membrane joint

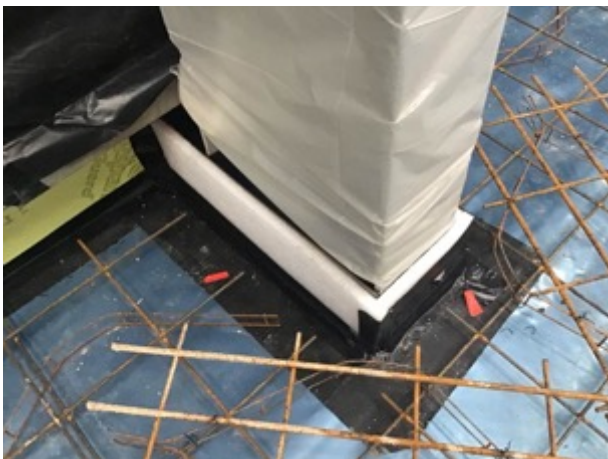
Restricted inspection to stanchion detailing

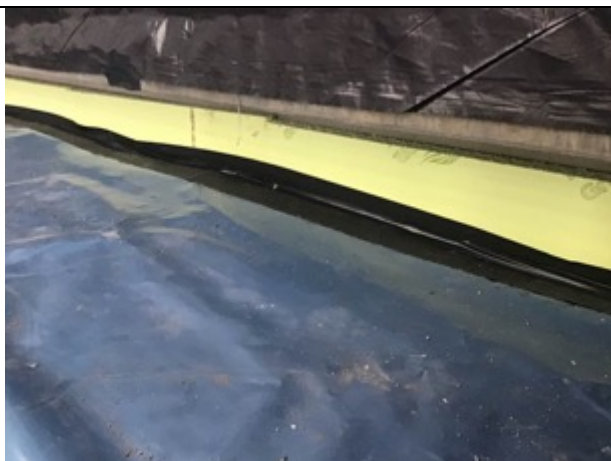
Restricted inspection to perimeter retro fit detailing

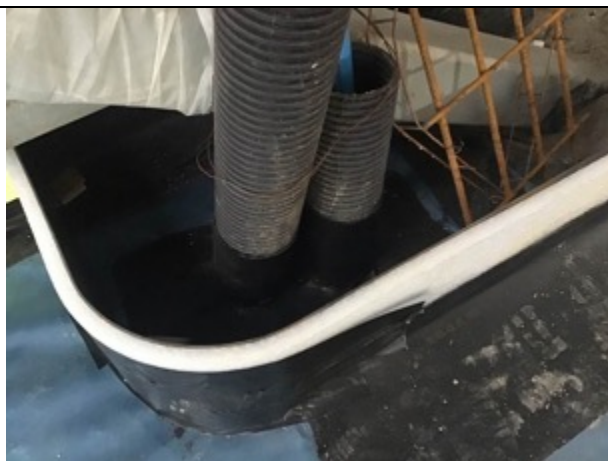
Sealed pipe penetrations using SAGM

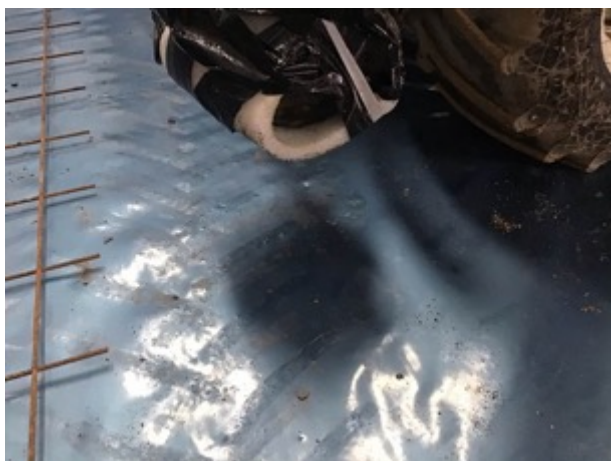
Membrane inspected after laser machine feet were raised

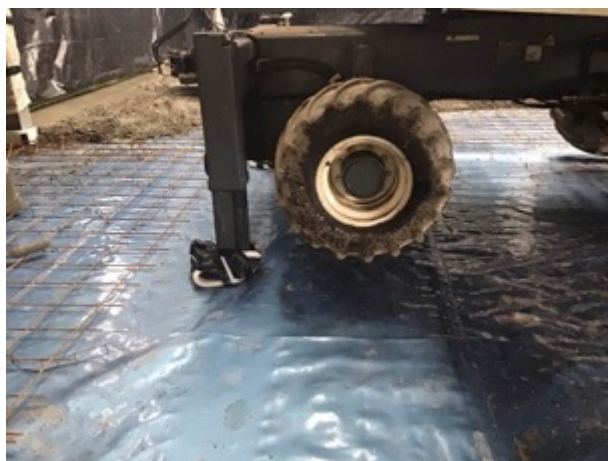
Plant keeping off the membrane and using miothene to protect the membrane from the laser machine feet

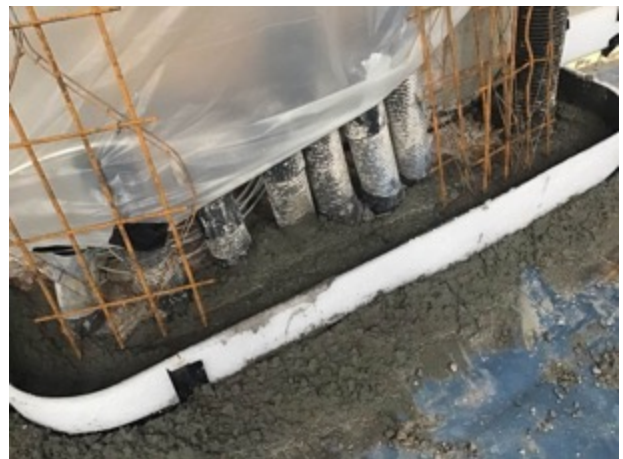
Restricted inspection to pipe penetrations

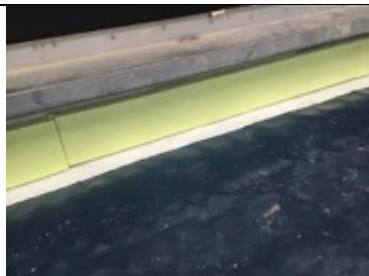
Restricted inspection to perimeter detailing

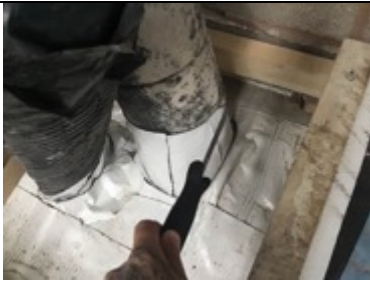
Probe test to pipe sealing

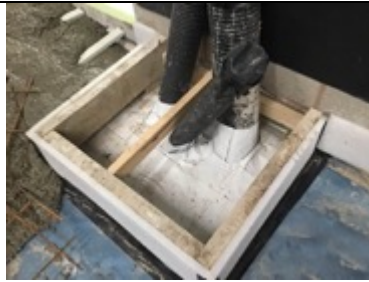
Pipe penetrations sealed using  
SAGM and heat applied

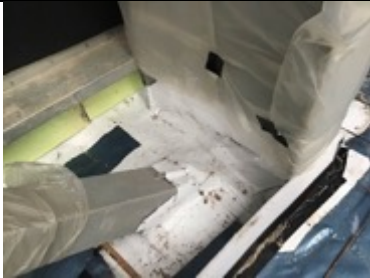
Sealed stanchion using SAGM  
and heat applied

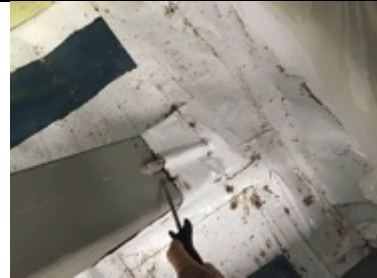
Probe test to stanchion sealing

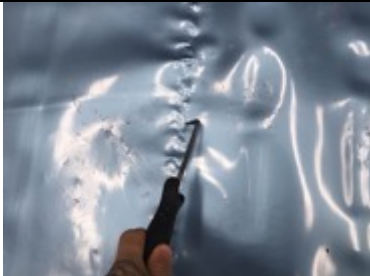
Probe test to hand weld  
membrane lap joint

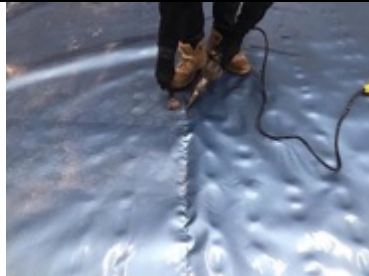
Membrane being hand welded  
together

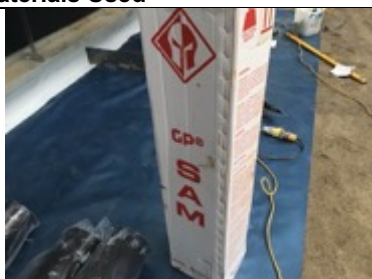
Evidence of Juta GPSAM

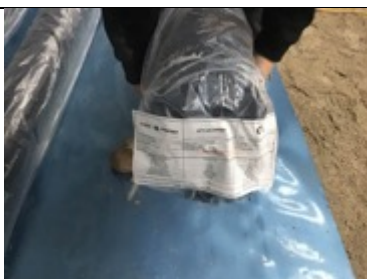
Evidence of Juta GP5 gas membrane

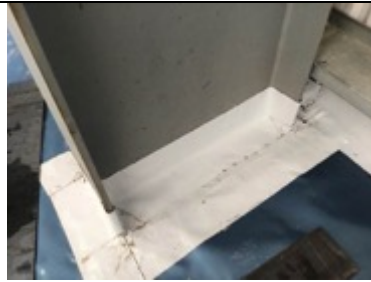
Sealed stanchion detailing using  
SAGM and heat applied

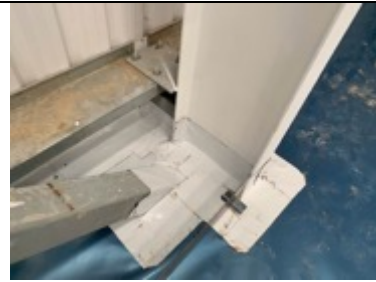
Sealed stanchion detailing using  
SAGM and heat applied

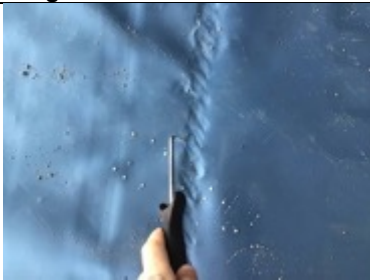
Hand weld membrane lap joint  
testing

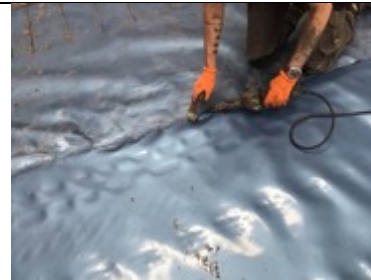
Hand welding membrane lap joint

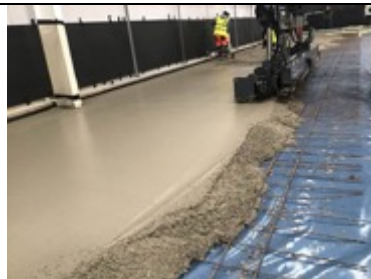
Laser screed installation over the  
membrane

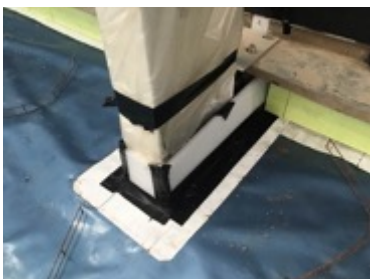
Insulation and miothene installed  
after the inspection of works  
carried out

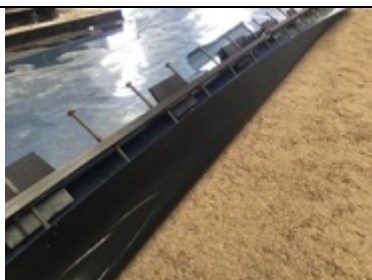
Acceptable sub base under the dock leveller membrane

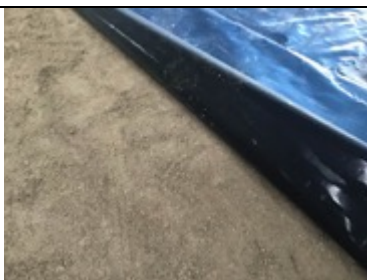
Acceptable sub base under the office area membrane

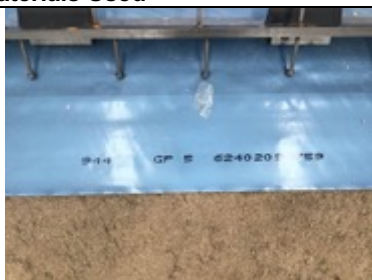
Evidence of Juta GP5 gas barrier membrane

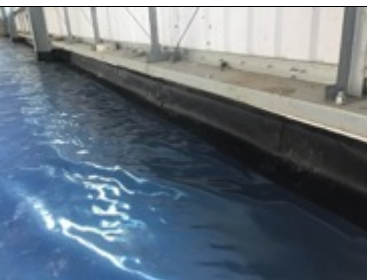
Office area retro fit detailing using SAGM and heat applied

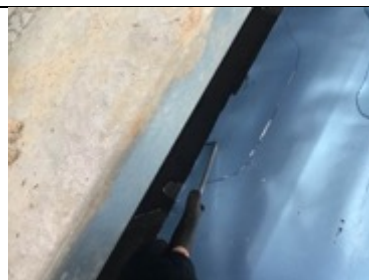
Perimeter detailing testing

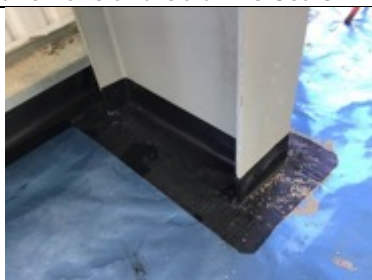
Sealed office area stanchion detailing using SAGM and heat applied

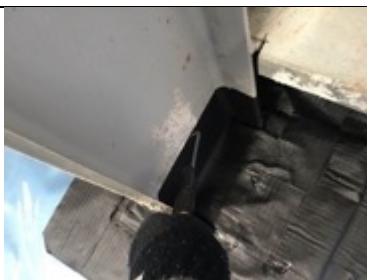
Testing sealed dock leveller area stanchion detailing using SAGM and heat applied

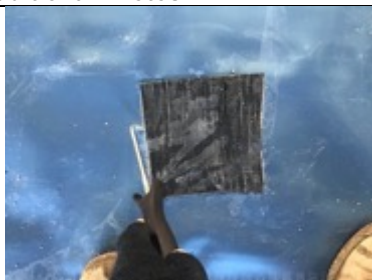
| (Section 3, Defects List) | Action Required |
|---|---|
| The installers made patch repairs prior to the inspection using SAGM patches and heat applied under their own CQA. No recorded defects found by MEC | No Action Required all Defects rectified at time of inspection |

Testing sealed patch repair made by the installers prior to our inspection using SAGM and heat applied

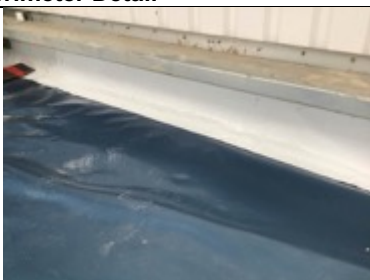
Perimeter retro fit detailing to  
cladding using SAGM and heat  
applied

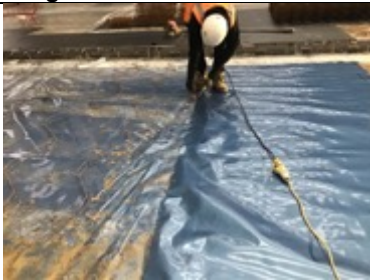
Membrane hand welded into  
position

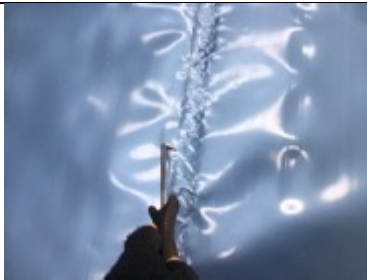
Probe test to hand welded  
membrane lap joint

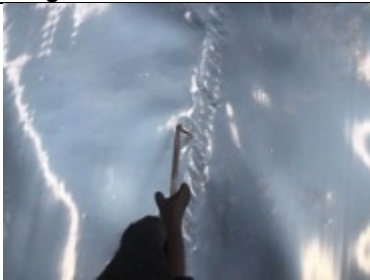
Testing hand welded membrane lap joint

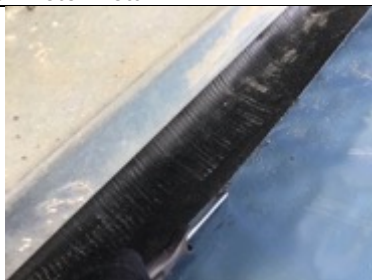
Testing perimeter detailing

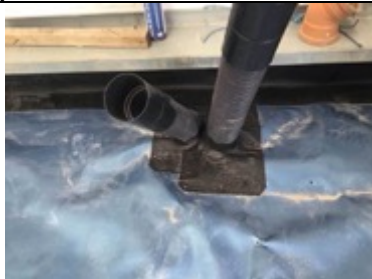
Sealed pipe penetrations using  
SAGM and heat applied

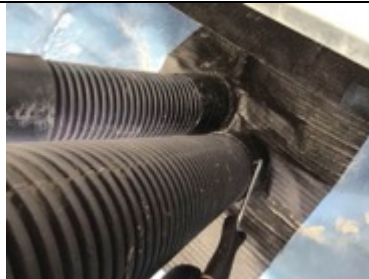
Testing pipe detailing

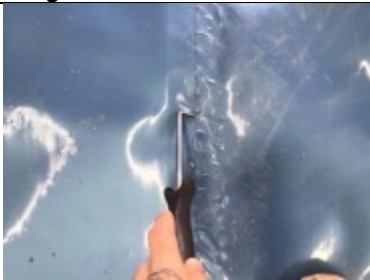
Testing hand welded membrane lap joint

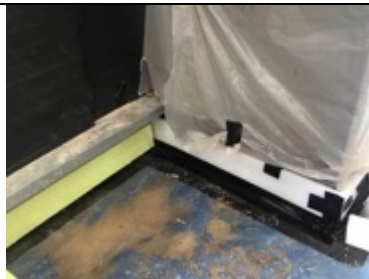
Insulation and miothene installed after the inspection

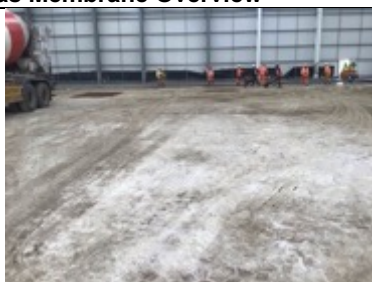
Overview of the pour area

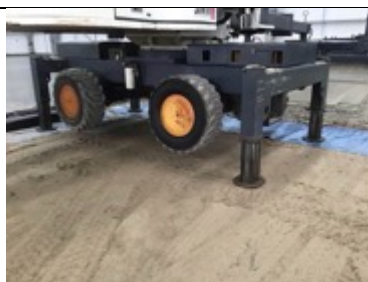
Plant keeping off the mesh above the membrane

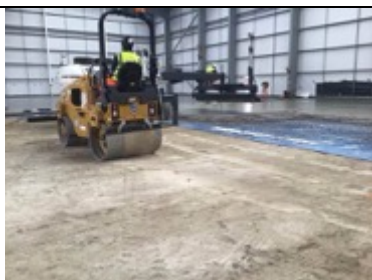
Roller prep ahead of the  
membrane installation

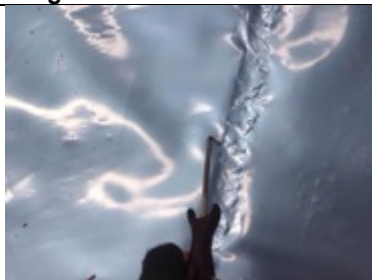
Testing hand welded membrane lap joint

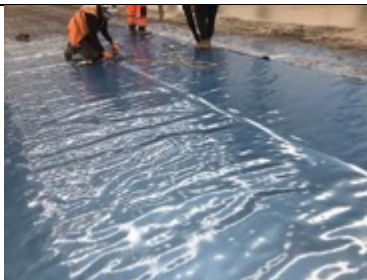
Membrane hand welded into position ahead of the pour

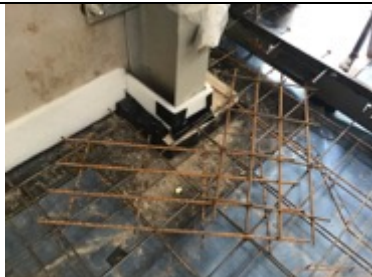
Miothene installed at the perimeter  
and around the stanchion detail

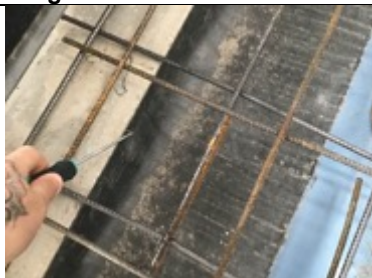
Probe testing the membrane retro  
fit detail to the dock levellers

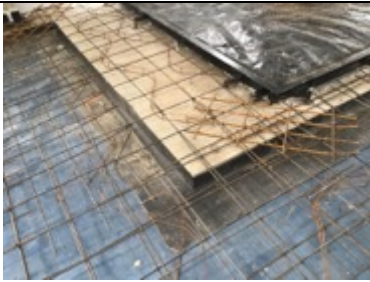
Corner retro fit detailing using  
SAGM and heat applied

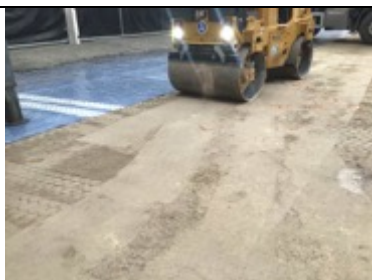
Substrate prep ahead of the  
membrane installation

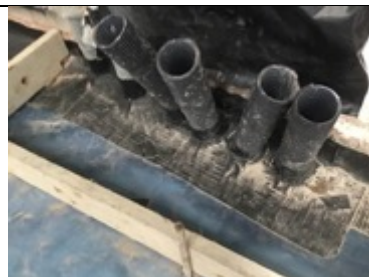
Pipe penetrations sealed using  
SAGM and heat applied

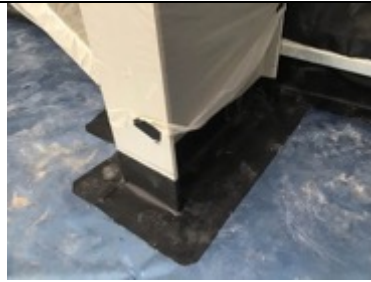
Stanchion detailing sealed using  
SAGM and heat applied

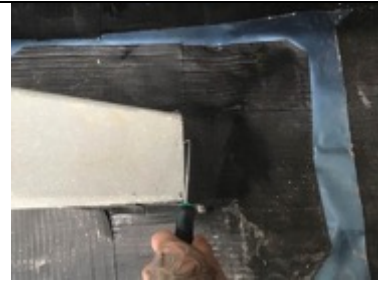
Stanchion detail testing

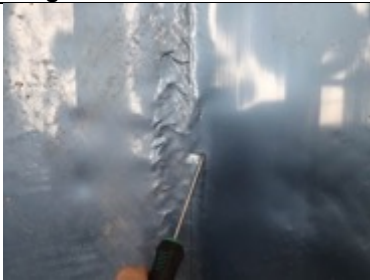
Probe test hand welded  
membrane lap joint

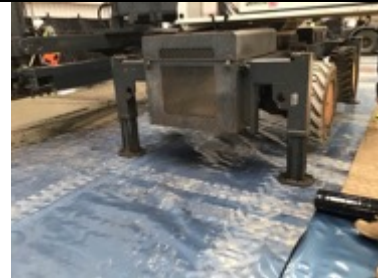
Plant keeping off the mesh above  
the membrane

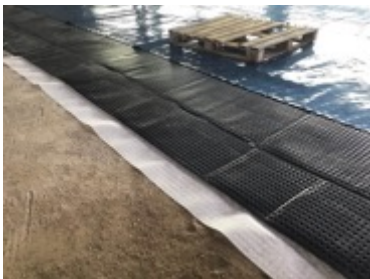
Vent mat installed under the  
mezzanine floor area

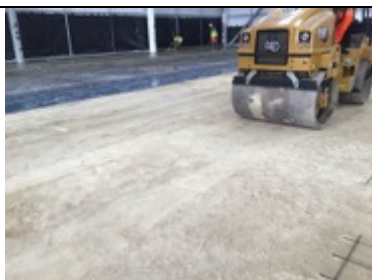
Substrate prep ahead of the  
membrane installation

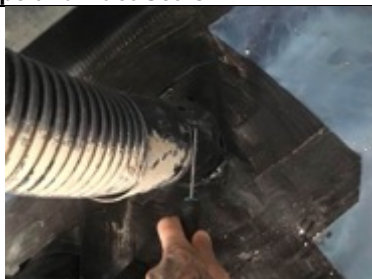
Pipe penetrations testing

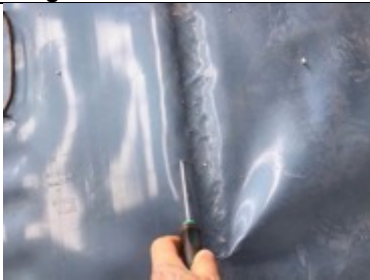
Probe test hand welded membrane lap joint

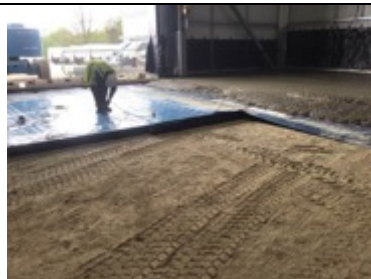
Membrane installed 4 meters at a time ahead of the pour

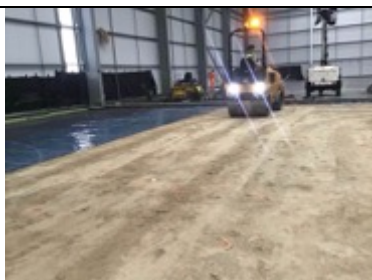
Substrate prep ahead of the  
membrane installation

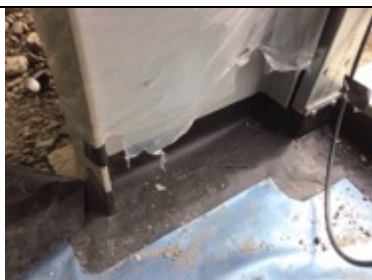
Stanchion detailing sealed using  
SAGM and heat applied

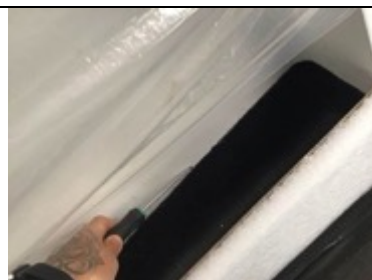
Stanchion detail testing

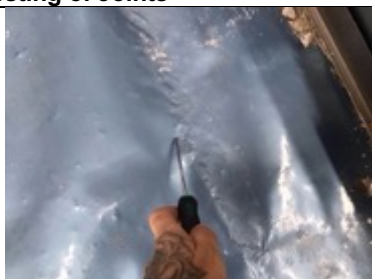
Probe test hand welded  
membrane lap joint
