Our Ref: 1826-01  
20<sup>th</sup> February 2024  
Client:  
Greg Cawley  
Senior Project Manager  
AtkinsRéalis  
The Exchange, 3 New York Street  
Manchester  
M1 4HN

## Poland Street Zone – Ancoats Green – Boundary Wall Inspection Summary Report

Civic Engineers Mark-Up - 1826-01-SK- 1000 - PL - Sht 1  
Non-Intrusive Condition Survey To Boundary Wall  
Ancoats Green - Manchester  
PSL Date - Feb 2024

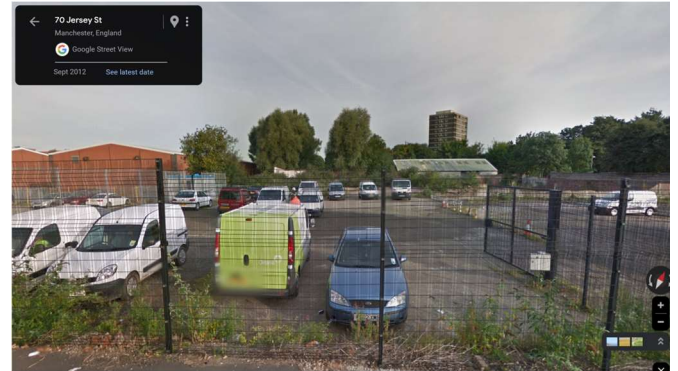
Figure 3 – Google maps image capture – Sept 2012

An additional review of google maps image capture history, documents that between Jul 2008 and Sept 2012 a warehouse building, constructed in solid brickwork was demolished at the site, and it appears probable that the boundary wall is the remnants of the demolished building indicated in figure 2.

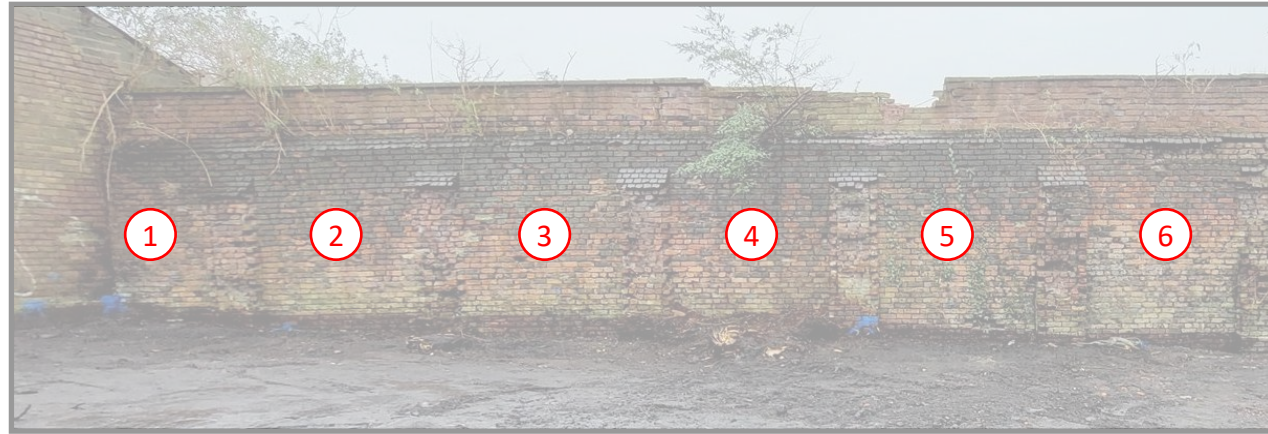
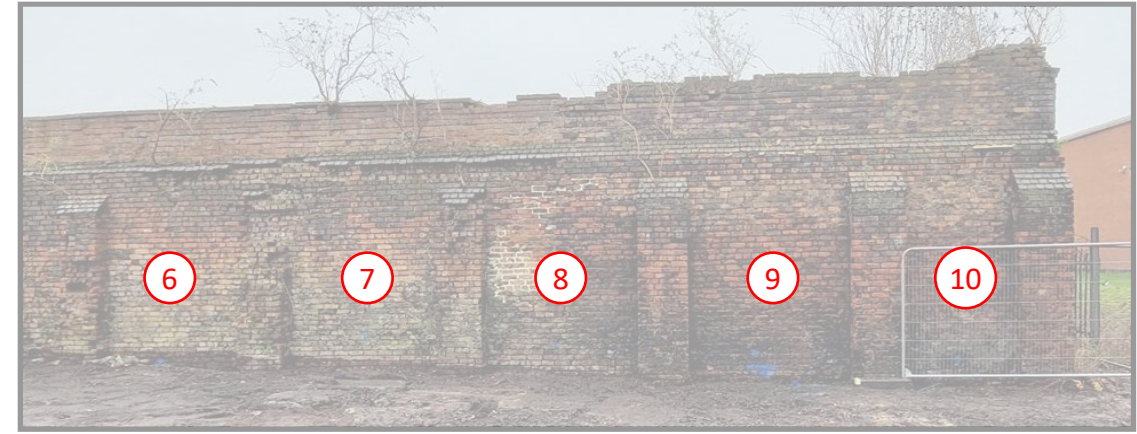
Panel 4: Wall Defect / Deterioration Checklist

A partial collapse of the wall has occurred in panels 4, 5, 8 and 10, and this is accompanied by adjacent structural cracking and loosening of the brickwork panel, further weakening the masonry construction increasing the likelihood of further collapse.

As discussed above structural cracking has occurred in panel 3, 4, 5, 6, 7 & 8. The more obvious structural cracking has occurred in the top section of the wall where the wall thickness appears to

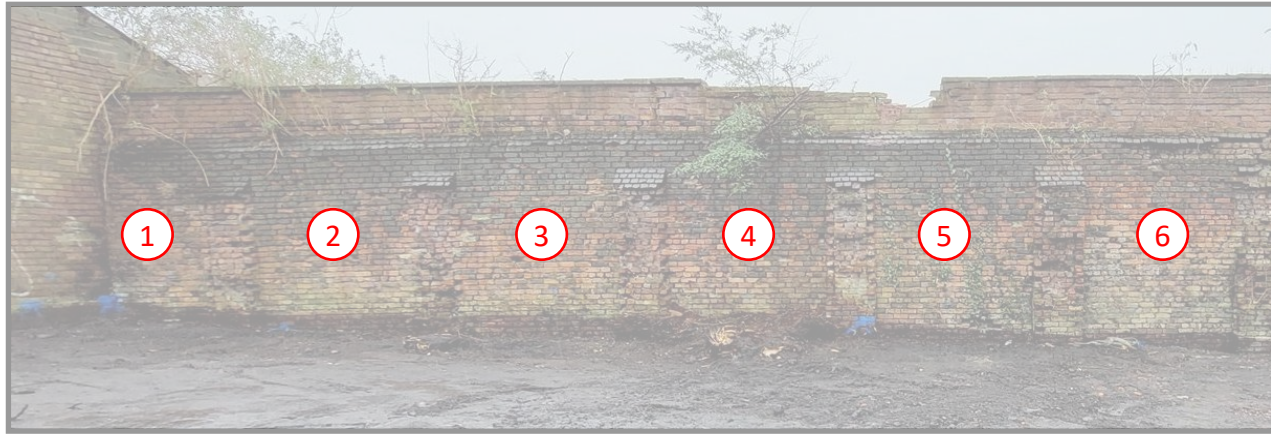
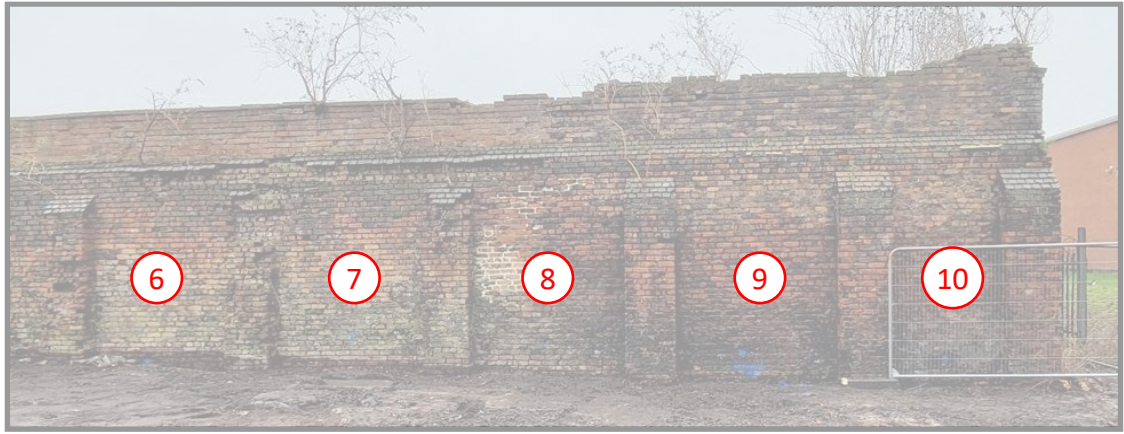
Panel 7: Wall Defect / Deterioration Checklist

A section of stretcher courses, (3No.) have locally broken away from panels 6 to 8 revealing the inner snapped header coursing. Adjacent to this section of wall further failure of the neighbouring brickwork can be seen such as loosened and missing brick sections, this results in local weakening of the masonry construction and increasing the likelihood of further local collapse.

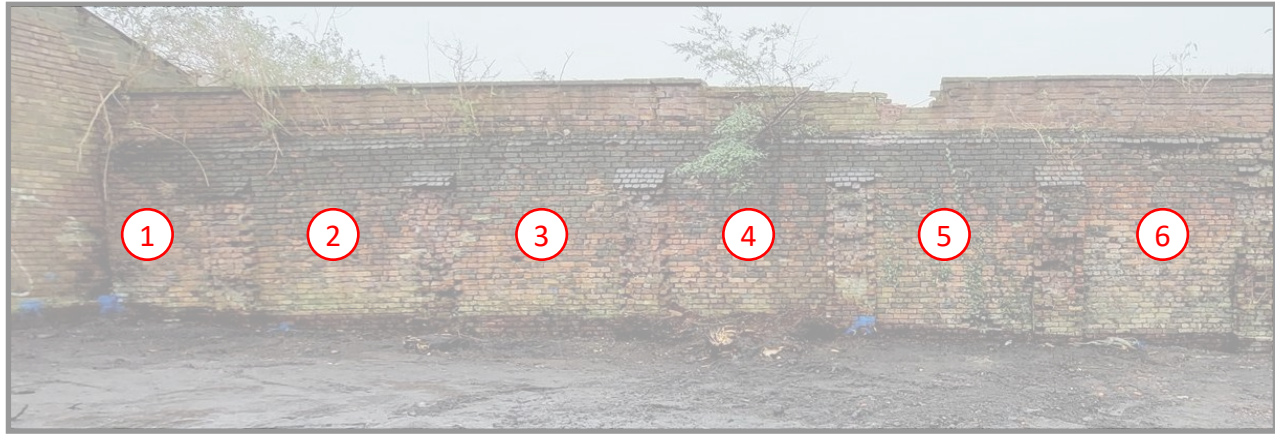
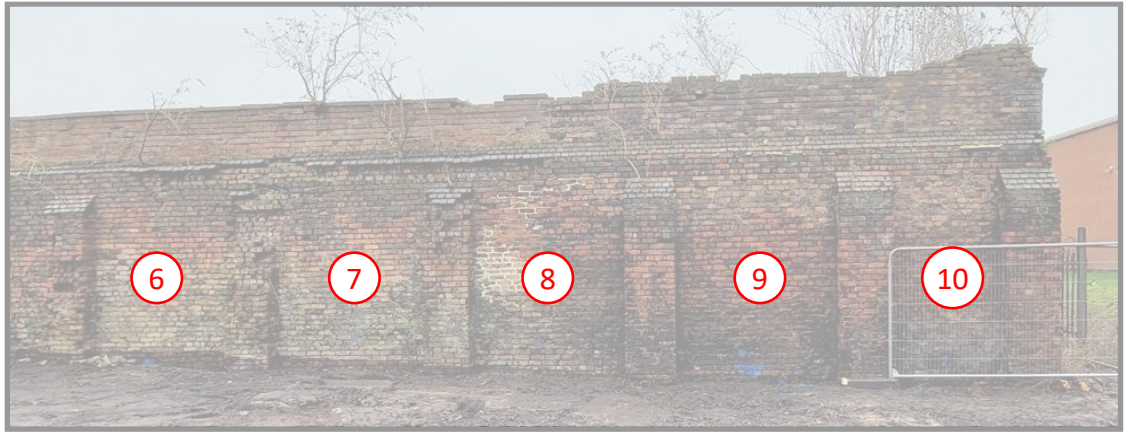
Wall Height Estimate

A further observation noted in the original photographs was the height of the wall which by simply counting of the brickwork course can be estimated to be approximately 4.10m high.
