# 117-119 Portland Street, Manchester

## Results of Architectural Paint Research

29/02/2024

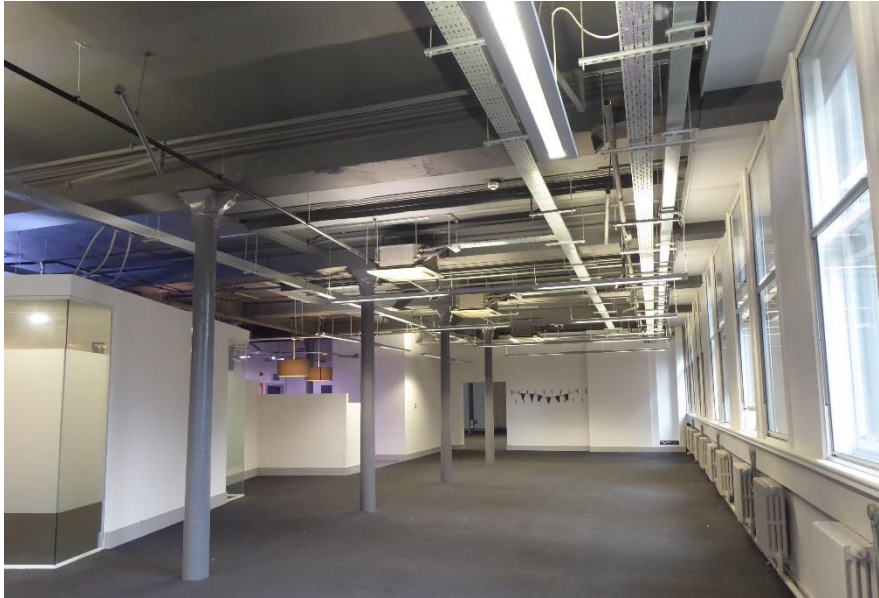
*Figure 9: Level 1 looking towards the rear of the building with Dickinson Street elevation to the right.*

The space was vacant at the time of sampling with significant evidence of long use as an office space. Level 1 was identified by the client as being of most historic interest due to the presence of cornice and perimeter mouldings to the ceilings (Figure 10). These were noted across much of the front office space with some interruptions identified that may signal the line of past subdivisions, though the dates of these cannot be

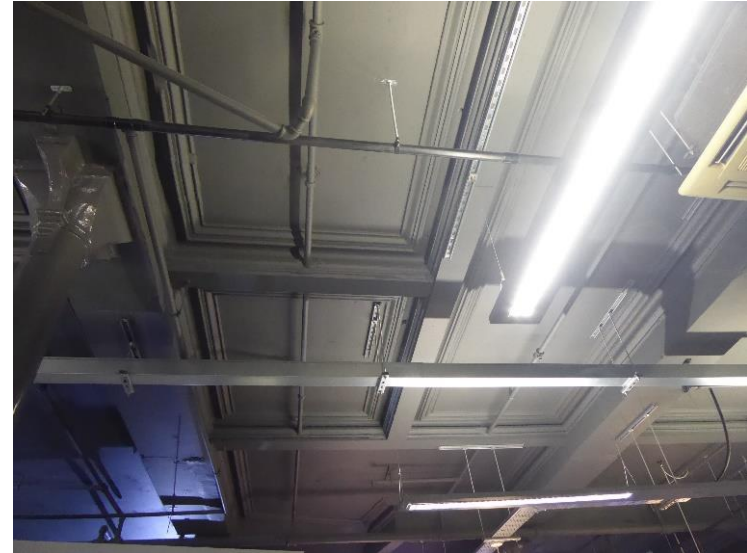
*Figure 10: image of the ceiling of Level 1 showing architectural mouldings to the ceiling and beam casings.*

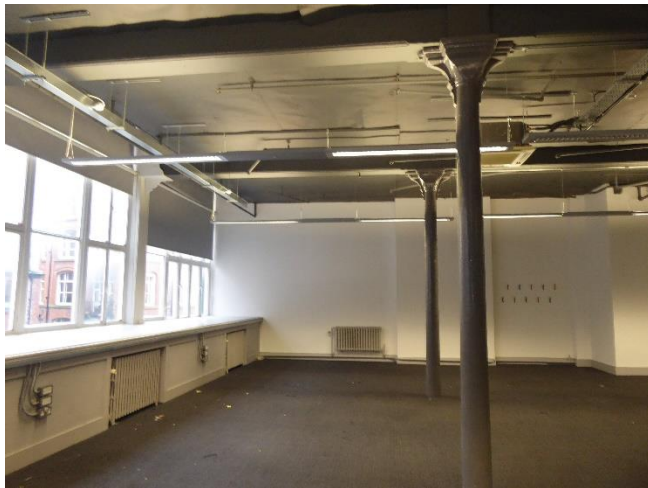
The presence of architectural mouldings to this area of the building would also suggest the presence of offices and, depending on the exact nature of the earlier trades, perhaps a show floor to inspect wares (fabrics etc). it was noted when walking through to the rear of the building the large expanse of windows with what appears to be a deep windowsill upon which one could inspect or cut fabrics under daylight.

*Figure 11: image of the rear of level 1 showing the large expanse of window glass and deep windowsill.*

The depth of the sill was not measured but may have been intended to take a roll of fabric. To the rear of the building the goods lift door is also noted and whilst the doors have been altered the iron safety bars are still in situ.

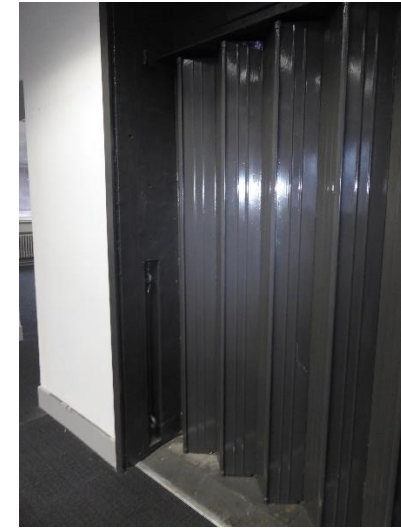
*Figure 14: the former goods lift shaft to the rear space of the building.*

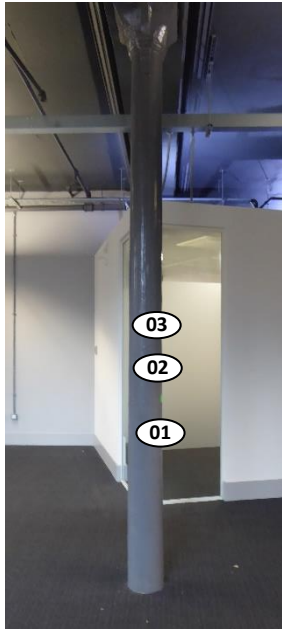
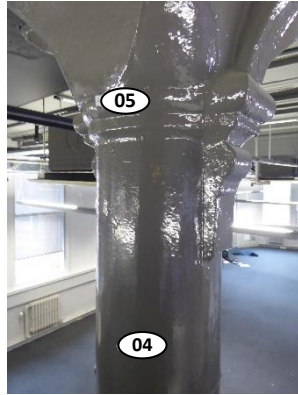
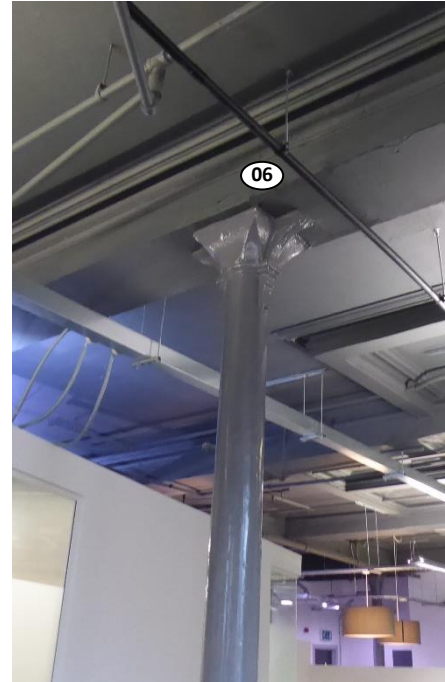
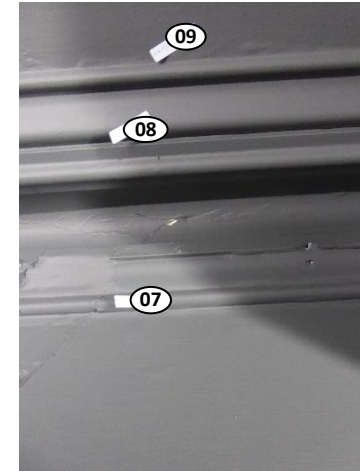
### 5.1. Level 1 Column 7 & Ceiling

- 01 – Column, lower (
- 02 – Column, mid height (
- 03 – Column, lower portion of upper section (
- 04 – Column, Upper section
- 05 – Column, capital, lower
- 06 – Beam casing,
- 07 – Cornice, lower ovolo moulding
- 08 – Ceiling, perimeter moulding
- 09 – Ceiling, panel flat

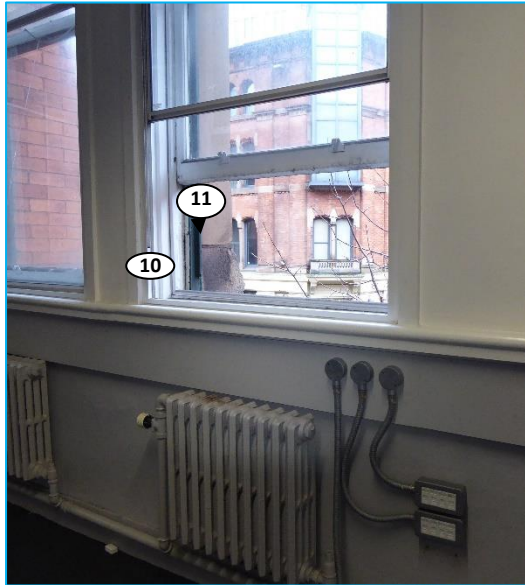
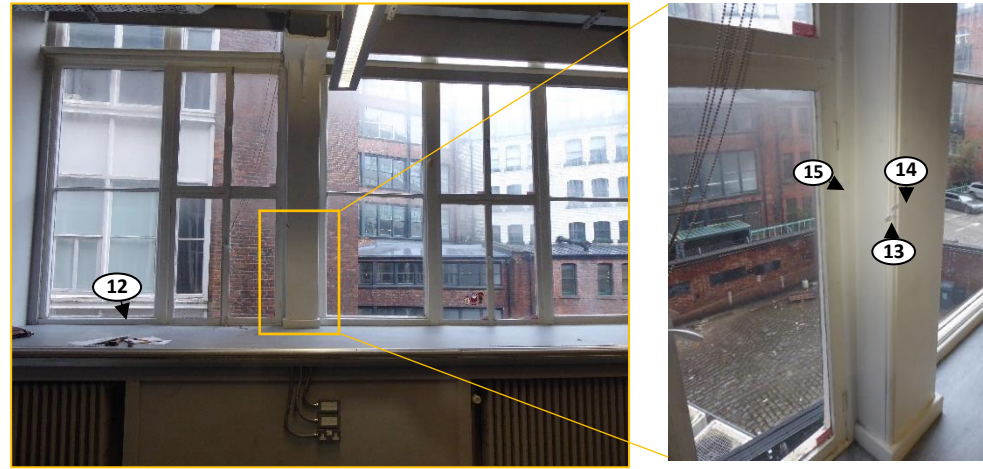
## 5.2. Level 1 Windows

- 10 – Portland Street elevation, window, interior surround
- 11 – Portland Street elevation, window, exterior surround (not analysed)
- 12 – Rear elevation, window, lower horizontal to window
- 13 – Rear elevation, window, vertical beam, ovolo beading
- 14 – Rear elevation, window, vertical beam, panel flat (front)
- 15 – Rear elevation, window, window frame (casement window)
- 16 – Goods Lift, door surround (not analysed)

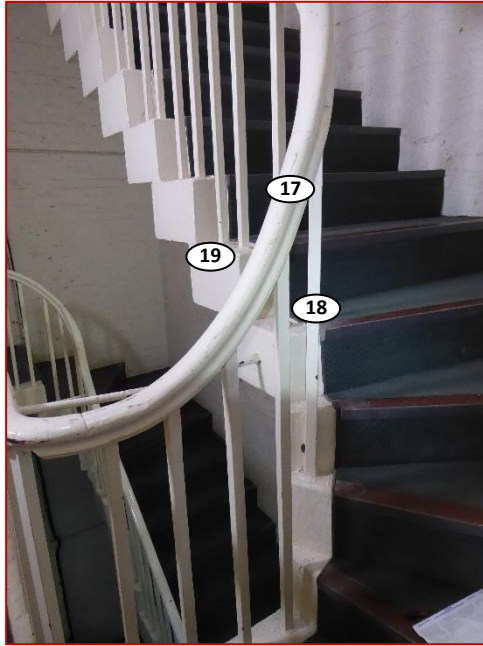
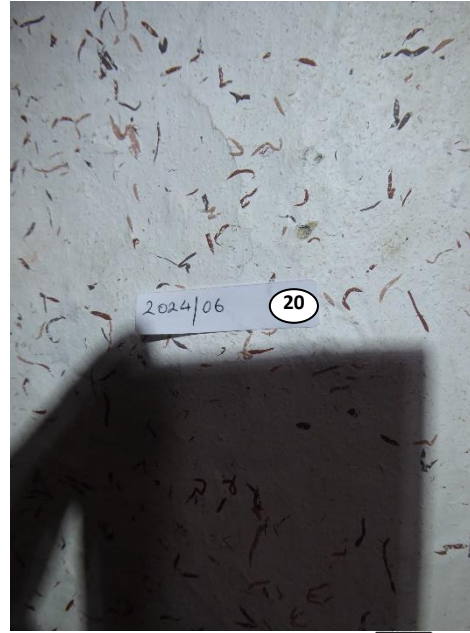
### 5.3. Level 1 Staircase

- 17 – Rear (historic) staircase, handrail
- 18 – Rear (historic) staircase, spindle
- 19 – Rear (historic) staircase, corner of concrete nosing
- 20 – Rear (historic) staircase, wall
