## DESIGN AND ACCESS REPORT

### MIDLAND HOTEL - WEST ENTRANCE

| PROJECT REF. | 2045 |

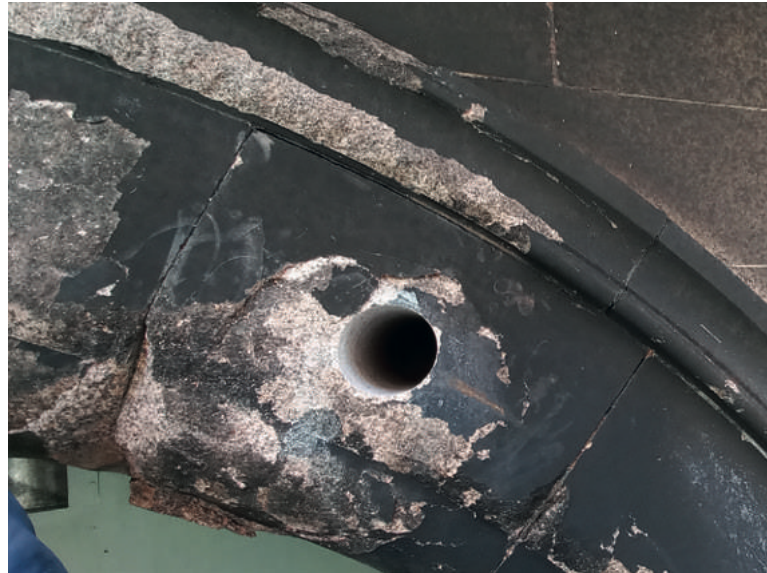
- There are 2 no. types of bedding mortar.
- a) bedding of the walls with a dark relatively crumbly sandy mix. Little textural variation.
- b) voussoir bedding darker and harder in nature. Possibly formed from cinder. Again, sandy with little texture variation.
