| <b>20820-DWC-EX-ZZ-RP-S-00001-P03</b> | <b>26<sup>th</sup> March 2024</b> |
| <b>117-119 Portland Street<br/>Manchester</b><br><br><b>Structural Report for Planning</b> | |
| <b>Bruntwood AV Limited</b> | |

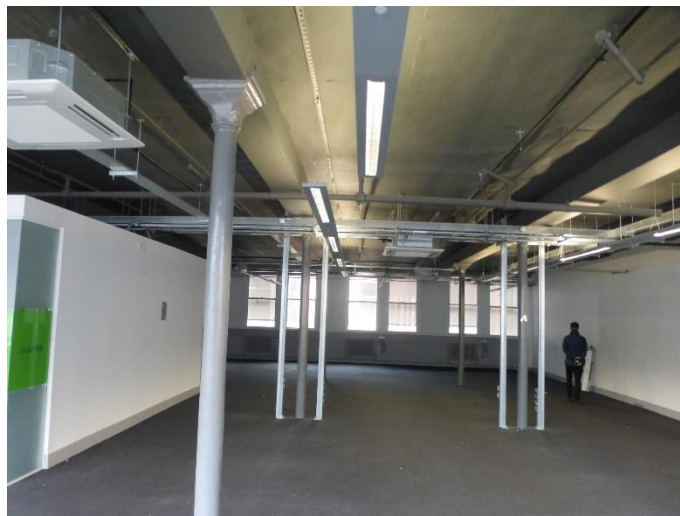
Typical floorplate- Note main timber beams are encased in this location.

- 3.2 We noted that to some areas of the floorplates, the large timber beams are encased in boarding, whilst some areas are exposed. Both of these situations are shown in the photos immediately above.
- 3.3 The size of the cast iron columns increases as you go down the building. At 4<sup>th</sup> floor level the columns are in the order of 110mm diameter increasing to approx. 240mm diameter at Lower Ground level.
- 3.4 The lift shaft and stair core walls are all of solid brickwork. One of the shafts is also lined with plasterboard. The main access stair is structural steel with steel durbar plate treads. The 'original' fire escape stair is constructed with stone treads.

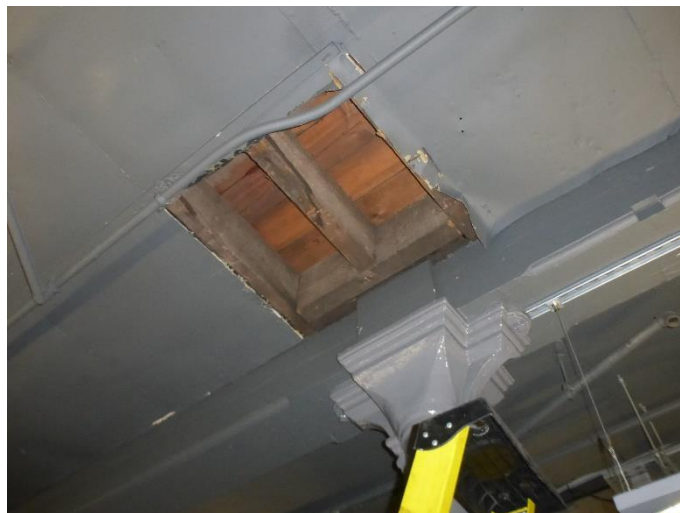
Typical floor joist arrangement at cast iron column heads with localised trimmer.  
Note feature column support heads to underside of main timber beams

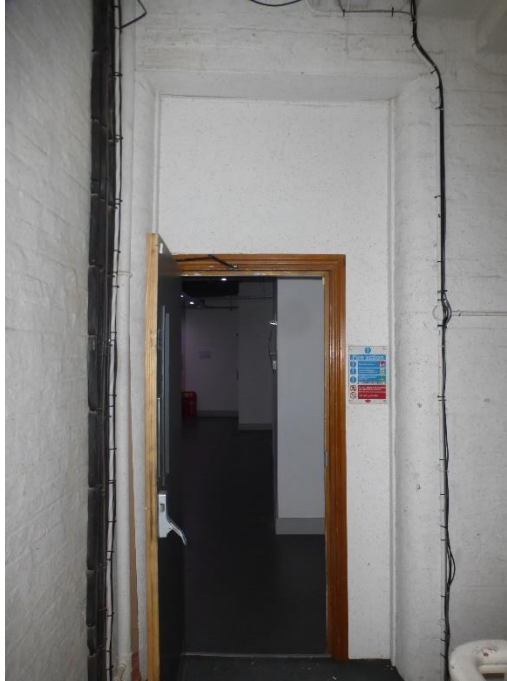
- 3.10 The access doors off the fire escape stair, at most levels, are formed within wider original masonry openings, with the space at the side and above infilled with board.

Door to fire escape stair (typical at most levels)

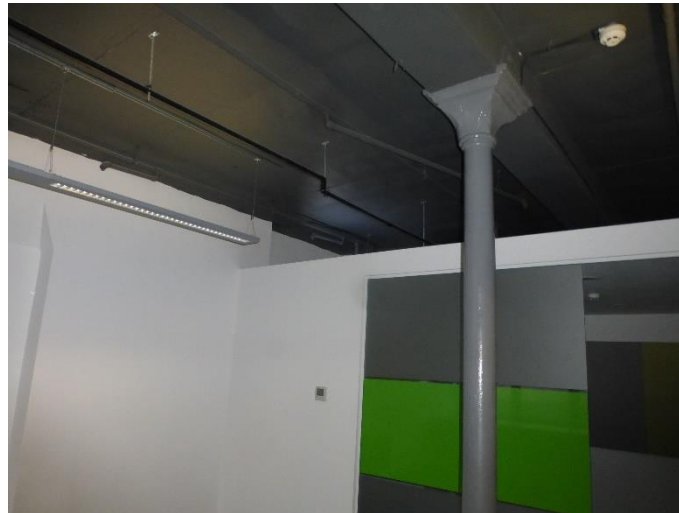
- 3.11 The large floor beams at 3<sup>rd</sup> floor are mainly encased in board. The type of board is not known.

3<sup>rd</sup> floor – Large beams to u/s 4<sup>th</sup> floor encased in board.

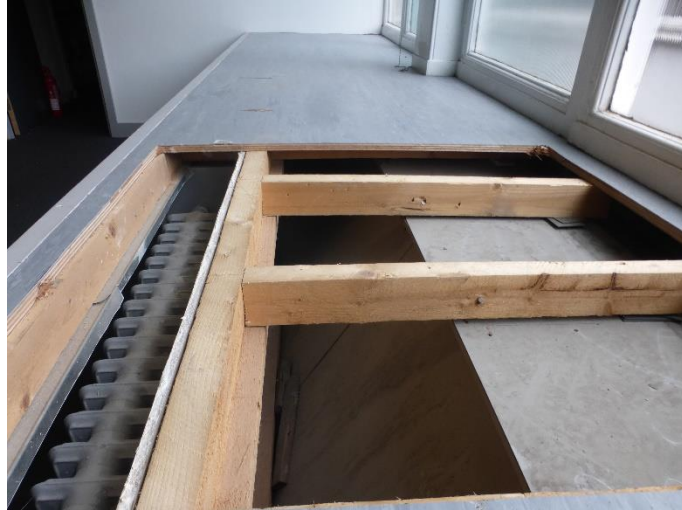
- 3.12 The rear glazed elevation contains raised 'cotton tables' against the wall. The soffit to the tables has been 'squared off' in the past and boxed in.

Note sloping face to tables on rear glazed elevation.

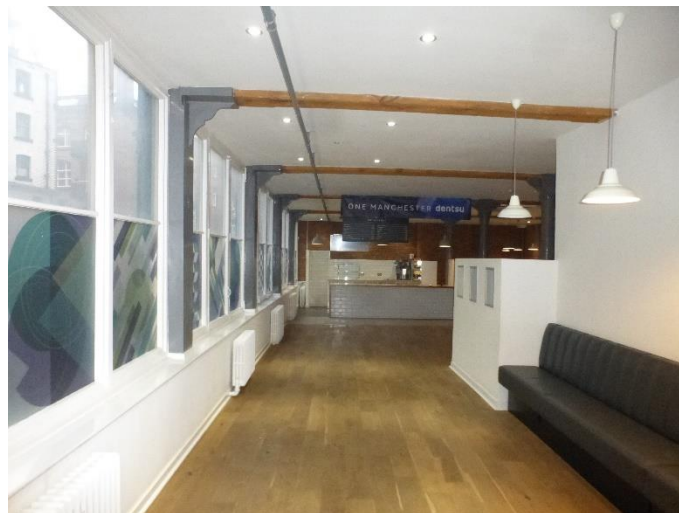
- 3.23 The cast iron brackets from the rear glazed elevation stanchions are again visible and providing support to the main floor beams at u/s 1<sup>st</sup> floor. However the sloping soffit is not present, as it is at underside of 2<sup>nd</sup> & 3<sup>rd</sup> floors.

Cast iron brackets supporting floor beams off rear glazed elevation.  
Note the soffit is flat rather than sloping.

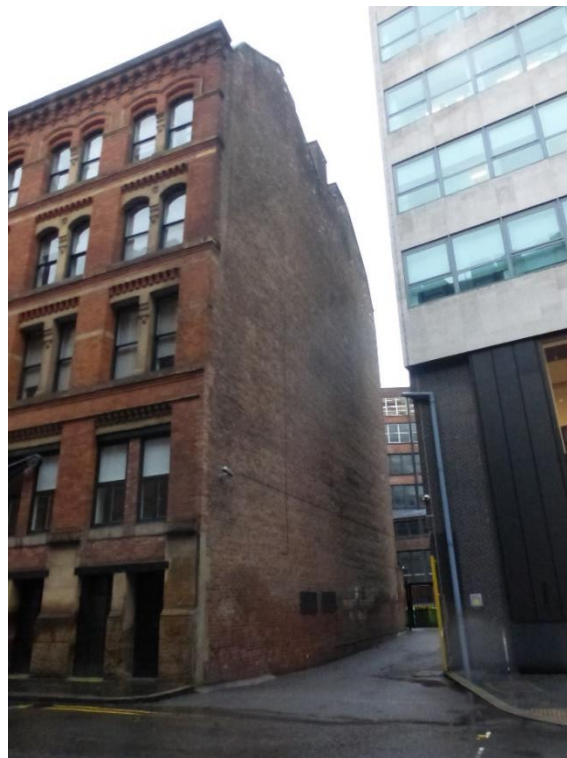
- 3.39 The gable (to the East) elevation contains no windows but does have 2 vent openings. We noted that the brickwork face is not 100% vertical, but we did not consider any of the areas that appears to bulge outwards or inwards to be excessive and certainly as would be expected for a building of this type and age. The wall thickness was measured as 490mm at ground floor level.

Gable elevation off Dickinson Street

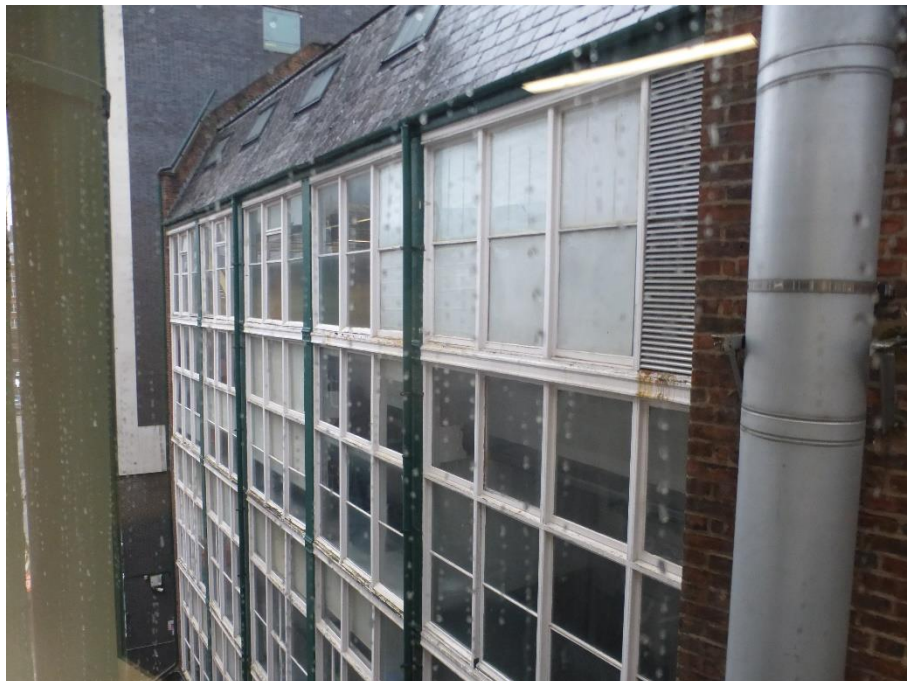
- 3.40 The main rear (North) elevation is formed with a cast iron frame of stanchions and beams. The stanchions support the building floor beams at each level. From street level, the cast iron framing appears to be in good condition, albeit in need of refurbishment; cleaning and repainting etc. The timber framed windows are showing signs of deterioration.

Main rear elevation viewed from 3<sup>rd</sup> floor of 115 Portland Street
