## HERITAGE IMPACT ASSESSMENT - ADDENDUM NOVEMBER 2023

This Heritage Impact Assessment addendum has been drafted to support planning applications reference **36699/FO/2023** and **136701/LO/2023**.

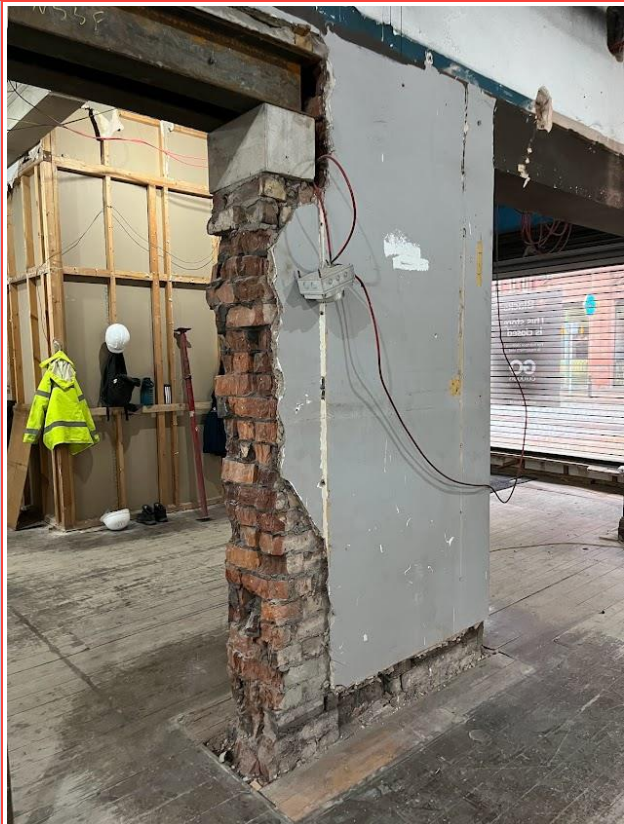
22

There will be no harm resulting from the works proposed in this location and but there will however be a decorative improvement, concealing the steel, padstone (non-original) and creating an attractive and useable space. Together the works will conserve the asset and enhance how the space is experienced.

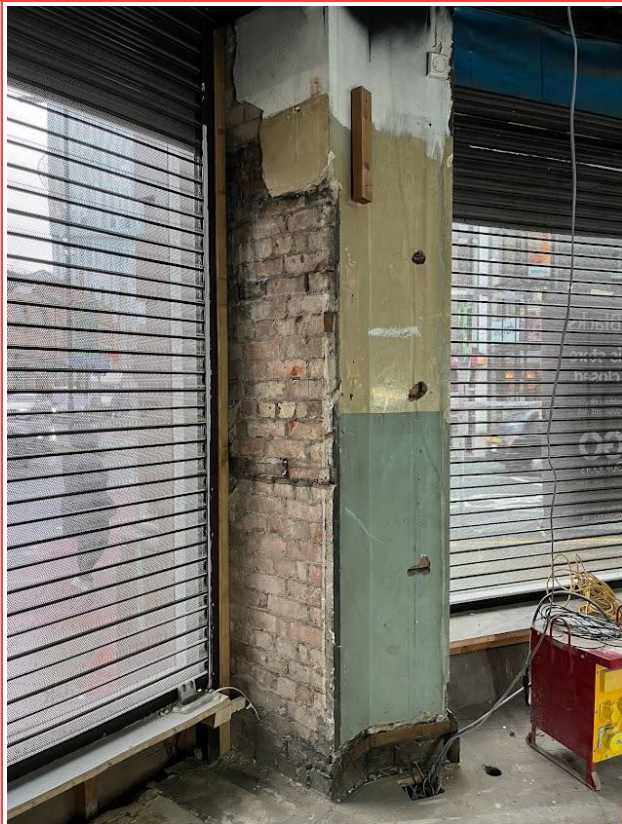
34

This area at the front of the unit is in poor condition. It contains areas of exposed brickwork and wooden finishes. Due to the condition, and limited areas it is not possible to incorporate this within the design.

Existing skirting will be retained, where missing, new softwood painted skirting will be installed to match existing historic skirting. The existing cornice will be repaired and template to be taken of cornice and reproduced in traditional fibre reinforced plaster for reinstatement where needed. Lime plaster to be reinstated / repaired.

Glazing to be installed , to replace fascia board.

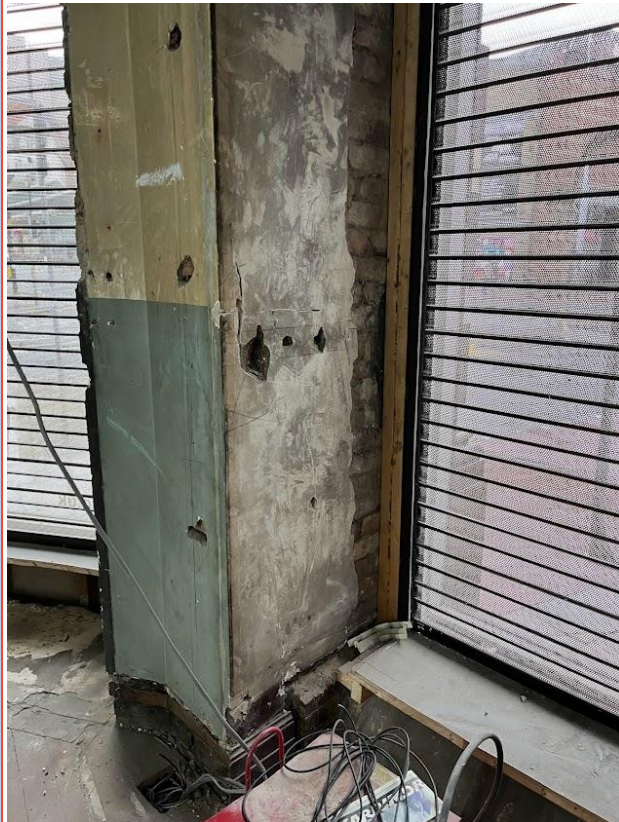
35

This area at the front of the unit is in poor condition. It contains areas of exposed brickwork and wooden finishes. Due to the condition, and limited areas it is not possible to incorporate this within the design.

Existing skirting will be retained, where missing, new softwood painted skirting will be installed to match existing historic skirting. The existing cornice will be repaired and template to be taken of cornice and reproduced in traditional fibre reinforced plaster for reinstatement where needed. Lime plaster to be reinstated / repaired.

Glazing to be installed, to replace fascia board.

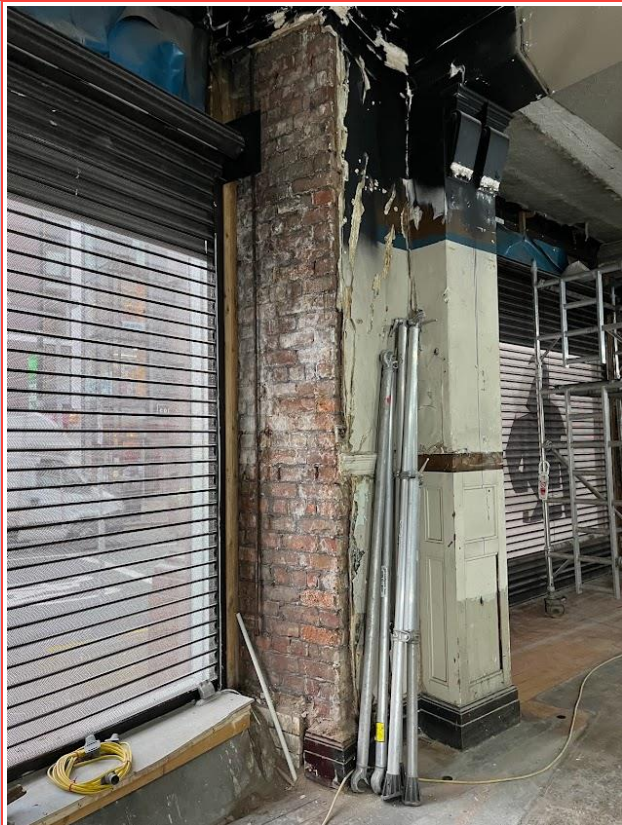
36

The condition of the plaster is in poor decorative finish and a section is missing where the brickwork is exposed. The new plaster and repairs as proposed will create a high-quality, consistent, finish.

Existing cornice to be repaired. Template to be taken of cornice and reproduced in traditional fibre reinforced plaster for reinstatement where required.

Lime plaster render to be reinstated / repaired.

Plaster corbels to be repaired / replaced. Template to be taken of corbels and reproduced as required with traditional fibre reinforced moulding plaster.

Existing skirting will be retained, where missing, new softwood painted skirting will be installed to match existing historic skirting.

Original softwood panelling to be repaired and made good where required, to receive paint finish.

Glazing to be installed, to replace fascia board.

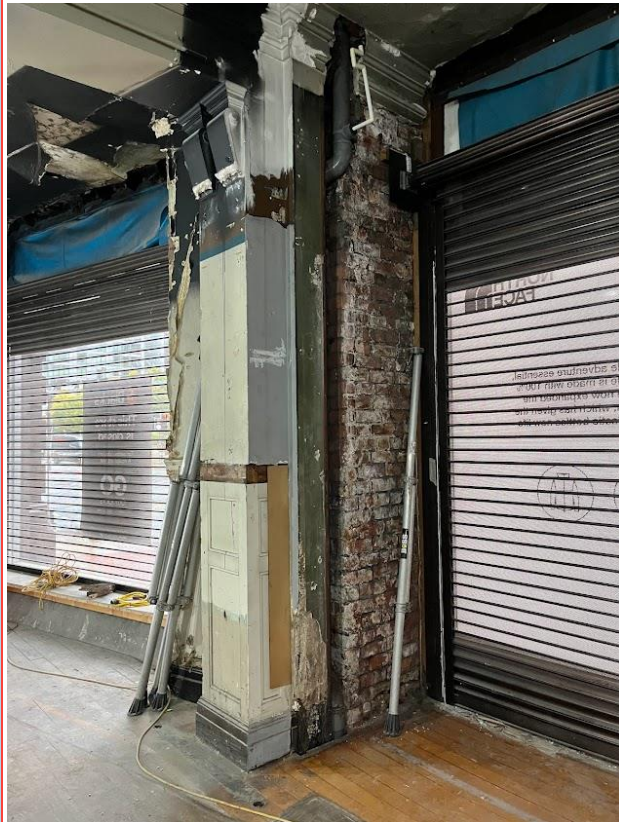
37

The condition of the plaster is in poor decorative finish and a section is missing where the brickwork is exposed. Lime plaster is reinstated where it is practicable. There is significant water ingress and damp to some of the masonry which would prevent the successful application of plaster – the walls would require six months in dry condition to be dry enough for such works. In these areas softwood panelling is proposed. Moreover, the Landlord will repair pipework above to stop any further water ingress and potential further damage.

Existing cornice to be repaired. Template to be taken of cornice and reproduced in traditional fibre reinforced plaster for reinstatement where required.

Lime plaster render to be reinstated / repaired.

Rainwater pipe to be replaced and concealed.

Plaster corbels to be repaired / replaced. Template to be taken of corbels and reproduced as required with traditional fibre reinforced moulding plaster.

Existing skirting will be retained, where missing, new softwood painted skirting will be installed.

The roller shutters will be removed. Fanlights will be installed to replace fascia board.

Original softwood panelling to be repaired and made good where required, to receive paint finish.

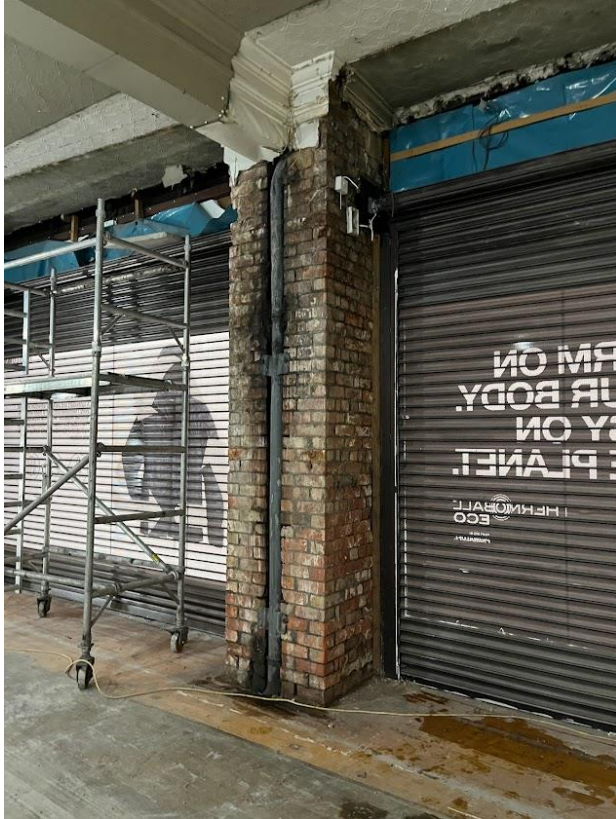
39

This particular area of brickwork is water damaged and so will need to be left until it is dried out and treated before any works can be done.

The cornice is a historic feature, but it requires repair.

Lime plaster is reinstated where it is practicable. There is significant water ingress and damp to some of the masonry which would prevent the successful application of plaster – the walls would require six months in dry condition to be dry enough for such works. In these areas softwood panelling is proposed.

Existing cornice to be repaired. Template to be taken of cornice and reproduced in traditional fibre reinforced plaster for reinstatement where required.

Rainwater pipe to be replaced and concealed.

Glazing to be installed, to replace fascia board.

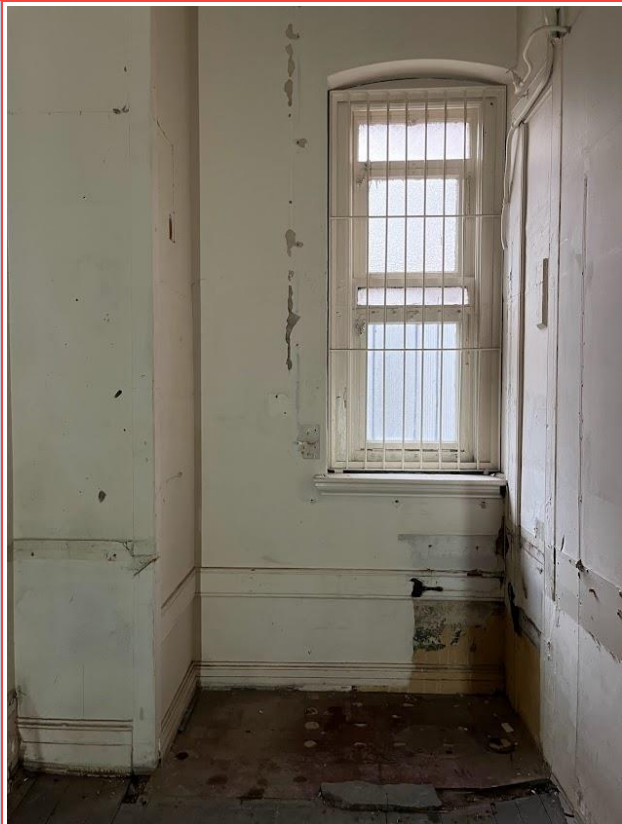
42

Retention and redecoration of the plasterwork will have a positive impact. The plaster and decorative finish are in poor condition.

Existing plasterwork will be retained, stabilised and repainted.

An area of new floating hardwood timber flooring loose laid over existing floor.

Existing skirting will be retained, where missing, new softwood painted skirting will be installed to match existing historic skirting. New grab rails, toilet, handbasin will be installed to form the new DDA toilet.

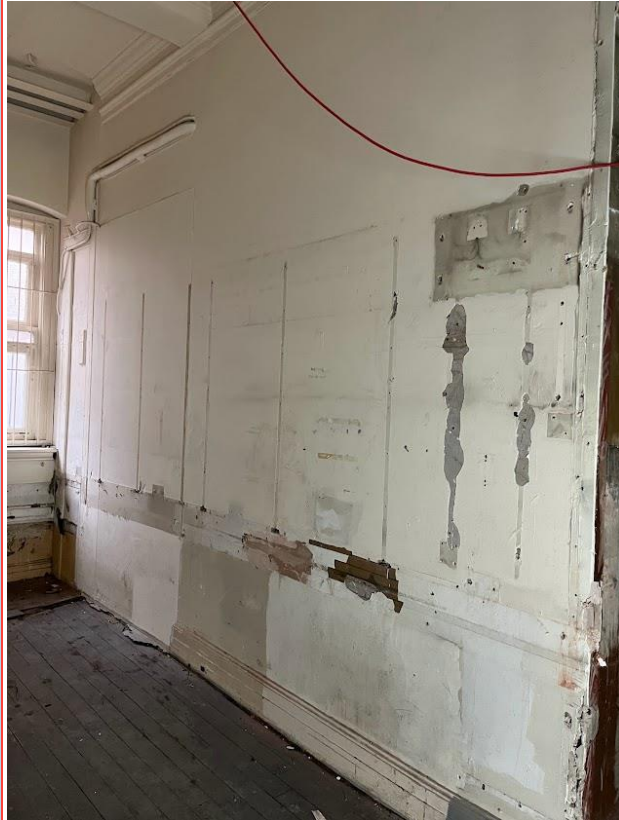
43

Retention and redecoration of the plasterwork will have a positive impact. The plaster and decorative finish are in poor condition.

Existing plasterwork will be retained, stabilised and repainted.

An area of new floating hardwood timber flooring loose laid over existing floor.

Existing skirting will be retained, where missing, new softwood painted skirting will be installed to match existing historic skirting.

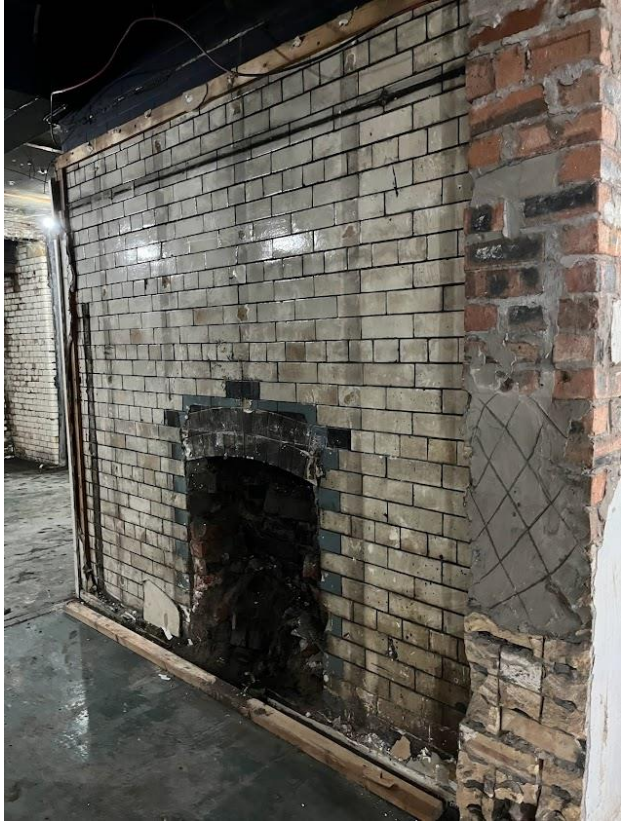
| BASEMENT | | |
|---|---|---|
| 1B | | <p>Existing fireplace opening in existing masonry wall to be blocked up with brickwork.</p> <p>New full height partitions installed to create the food prep area.</p> <p>Independent wall lining installed to prep area with hygienic sheet wall covering.</p> <p>Brick infill panel will be set back in reveal and will not be keyed into existing brickwork. Intervention will be fully reversible.</p> <p>The glazed bricks and fireplace hold heritage significance. However, as this is proposed to be a prep-space, the glazed bricks and fireplace needs to be lined and finished with hygienic wall cladding. This is required to create the prep area and the hygienic surface is necessary for this function. This will be achieved with an independent wall lining with no fixings into the wall.</p> <p>This was initially proposed to be an office, but this would have involved removal of the wall. As such a solution has been found to reconfigure the layout, so that the original fireplace and glazed bricks can be retained and preserved behind the partition walls, therefore conserving the heritage asset.</p> <p>The flooring is mastic asphalt with no heritage significance. A floating flooring is proposed to sit on top of the existing surface. The flooring will be reversible, not fixed, and not concreted as agreed on site. It will introduce more appropriate materials, improving upon the existing finish.</p> |

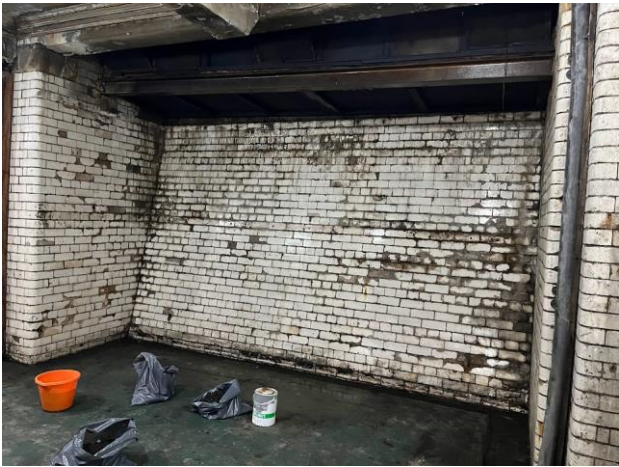
| Reference Photo | DESCRIPTION OF PROPOSED WORKS | SIGNIFICANCE OF HERITAGE ASSET AND ASSESSMENT OF IMPACT |
|---|---|---|
| <p>4B</p> | <p>2No physical junctions are required here between new fire rated partitions and existing glazed bricks. Fire rated partitions are required to form a separate fire compartment between the guest facing space and back of house space. The bin store also required to be a stand-alone fire compartment. Refer to drawing No. 03(08)E</p> <p>The glazed brick walls are to be cleaned and made good. If repairs are required, this will be done using white hydraulic restoration mortar by Keim.</p> <p>Hangers to new suspended ceiling will be fitted using fixing holes from existing suspended ceiling.</p> | <p>The glazed bricks hold aesthetic significance and their exposure and retention is beneficial. The partitions are necessary for health, safety and fire reasons. Throughout the unit the layout has been revisited to minimise the amount of connections required to the historic features.</p> <p>The bricks will be cleaned and conserved within the scheme.</p> <p>The flooring is as described at reference photo 1B.</p> |

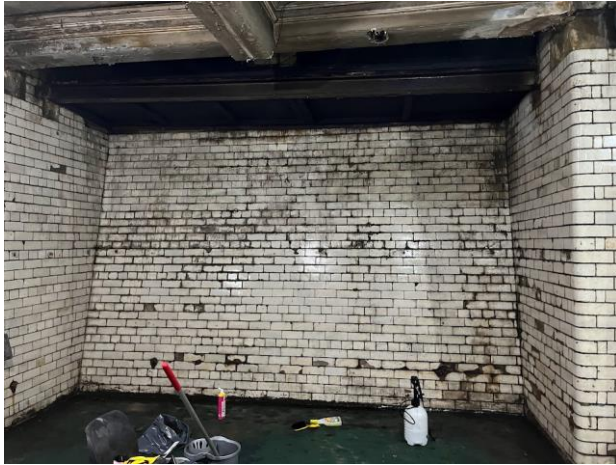
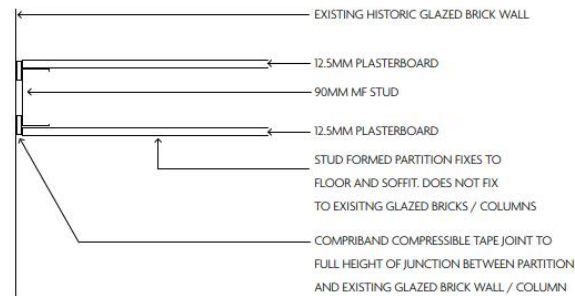
7B

The guest toilets have been reconfigured to minimise partitioning and to allow the glazed brick walls to be visible in all front of house areas. A previous version of the proposal would have concealed the glazed bricks and therefore this is an improvement as the glazed brick will now be incorporated in the scheme.

The glazed brick walls are to be cleaned and made good. If repairs are required, this will be done using white hydraulic restoration mortar by Keim.

Plasterboard suspended ceiling proposed in guest toilets. There will be 2 120 mm DIA core drill holes in existing slab above for service arrangements.

The flooring (Staffordshire blue quarry) will be laid over existing mastic asphalt flooring.

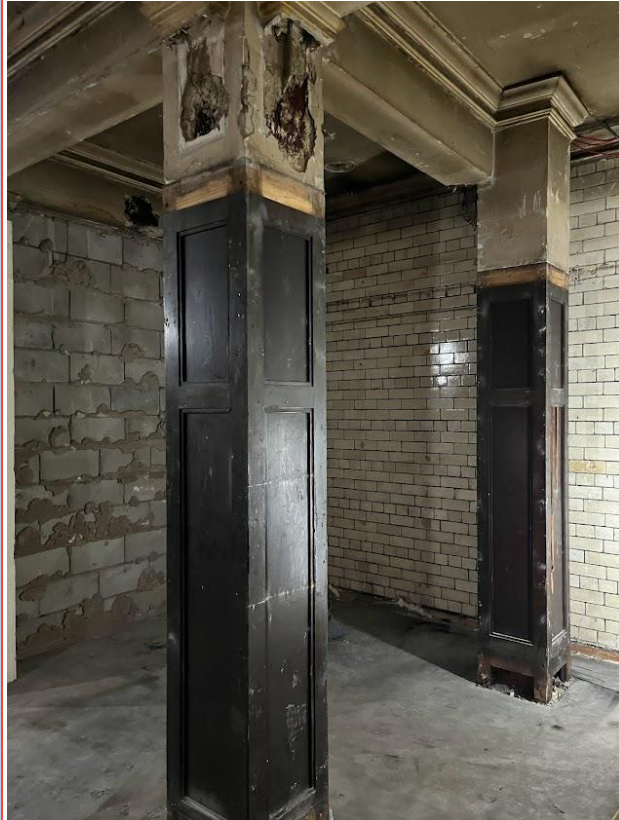
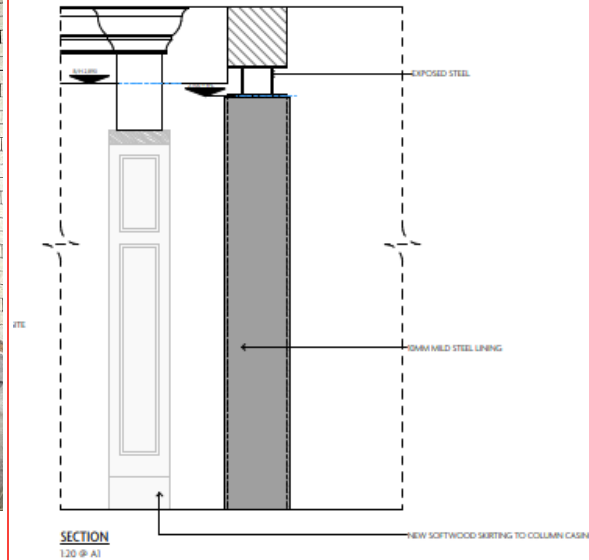
10B

The proposed works will enhance and protect the existing columns whilst better revealing them by incorporating them into the design of the scheme.

Wooden column casing and cornicing will be retained and repainted. New softwood skirting will be added to column casing.

The damaged corbels will be reinstated.

There will be exposed suspended cable tray provided containment for wiring and fixings for light fittings.

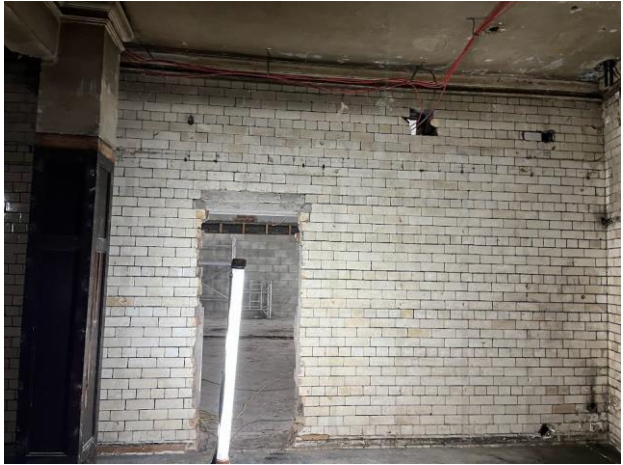
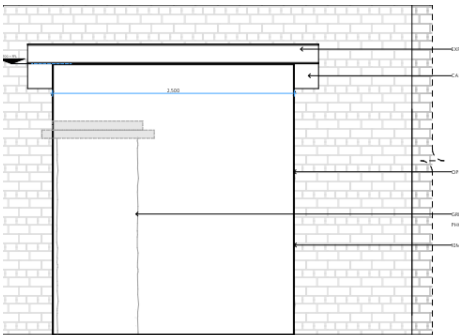
| 11B | | <p>Opening to be neatly cut using masonry saw to widen the opening. 10mm mild steel lining, exposed steel and cast padstone installed.</p> |

There is harm associated with the widened opening and removal of original glazed bricks. However, the glazed bricks will be carefully removed and where possible reused elsewhere in the scheme. The glazed bricks on this wall will also be exposed and in the majority of the basement meaning that the impact here is low on balance. The existing opening is not structurally sound, and a wider joist is required above the opening to secure this.

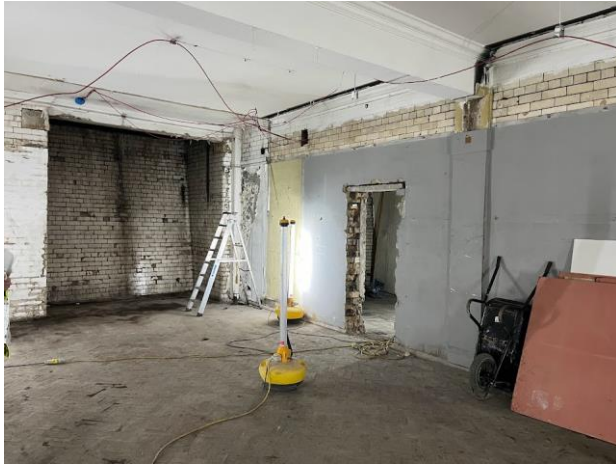
13B

Due to the slurry on the wall, removal of the plaster will likely damage the original brickwork underneath. Therefore, to minimise harm the slurry will be retained. Moreover, we will be exposing the brickwork on the other side of the wall and so overall there is a neutral impact.

Making the unit watertight will protect against further water ingress and potential damage. The works proposed will help conserve the asset.

This wall will be replastered.

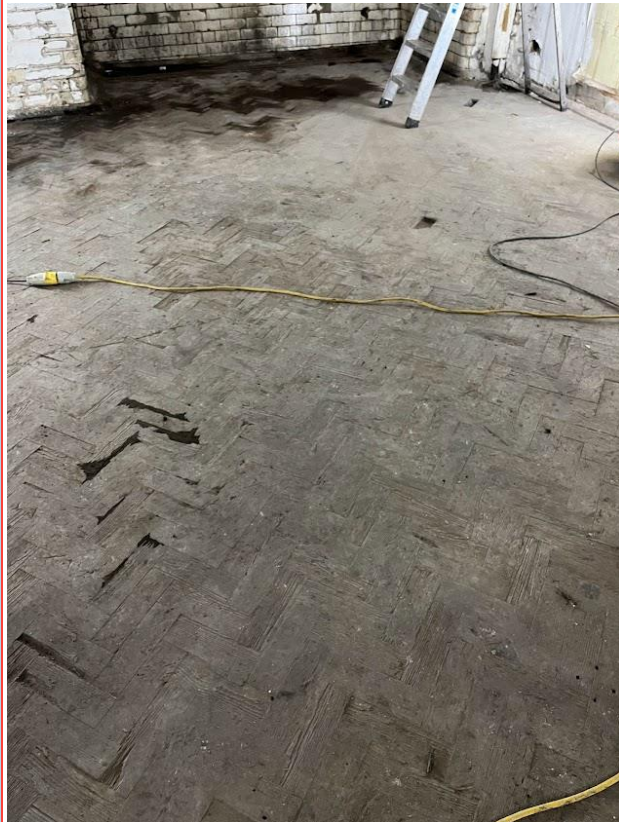
14B

The original parquet flooring is preserved in this area of the basement. It has aesthetic heritage significance but requires repair in places. Retention of the original parquet and incorporating it into the scheme is a significant benefit.

Existing wood herringbone parquet flooring to be retained. To be stripped, sanded and resealed.

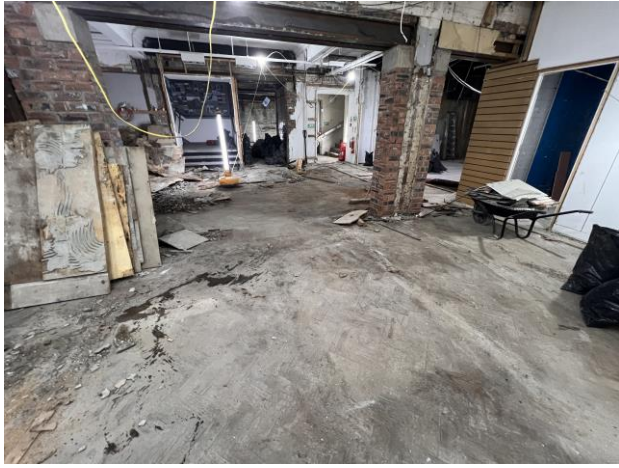
| Reference Photo | DESCRIPTION OF PROPOSED WORKS | SIGNIFICANCE OF HERITAGE ASSET AND ASSESSMENT OF IMPACT |
|---|---|---|
| <p>15B</p> | | <p>2 no 150 mm DIA core drill holes in existing slab above for service penetrations.</p> <p>The penetrations do not damage any decorative original historic building fabric such as beams or cornice and are necessary for the servicing.</p> |

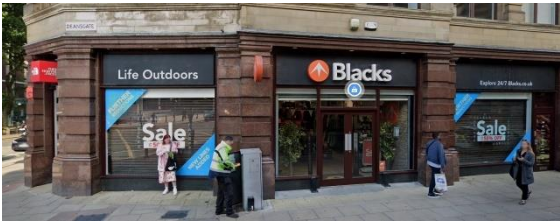
| Reference Photo | DESCRIPTION OF PROPOSED WORKS | SIGNIFICANCE OF HERITAGE ASSET AND ASSESSMENT OF IMPACT |
|---|---|---|
| <p>EXT 1</p> | | <p>Installation of new awning and new awning box, green awning fabric with Flat Iron branding in cream.</p> <p>Historically there were awnings on the building. Installing traditional awnings will respect this historic feature and will have a beneficial impact.</p> <p>The awning frame will sit within the window openings, respecting the building's architecture and without concealing the elevation. The awning will mirror those already installed at Manahatta, creating consistency across the elevation.</p> |
