**Project****Project Name:** 63-65 Upper Chorlton Road**Project Description:** 63-65 Upper Chorlton Road**Project Number:** DCCTMT26369**Project Date:** 06/07/2023**Inspection Standard:** MSCC5 Sewers & Drainage GB (SRM5 Scoring)

| <b>Project Name</b><br>63-65 Upper Chorlton Road | <b>Project Number</b><br>DCCTMT26369 | <b>Project Date</b><br>06/07/2023 |

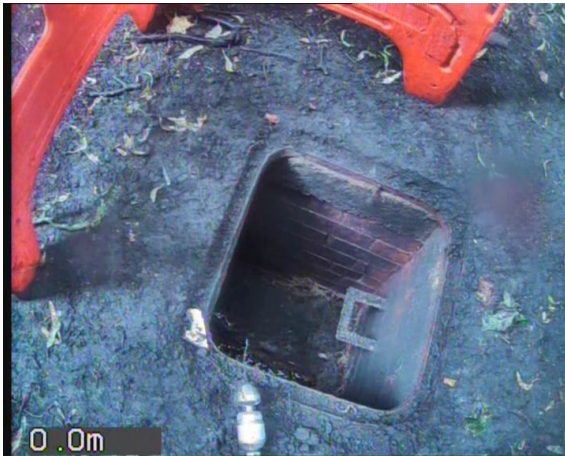
HOLX\_2efcba20-13ea-422d-b7ad-25f7ba9eba09\_20230706\_141059\_456.jpg, 00:00:00, 0.00 m  
Start node, manhole, reference: MH1

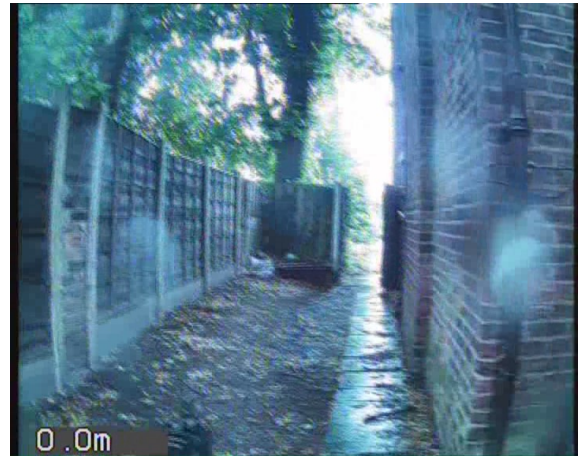
HOLX\_2d27a53e-01f3-4f93-9dff-d5e5ec7c559f\_20230706\_141106\_440.jpg, 00:00:00, 0.00 m  
Start node, manhole, reference: MH1

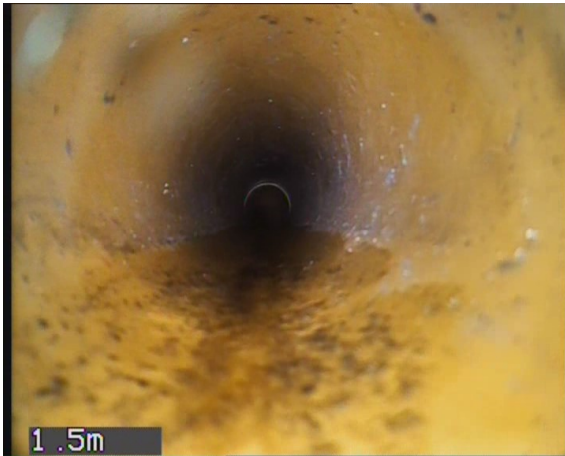
HOLX\_4ab13148-c682-4458-936e-7e84e96c06df\_20230706\_141351\_920.jpg, 00:00:44, 1.50 m  
Pipe material changes to polyvinyl chloride at this point

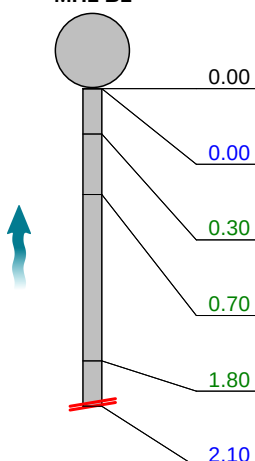
| Scale: | 1:50 | Position [m] | Code | Observation | MPEG | Photo | Grade |
|---|---|---|---|---|---|---|---|
| Depth: 1.10 m<br>MH1 B1 | | | | | | | |

| Scale: | 1:50 | Position [m] | Code | Observation | MPEG | Photo | Grade |
|---|---|---|---|---|---|---|---|
| | | 0.30 | RFJ | Roots, fine at joint | 00:00:36 | HOLX_f19<br>a829c-729<br>a-4d22-b1 | 2 |
| | | 0.70 | RFJ | Roots, fine at joint: to 1.8m | 00:00:39 | HOLX_b70<br>94c9e-f71<br>a-4390-8a | 2 |
| | | 1.80 | RM | Roots, mass, 20% cross-sectional area loss | 00:00:47 | HOLX_c49<br>5cdf7-afae<br>-413b-8d7 | 5 |
| | | 2.10 | SA | Survey abandoned: Unable to pass roots | 00:00:54 | | |

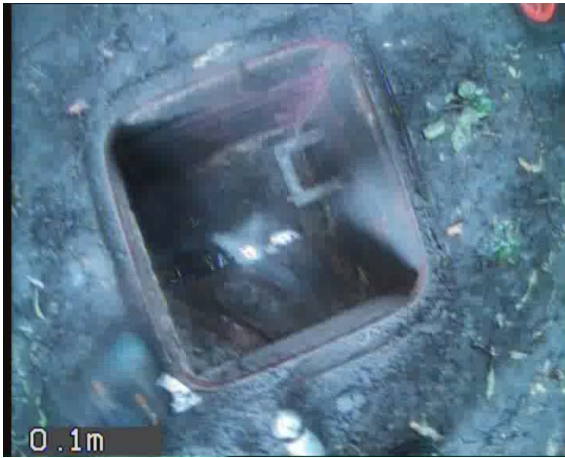
HOLX\_bf044e95-4274-443b-a248-26ec7f06f272\_20230706\_144542\_575.jpg, 00:00:00, 0.00 m  
Start node, manhole, reference: MH1 B1

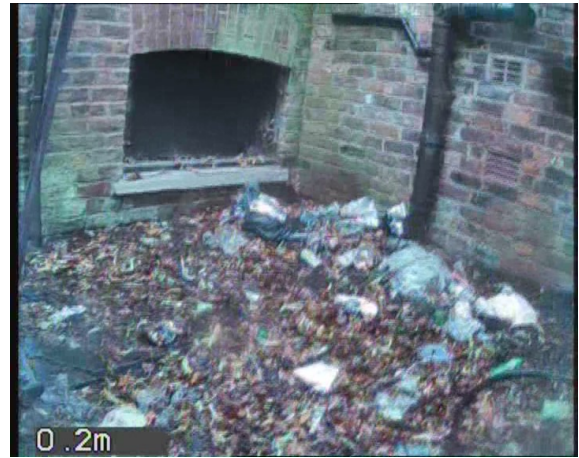
HOLX\_1e49bc03-7cb6-40a1-949b-1ed1152b80c2\_20230706\_144547\_861.jpg, 00:00:00, 0.00 m  
Start node, manhole, reference: MH1 B1

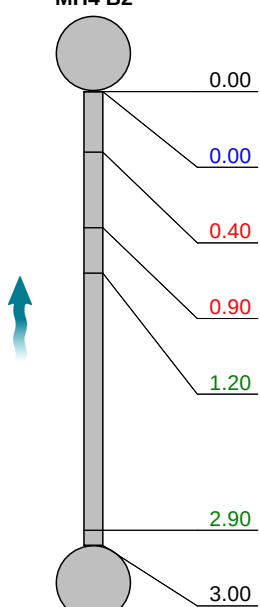
<table><tr><th>Position [m]</th><th>Code</th><th>Observation</th><th>MPEG</th><th>Photo</th><th>Grade</th></tr><tr><td>0.40</td><td>CC</td><td>Crack, circumferential from 8 o'clock to 4 o'clock</td><td>00:00:16</td><td>HOLX_3aa<br/>05ce1-21f<br/>2-4054-9a</td><td>2 / 2</td></tr></table>

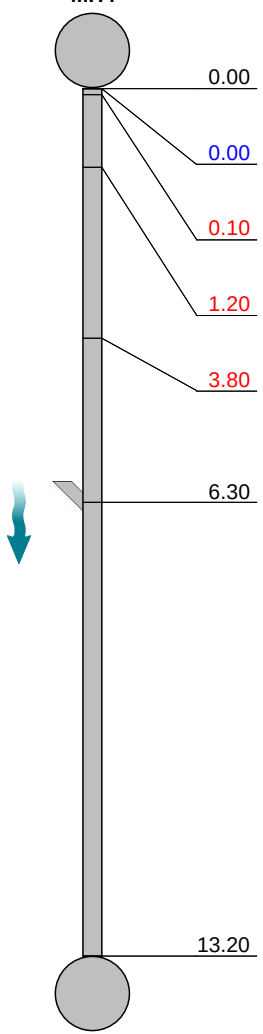
| Scale: 1:115 | Position [m] | Code | Observation | MPEG | Photo | Grade |
|---|---|---|---|---|---|---|
| Depth: 0.70 m<br>MH4 | | | | | | |

| Scale: 1:115 | Position [m] | Code | Observation | MPEG | Photo | Grade |
|---|---|---|---|---|---|---|
| | 0.10 | CC | Crack, circumferential from 8 o'clock to 4 o'clock | 00:00:24 | MH4X_cc0<br>20988-001<br>1-4340-9d | 2 / 2 |

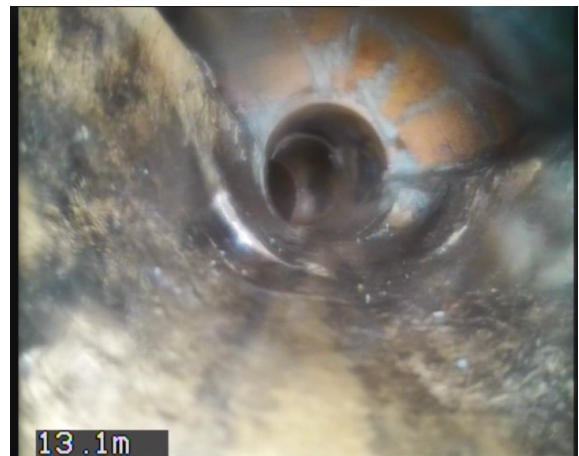
MH4X\_c72011d5-567b-42df-b57e-b0b97a1b682b\_20230706\_162504\_568.jpg, 00:01:25, 13.20 m  
Finish node, manhole, reference: Discharge, MH5 (Buried)

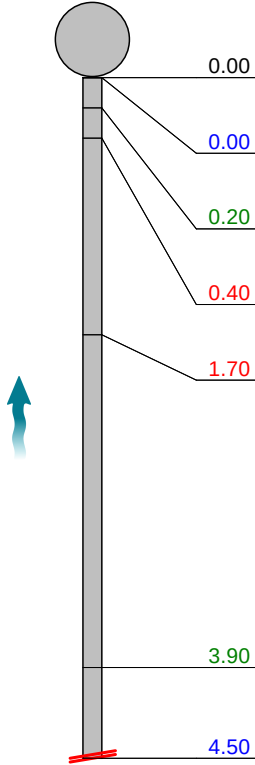
| Scale: | 1:50 | Position [m] | Code | Observation | MPEG | Photo | Grade |
|---|---|---|---|---|---|---|---|
| Depth: 2.70 m<br>MH3 B1 | | | | | | | |

| Scale: | 1:50 | Position [m] | Code | Observation | MPEG | Photo | Grade |
|---|---|---|---|---|---|---|---|
| | | 0.20 | LR | Line deviates right: Slight | 00:00:18 | | |
| | | 0.40 | CL | Crack, longitudinal at 9 o'clock | 00:00:18 | HOLX_4e1<br>bb815-3bc<br>9-4277-90f | 2 / 2 |
