| snookarchitects | project: | bridgewater house |
| 89 Wood Street | dwg no: | 301 |
| Liverpool | dwg title: | GF ceilings & cornice |

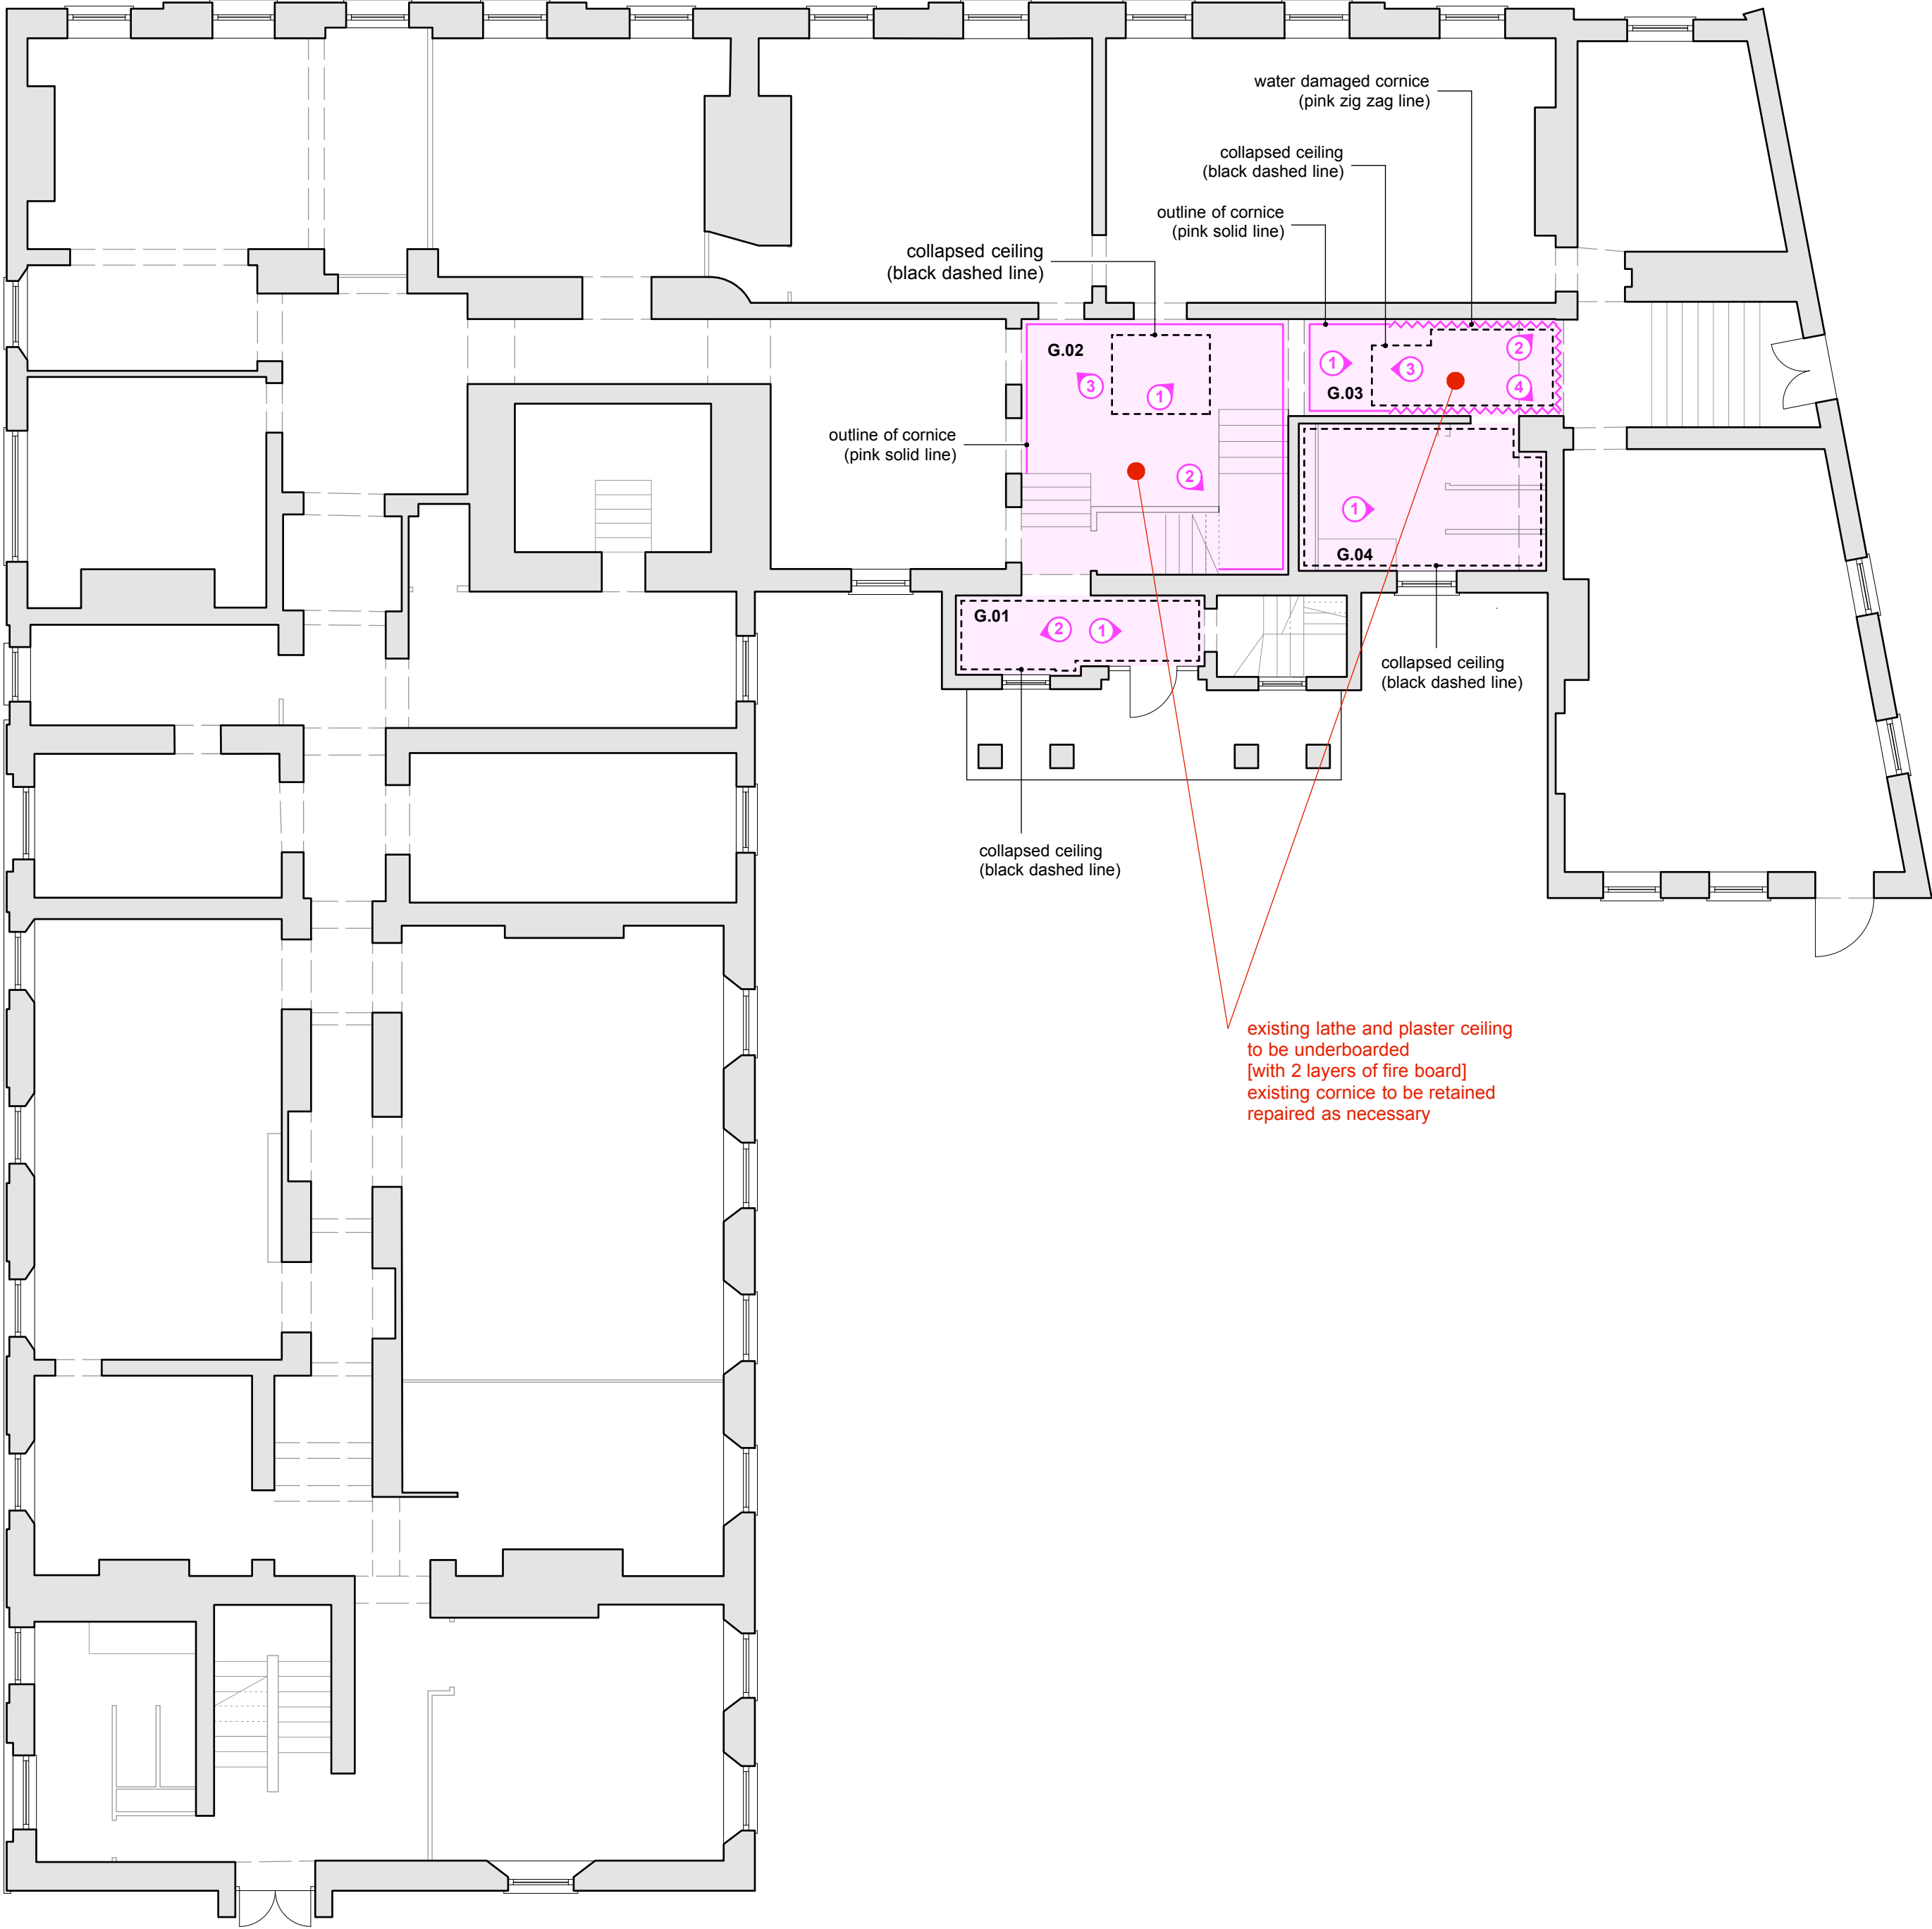
ROOM G.03

- Cornice as noted on the plan
- Most of the cornice is water damaged
- Partially collapsed ceiling as noted on the plan
- Ceiling is damaged
