FEDERATION  
COOPERATIVE WHOLESALE  
NEW CENTRAL PREMISES - MANCHESTER

Hanover House  
And E-Block,  
Manchester

**HERITAGE STATEMENT:**

Significance Appraisal and Impact Assessment

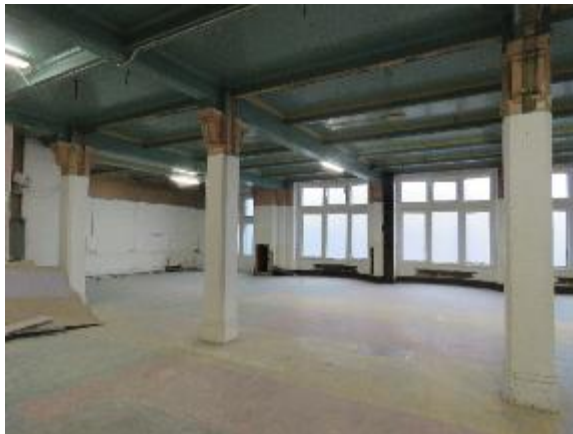
**Figure 54:** General view of northern area of the ground floor showing current condition of space.

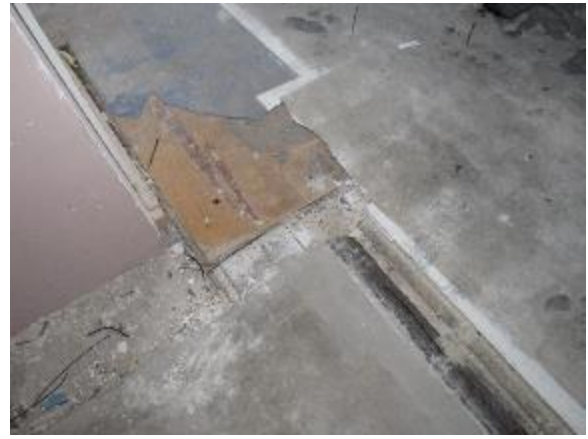
**Figure 63:** Timber floor coverings with boarding and vinyl over.

| <b>Floor</b> | Removal of modern vinyl and OSB board to floors before repairing timber floorboards. Section of floorboards to be removed to enable the staircases to be installed. | The proposed work will have a <b>negligible adverse impact</b> on the floor, although the removal of the modern floor finish and OSB board is beneficial, the removal of the sections to create the new stair access and potential overlay of the floor has an adverse impact due to the removal of historic fabric. |

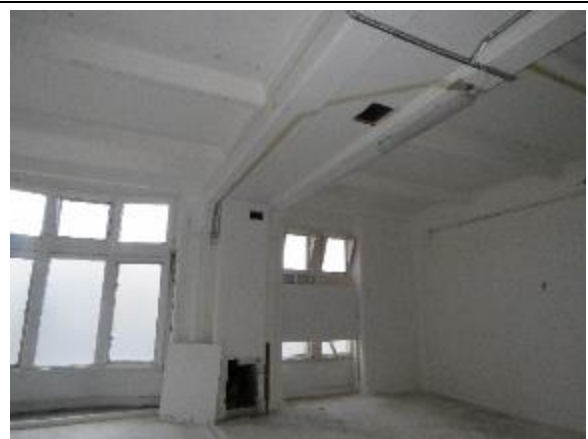
**Figure 69:** General view of ceiling ductwork and structural beams.

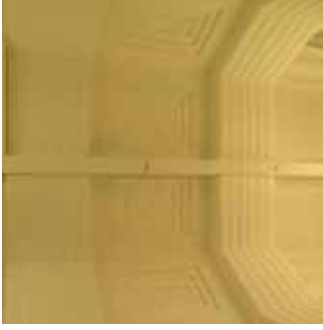
**Photo 52.** HB.1F.27- Early central corridor joinery

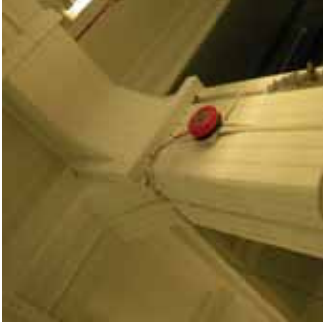
**Photo 53.** HB.1F.27- Early corridor column detailing

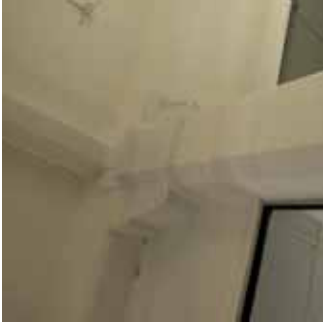
**Photo 54.** Typical original column and ceiling detail

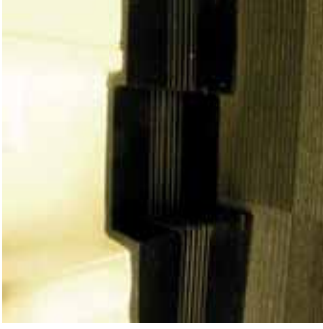
**Photo 55.** HB.1F.27- Early skirting

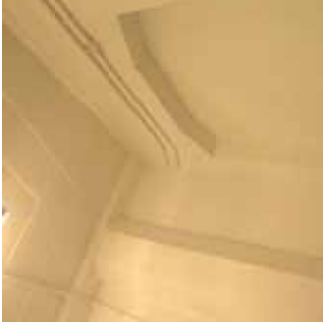
**Photo 56. HB.2F.13-** ca. 1930's moulded ceiling and arched wall.

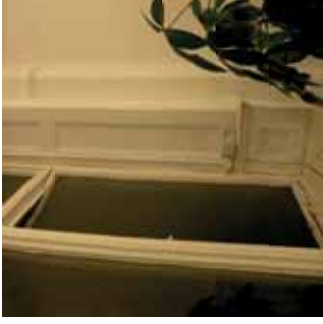
**Photo 59. HB.2F.14-** Original or early joinery around window, present on parts of the 2<sup>nd</sup> floor and also on the 3<sup>rd</sup> floor.

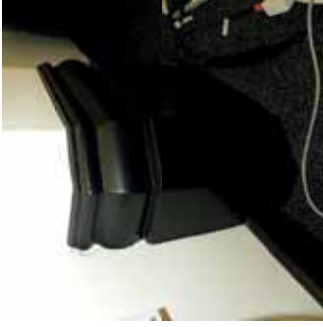
**Photo 60.** Typical original skirting around columns
