## Jonathan Davidson Architects

Neptune Mill  
Chapelton St, Manchester

Historic & Industrial Features Audit  
353 PD 2001 (P2)

*October 2023*

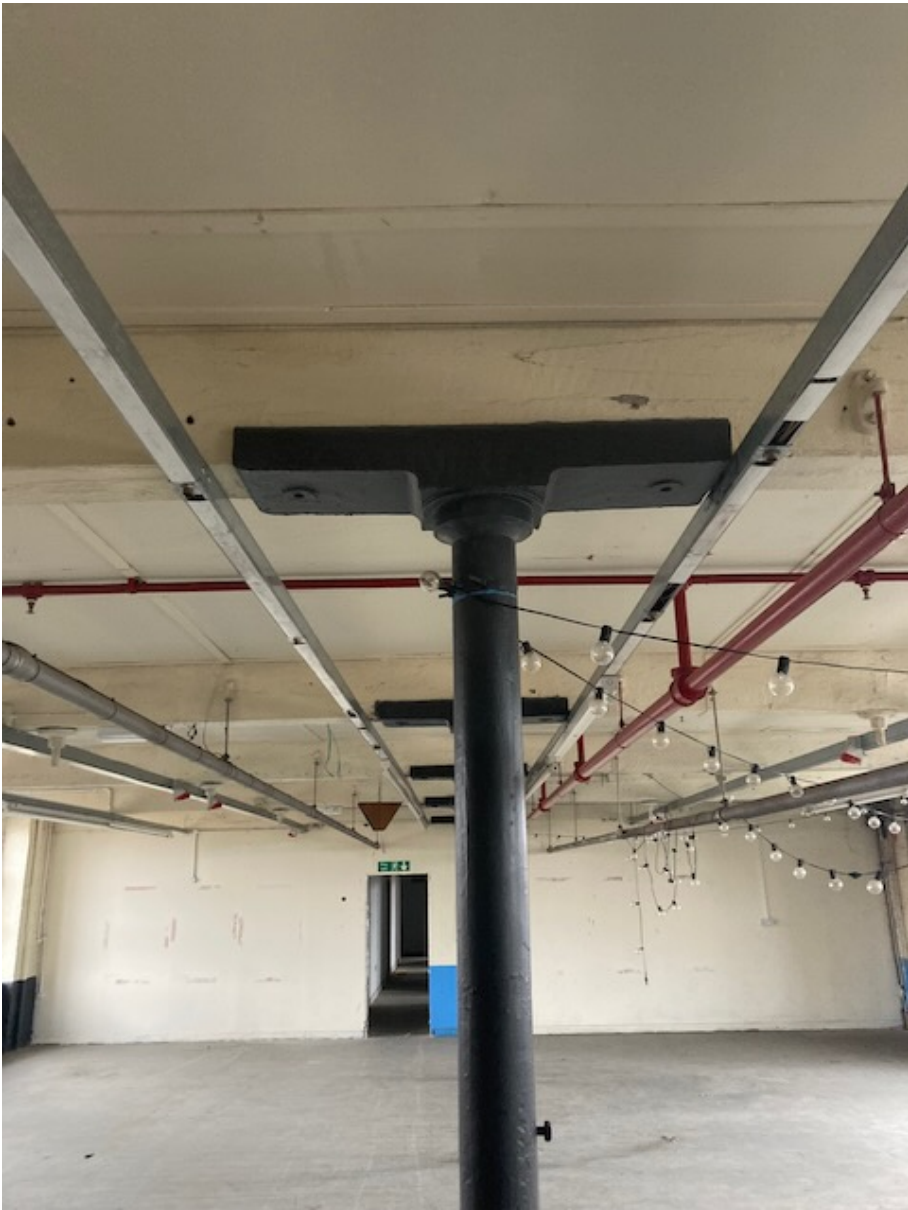
**ITEM G1**  
Typical column and beam shoe at 3rd floor

| Ref | Historic / Industrial Feature | Description | Removed / Retained | Works to be undertaken |
|---|---|---|---|---|
| G1 | Columns & beam shoes | Painted cast iron columns and varying types of primary beam support shoes | Retained | Existing paint to be lightly removed and new intumescent paint finish to be applied |

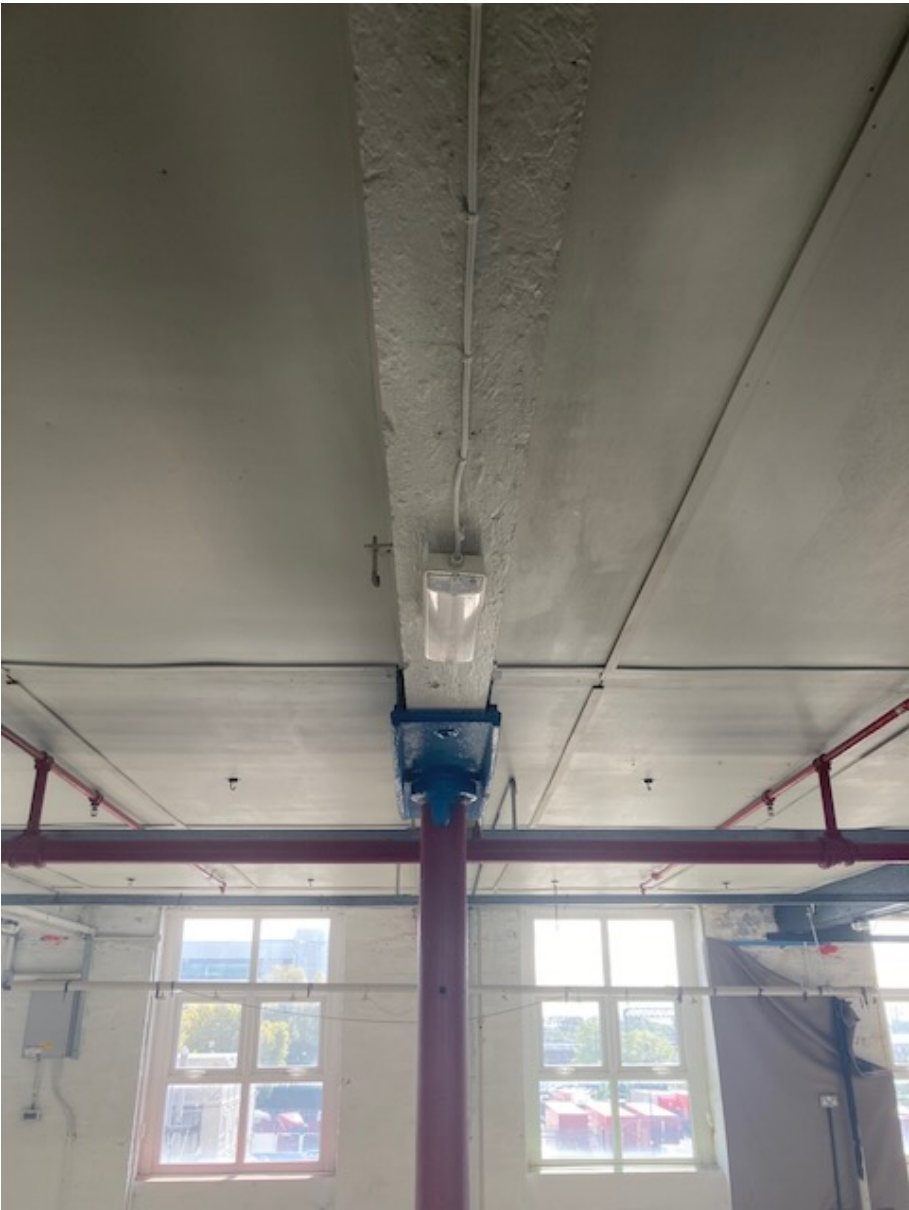
**ITEM G2**  
Typical primary beam at 2nd floor

| Ref | Historic / Industrial Feature | Description | Removed / Retained | Works to be undertaken |
|---|---|---|---|---|
| G2 | Primary beams | Painted 400 x 200mm timber beams spanning full width | Retained & fully revealed | Existing paint to be lightly removed and new clear intumescent coating to be applied. Beam ends to be replaced where rotten to be confirmed following strip out works |

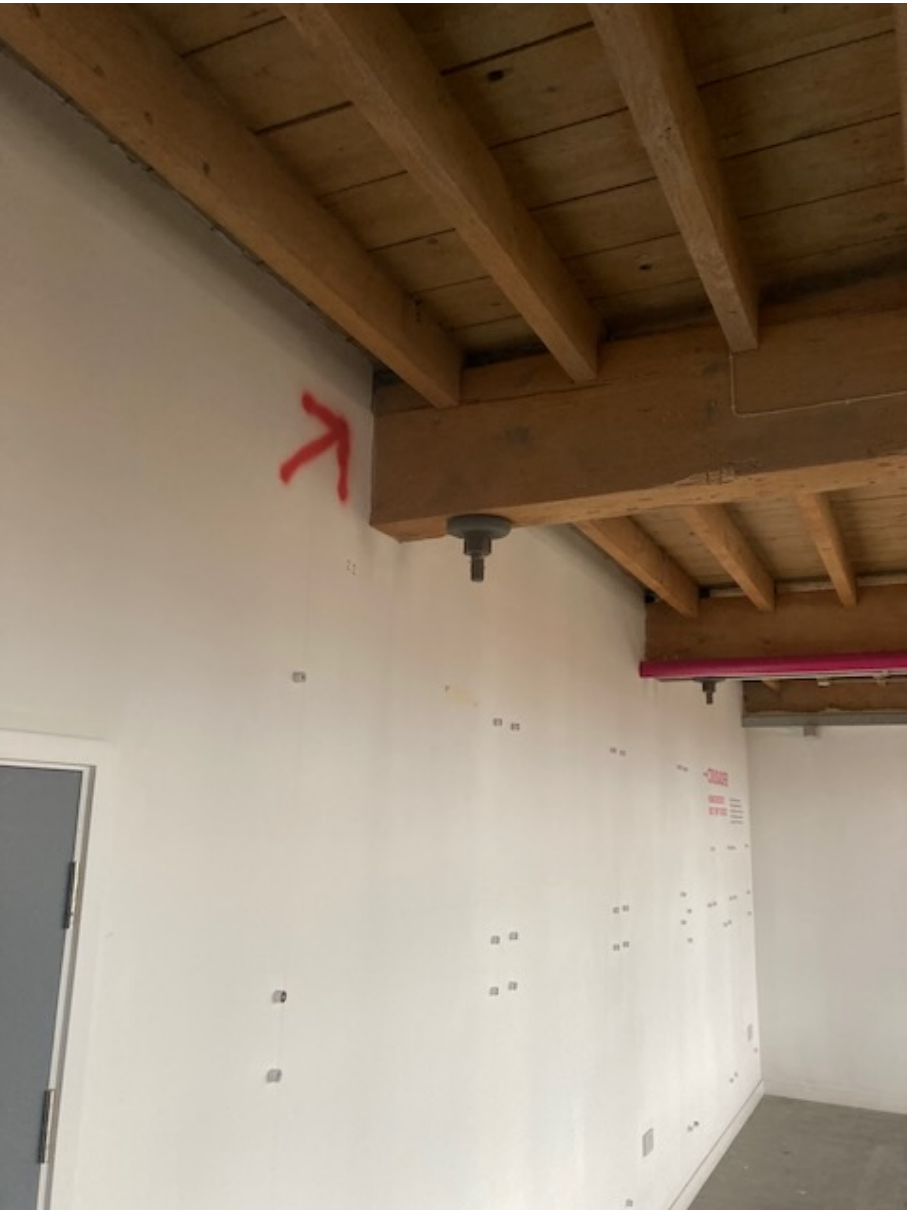
**ITEM G2**  
Exposed primary beam at 3rd floor

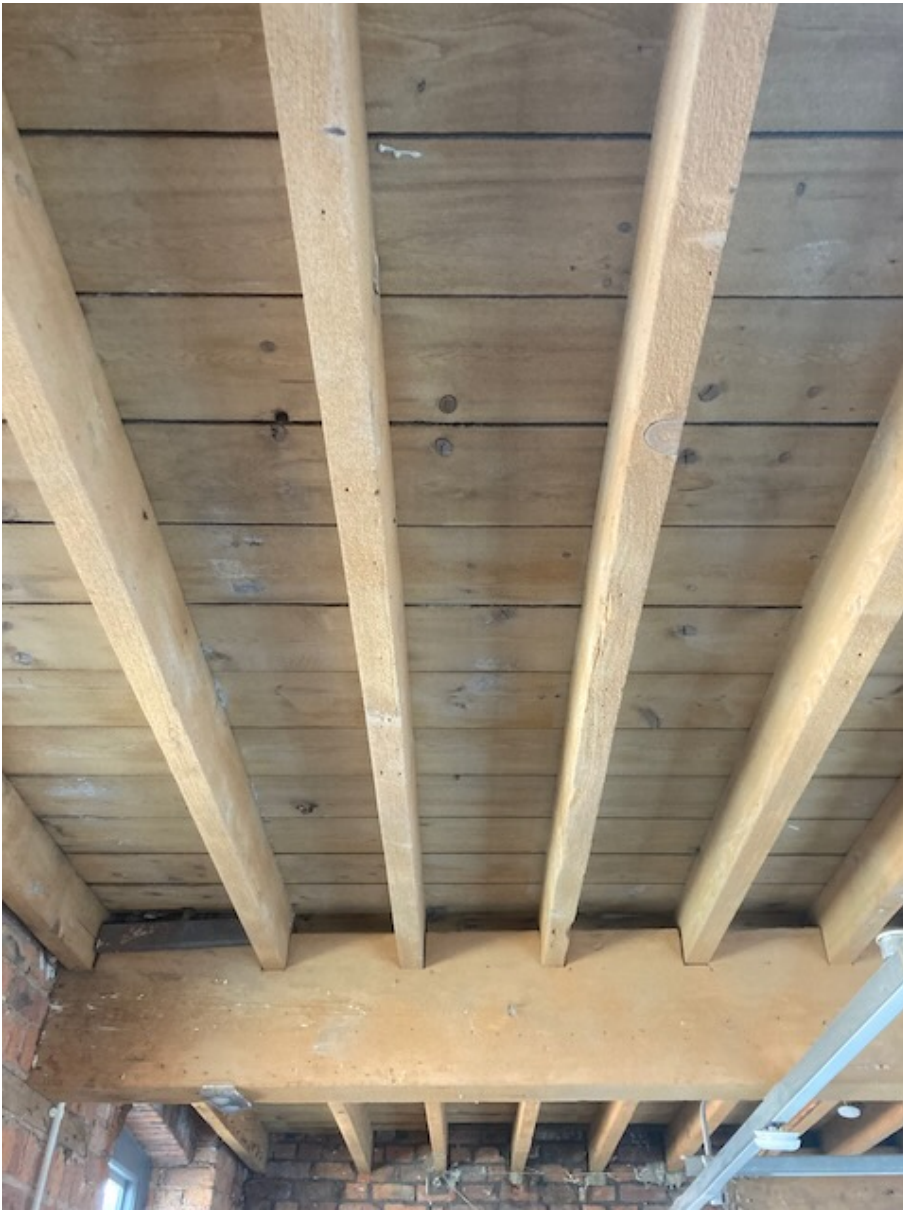
**ITEM G3 / G4**  
Exposed joists and timber boards at 3rd floor

| Ref | Historic / Industrial Feature | Description | Removed / Retained | Works to be undertaken |
|---|---|---|---|---|
| G3 | Joists | 175 x 65mm timber joists at 400mm centres spanning between primary beams | Retained & exposed | Joists to be lightly sanded and new clear intumescent coating to be applied |
| G4 | Timber board soffits | Two layers of timber planks spanning across joists forming floor deck above | Retained & exposed | Boards to be lightly sanded and new clear intumescent coating to be applied |

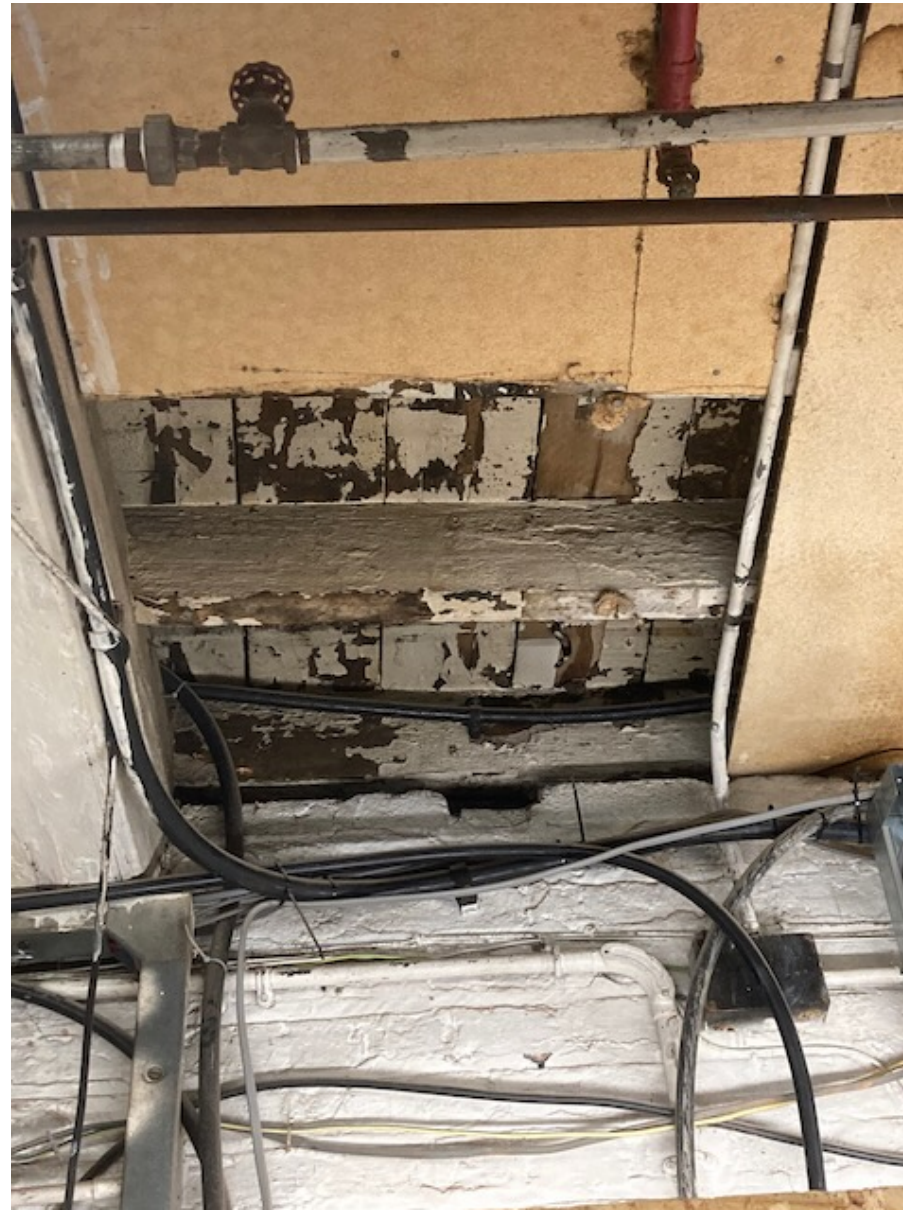
**ITEM G3 / G4**  
Hardboard ceiling to joists at ground floor

| Ref | Historic / Industrial Feature | Description | Removed / Retained | Works to be undertaken |
|---|---|---|---|---|
| G5 | Board ceilings | Various types of overlay board ceilings fixed to underside of joists with cover strips over board joints | Removed | All board ceilings to be removed to expose joists and timber board soffits above. Ceilings linings not considered to be original. |

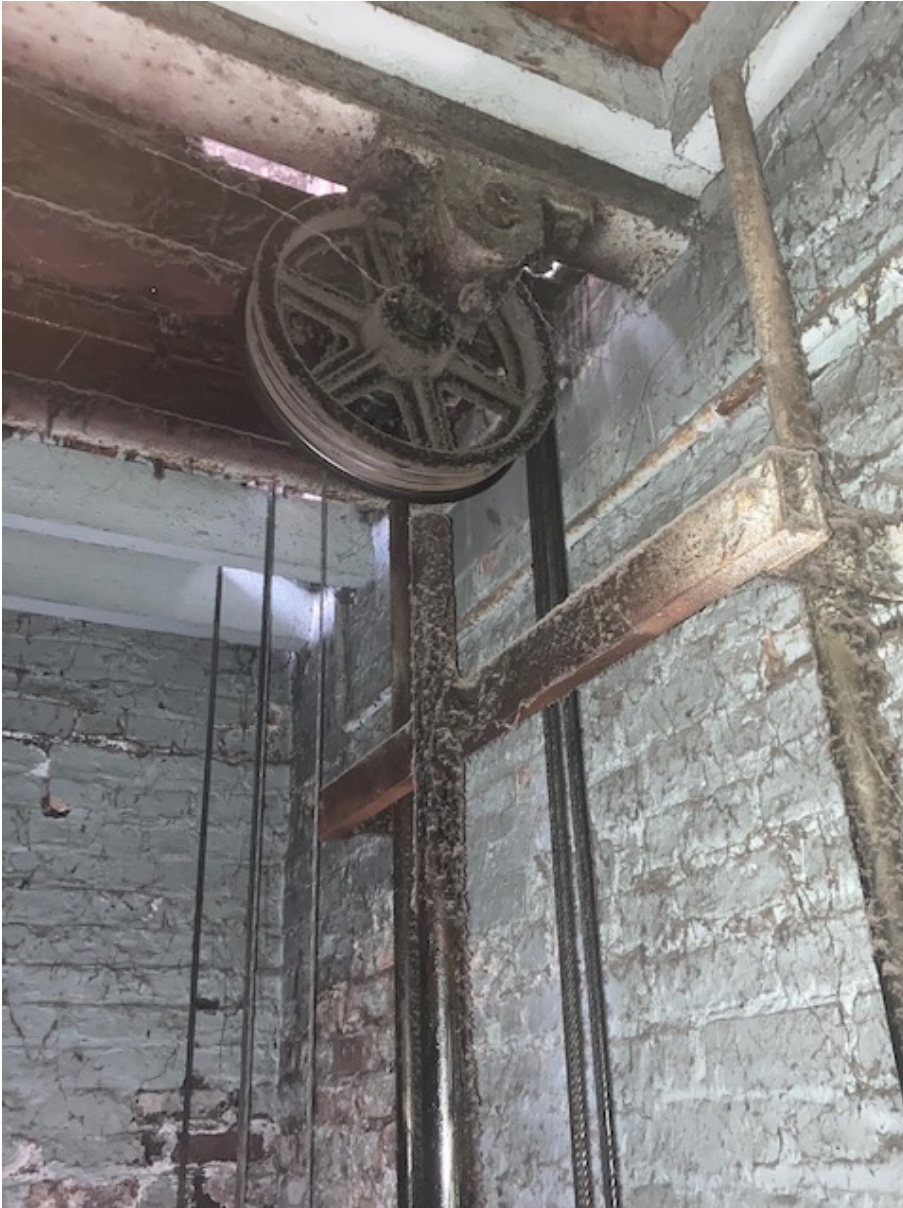
**ITEM G7**  
Lift pulley at head of shaft

| Ref | Historic / Industrial Feature | Description | Removed / Retained | Works to be undertaken |
|---|---|---|---|---|
| G7 | Lift doors and equipment | Goods lift with steel concertina doors at each level and pulley wheel at head of shaft | Removed | All lift equipment to be removed and replaced with new, full lift installation. Lift car and doors not considered original. |

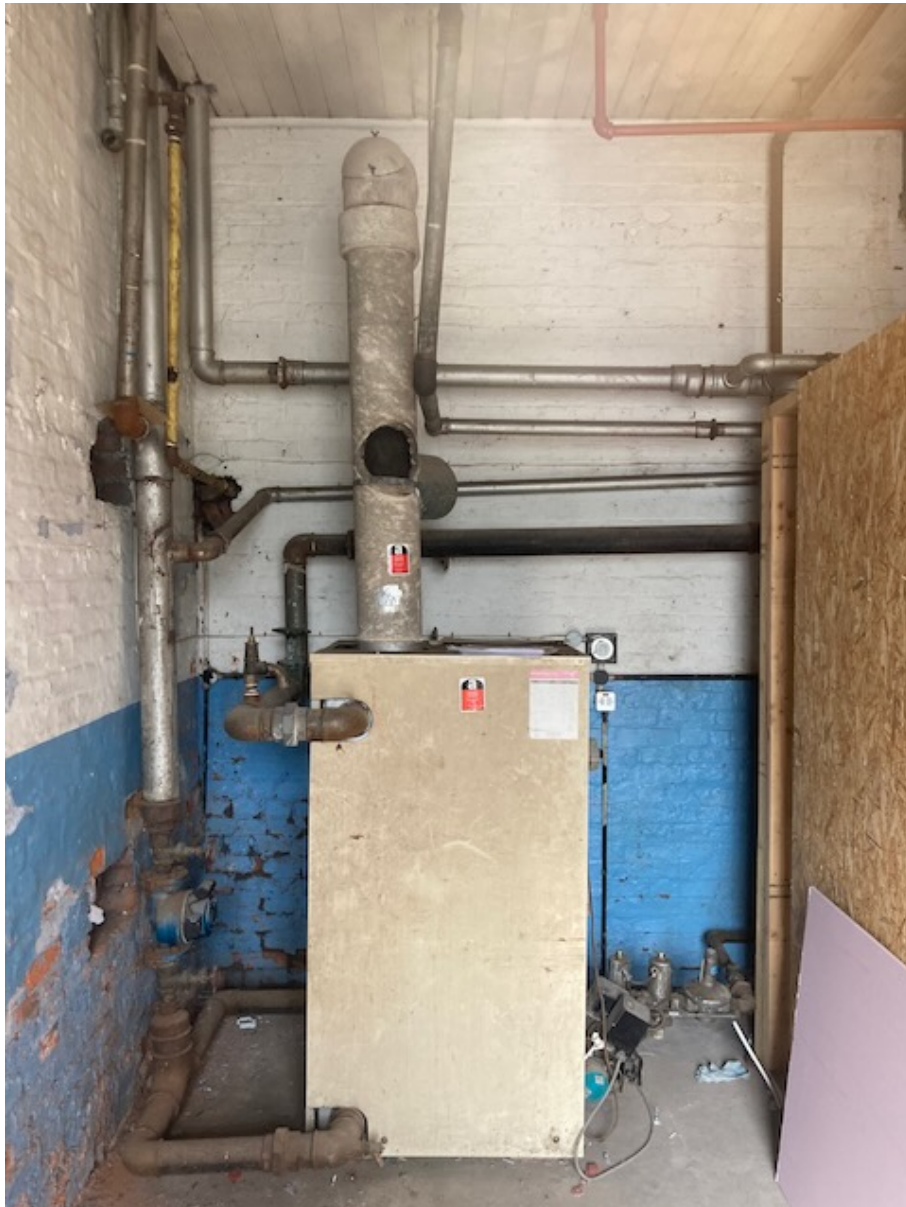
**ITEM G9**  
Boiler installation at ground floor

| Ref | Historic / Industrial Feature | Description | Removed / Retained | Works to be undertaken |
|---|---|---|---|---|
| G9 | Piped services & equipment | Boiler, pipework and flues | Removed | All heating pipework and equipment to be removed |

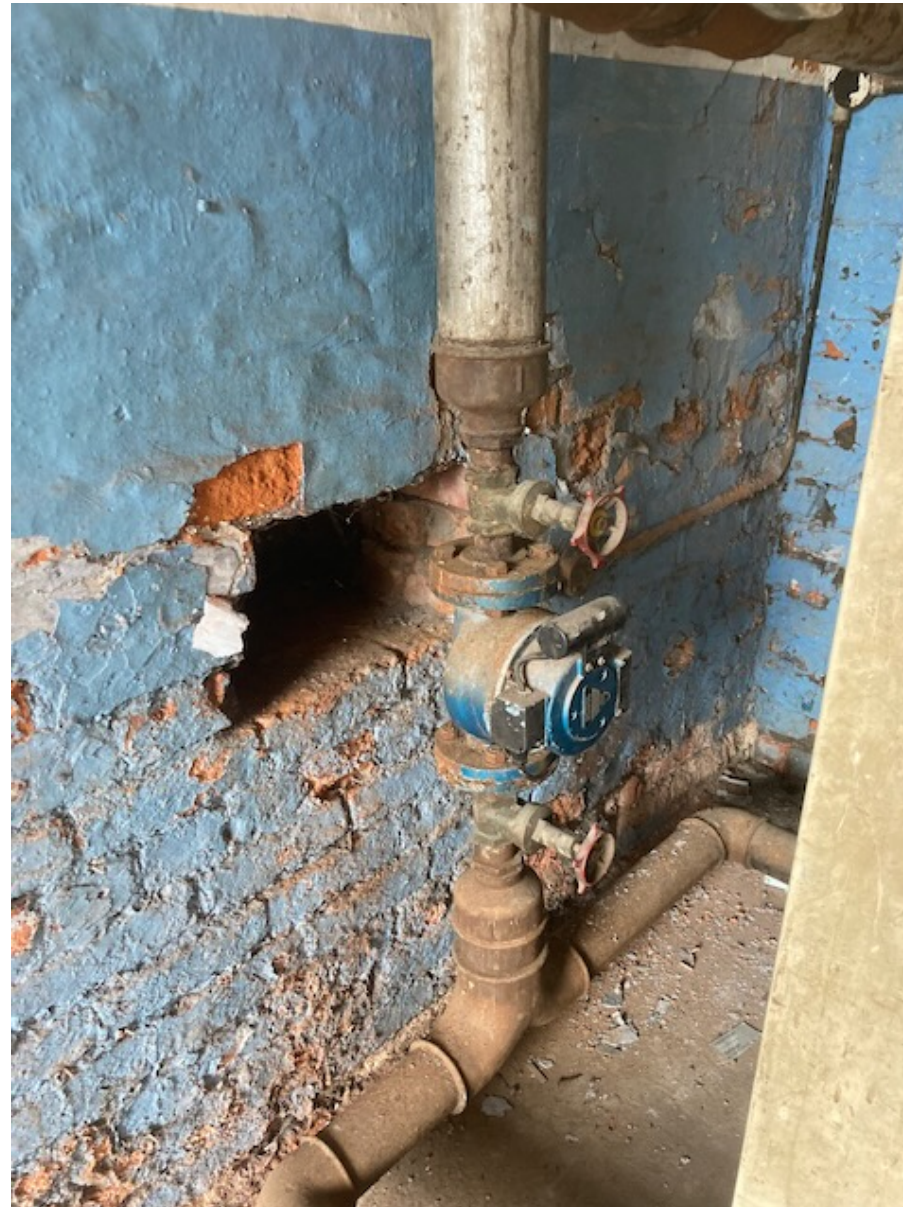
**ITEM G9**  
Valve arrangement alongside boiler

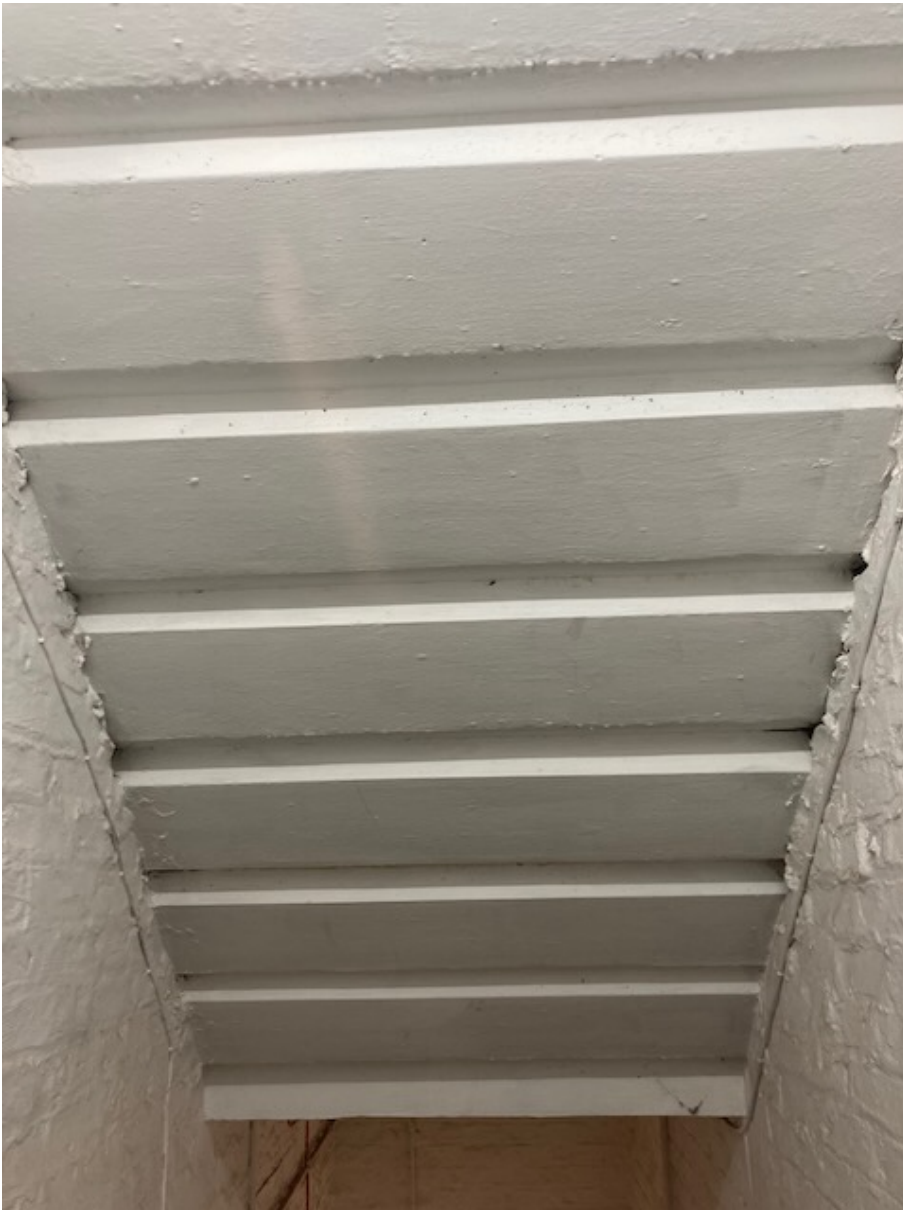
**ITEM G12**  
Painted concrete soffit to flights in north west stair

| Ref | Historic / Industrial Feature | Description | Removed / Retained | Works to be undertaken |
|---|---|---|---|---|
| G12 | North west stair | Painted brickwork walls to stair enclosure with stair construction of concrete flights with paint finish to exposed concrete soffits. | Retained & cleaned of paint | Existing paint finish to be lightly removed and brickwork left uncoated and exposed. Concrete elements to be cleaned of paint and coated with clear dust sealer. |

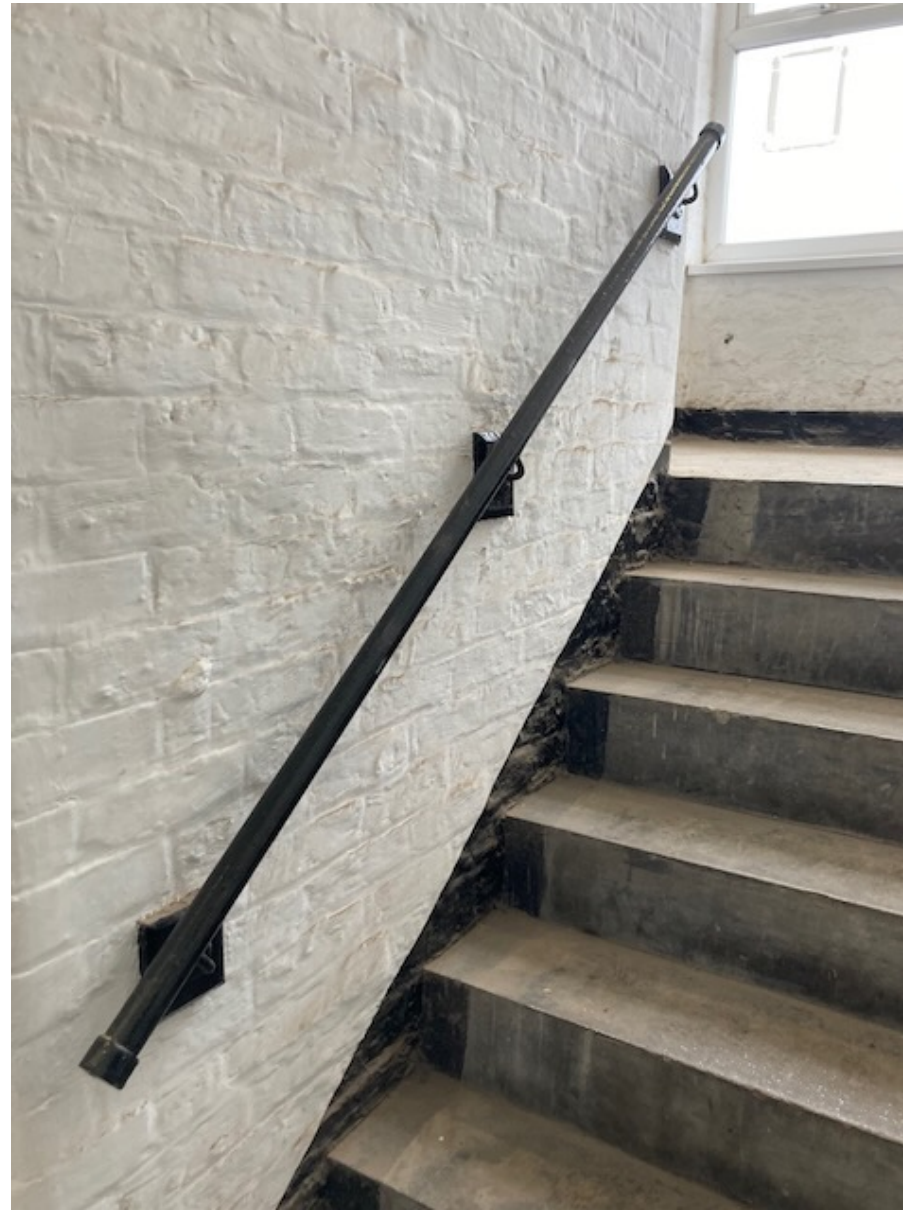
**ITEM G12**  
Painted walls, concrete steps and steel handrails to north west stair

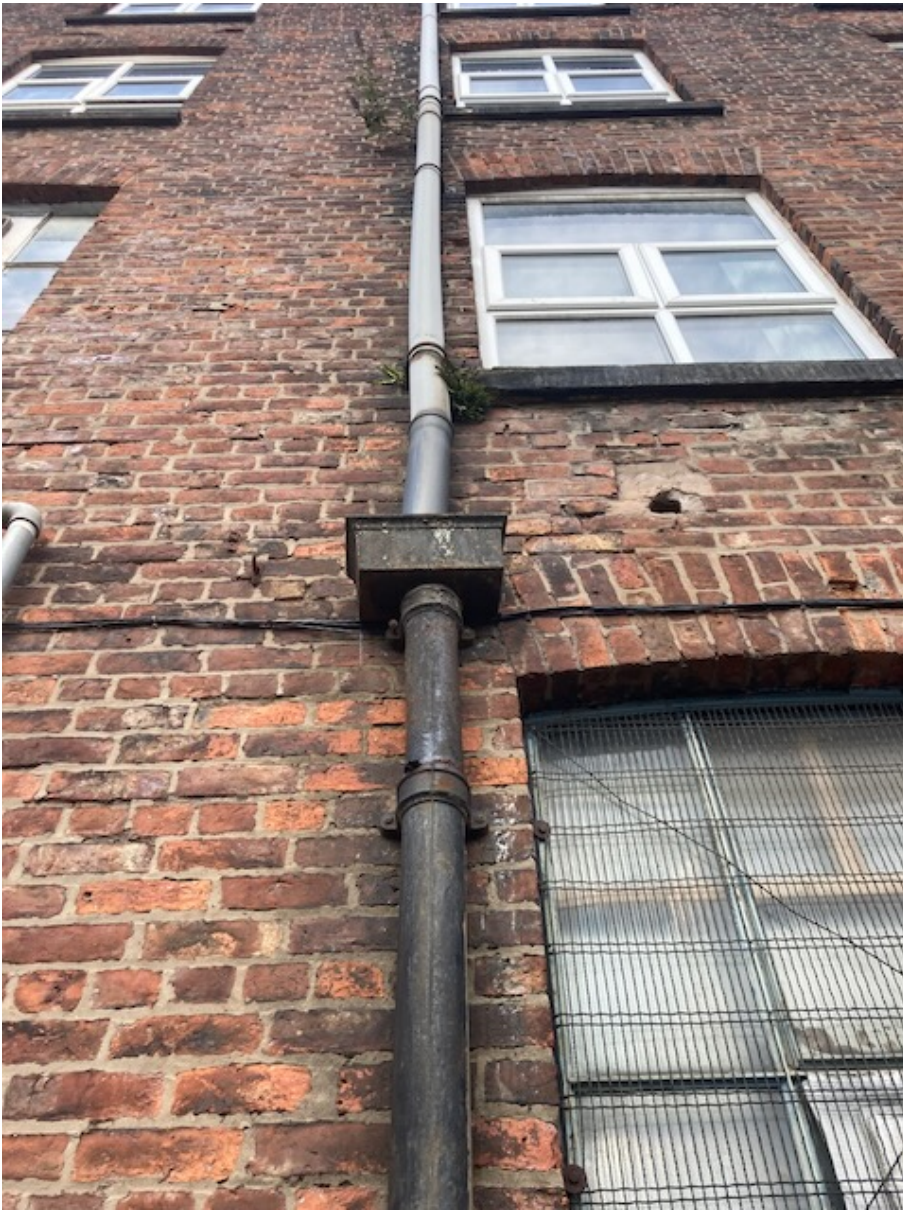
**ITEM G14**  
Part plastic part cast iron hopper head and pipework to Baird Street

| Ref | Historic / Industrial Feature | Description | Removed / Retained | Works to be undertaken |
|---|---|---|---|---|
| G14 | External rainwater goods | Mixture of cast iron and uPVC hopper heads and downpipes | Removed & replaced | All rainwater goods to be renewed in cast iron |

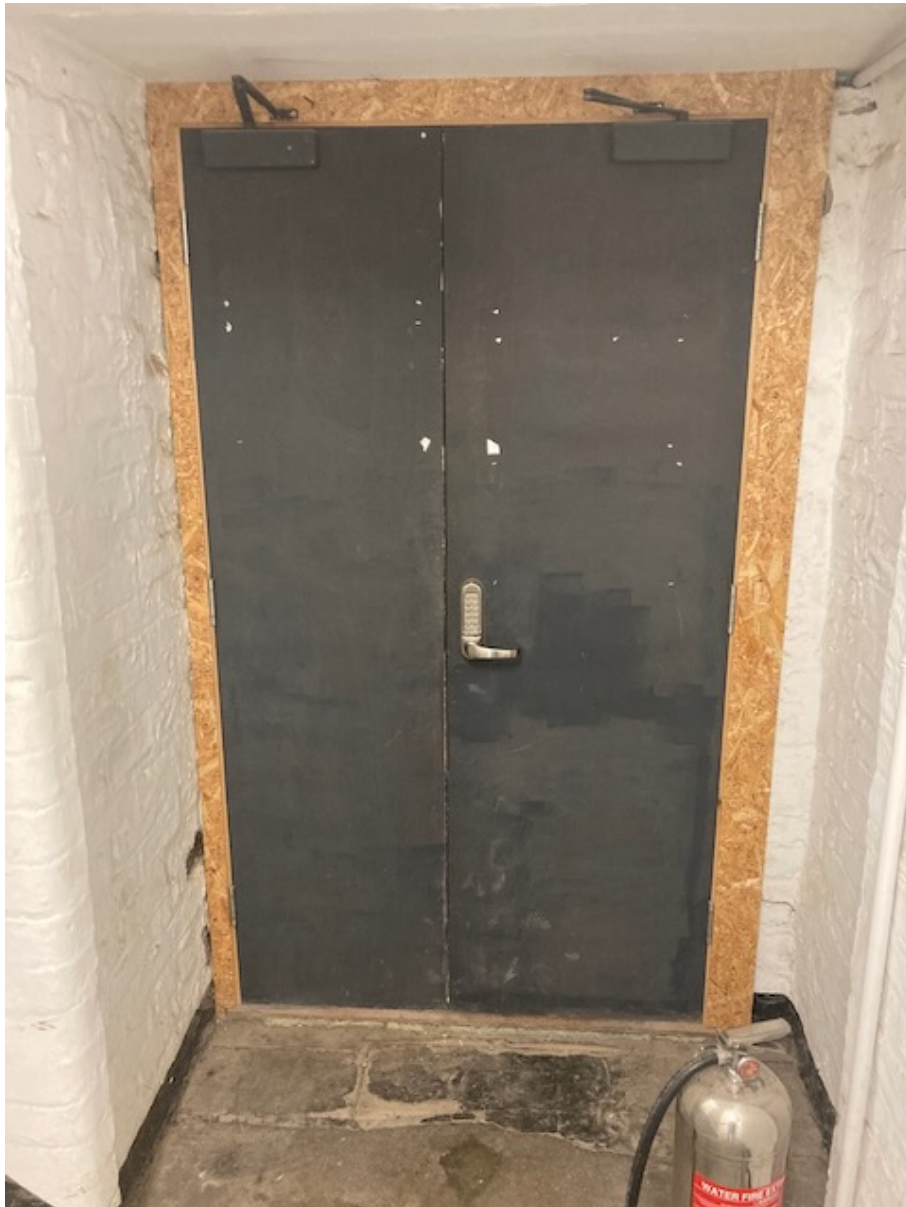
**ITEM 12**  
Brickwork lobby and timber doors to north west stair (stair side)

| Ref | Historic / Industrial Feature | Description | Removed / Retained | Works to be undertaken |
|---|---|---|---|---|
| 12 | Doors to NW staircase | Timber doors with boarded overlay | Door and frame only to be removed. Brick surround and concrete lid retained | Door to be removed and replaced with new FD30 rated fire door |

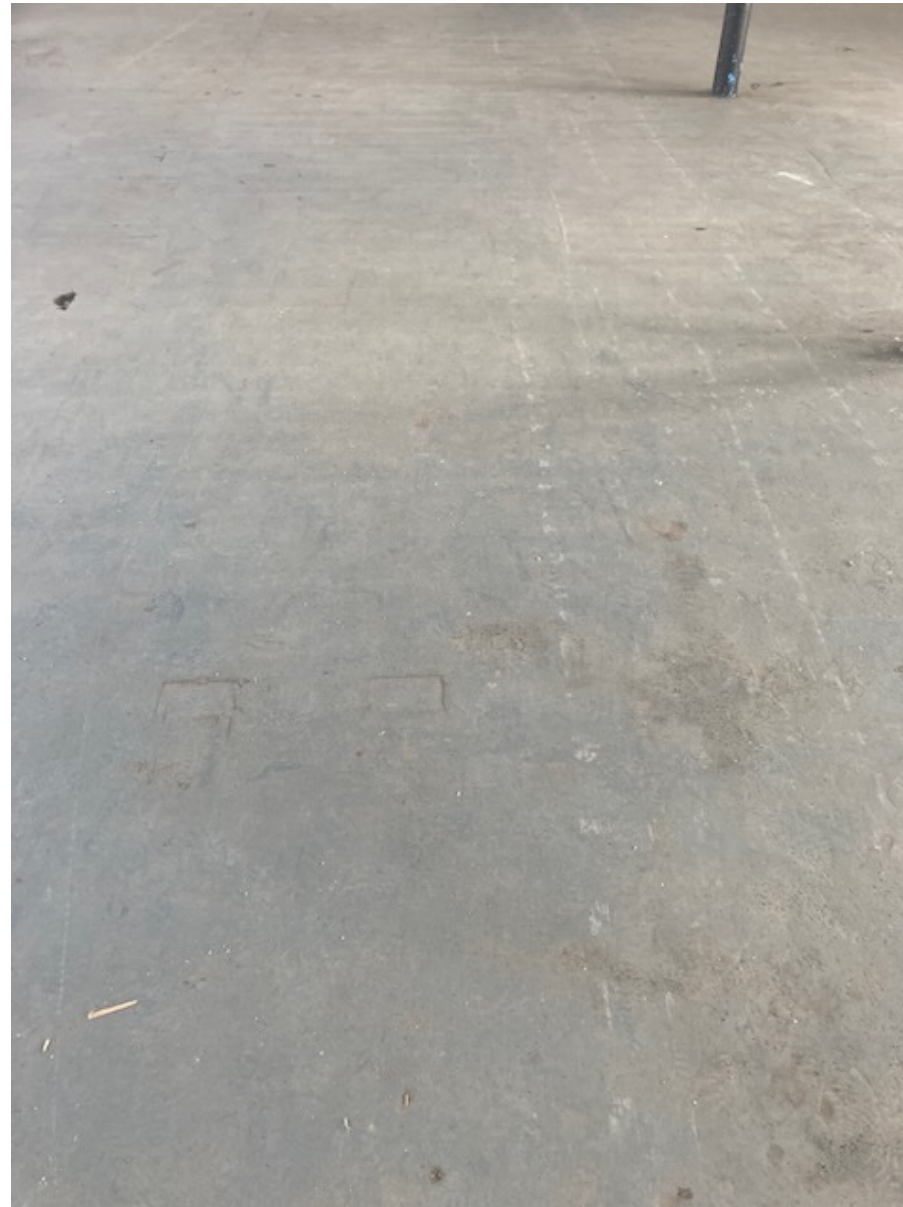
**ITEM 13**  
Asphalt topping to timber boarded floor

| Ref | Historic / Industrial Feature | Description | Removed / Retained | Works to be undertaken |
|---|---|---|---|---|
| 13 | Floor | Asphalt topping to timber boards | Retained and covered | Existing asphalt to be filled and levelled and new micro cement topping applied over. |

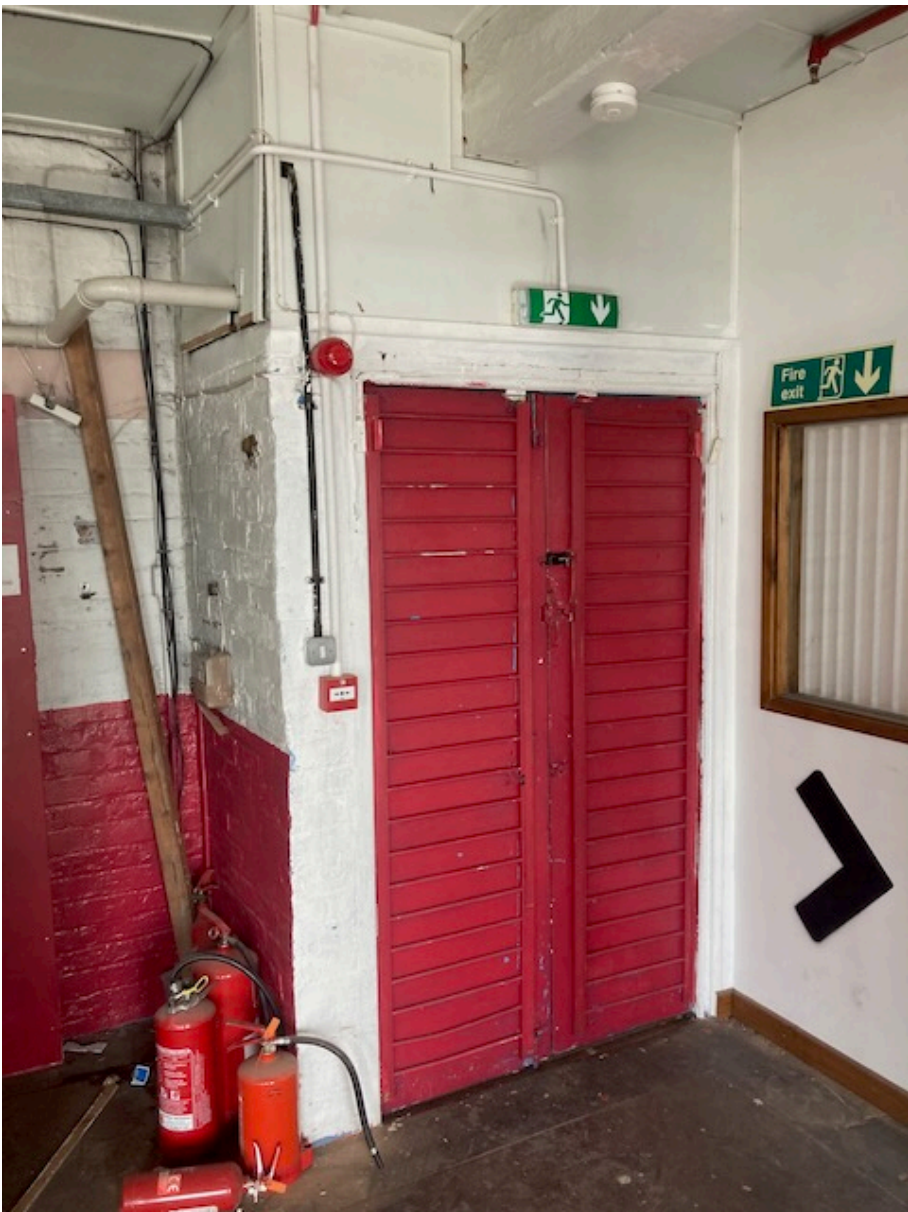
**ITEM 21**  
Brickwork lobby and timber doors to north east stair (office side)

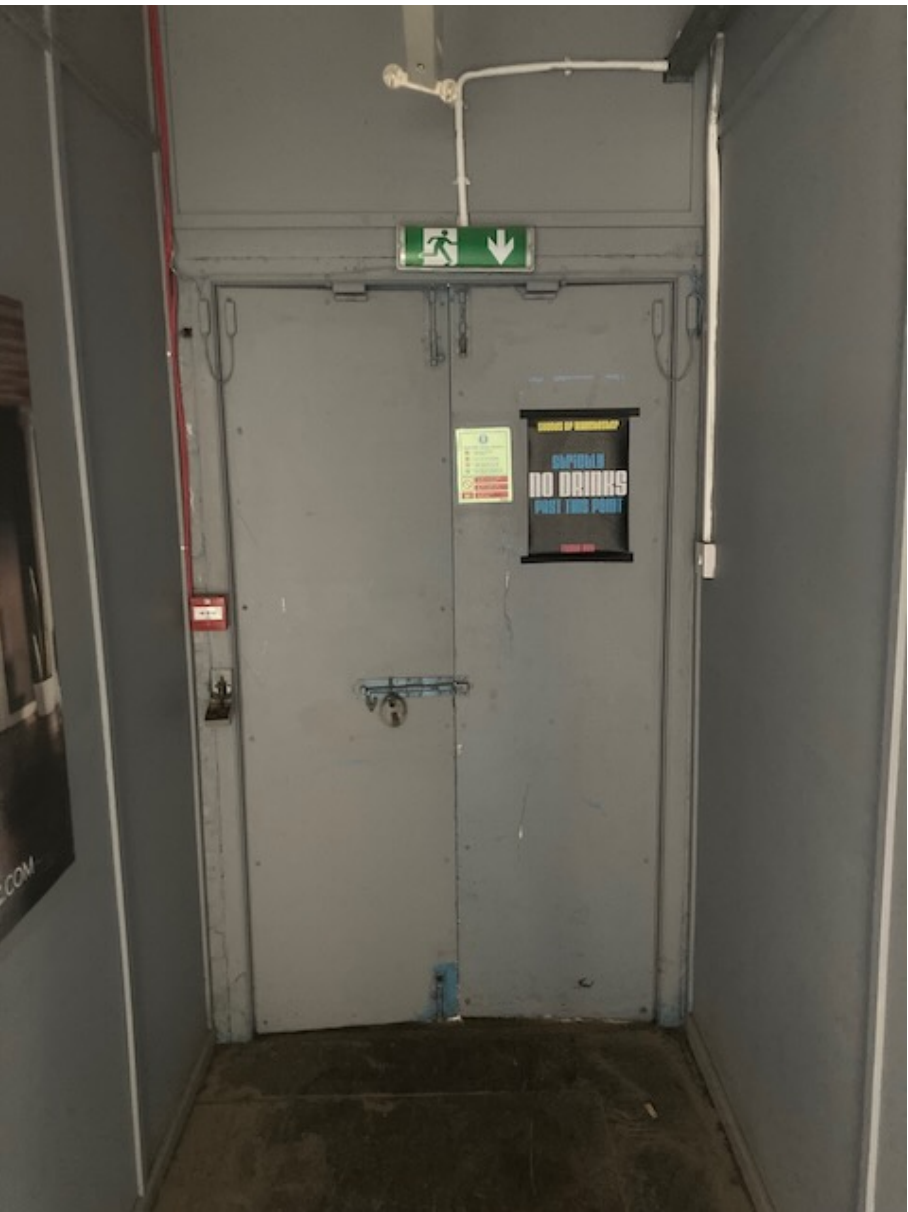
**ITEM 22**  
Brickwork lobby and timber doors to north west stair (office side)

| Ref | Historic / Industrial Feature | Description | Removed / Retained | Works to be undertaken |
|---|---|---|---|---|
| 22 | Doors to NW staircase | Timber doors with boarded overlay | Door and frame only to be removed. Brick surround and concrete lid retained | Door to be removed and replaced with new FD30 rated fire door |

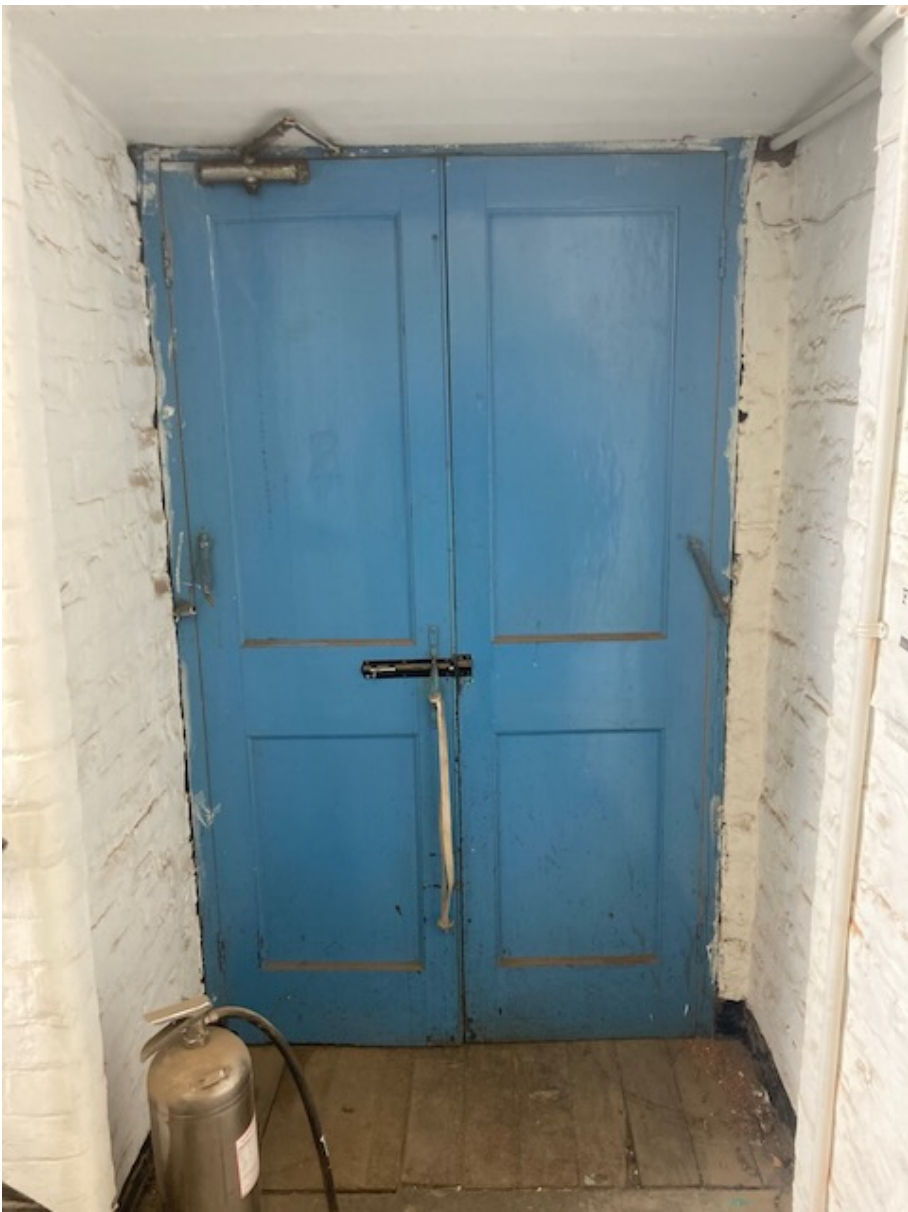
**ITEM 22**  
Brickwork lobby and timber doors to north west stair (stair side)

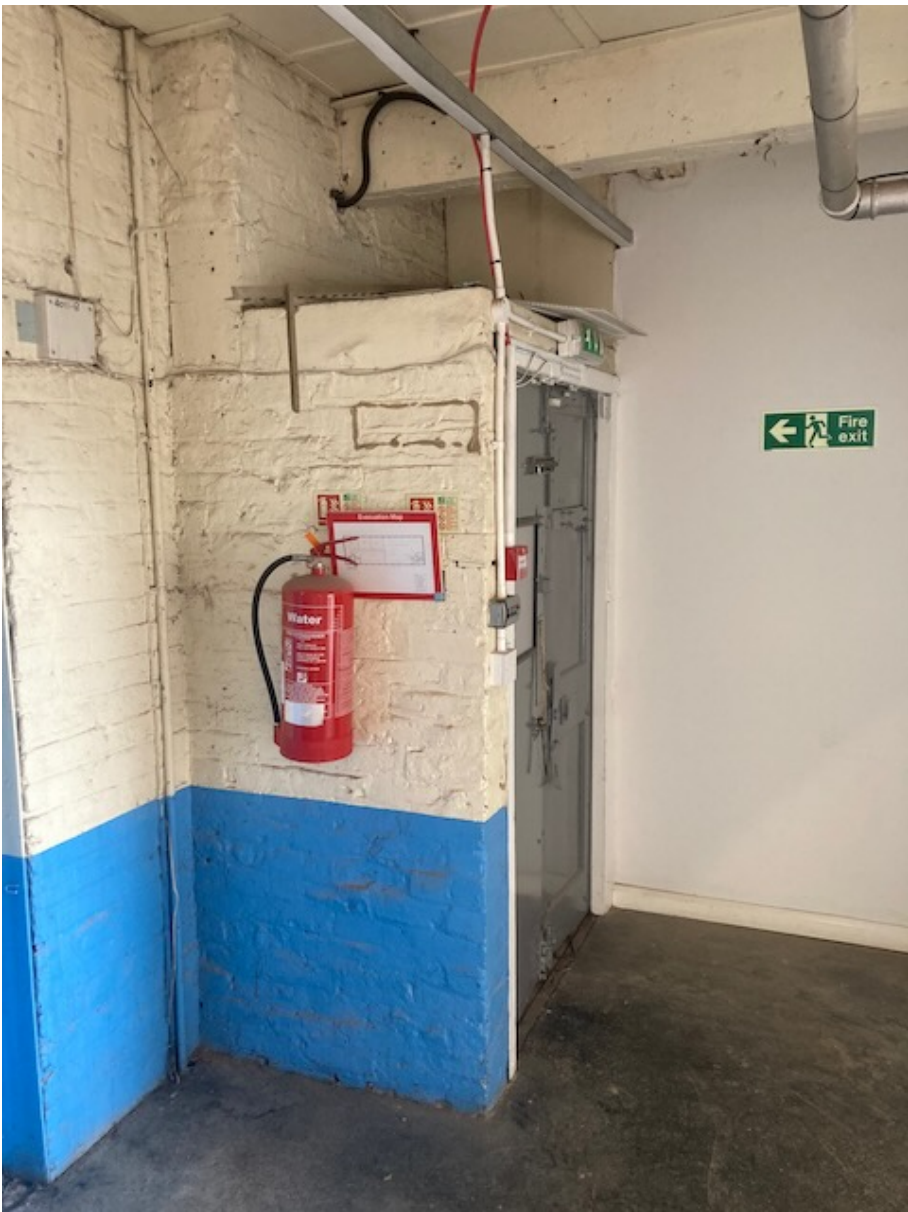
**ITEM 31**  
Brickwork lobby and timber doors to north east stair (office side)

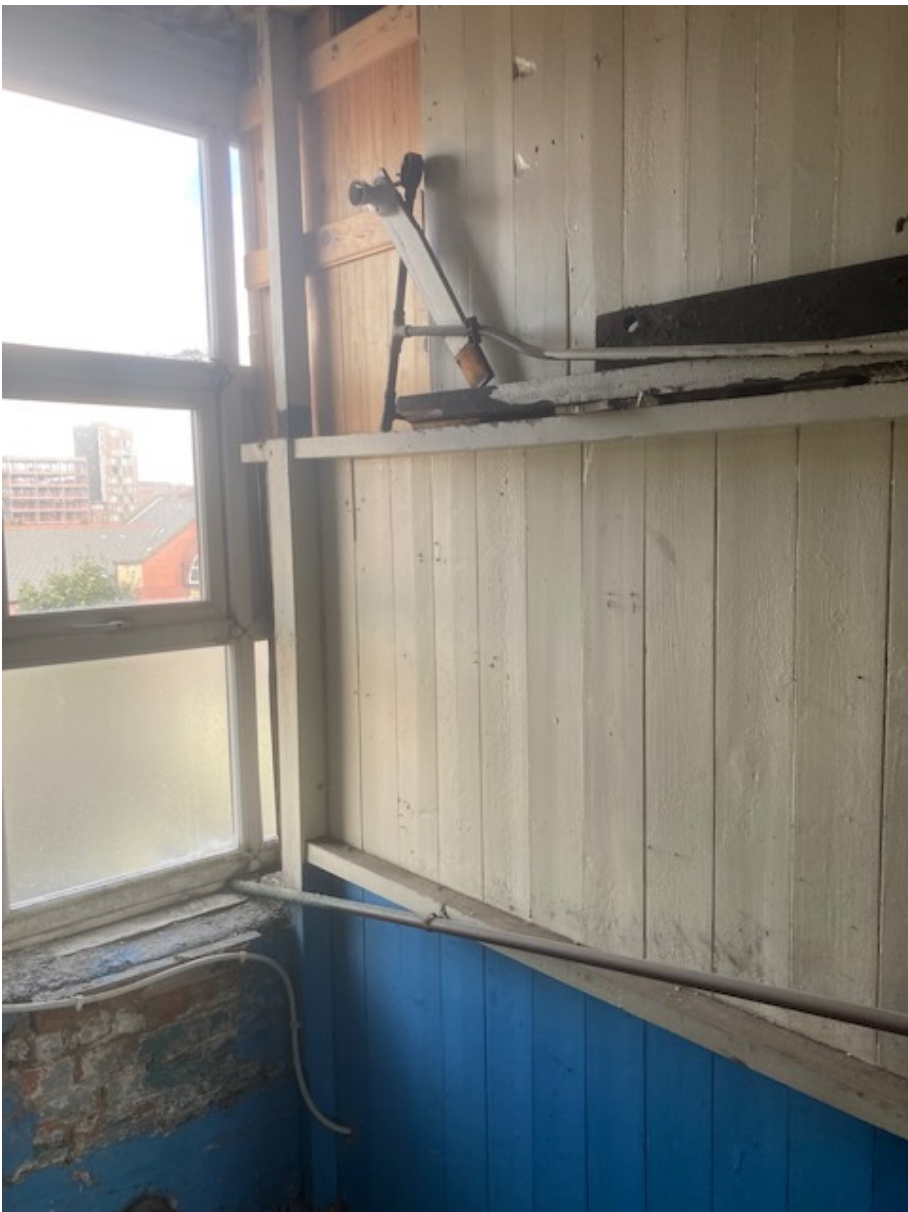
ITEM 33  
Timber board partition forming WC area

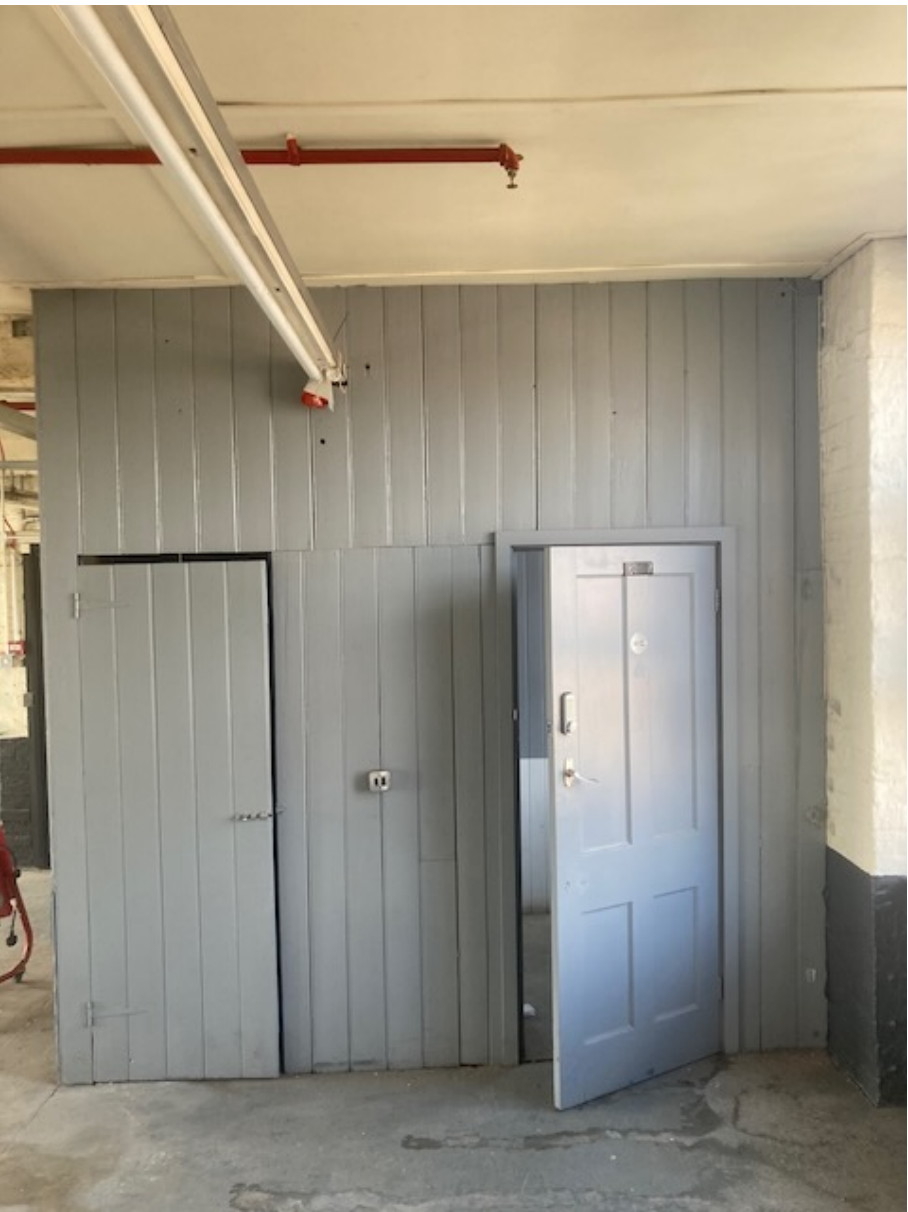
ITEM 33  
Timber board partition forming WC area
