## Jonathan Davidson Architects

Neptune Mill  
Chapelton St, Manchester

Historic & Industrial Features Audit  
353 PD 2001 (P2)

*October 2023*

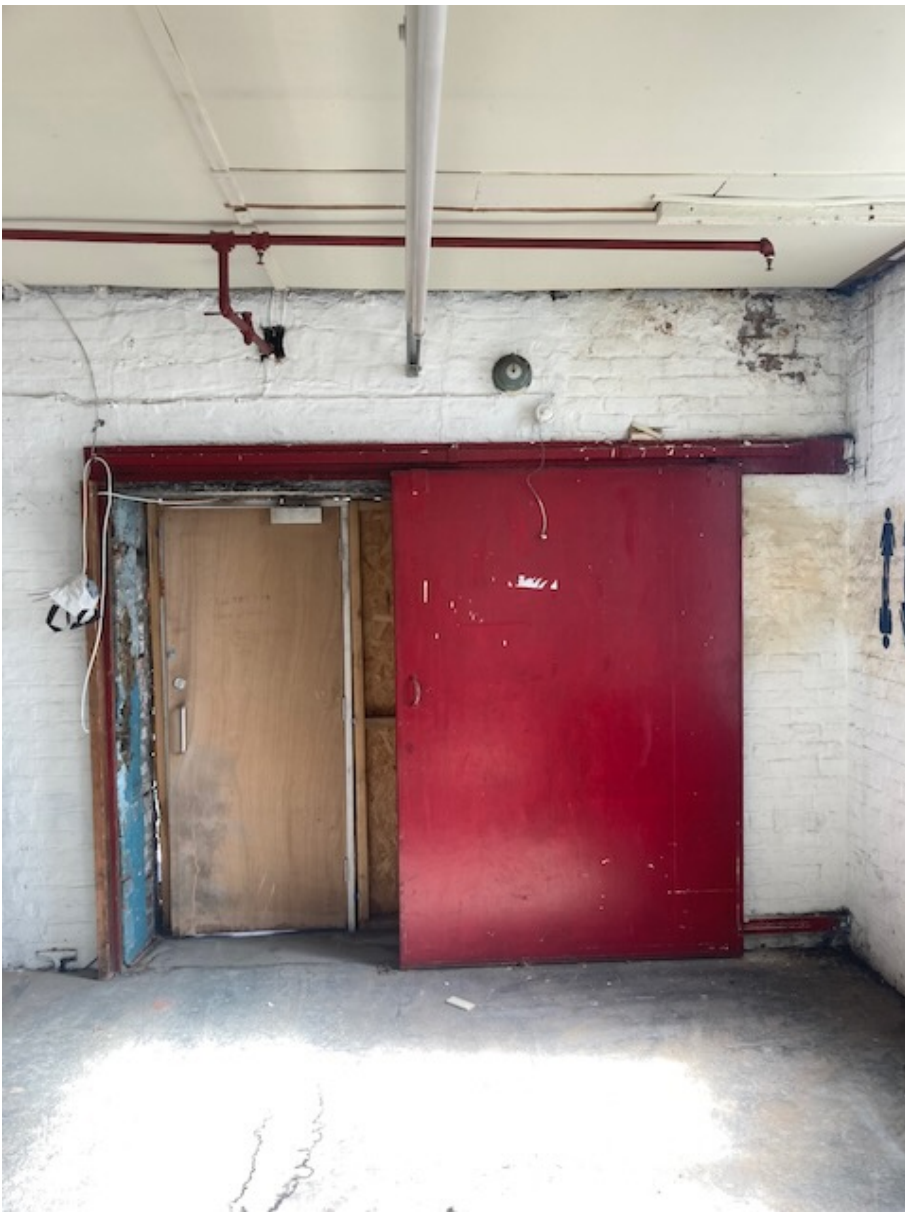
**ITEM 34**  
Sliding door and track to bridge link access

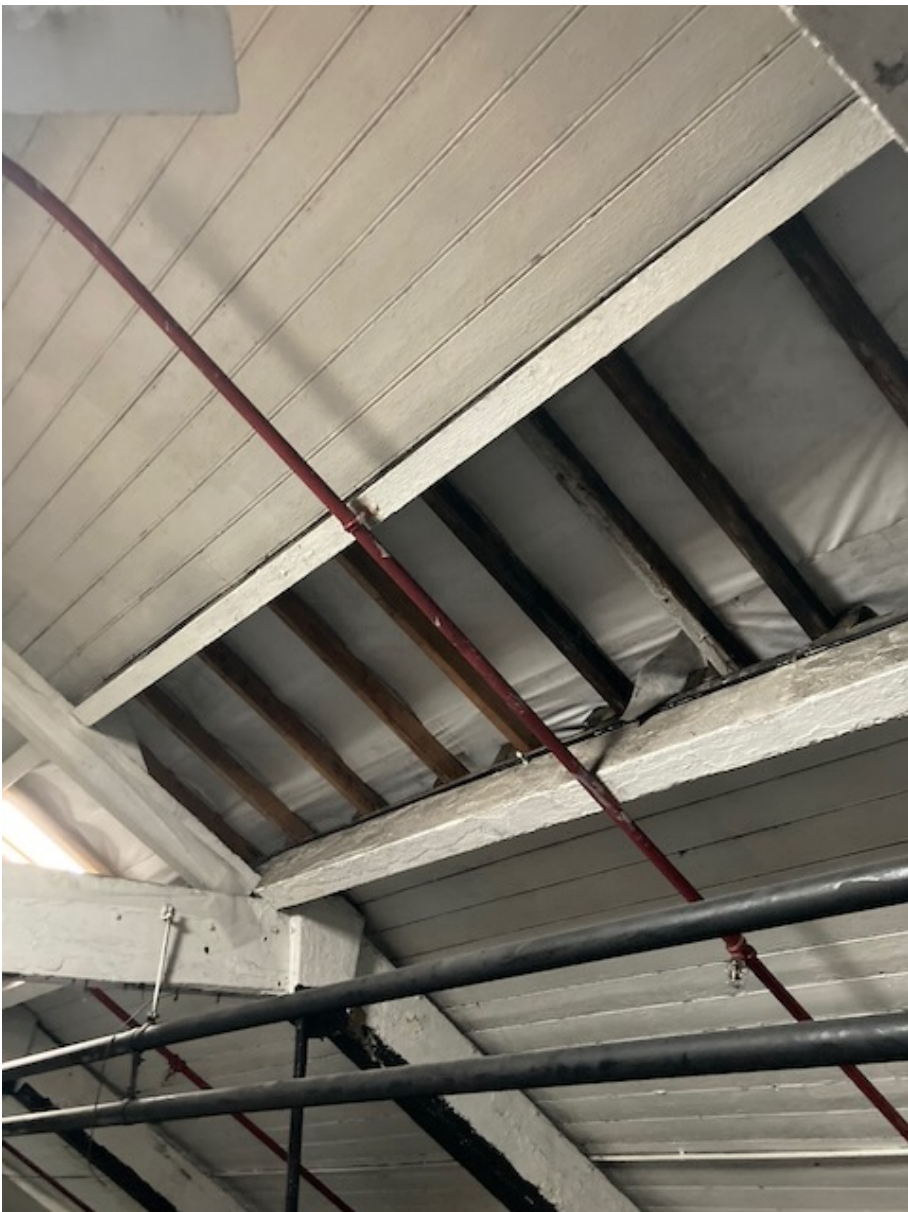
**ITEM 42**  
Purlins to south roof slope with infill to former rooflight opening

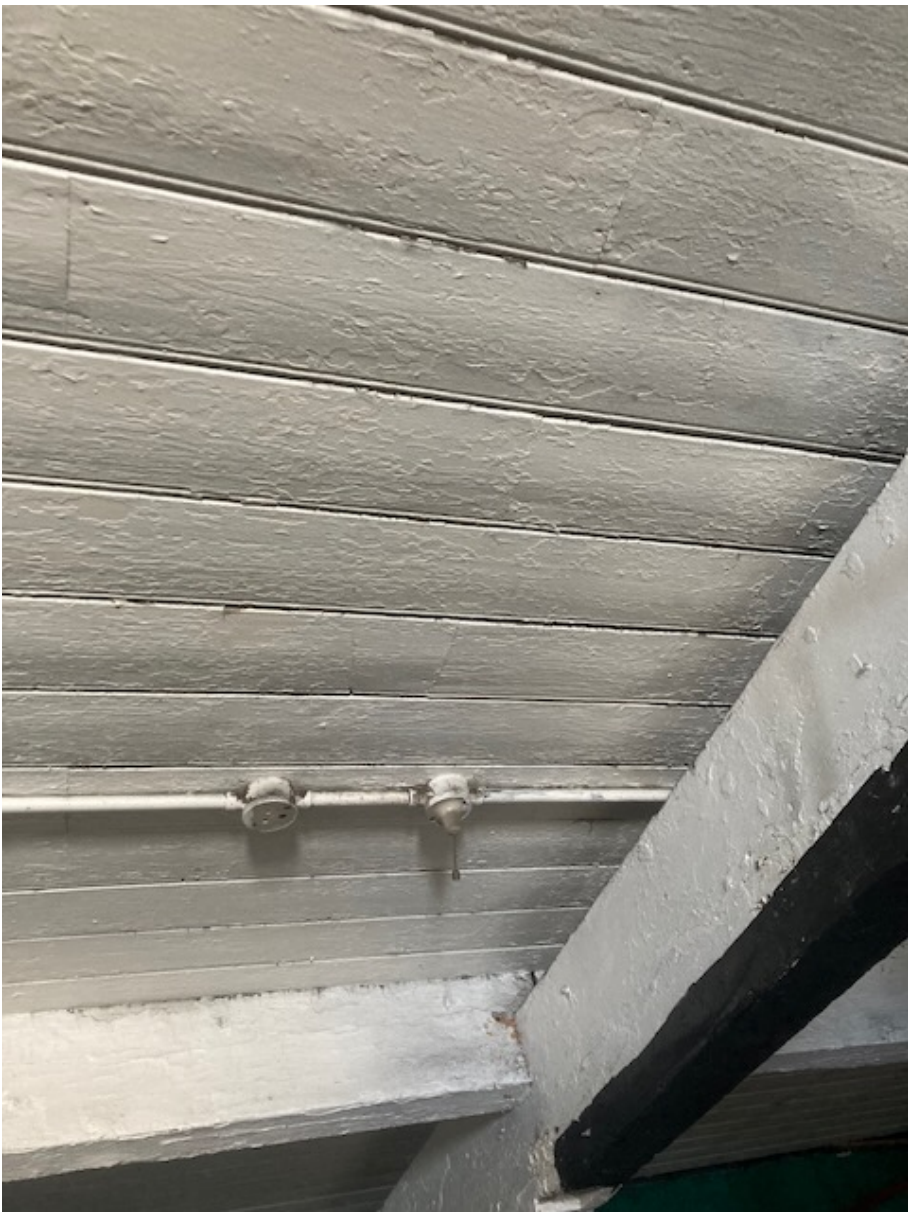
**ITEM 44**  
Timber board lining to underside of rafters

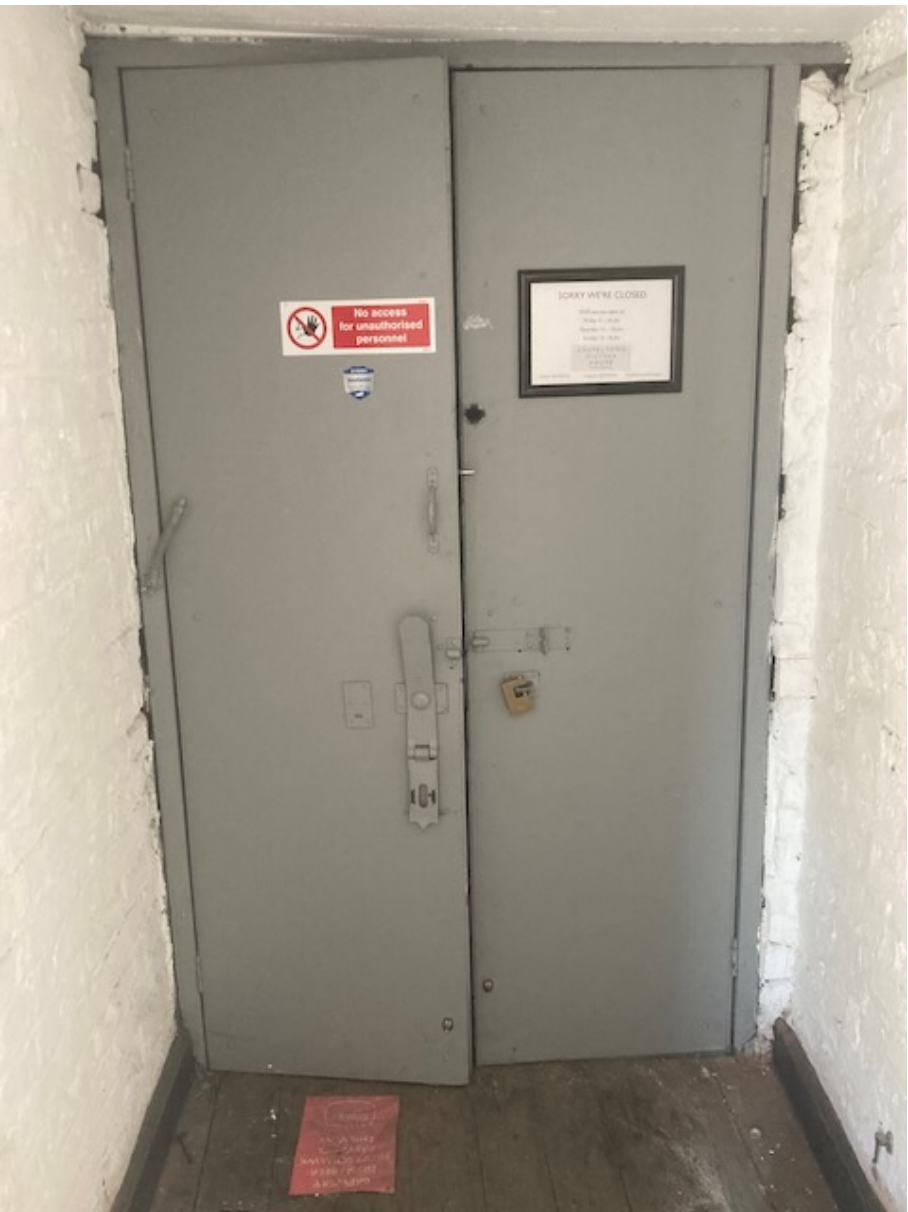
**ITEM 45**  
Brick lobby and timber doors to north east stair (stair side)

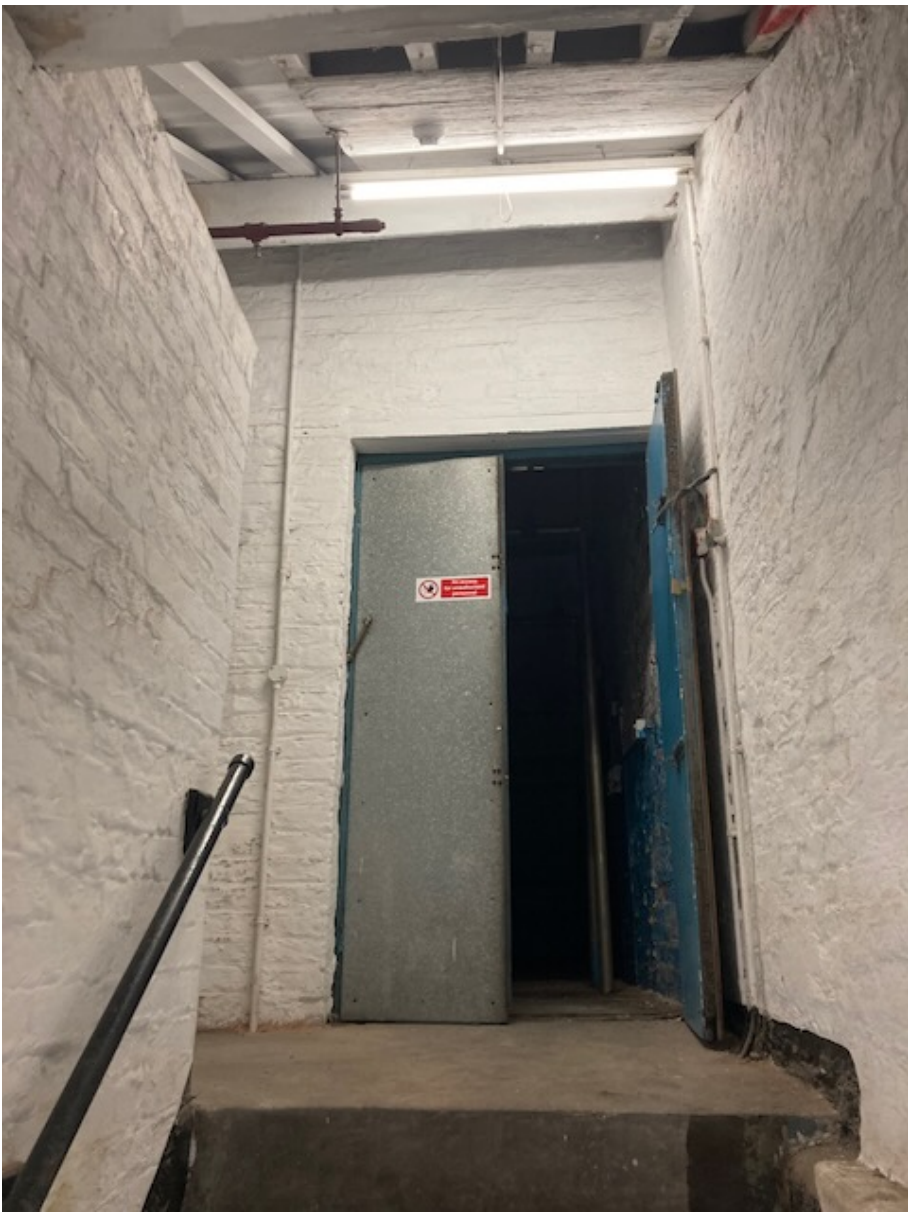
**ITEM 46**  
Timber doors to north west stair

| Ref | Historic / Industrial Feature | Description | Removed / Retained | Works to be undertaken |
|---|---|---|---|---|
| 46 | Doors to NW staircase | Timber doors with boarded overlay | Removed & replaced | Door to be removed and replaced with new FD30 rated fire door |
