## Neptune Mill, Manchester - Paint Analysis

### Report on Findings Report No HPMLNM01

ISSUE 01– 01/12/2023

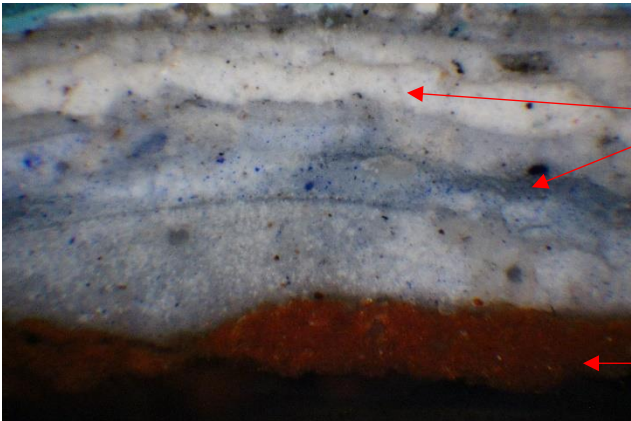
| Sample Ref: P07 – (Third Floor Wall) | Location: Neptune Mill |
|---|---|
| | <p>100x Magnification.<br/>Current visible paint layer (modern Titanium white).</p> <p>Earliest paint layer.</p> <p>Earliest paint layers 400x Magnification.</p> <p>3x White Lime Wash layers.<br/>3x Blue Lime Wash layers.</p> <p>Brick fragment</p> |

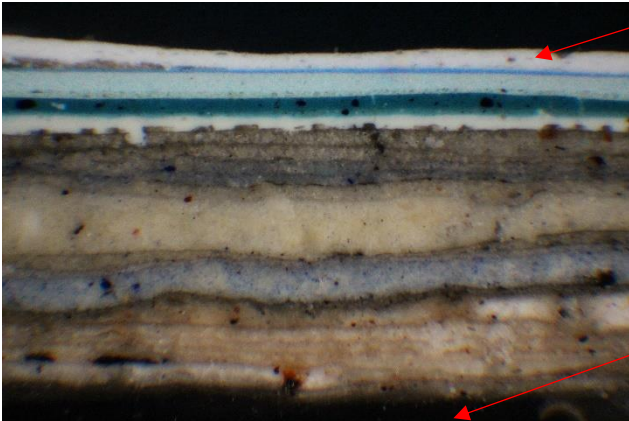
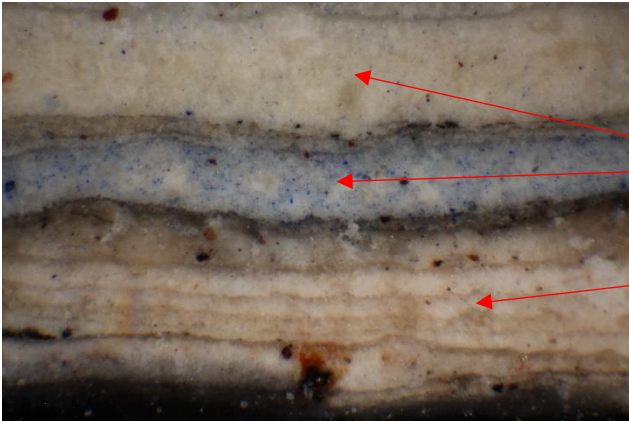
| Sample Ref: P08 – (Third Floor Wall) | Location: Neptune Mill |
|---|---|
| <br> | <p>100x Magnification.</p> <p>Current visible paint layer (Modern Titanium white).</p> <p>(17 layers of white and blue limewash coatings).</p> <p>Earliest paint layer.</p> <p>Earliest paint layers 400x Magnification.</p> <p>2x White Lime Wash layers.</p> <p>Single Blue Lime Wash layer.</p> <p>7x White Lime Wash paint layers.</p> |

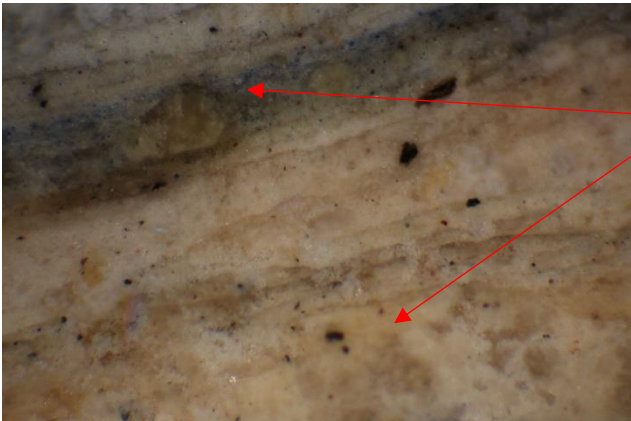
| Sample Ref: P10 – (Third Floor Beam) | Location: Neptune Mill |
|---|---|
| | <p>100x Magnification.</p> <p>Current visible paint layer (Modern Titanium white paint).</p> <p>21 layers of white and blue Lime Wash.</p> <p>Earliest paint layers.</p><br><p>Earliest paint layers 400x Magnification.</p> <p>5 No light blue Lime Wash layers.</p> <p>7 No white Lime Wash layers.</p> |

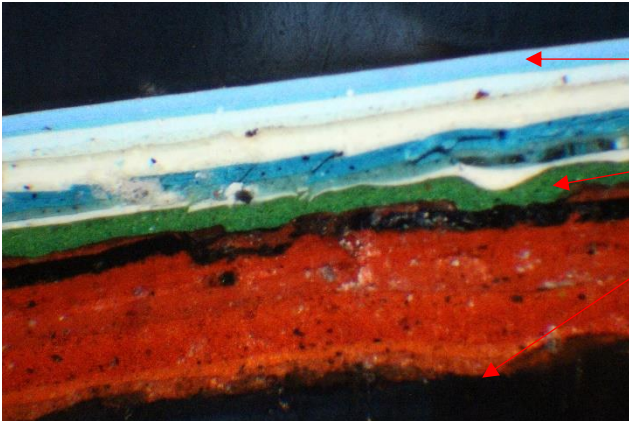
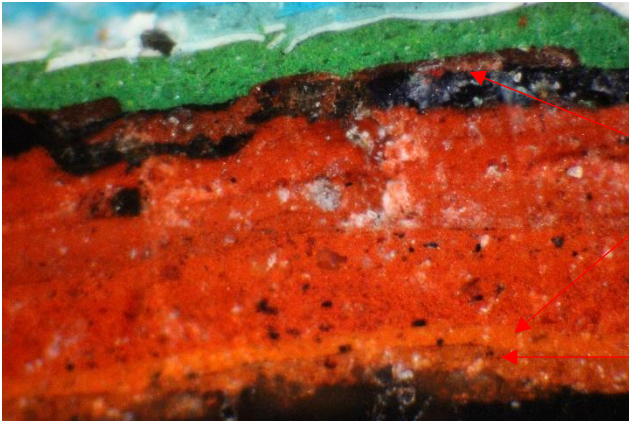
| Sample Ref: P11 – (Third Floor Blue Column) | Location: Neptune Mill |
|---|---|
| <br> | <p>100x Magnification.</p> <p>Current visible paint layer (Modern blue alkyd paint).</p> <p>Single green paint layer (probably the first post WW2 paint layer).</p> <p>Earliest paint layer.</p><br><p>Earliest paint layers 400x Magnification.</p> <p>Varnish layer over red iron oxide paint layer (gloss finish).</p> <p>7 No Red Iron Oxide oil paints layers.</p> <p>Earliest decorative paint layer.</p> |

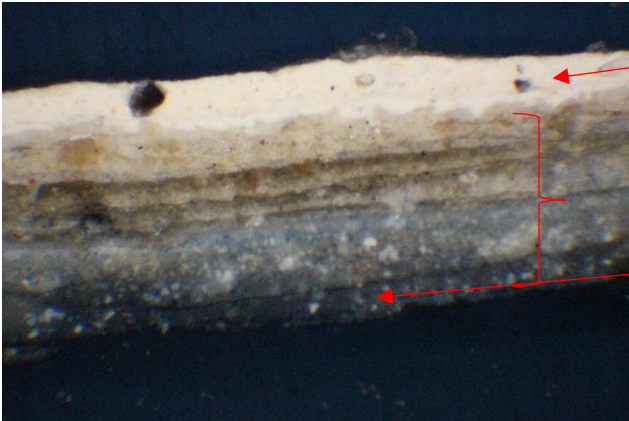
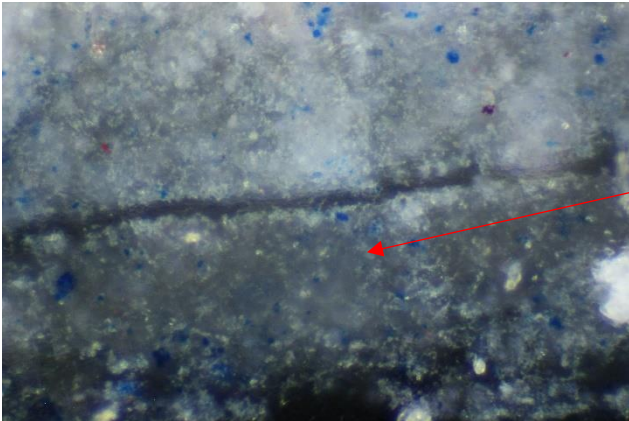
| Sample Ref: P13 – (Third Floor Ceiling Boarding) | Location: Neptune Mill |
|---|---|
| <br> | <p>100x Magnification.</p> <p>Current visible paint layer (Modern Titanium white scheme).</p> <p>(9No white and blue Lime Wash paint layers).</p> <p>Earliest paint layers.</p><br><p>Earliest paint layers 400x Magnification.</p> <p>5No Blue Lime Wash paint layers.</p> <p>Note: Lime Wash is tinted with Prussian Blue pigment.</p> |

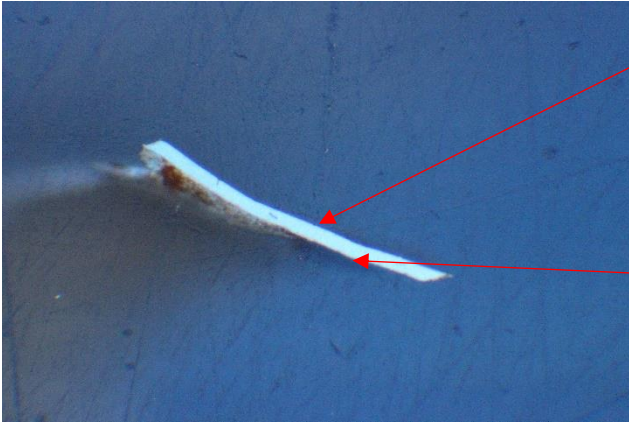
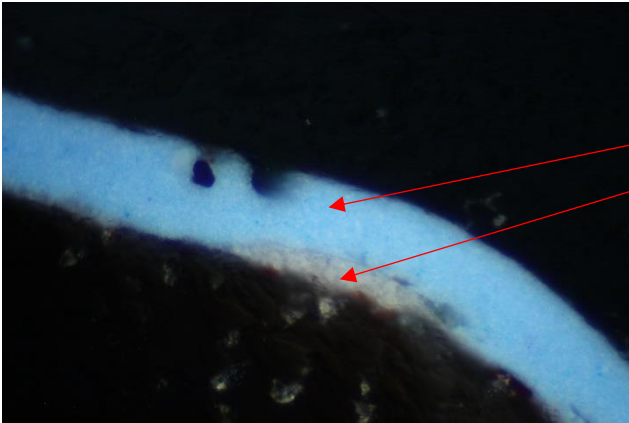
| Sample Ref: P14 – (Third Floor Lift Door) | Location: Neptune Mill |
|---|---|
| | <p>100x Magnification.</p> <p>Current visible paint layer (Fine Blue alkyd paint).</p> <p>Earliest paint layer.</p> <p>Earliest paint layers 400x Magnification.</p> <p>Modern blue alkyd paint.</p> <p>Grey undercoat / primer layer.</p> <p>Note: Current visible paint layer is the original decorative colour applied.</p> |

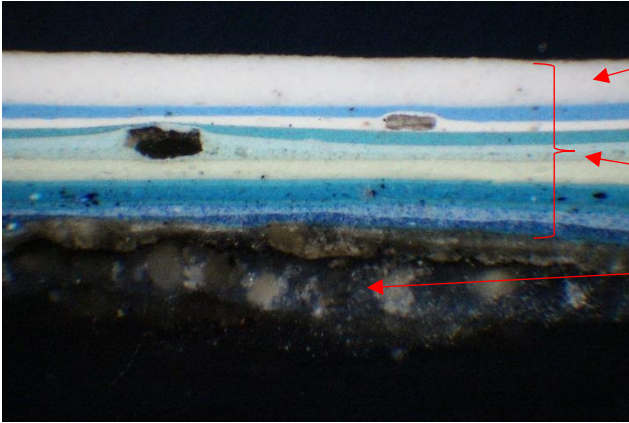
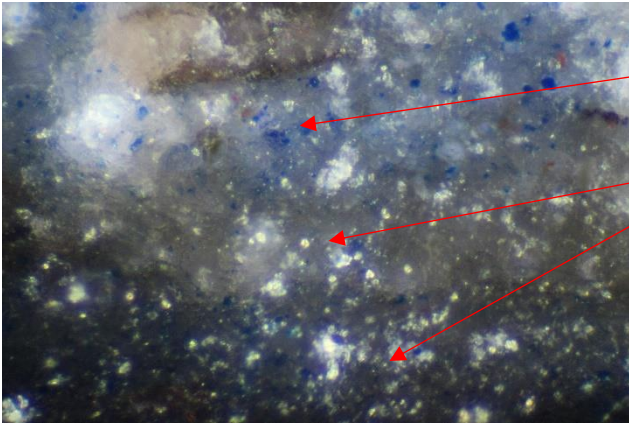
| Sample Ref: P16 – (Second Floor Wall) | Location: Neptune Mill |
|---|---|
| <br> | <p>100x Magnification.</p> <p>Current visible paint layer (Modern Titanium white scheme).</p> <p>Post WW2 paint layers.</p> <p>Earliest paint layers.</p><br><p>Earliest paint layers 400x Magnification.</p> <p>Blue Lime Wash paint layer.</p> <p>White Lime Wash paint layer</p> <p>Blue Lime Wash paint layer. (earliest decorative scheme).</p> |

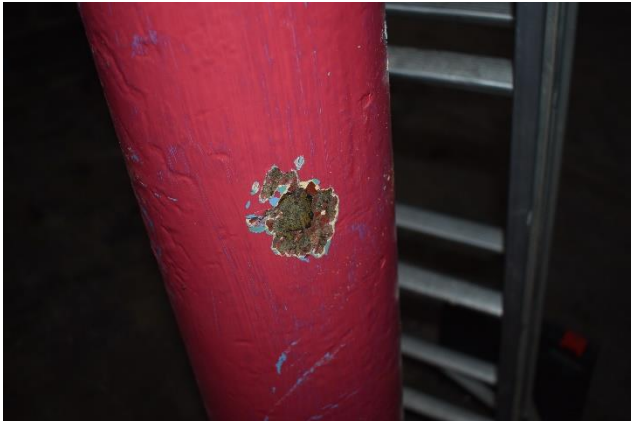
| Sample Ref: P17 – (Second Floor Column) | Location: Neptune Mill |
|---|---|
| <p>Paint sample removed from:</p> <p>Location: P17- Paint on cast iron column to second floor.</p> <p>13 No separate paint layers identified.</p> | |
| <p>Note: - Dirt on the surface of the grey paint indicates that it was a visible paint layer ie the first decorative paint scheme. However repainted on 5 separate occasions with an Iron Oxide red.</p> | <p>Earliest paint layers 400x Magnification.</p> <p>Grey oil paint with dirt on surface of paint layer.</p> <p>Carbon Black oil paint (foundry paint).</p> <p>Primer</p> |

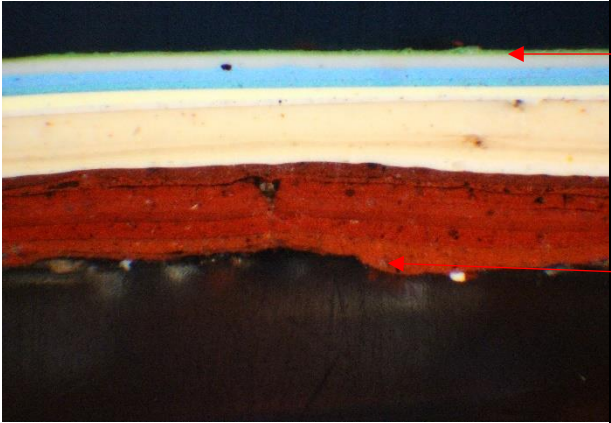
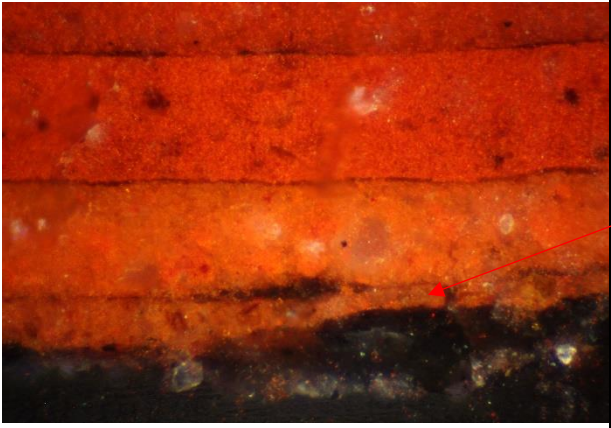
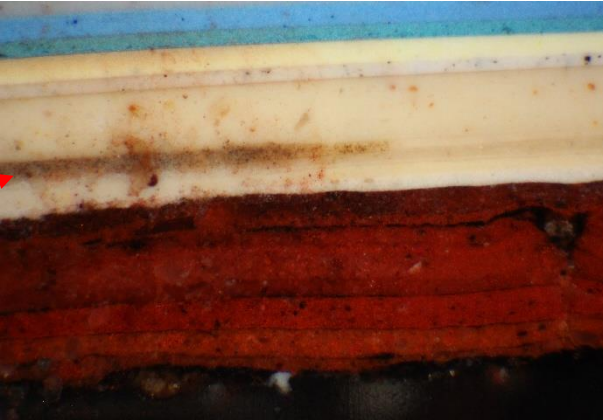
| Sample Ref: P18 – (Second Floor Column) | Location: Neptune Mill |
|---|---|
| <p>Paint sample removed from:</p> <p>Location: P18- Paint on green cast iron column to second floor.</p> <p>19 No separate paint layers identified.</p> | |

| Sample Ref: P18 – (Second Floor Column) | Location: Neptune Mill |
|---|---|
| | <p>100x Magnification.</p> <p>Current visible paint layer (Thin layer of green alkyd paint).</p> <p>(8No red iron oxide decorative schemes)</p> <p>Earliest paint layers.</p> |
| <p>Note: Indication of lead carbonate within layer 11.</p> | <p>Earliest paint layers 400x Magnification.</p> <p>8 No Red Iron Oxide oil paints</p> <p>Earliest decorative scheme.</p> |
| Yes. | Positive for single off-white paint layer. |

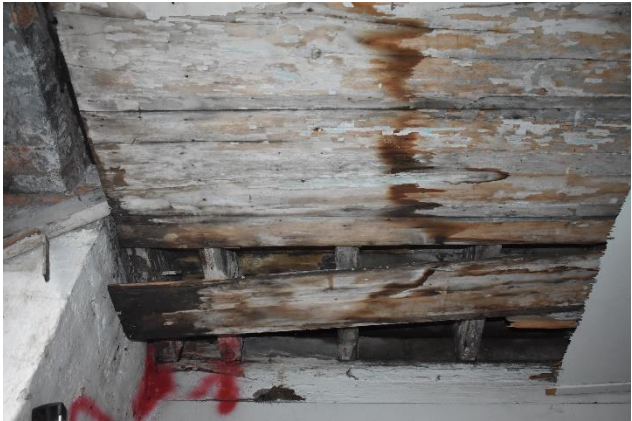
| Sample Ref: P19 – (Second Floor Ceiling Boards) | Location: Neptune Mill |
|---|---|
| <p>Paint sample removed from:</p> <p>Location: P19- Paint on ceiling boards to second floor.</p> <p>5No separate paint layers identified.</p> | |

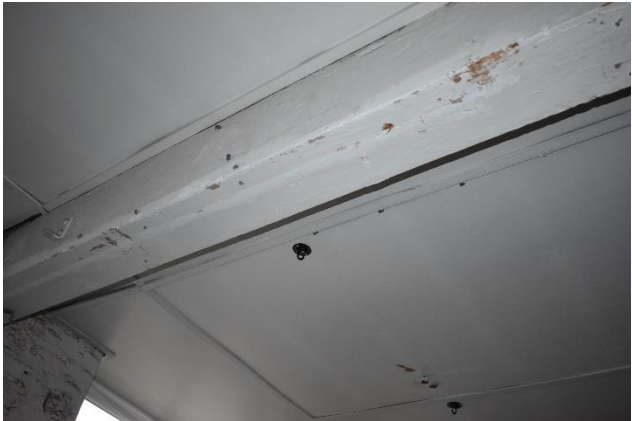
| Sample Ref: P20 – (Second Floor Timber Ceiling Beam) | Location: Neptune Mill |
|---|---|
| <p>Paint sample removed from:</p> <p>Location: P20- Paint on timber beam to second floor.</p> <p>16 No separate paint layers identified.</p> | |

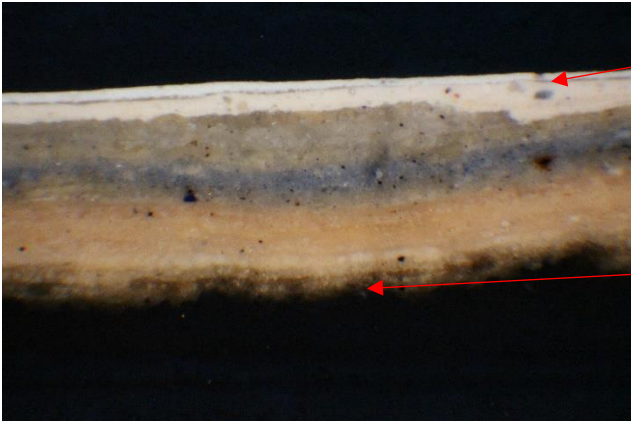
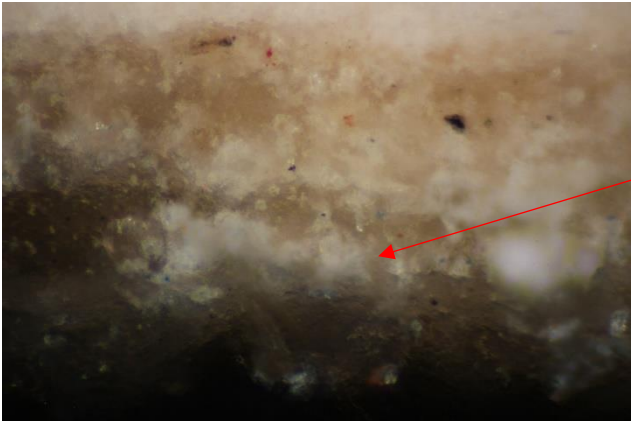
| Sample Ref: P20 – (Second Floor Timber Ceiling Beam) | Location: Neptune Mill |
|---|---|
| <br> | <p>100x Magnification.</p> <p>Current visible paint layer (Modern Titanium white scheme).</p> <p>(2No blue Lime Wash paint layers)<br/>(9No white Lime Wash paint layers).</p> <p>Earliest paint layers.</p><br><p>Earliest paint layers 400x Magnification.</p> <p>9x White Lime Wash paint layers.</p> <p>Earliest decorative scheme – white Lime Wash.</p> |

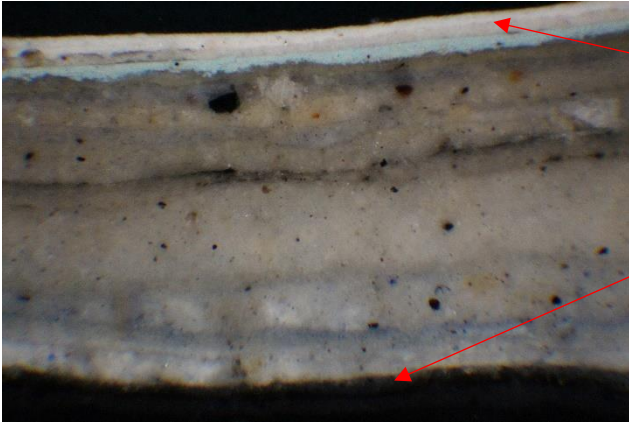
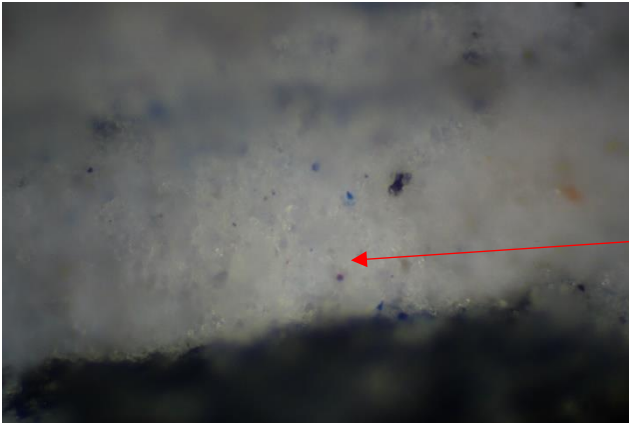
| Sample Ref: P22 – (Ground Floor Wall) | Location: Neptune Mill |
|---|---|
| <br> | <p>100x Magnification.</p> <p>Current visible paint layer (Modern Titanium white scheme).</p> <p>(12 layers of white and blue Lime Wash).</p> <p>Earliest paint layers.</p><br><p>Earliest paint layers 400x Magnification.</p> <p>2 No white Lime Wash paint layers. (earliest decorative scheme).</p> <p>Note: The white Lime Wash is lightly tinted with Prussian Blue to a bright white colour.</p> |

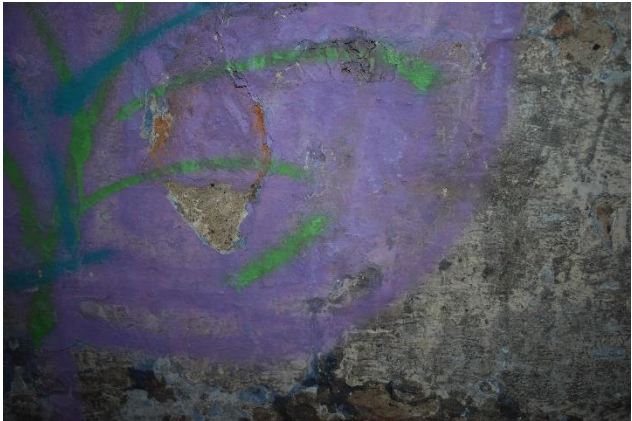
| Sample Ref: P23 – (Ground Floor External Wall) | Location: Neptune Mill |
|---|---|
| <p>Paint sample removed from:</p> <p>Location: P23- Paint on exterior wall to ground floor covered area.</p> <p>25 No separate paint layers identified.</p> | |

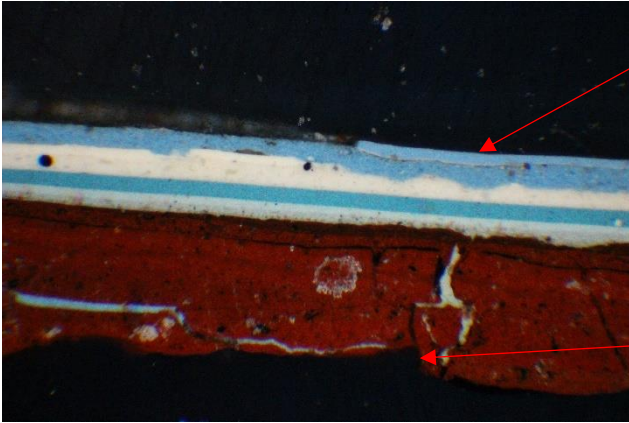
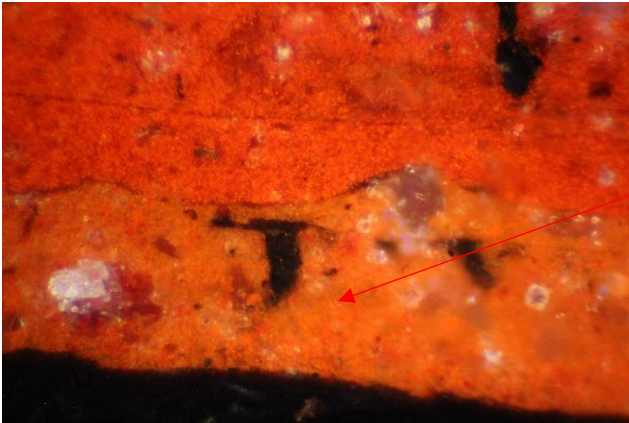
| Sample Ref: P24 – (Ground Floor Column) | Location: Neptune Mill |
|---|---|
| <br> | <p>100x Magnification.</p> <p>Current visible paint layer (Modern blue alkyd paint).</p> <p>(5No modern post WW2 blue / Titanium white paint layers)</p> <p>(5No red iron oxide oil paint layers).</p> <p>Earliest paint layer.</p><br><p>Earliest paint layers 400x Magnification.</p> <p>Red iron oxide oil paint (earliest decorative scheme).</p> |

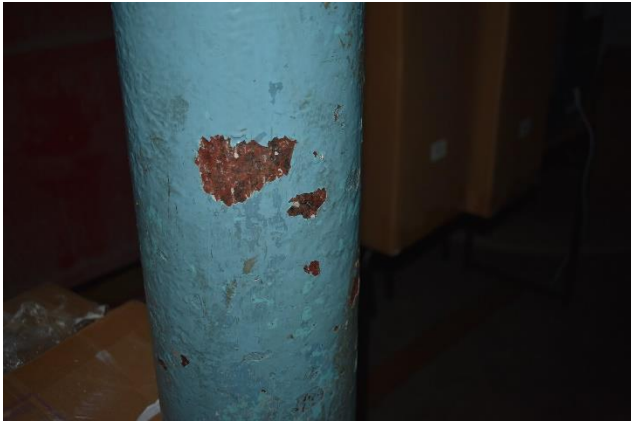
| Sample Ref: P25 – (Ground Floor Blue Column ) | Location: Neptune Mill |
|---|---|
| <p>Paint sample removed from:</p> <p>Location: P25- Plaster on blue cast iron column to ground floor.</p> <p>16 No separate paint layers identified.</p> | |

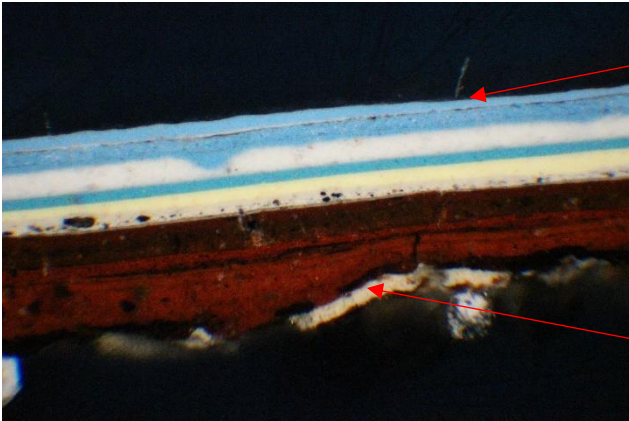
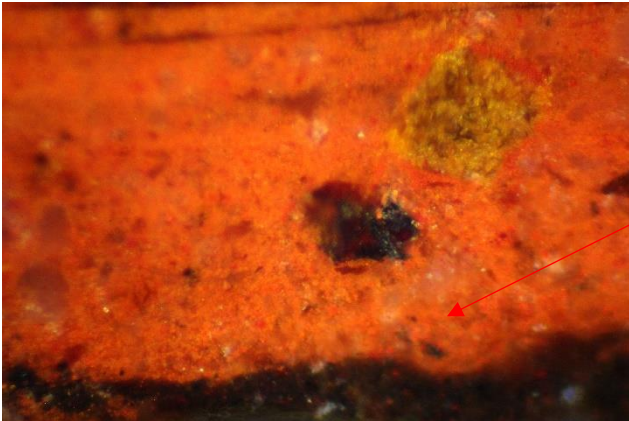
| Sample Ref: P25 – (Ground Floor Blue Column ) | Location: Neptune Mill |
|---|---|
| <br> | <p>100x Magnification.</p> <p>Current visible paint layer (Modern blue alkyd paint).</p> <p>(9 No modern post WW2 blue / white and single yellow paint layers).</p> <p>(7 No red iron oxide oil paint layers).</p> <p>Earliest paint layer.</p><br><p>Earliest paint layers 400x Magnification.</p> <p>Red iron oxide oil paint. (Earliest decorative scheme).</p> |

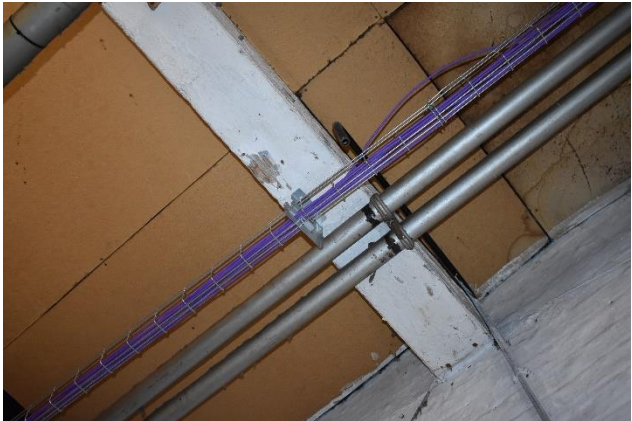
| Sample Ref: P26 – (Ground Floor Ceiling Beam) | Location: Neptune Mill |
|---|---|
| <p>Paint sample removed from:</p> <p>Location: P26- Paint on ceiling beam to ground floor.</p> <p>25 No separate paint layers identified.</p> | |

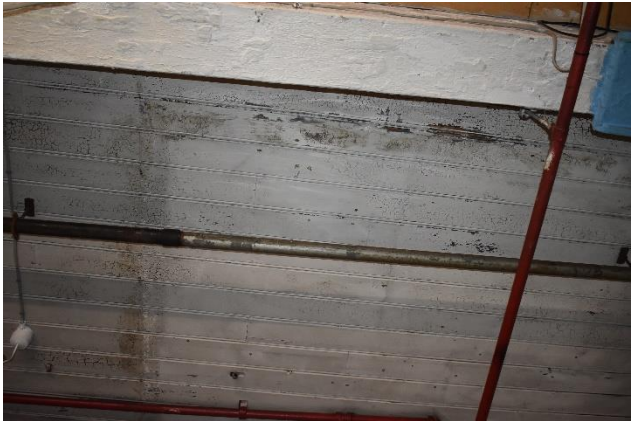
| Sample Ref: P27 – (Ground Floor Ceiling Boarding) | Location: Neptune Mill |
|---|---|
| <p>Paint sample removed from:</p> <p>Location: P27- Paint on ceiling boarding to ground floor.</p> <p>3No separate paint layers identified.</p> | |

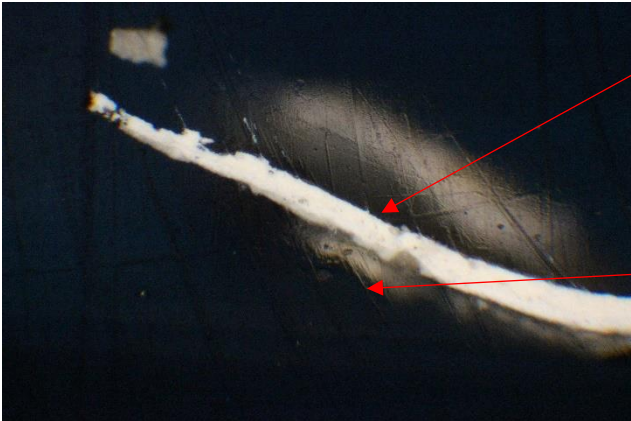
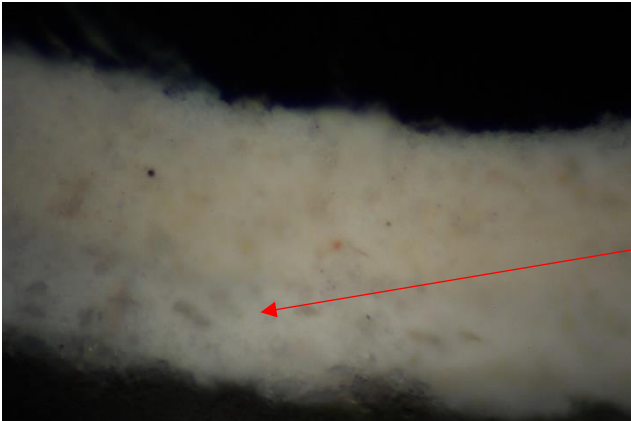
| Sample Ref: P27 – (Ground Floor Ceiling Boarding) | Location: Neptune Mill |
|---|---|
| | <p>100x Magnification.<br/>Current visible paint layer (Modern Titanium white alkyd paint)</p> <p>Earliest paint layer.</p> <p>Earliest paint layers 400x Magnification.</p> <p>Modern Titanium white paint scheme.</p> <p>Note: Boards are not original to the Mill construction – only 3No modern paint layers present.</p> |

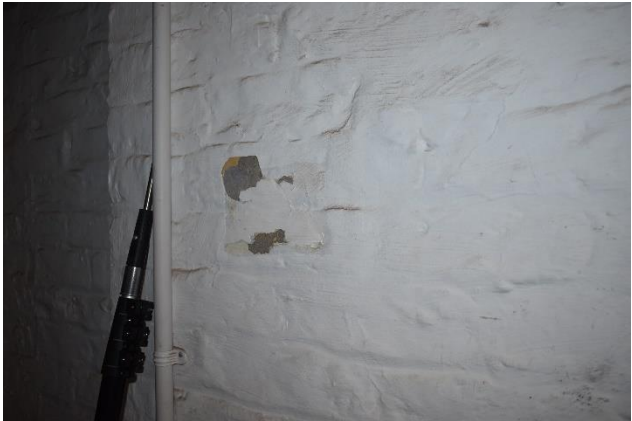
| Sample Ref: P31 – (First Floor Stairway Wall) | Location: Neptune Mill |
|---|---|
| <p>Paint sample removed from:</p> <p>Location: P31- Paint on brick stairway wall to first floor.</p> <p>9No separate paint layers identified.</p> | |

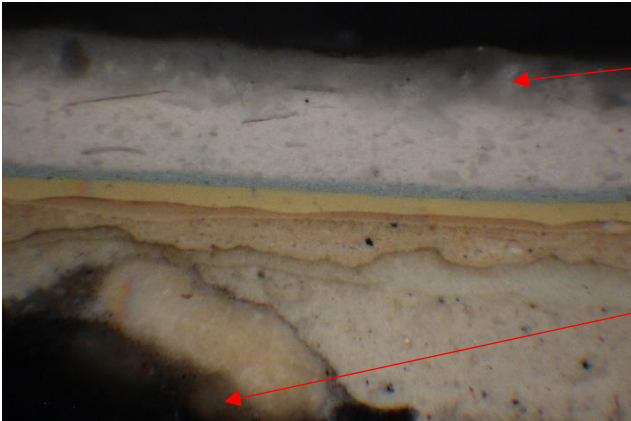
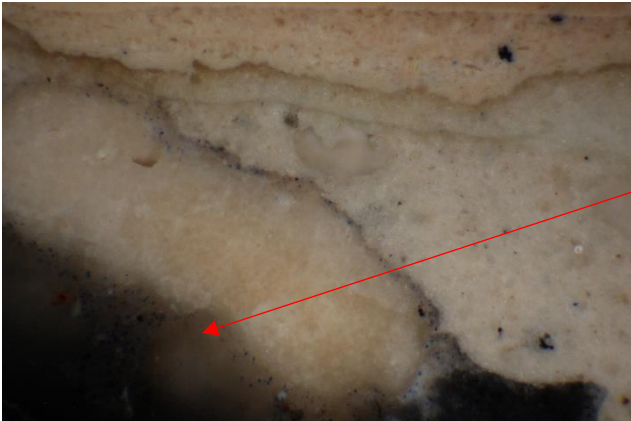
| Sample Ref: P31 – (First Floor Stairway Wall) | Location: Neptune Mill |
|---|---|
| <br> | <p>100x Magnification.</p> <p>Current visible paint layer (Modern Titanium white scheme).</p> <p>(Single blue and yellow paint layers).</p> <p>(6No off-white and white paint layers).</p> <p>Earliest paint layer.</p><br><p>Earliest paint layers 400x Magnification.</p> <p>White Lime wash paint layer (tinted with a small amount of Prussian Blue pigment).</p> <p>Earliest decorative layer.</p> |
| Yes. | No lead-based paints present. |

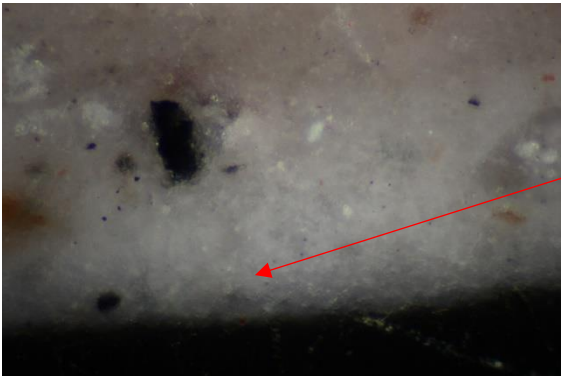
| Sample Ref: P32 – (First Floor Brick Wall) | Location: Neptune Mill |
|---|---|
| | <p>100x Magnification.</p> <p>Current visible paint layer (Modern Titanium white scheme).</p> <p>(3No modern schemes base don Titanium white).</p> <p>(7No white decorative schemes).</p> <p>(8No blue Lime Wash paint layers)</p> <p>(12No white Lime Wash paint layers)</p> <p>Earliest paint layer.</p> <p>Earliest paint layers 400x Magnification.</p> <p>White Lime Wash paint layer – earliest decorative scheme.</p> |
| Yes. | No lead-based paints present. |

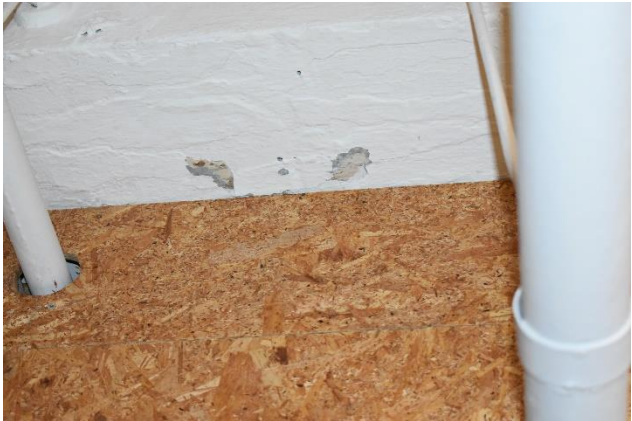
| Sample Ref: P33 – (First Floor Ceiling Beam) | Location: Neptune Mill |
|---|---|
| <p>Paint sample removed from:</p> <p>Location: P33- Paint on ceiling beam to first floor.</p> <p>20 No total paint layers identified.</p> | |

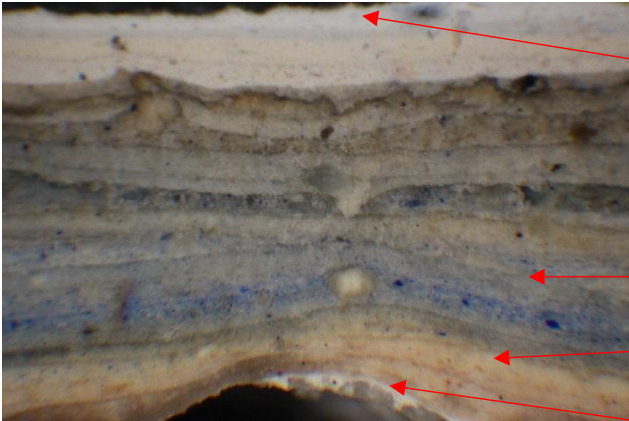
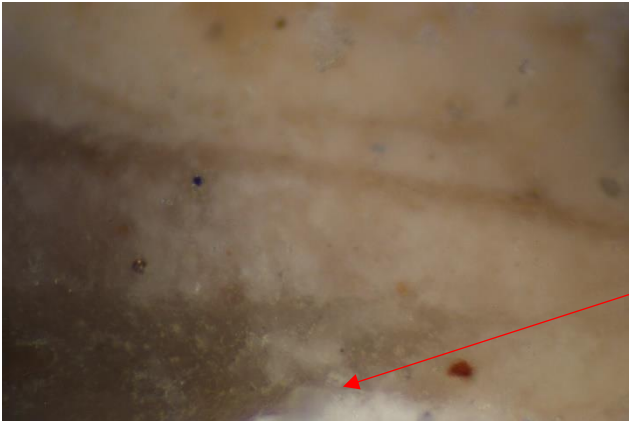
| Sample Ref: P33 – (First Floor Ceiling Beam) | Location: Neptune Mill |
|---|---|
| <br> | <p>100x Magnification.<br/>Current visible paint layer (Modern Titanium white scheme).</p> <p>(4No blue Lime Wash paint layers).</p> <p>(4No white Lime Wash paint layers)</p> <p>Earliest paint layer.</p><br><p>Earliest paint layers 400x Magnification.</p> <p>White Lime Wash paint layer. (earliest decorative scheme).</p> |
| Yes. | No lead-based paints present. |

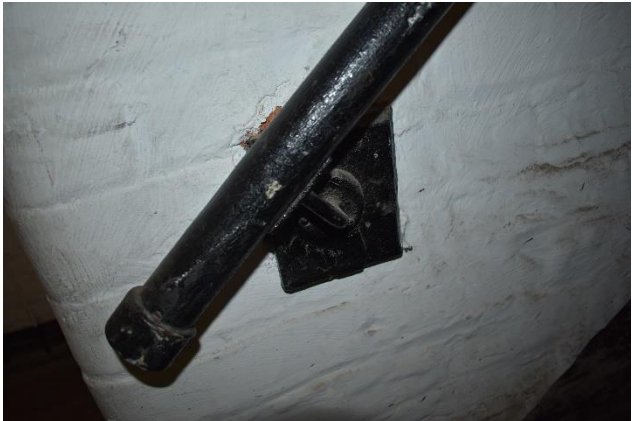
| Sample Ref: P35 – (First Floor Joinery) | Location: Neptune Mill |
|---|---|
| <p>Paint sample removed from:</p> <p>Location: P35- Timber handrail bracket to stairway of first floor.</p> <p>9 No separate paint layers identified.</p> | |

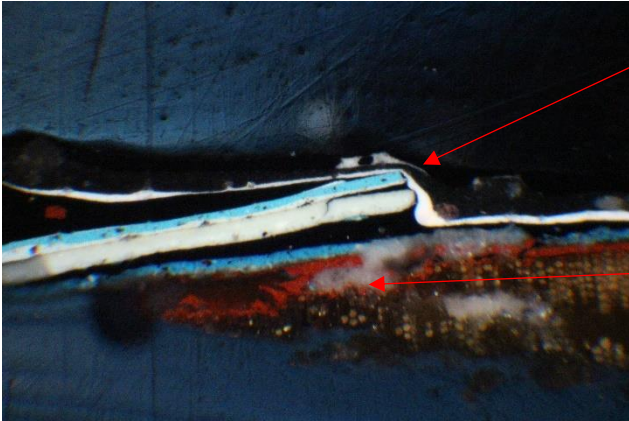
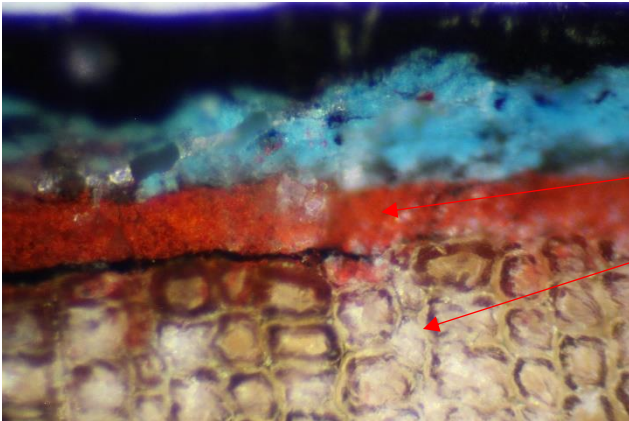
| Sample Ref: P35 – (First Floor Joinery) | Location: Neptune Mill |
|---|---|
| <br> | <p>100x Magnification.</p> <p>Current visible paint layer (Black alkyd paint).</p><br><p>Earliest paint layer.</p><br><p>Earliest paint layers 400x Magnification.</p> <p>Black alkyd paint</p> <p>Red iron oxide oil paint (earliest decorative layer).</p> <p>Timber of bracket.</p> |
| Yes. | No lead-based paints present. |

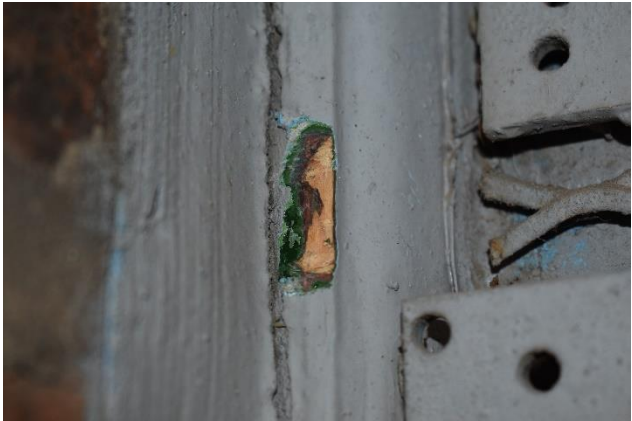
| Sample Ref: P36 – (First Floor Outside Door Frame) | Location: Neptune Mill |
|---|---|
| <p>Paint sample removed from:</p> <p>Location: P36- Paint on outside door frame to first floor.</p> <p>19 No separate paint layers identified.</p> | |

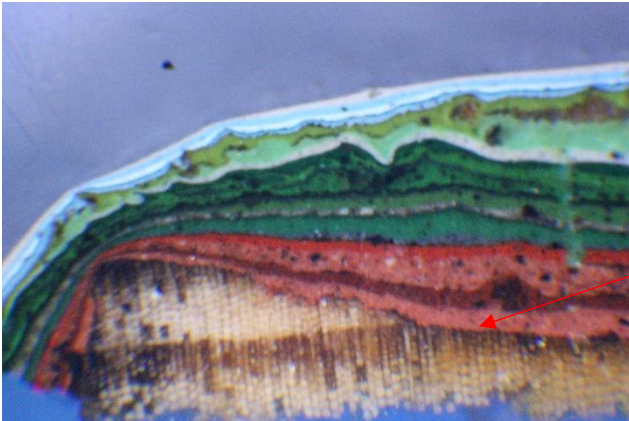
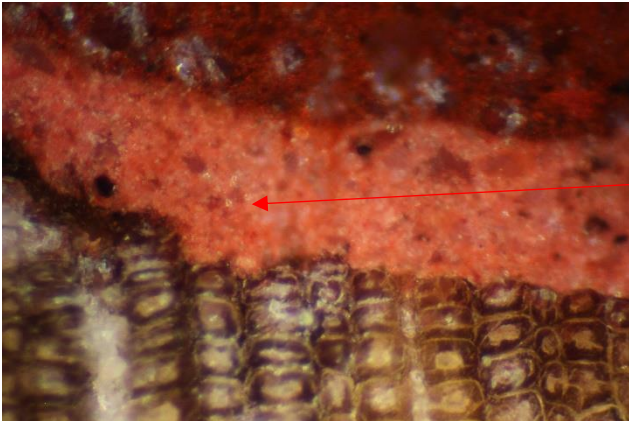
| Sample Ref: P36 – (First Floor Outside Door Frame) | Location: Neptune Mill |
|---|---|
| <br> | <p>100x Magnification.</p> <p>Current visible paint layer (Thin layer of grey alkyd paint).</p> <p>(7 No separate green paint schemes).</p> <p>(4No iron oxide red paint schemes).</p> <p>Earliest paint layer.</p><br><p>Earliest paint layers 400x Magnification.</p> <p>Red iron oxide oil paint (earliest decorative scheme).</p> <p>Timber of joinery</p> |
| Yes. | No lead-based paint present. |
