# DRAINAGE SURVEY

Job Number  
**LAYERSERV0001859**

Brunswick Mill,  
Bradford Road,  
Manchester,  
M40 7EZ

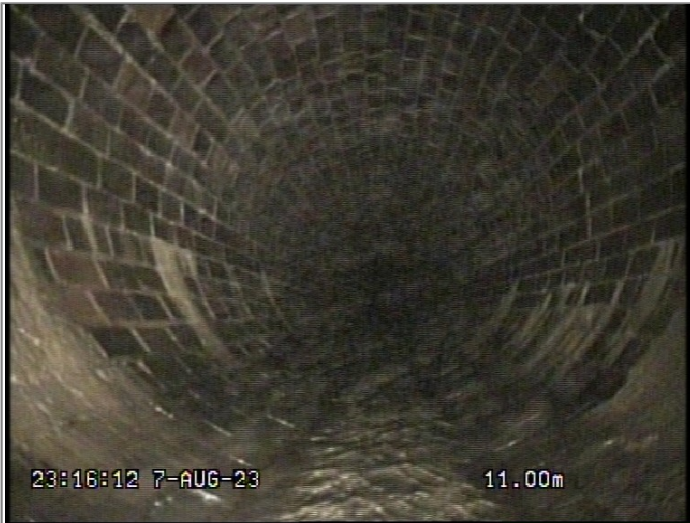
Start node type, manhole, reference 7600

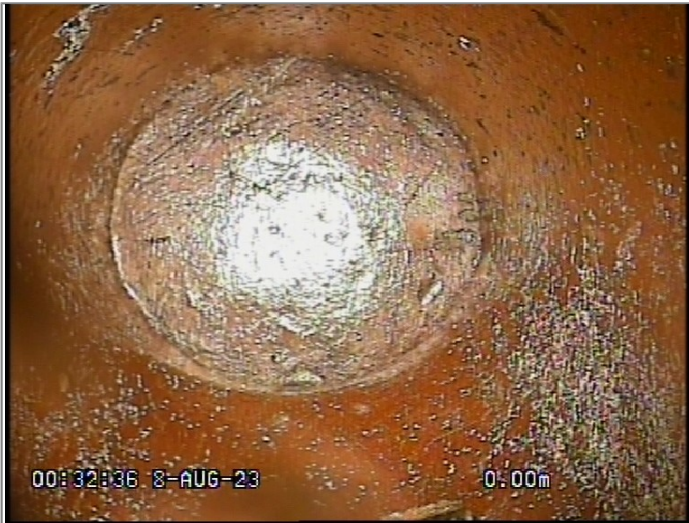
Start node type, manhole, reference 6602

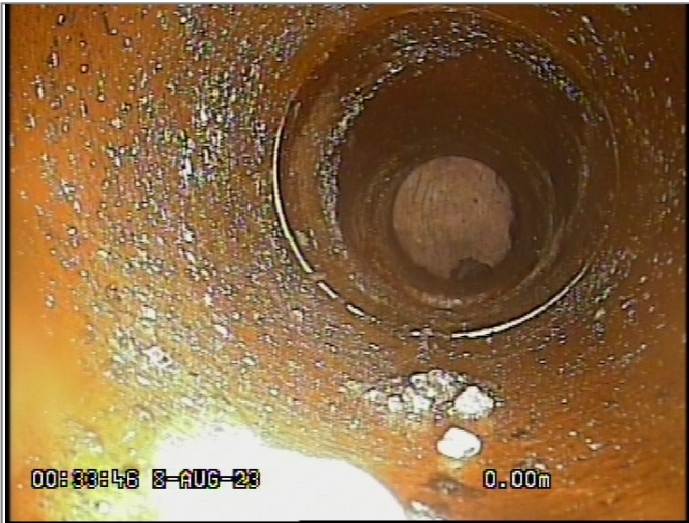
Start node type, manhole, reference 6602

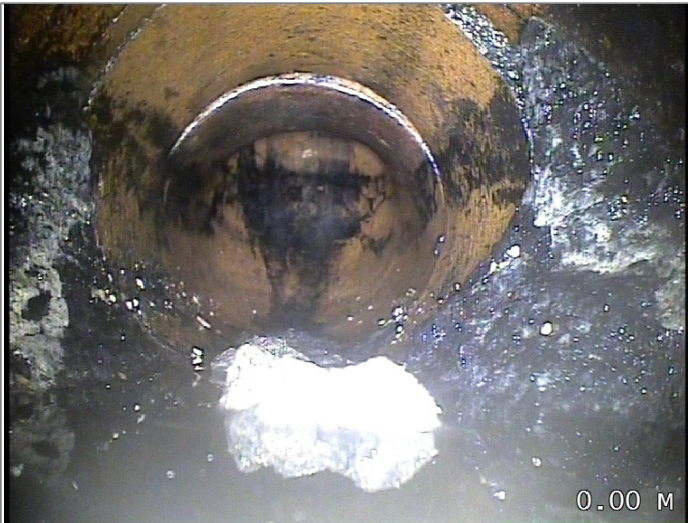
Start node type, manhole, reference MH1

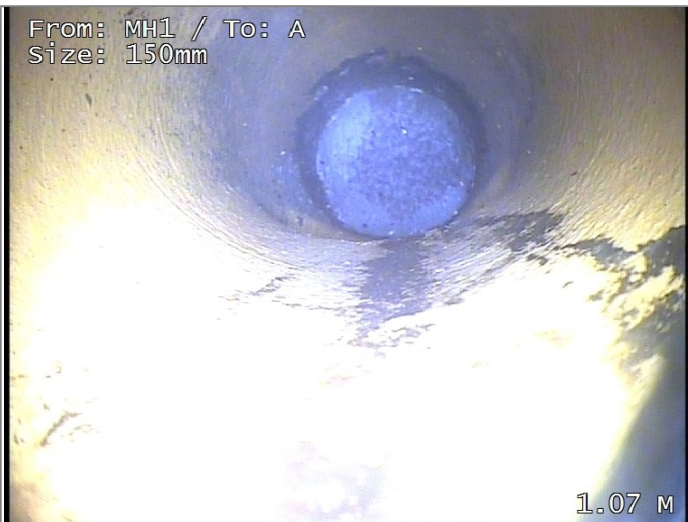
Line of drain/sewer deviates up

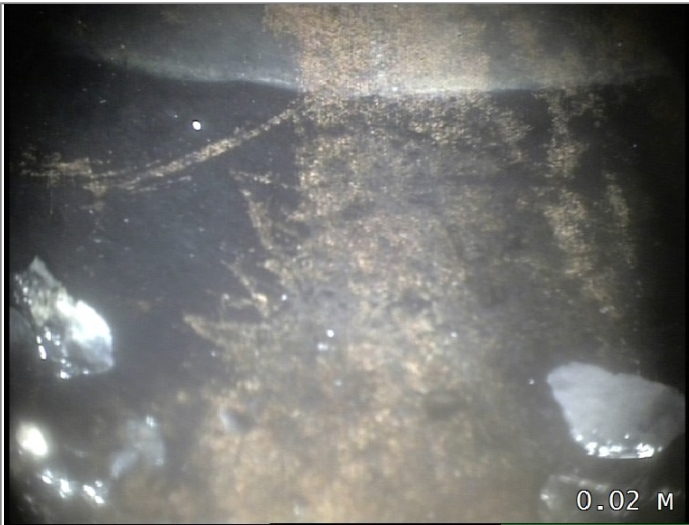
Start node type, manhole, reference MH1

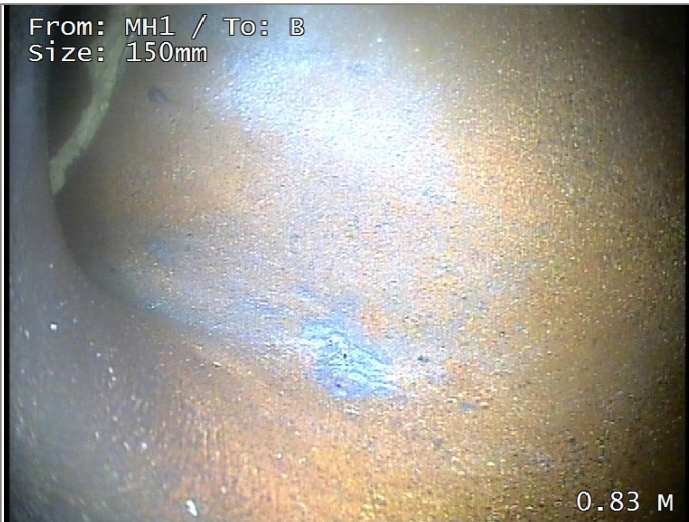
Line of drain/sewer deviates up

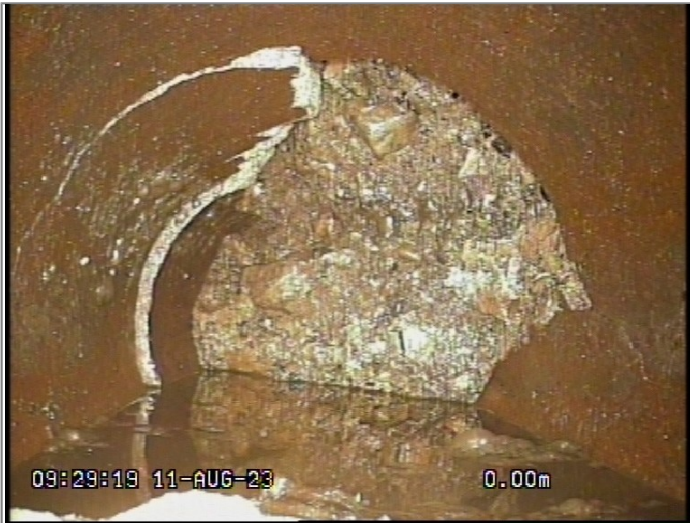
Start node type, manhole, reference MH3

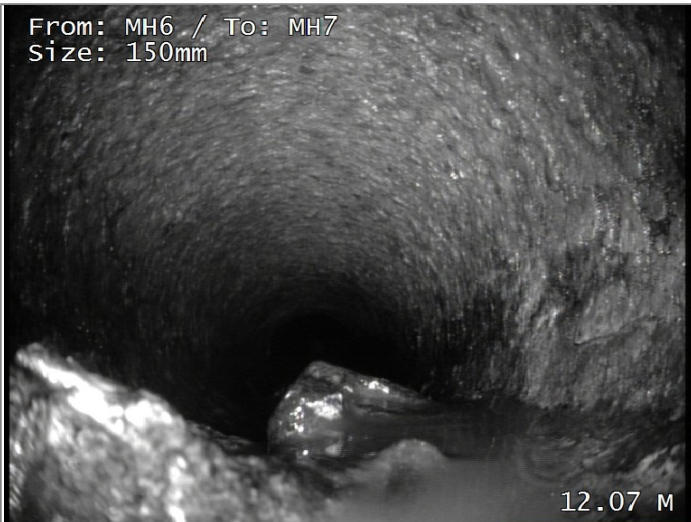
| Position | Code | Description | Photo | Type/Grade |
|---|---|---|---|---|
| 12.10 | DER | Settled deposits coarse 25% cross-sectional area loss | 8337929 | Service / 4 |

Settled deposits coarse 25% cross-sectional area loss

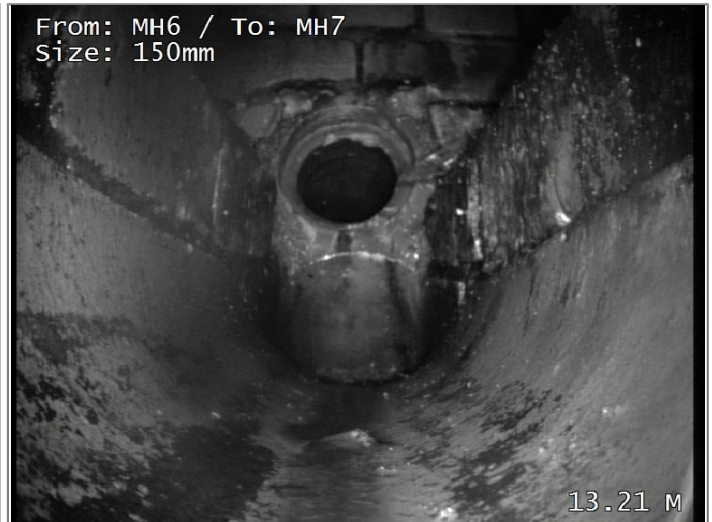
Finish node type, manhole, reference MH7

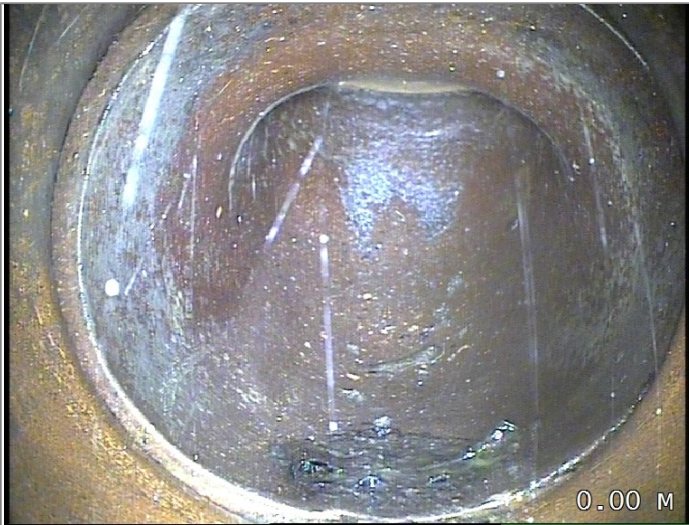
Start node type, manhole, reference MH6

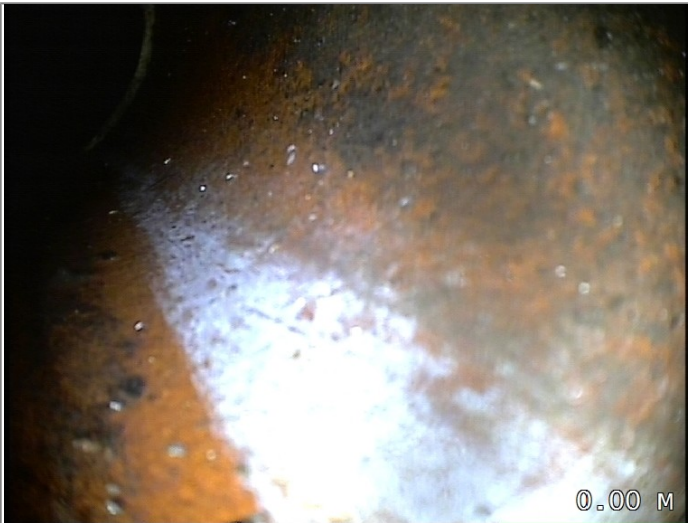
Start node type, manhole, reference MH6

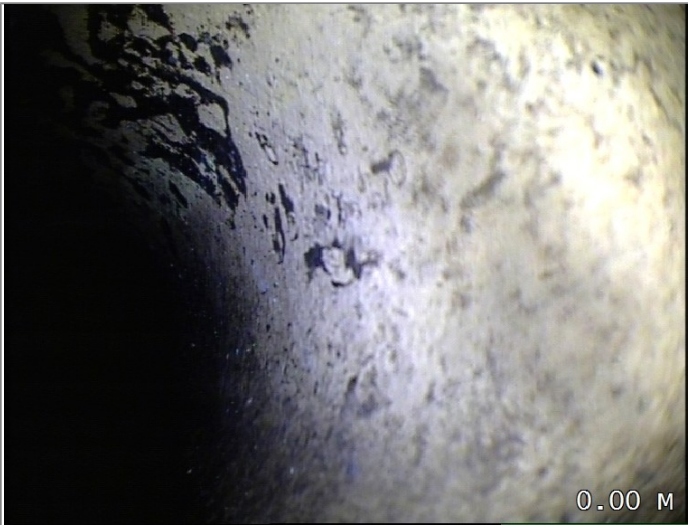
Start node type, manhole, reference MH6
