## Phase I GeoEnvironmental Desk Study

Bury Old Road

Cheetham Hill

**Report No. A5545/23/FDS**

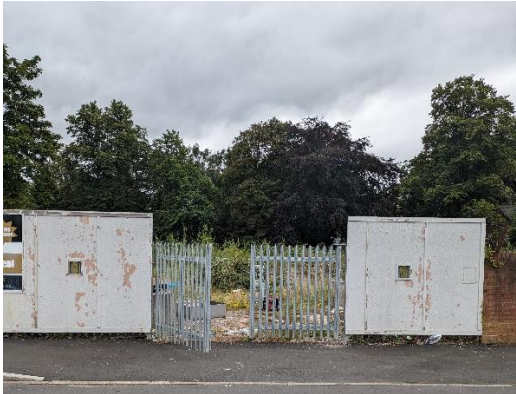
| <p><b>Plate 1 View of northern access to the site.</b></p> | <p><b>Plate 2 View of Catherine Road street sign located northwest to the site.</b></p> |

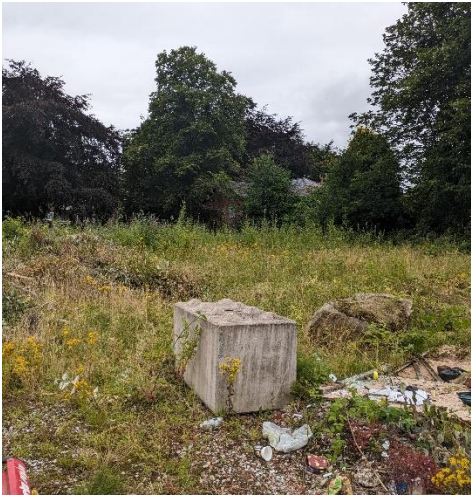
| <p><b>Plate 3 Overview of the site from the northern area.</b></p> | <p><b>Plate 4 Area of fly tipped material in the northern area of the site.</b></p> |

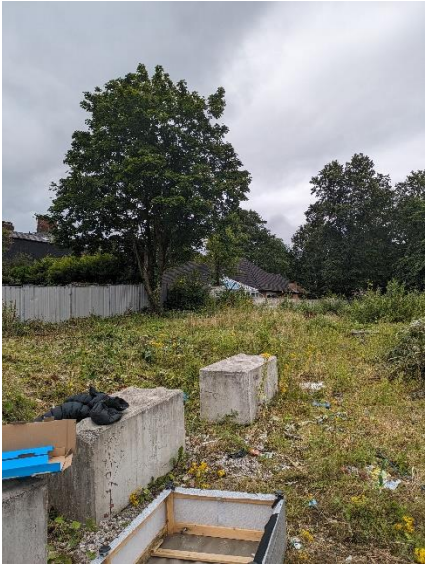
| <p><b>Plate 5 Fly tipped material and plant cuttings in the northern area of the site.</b></p> | <p><b>Plate 6 Overview of eastern area of the site from the northern access.</b></p> |

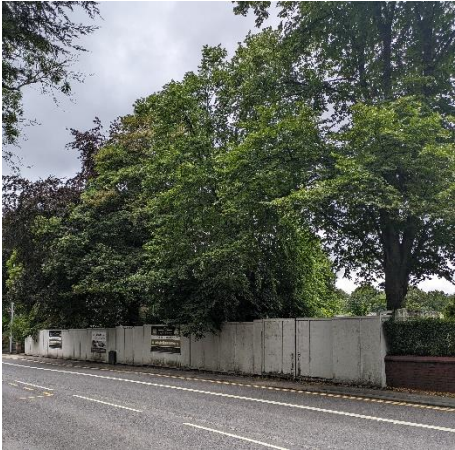
| <p><b>Plate 9 Southern border of the site taken from Bury Old Road.</b></p> | <p><b>Plate 10 Overview of southwestern access gate.</b></p> |

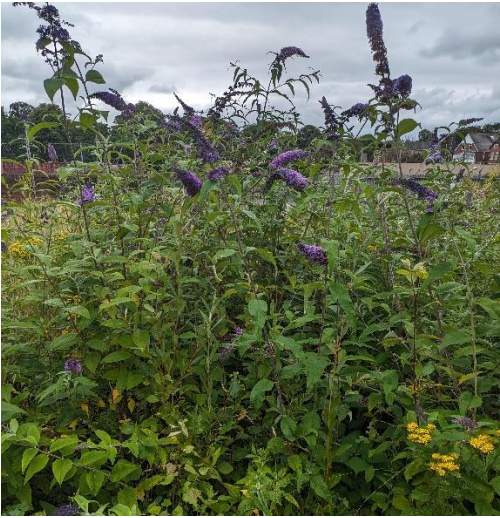
| <p><b>Plate 11 Overview of vegetation in central area of site.</b></p> | <p><b>Plate 12 Overview of northern border from the eastern area of the site.</b></p> |
