# ASBESTOS DEMOLITION SURVEY

LOCATION: Cheetham Hill Site, Herbert Street, Manchester M8 0DG

SURVEYED ON: 3 Jan 2024

OUR REF: PR12298

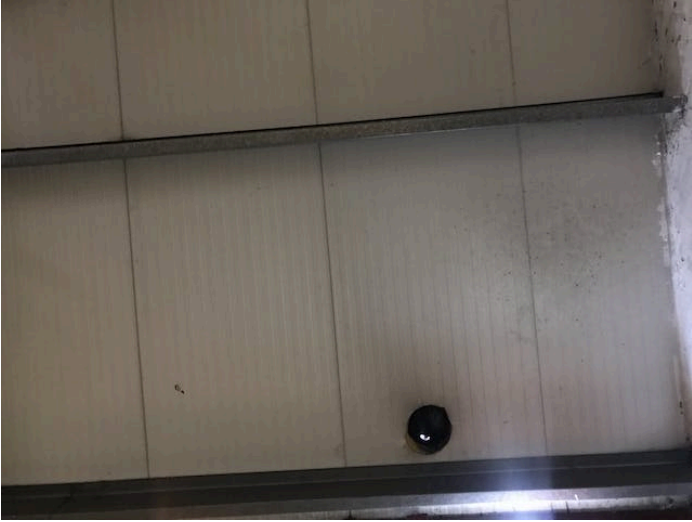
| Location | 001 - Unit 1 | Item | Ceiling |

| Material | Metal roof sheeting with foam insulation | Extent | |

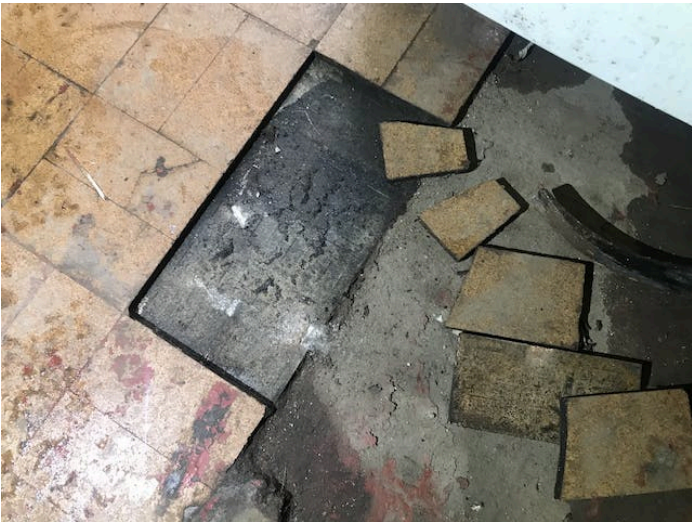
| Location | 001 - Unit 1 | Item | Floor |

| Material | Screed to ceramic tiles to concrete floor | Extent | |

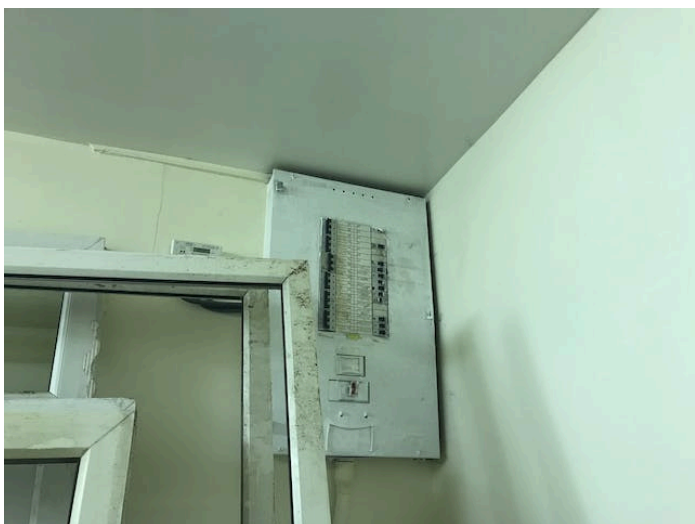
| <b>Location</b> | 001 - Unit 1 | <b>Item</b> | Other |

| <b>Material</b> | 2x modern fuse box | <b>Extent</b> | |

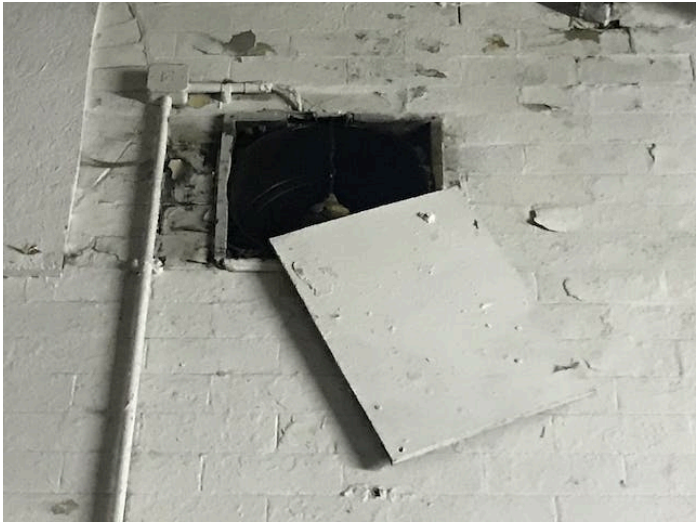
| Location | 001 - Unit 1 | Item | Wall |

| Material | Wood panel to old upvc extractor unit | Extent | |

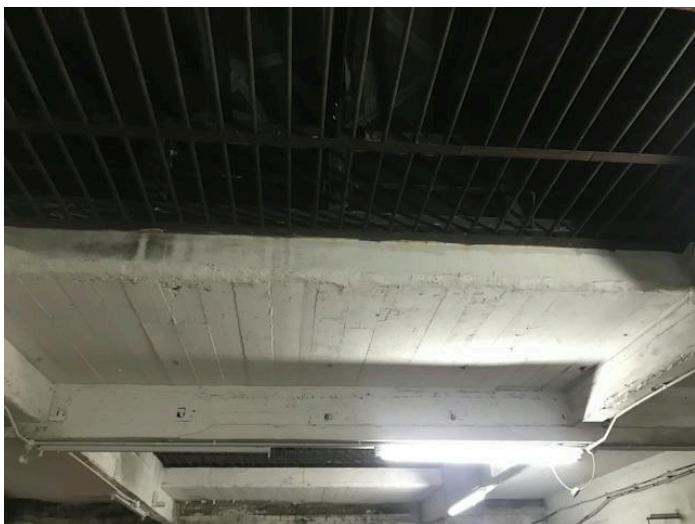
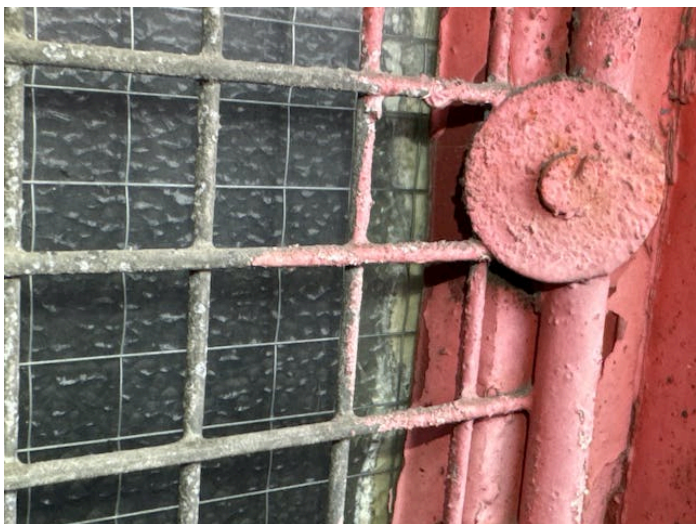
| Location | 003 - Unit 2 Room 2 | Item | Other |

| Material | Putty to skylights, access made from roof | Extent | 16M <sup>2</sup> |
| Strategy / Sample Id | Strongly Presume / RS04 | Presumed Fibre Type | NAD |

| Recommendation | No further action required | | |

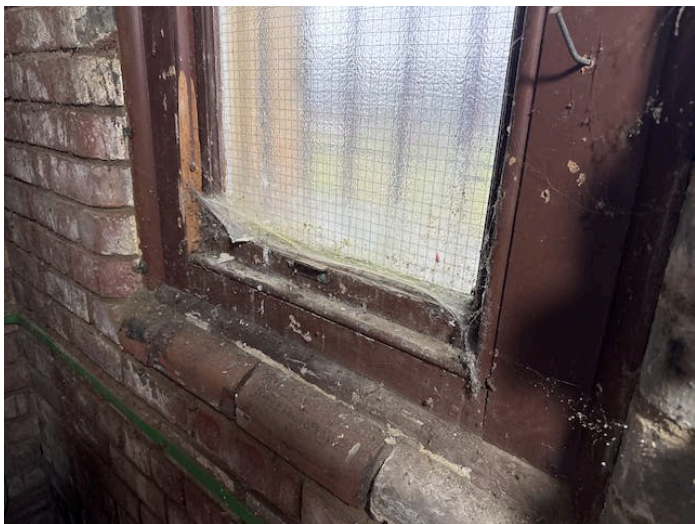
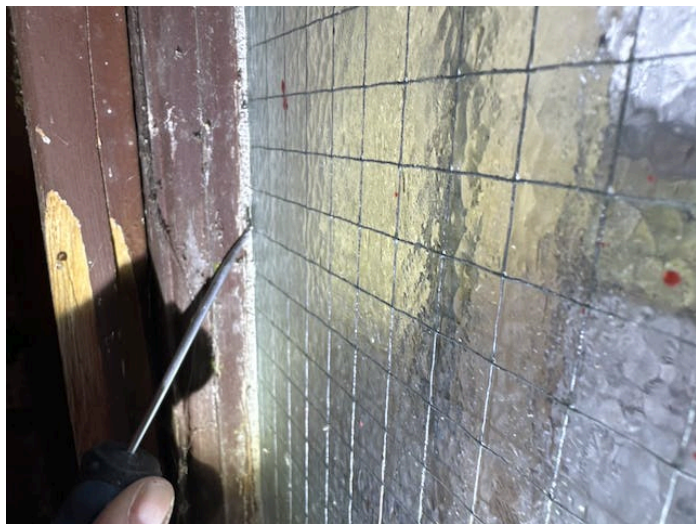
| Location | 005 - Unit 3 Electric store | Item | Other |

| Material | Putty to old window frame | Extent | 1M <sup>2</sup> |
| Strategy / Sample Id | Strongly Presume / RS04 | Presumed Fibre Type | NAD |

| Recommendation | No further action required | | |

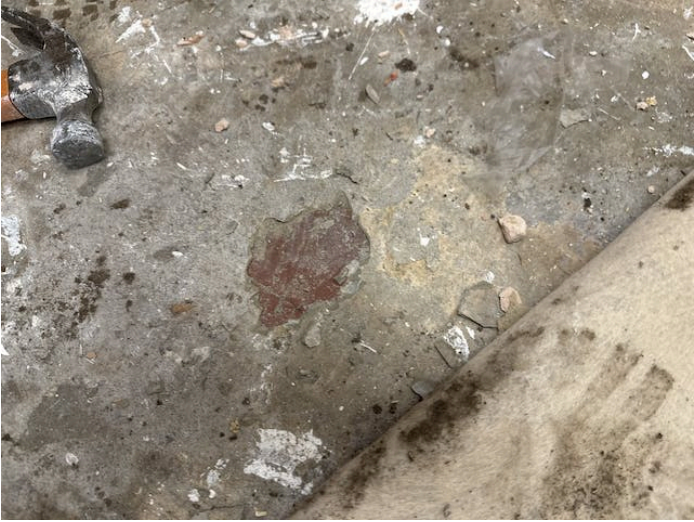
| Location | 006 - Unit 3 room 1 | Item | Floor |

| Material | Carpet to screed to red ceramic tiles | Extent | |

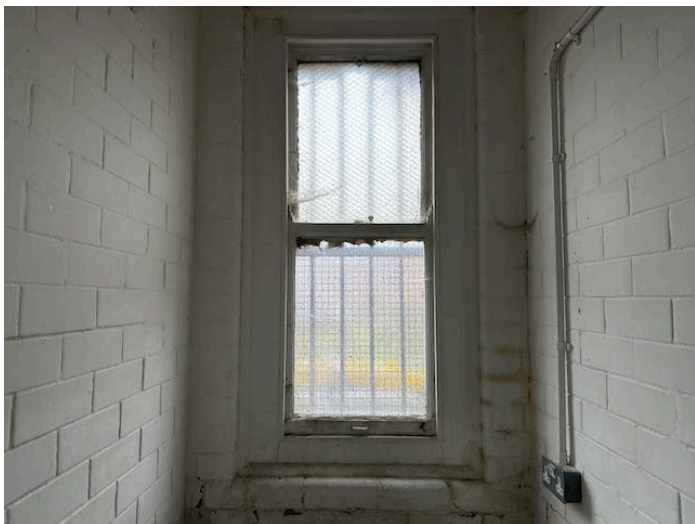
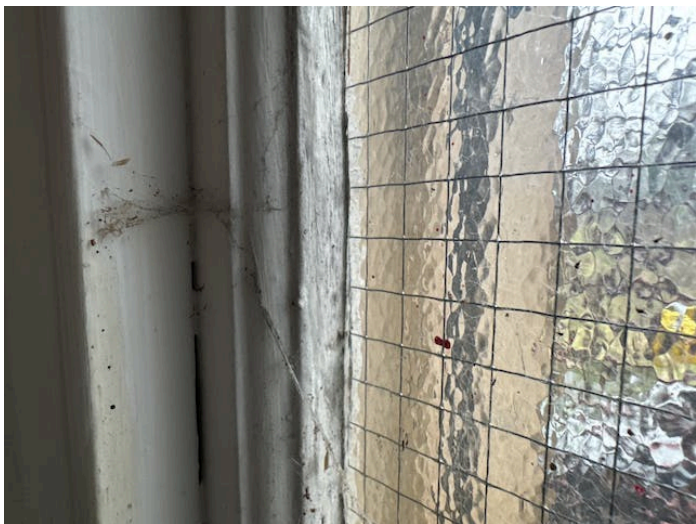
| <b>Location</b> | 007 - Unit 3 room 2 | <b>Item</b> | Other |

| <b>Material</b> | Putty to window | <b>Extent</b> | 1M <sup>2</sup> |
| <b>Strategy / Sample Id</b> | Strongly Presume / RS04 | <b>Presumed Fibre Type</b> | NAD |

| <b>Recommendation</b> | No further action required | | |

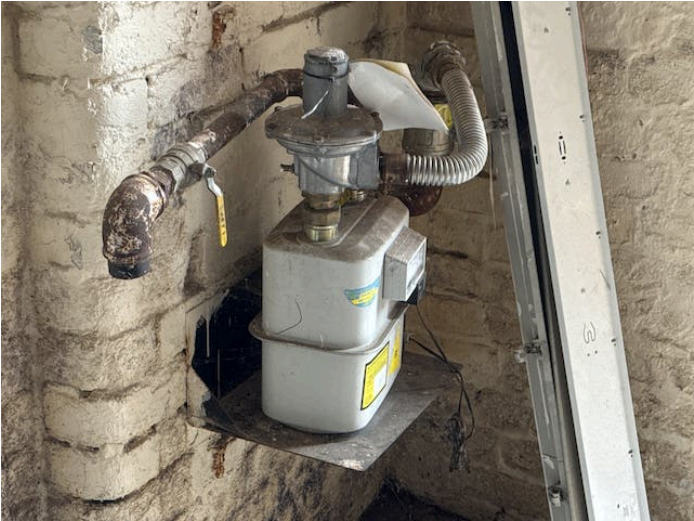
| Location | 008 - Unit 4 | Item | Other |

| Material | Gas meter | Extent | |

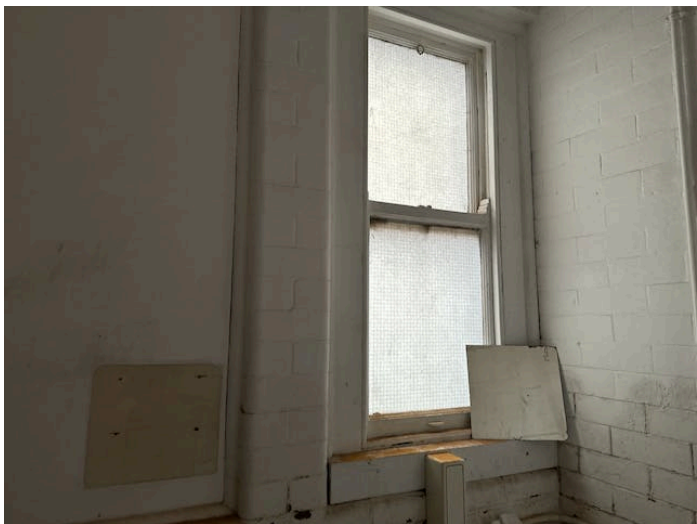
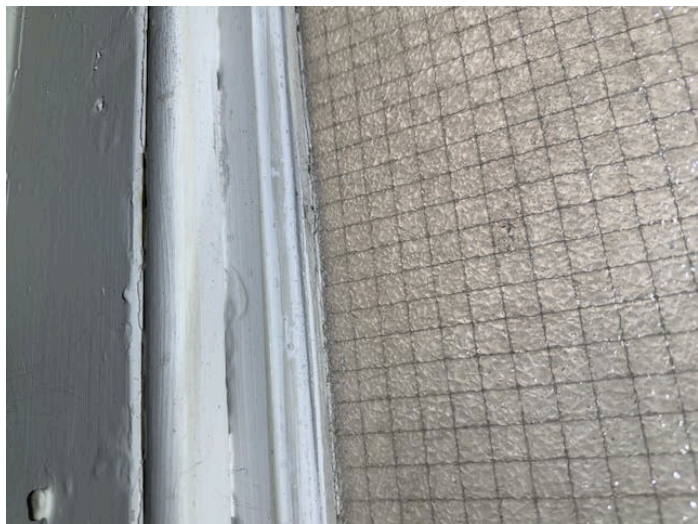
| Location | 009 - Unit 4 Toilet | Item | Other |

| Material | Putty to window | Extent | 1M <sup>2</sup> |
| Strategy / Sample Id | Strongly Presume / RS04 | Presumed Fibre Type | NAD |

| Recommendation | No further action required | | |

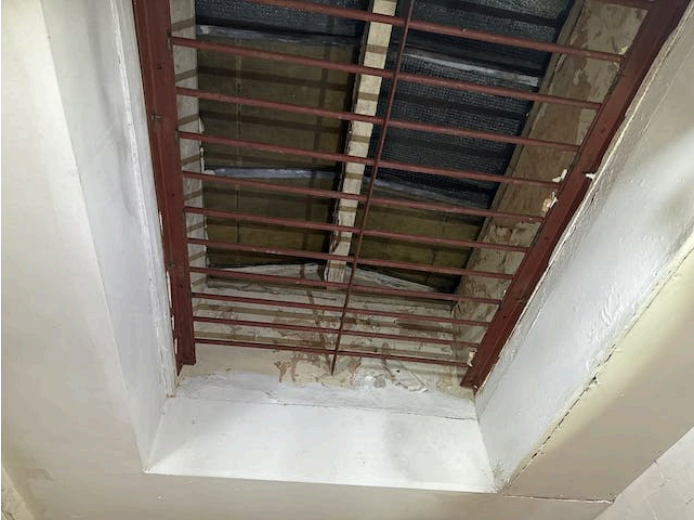
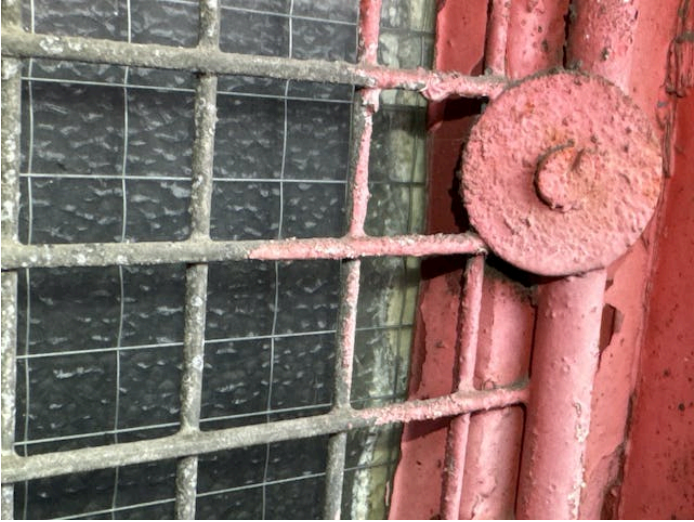
| Location | 010 - Unit 3 landing | Item | Other |

| Material | Putty to skylights, access made from roof | Extent | 4M <sup>2</sup> |
| Strategy / Sample Id | Strongly Presume / RS04 | Presumed Fibre Type | NAD |

| Recommendation | No further action required | | |

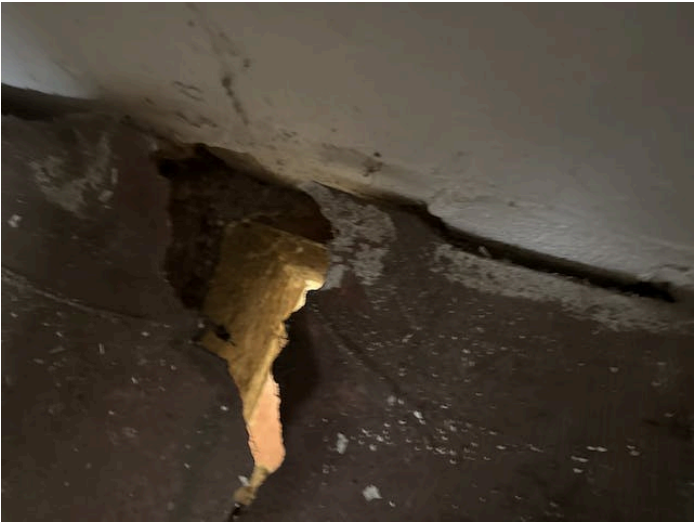
| Location | 011 - Unit 3 Kitchen | Item | Floor |

| Material | Modern floor covering to screed to concrete | Extent | |

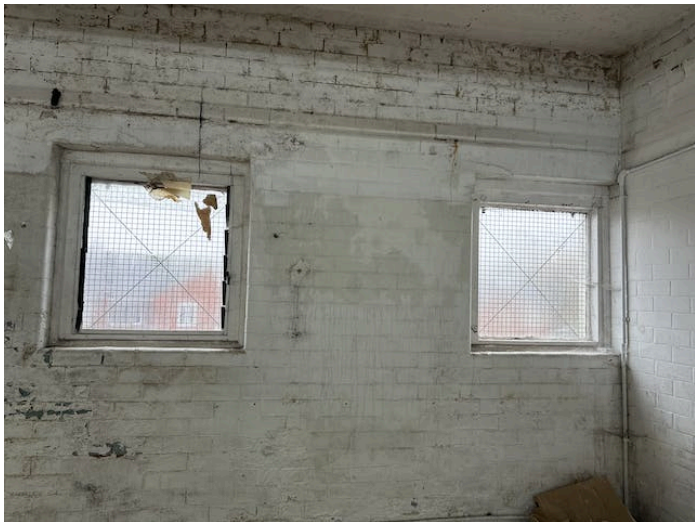
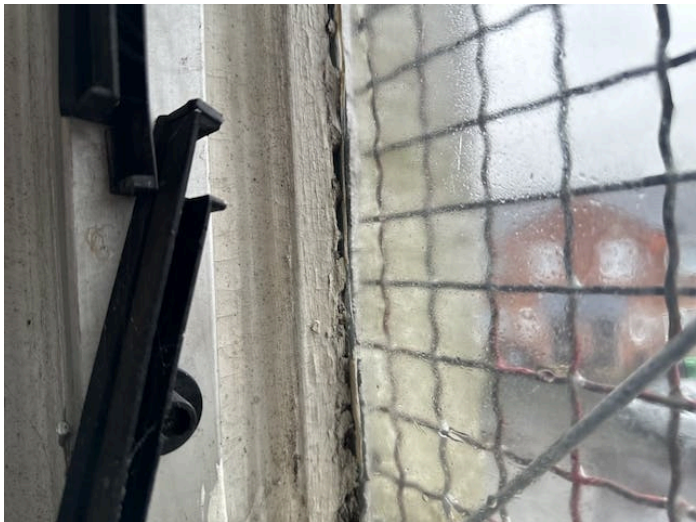
| Location | 012 - Unit 3 room 3 | Item | Other |

| Material | Putty to windows | Extent | 2M <sup>2</sup> |
| Strategy / Sample Id | Strongly Presume / RS04 | Presumed Fibre Type | NAD |

| Recommendation | No further action required | | |

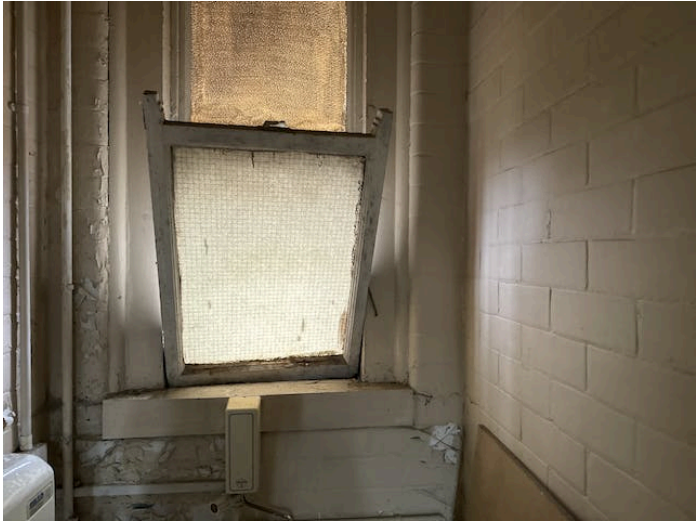
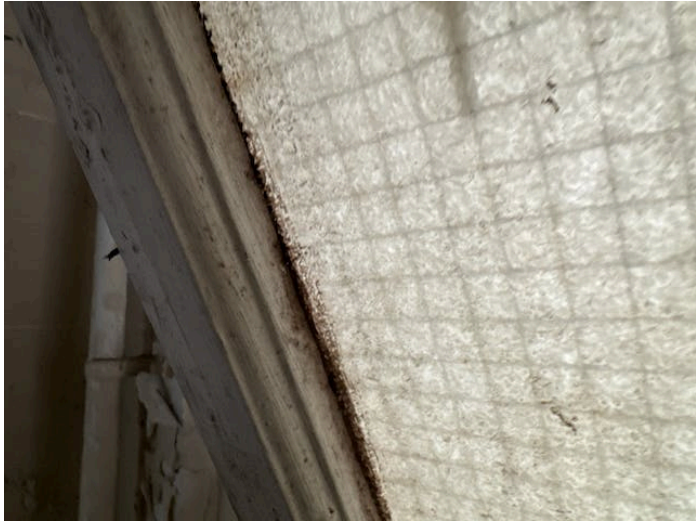
| Location | 013 - Unit 3 room 1 toilet | Item | Other |

| Material | Putty to windows | Extent | 1M <sup>2</sup> |
| Strategy / Sample Id | Strongly Presume / RS04 | Presumed Fibre Type | NAD |

| Recommendation | No further action required | | |

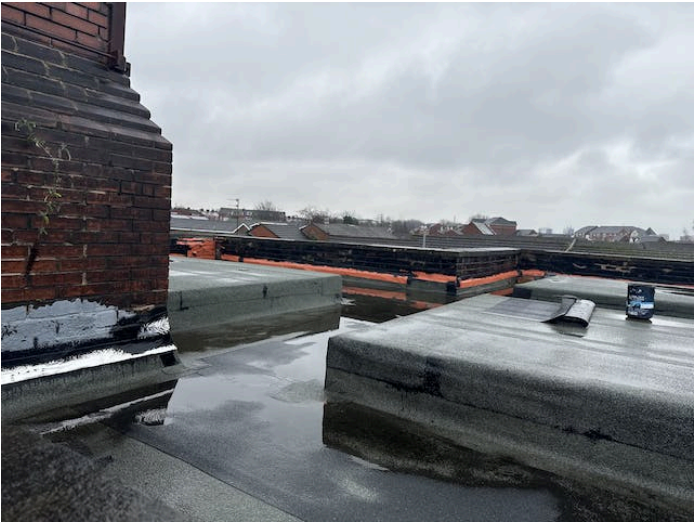
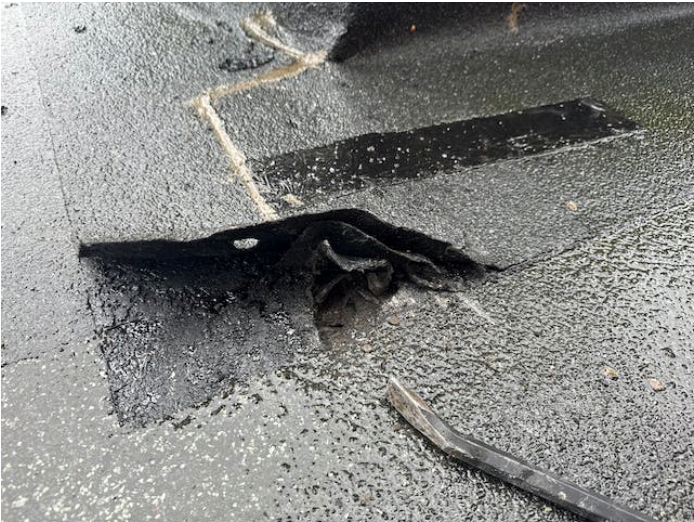
| Location | 017 - Level 2 Roof | Item | Floor |

| Material | Roofing felt to floor to concrete | Extent | 170M <sup>2</sup> |
| Strategy / Sample Id | Strongly Presume / RS08 | Presumed Fibre Type | NAD |

| Recommendation | No further action required | | |

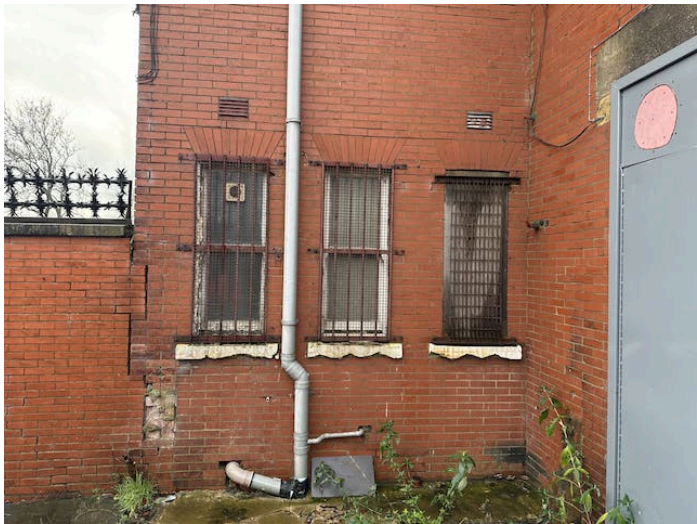
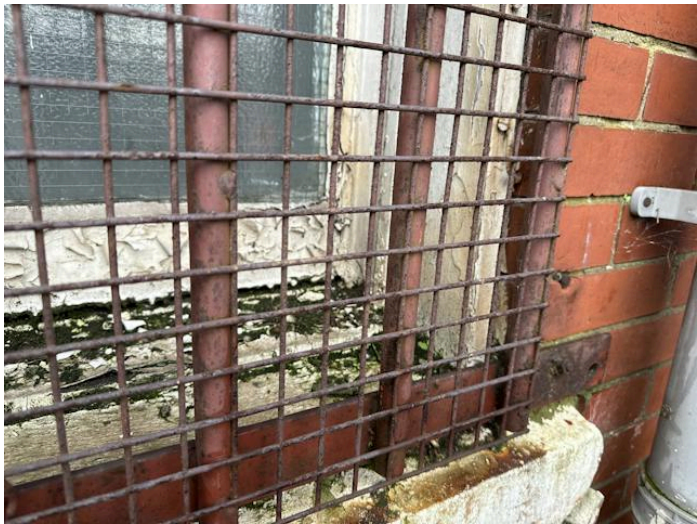
| Location | 018 - Externals | Item | Other |

| Material | Putty to all windows | Extent | 32M <sup>2</sup> |
| Strategy / Sample Id | Strongly Presume / RS04 | Presumed Fibre Type | NAD |

| Recommendation | No further action required | | |

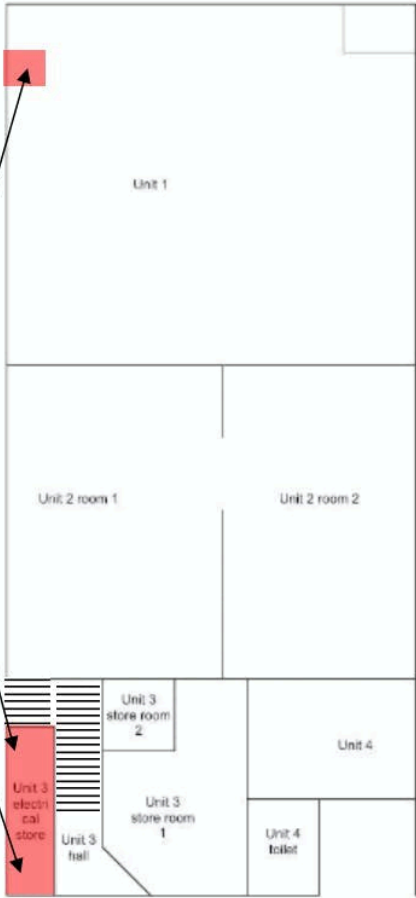
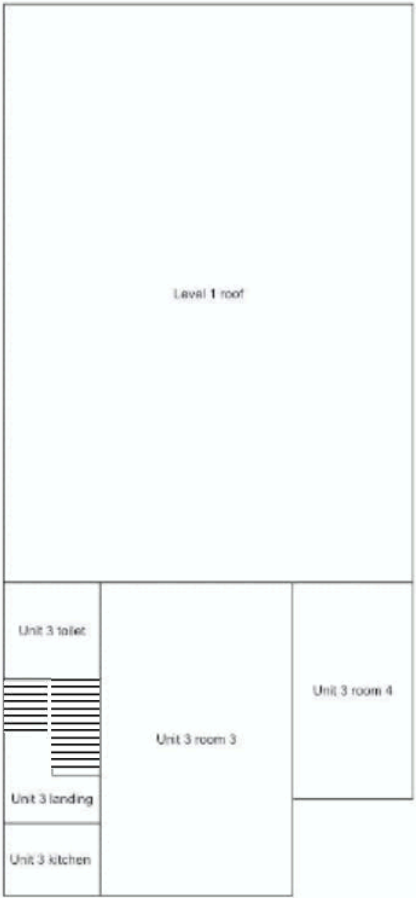
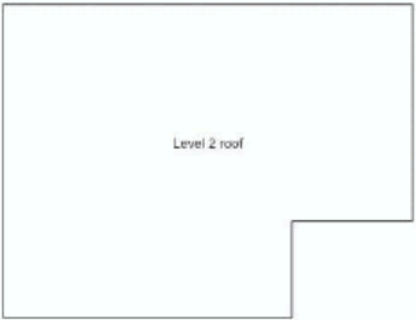
Ground Floor

PR12298-Presumed = Flash pads to fuse box = Chrysotile

PR12298-Presumed = Bitumen wrap to electrics = Chrysotile
