## PRELIMINARY INVESTIGATION OF DAMP

HEATON HALL ORANGERY, HEATON PARK, MANCHESTER

JOB NO. 212.97

16 FEBRUARY & 15 MARCH 2022

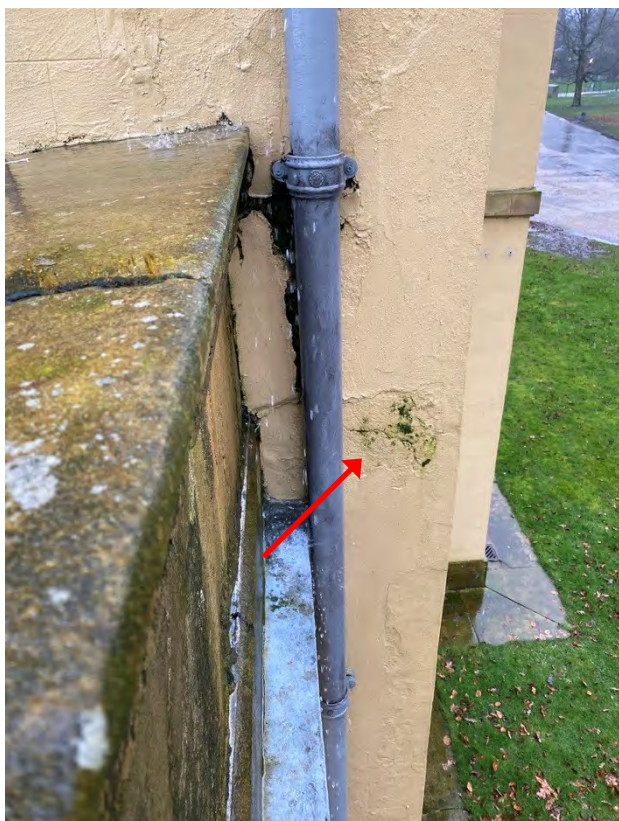
**Fig 12:**

RF-002; showing rainwater discharging onto the masonry beneath Fig 13. Biological growth was evidence of prolonged wetting

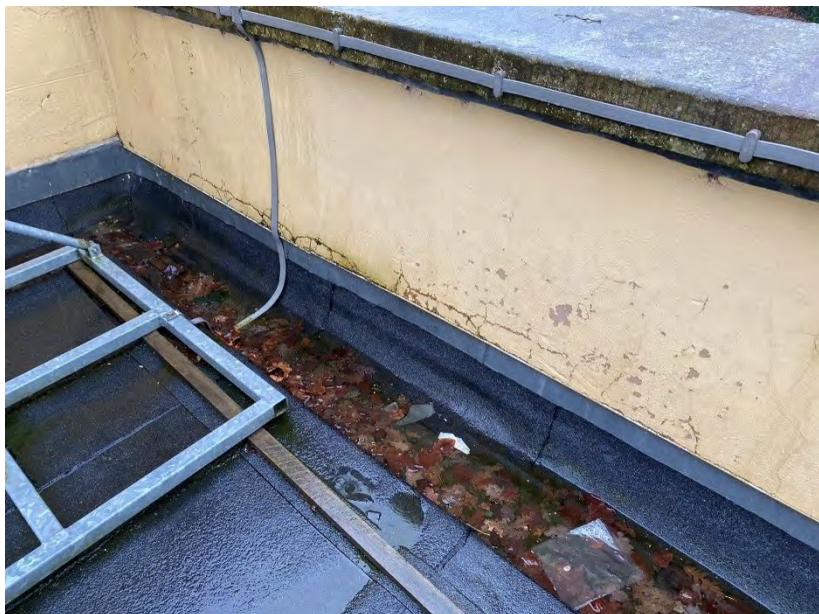
**Fig 13:**

RF-002; showing debris collecting in the drainage gulley along the north parapet

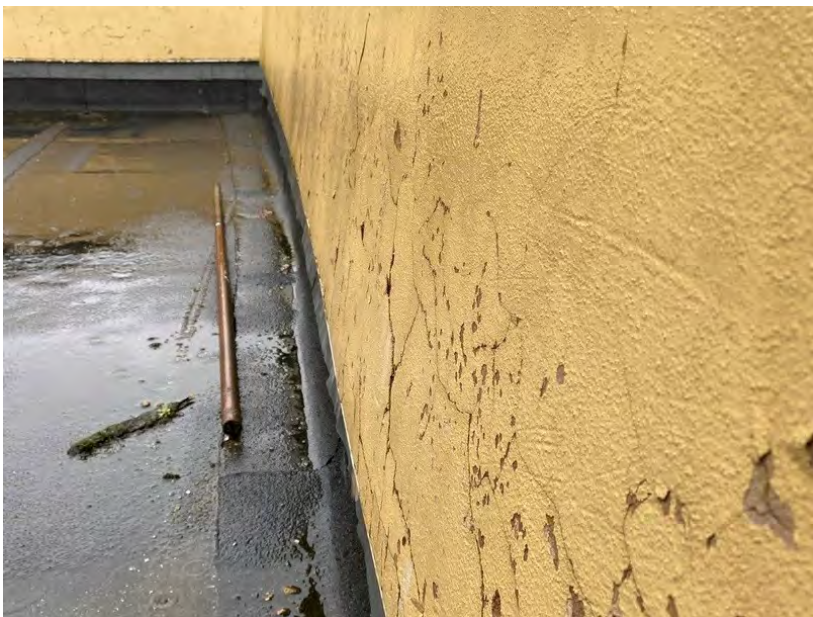
**Fig 16:**

RF-002; showing cracking and de-bonding of the render from the internal face of the brick parapets

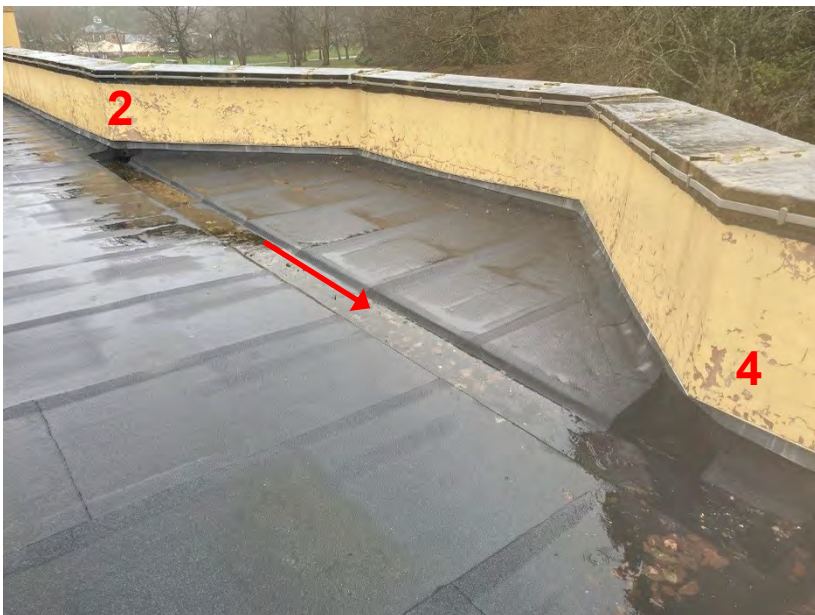
**Fig 18:**

RF-002; showing the drainage gully between outlets 2 and 4. Water from the central portion of the roof drained toward outlet 4 meaning outlet 2 provided little to no use. A high concentration of debris was noted at outlet 4 resulting in pooling water

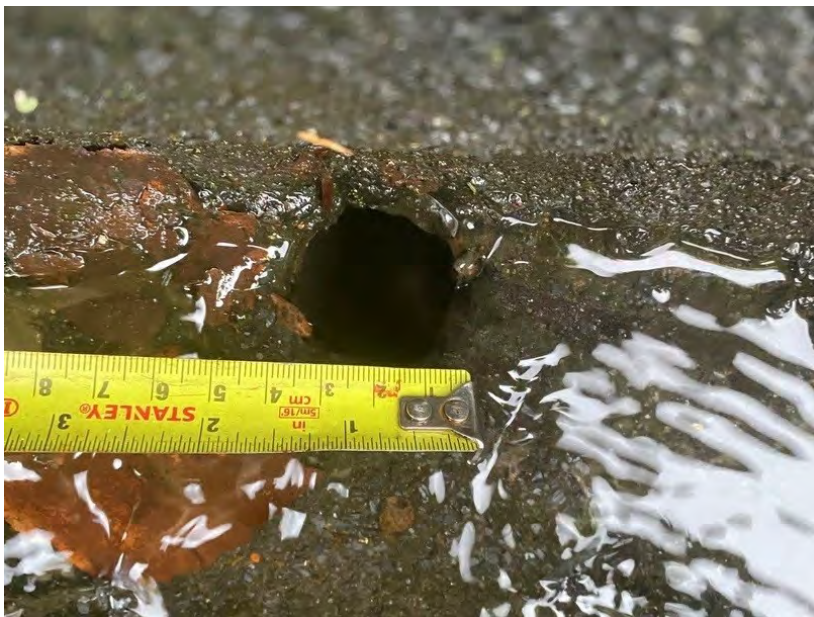
**Fig 20:**

- 4 Drainage condition: Generally, the diameter of catchpits and overflows were extremely small (between 40-60mm) and highly vulnerable to blockage. The roof was surveyed during heavy rain; due to the falls of the roof, no rainwater was discharging via outlet 2. Instead, water of the central portion drained to outlet 4, which was surrounded by debris at the time of survey. All outlets were generally clogged with debris. Outlet 6's lead downpipe was damaged

RF-002; showing a typical catchpit outlet of only ~40mm diameter. This is extremely small and highly vulnerable to blockage

Consideration should be given to increasing roof drainage outlet sizes and overflow capacity. Maintenance of all roofs and roof drainage should be improved by increasing frequency. A detailed survey of all drainage culverts, ventilating trenches and below ground drainage systems should be commissioned to determine their construction, condition and extent; to inform repairs/maintenance regimes

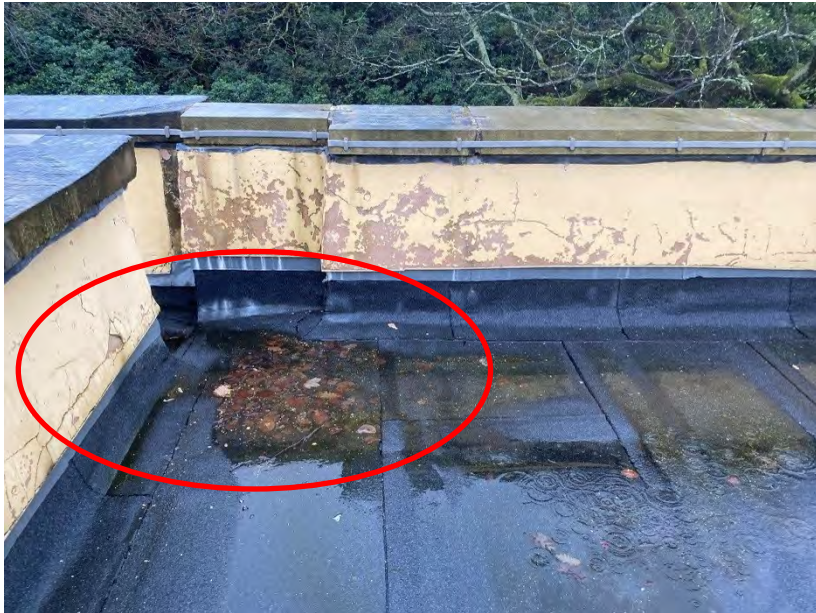
**Fig 23:**

RF-002; showing pooling water and debris collecting at outlet 6

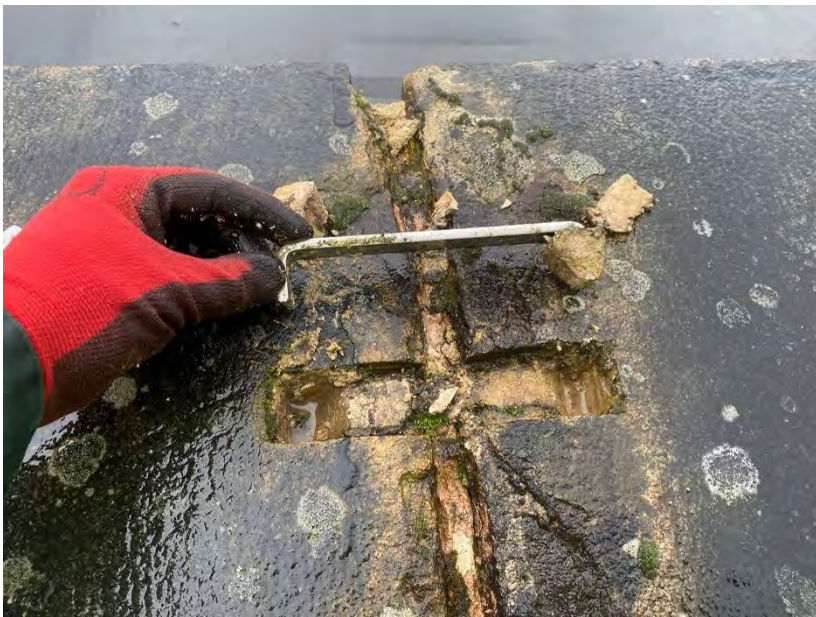
**Fig 24:**

- 2 Condition: There was corrosion and failure of original ferrous cramps, and many had been replaced with stainless steel. The corrosion had caused cracking of the cramp pockets of the coping stones. Mortars to cramps had failed throughout. There was splitting in the lowest layer of lead, possibly allowing for water penetration through the mortar joints of abutting string course units. Where exposed, sandstone was delaminating and soot-impregnated; where recently rendered, render was cracked and de-bonding throughout. Craze cracking was typical of shrinkage due to poorly managed/rapid drying. Water penetration via the parapets should be forestalled by the lead damp-proof courses; where failing, this presents a potential pathway for moisture ingress. Debonding render primarily poses a risk to surface drainage and, depending on the condition of the brick substrate, may allow a route for water penetration

RF-002; showing recent replacement metal cramps between coping stones to the head of the parapet. Mortar bedding had generally perished and the cramps had dislodged

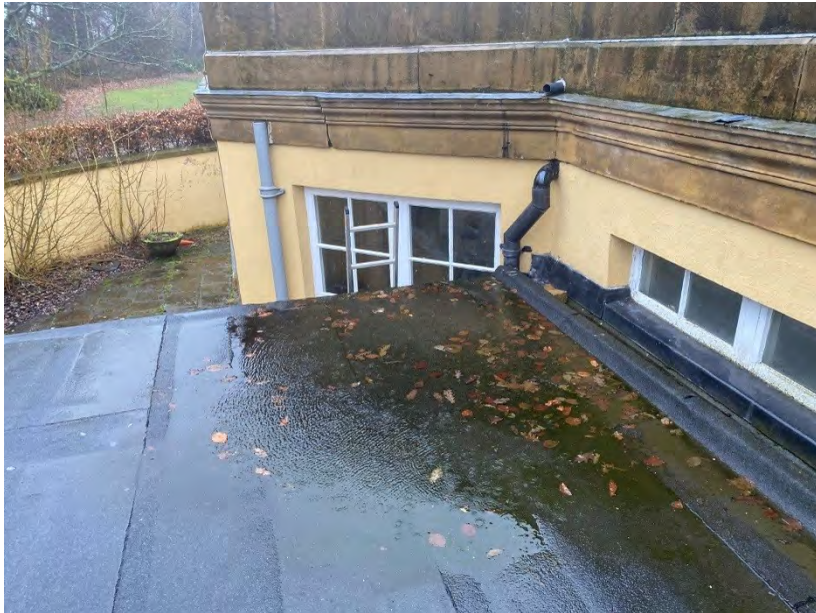
**Fig 29:**

RF-003; showing pooling rainwater to the south-east corner of the roof. This water was discharging into the eaves gutter to the east elevation

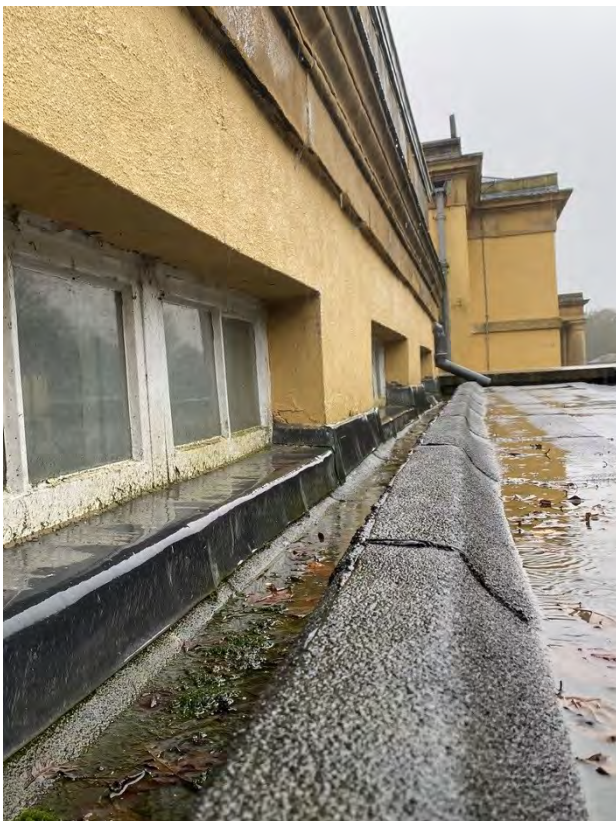
**Fig 30:**

RF-003; showing the drainage gulley alongside the north elevation of the main building. The gulley was supporting debris and some building materials

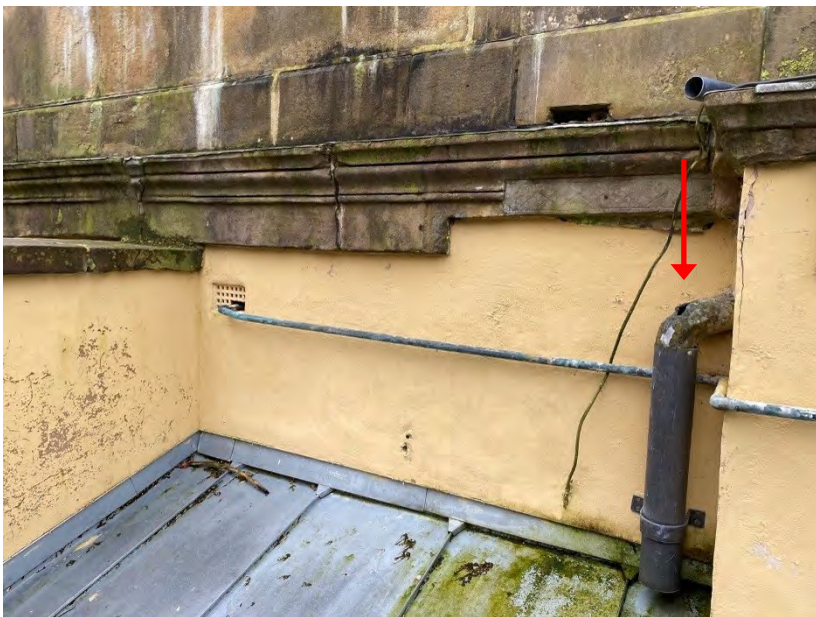
**Fig 34:**

RF-004; showing the lead pipe serving  
outlet 6 at its termination onto the  
mono-pitch roof. There was a tear in  
the older lead pipe that passes through  
the parapet

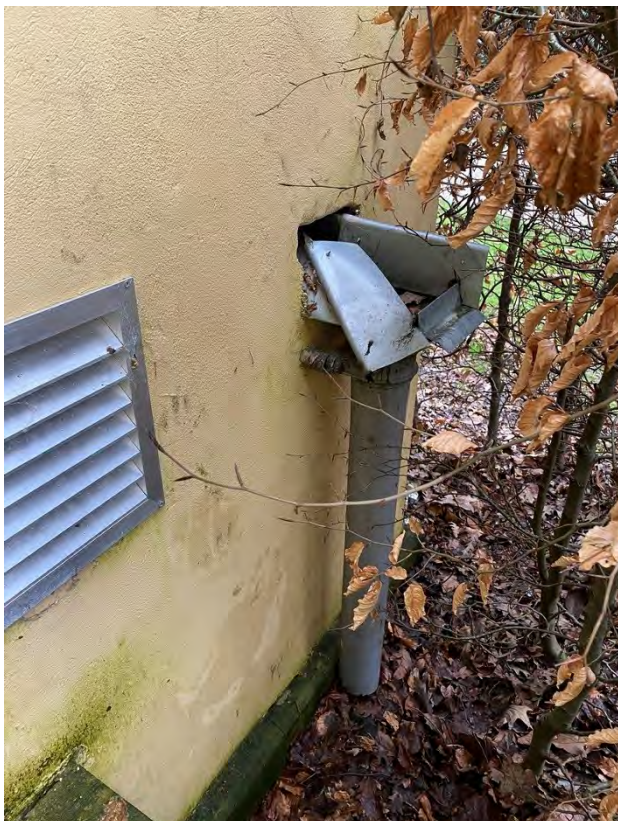
**Fig 36:**

East elevation; showing the hopper and downpipe that serve the valley gutter to RF-004. The downpipe appeared to discharge directly onto the ground rather than into a drain. Also note the damage to the hopper

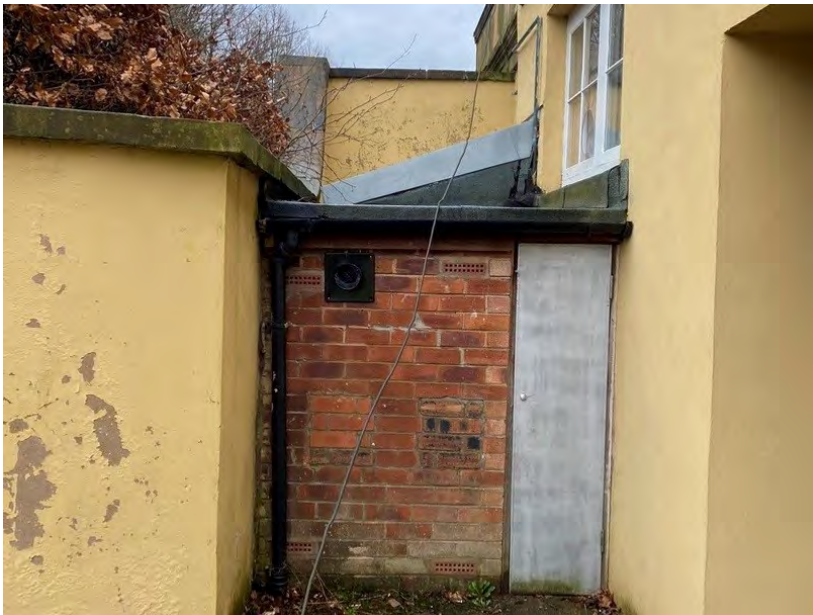
**Fig 38:**

West elevation of northeast extension; showing downpipe serving outlet 5 which discharged onto the hardstanding

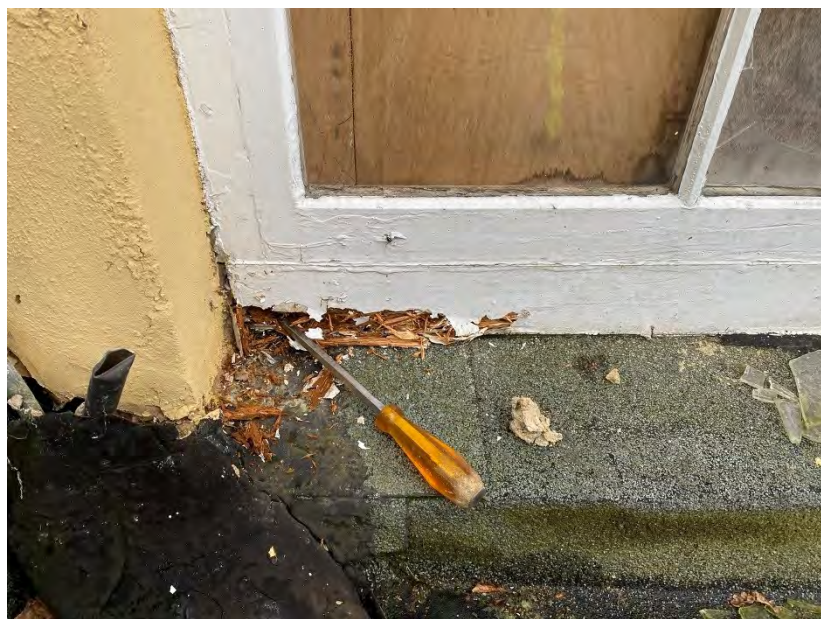
**Fig 40:**

- 2 Window condition: Windows to the south elevation showed no signs of significant decay. They were observed to rattle in the wind, which will aid in the building's ventilation, but may be undesirable upon occupation. Windows to the north elevation of the main gallery appeared to have been repainted relatively recently. The windows to the extensions likewise appeared to have recently been repainted. The easternmost window of the gallery was decayed by wet rot at its sill and the base of its casing, likely associated with the defect in roof coverings of roof RF-005

North elevation; showing decay in the base of the frame to the easternmost window. This was likely due to the defective opening surrounding the service pipe adjacent (arrowed). Also note the breakages in the glazing

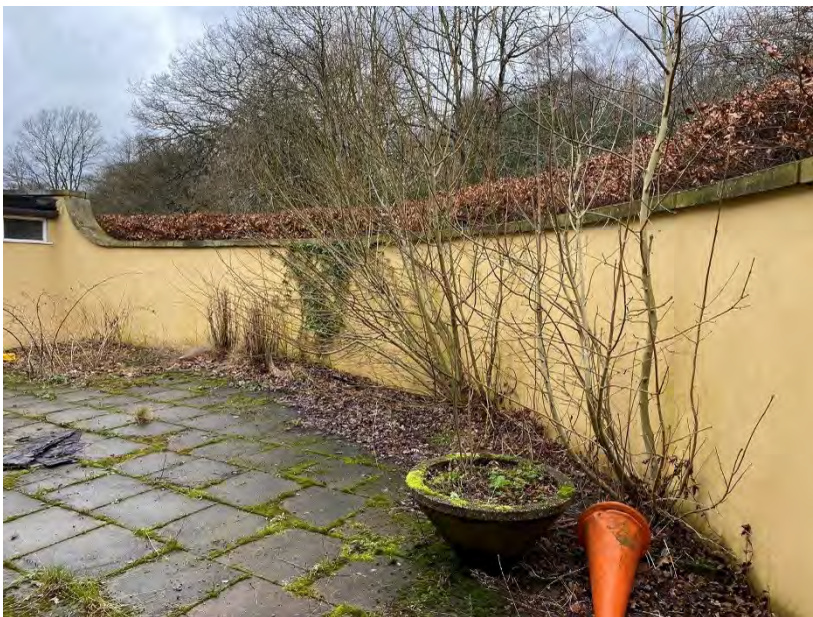
**Fig 42:**

North patio; showing trees rooted at the base of the north boundary wall. Roots may be causing damage to the foundations of this wall

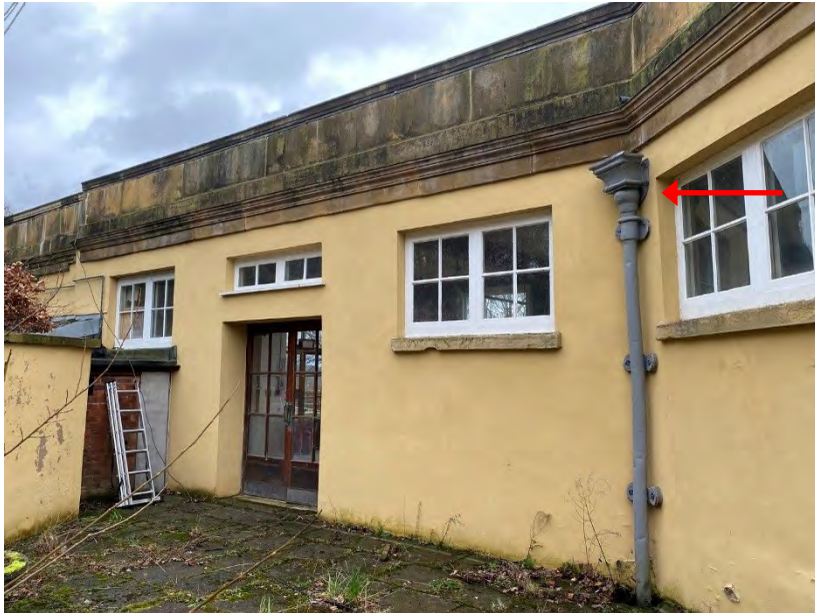
**Fig 43:**

North elevation; showing the lead downpipe serving outlet 4 that discharged onto the hardstanding

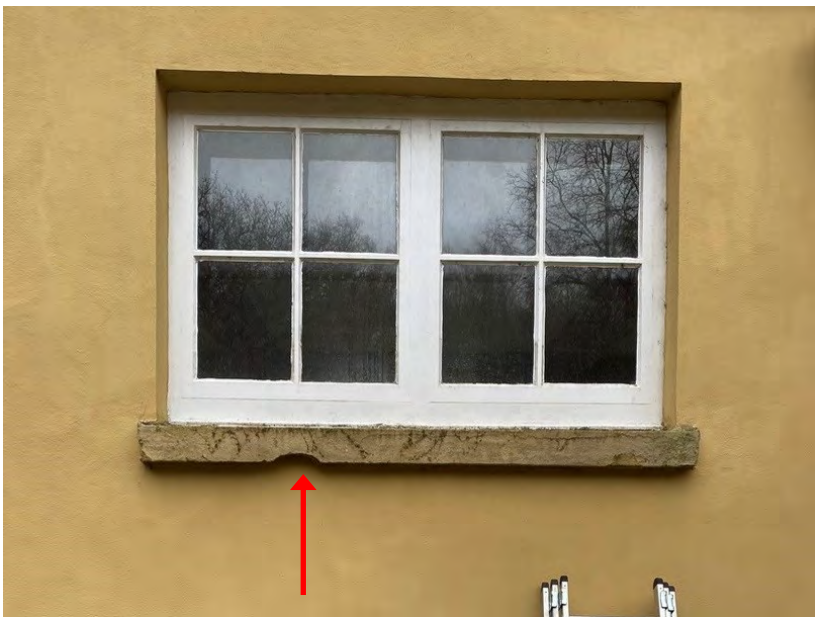
**Fig 44:**

North elevation; showing an example of one of the typical window forms. These windows show evidence of multiple layers of paint and appear to predate the new windows to the south elevation. Note the mechanical damage to the stone sill which will reduce the sill's ability to shed water

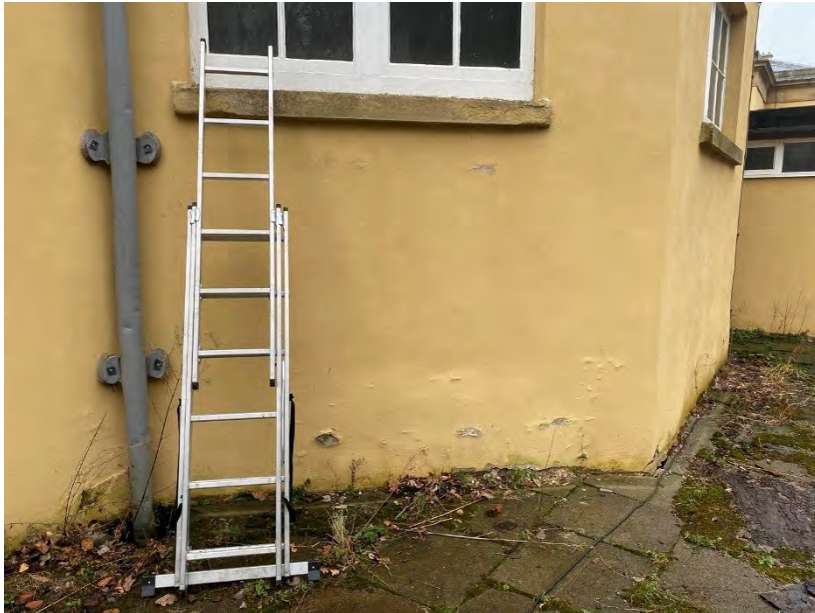
**Fig 45:**

- 4 North elevation condition: Some mechanical damage and cracking was noted to some stone sills. Render to the rear elevation was severely de-bonded and cracking to the bottom 500-1500mm of the wall. It is likely that wetting of the masonry has caused salt crystallisation and subsequent debonding of the render. This was also exacerbated by the render's direct contact with the patio hardstanding

North elevation; showing de-bonding of the lower 500mm of render

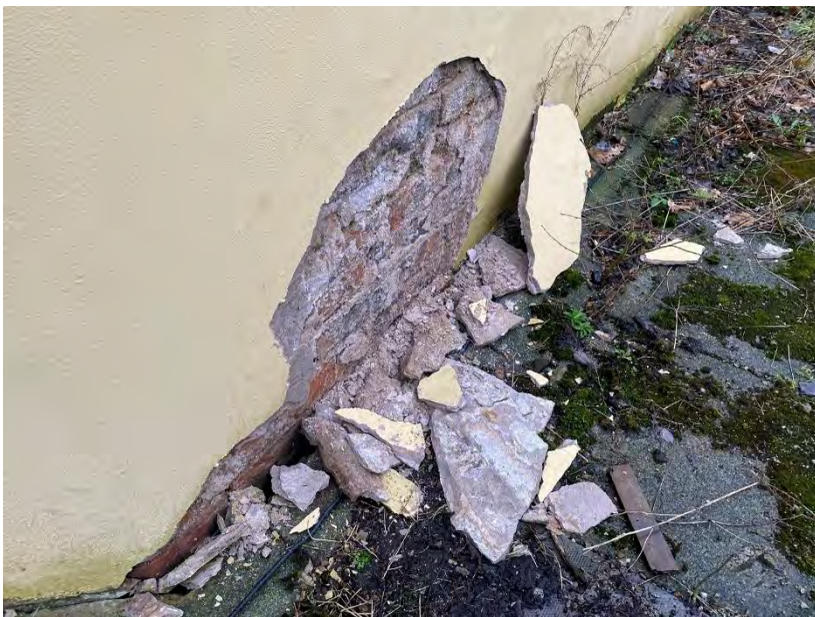
**Fig 46:**

North elevation; showing de-bonded render revealing the brick substrate

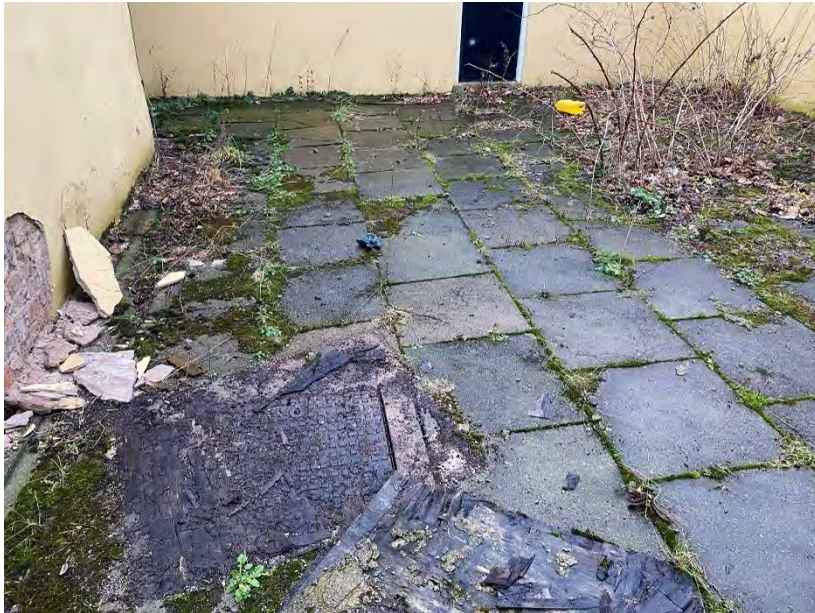
**Fig 47:**

- 2 Surface drainage condition: All downpipe outlets to the north patio were blocked with debris. Additionally, the patio was not graded toward the drain. Based on accounts by staff, splashback and tidemarks on the base of the wall, and debonding of the render, the patio supports a fair amount of standing water in times of heavy rainfall. The entrance to the northeast extension, likewise, suffered from pooling water and debris collection

North patio; showing hardstanding that was generally graded towards the north elevation. Plant growth and moss growth indicated poor drainage of the hardstanding

Note the manhole cover was poorly secured and this represented a potential hazard

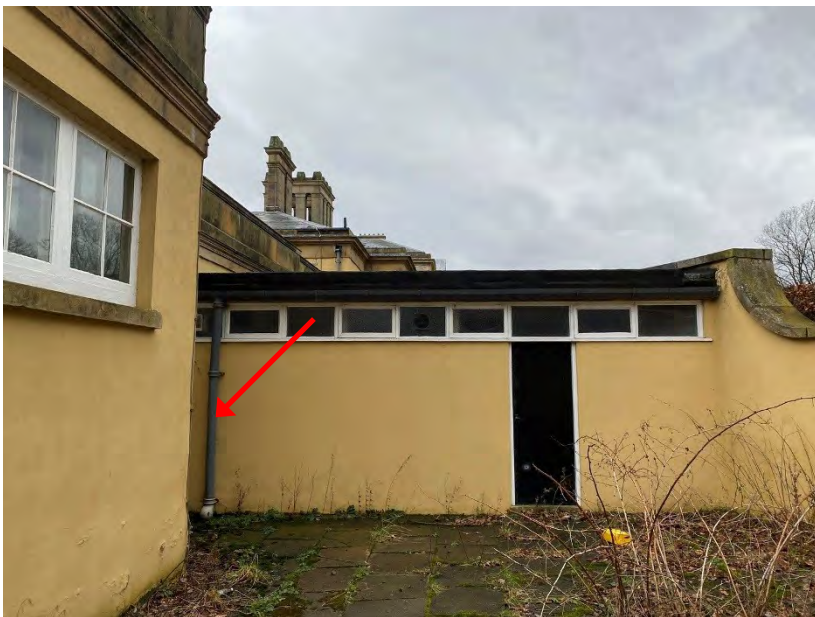
**Fig 48:**

East elevation of Northwest extension; showing timber framed fixed and hopper windows. The downpipe serving outlet 4 discharged onto the hardstanding

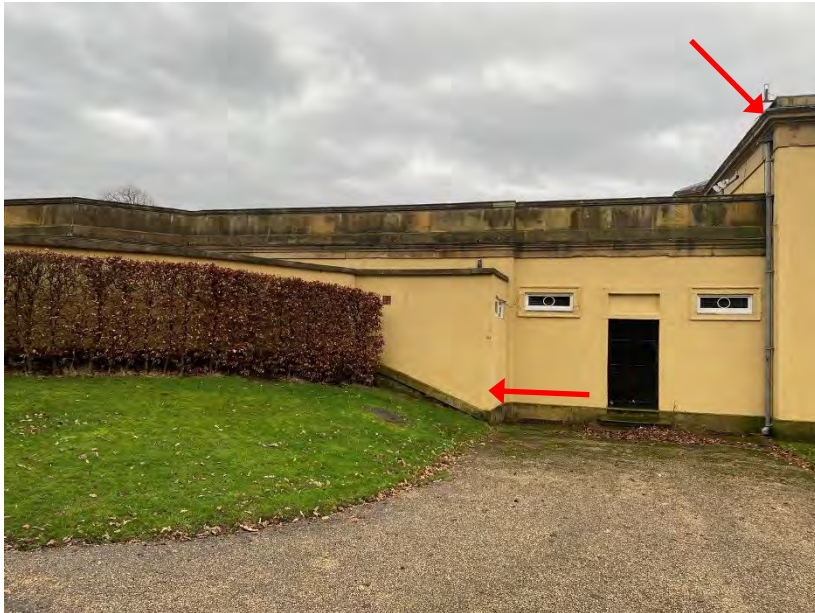
**Fig 49:**

North elevation; showing raised ground levels to the northwest extension. The lower arrow indicates the approximate height of the internal floor

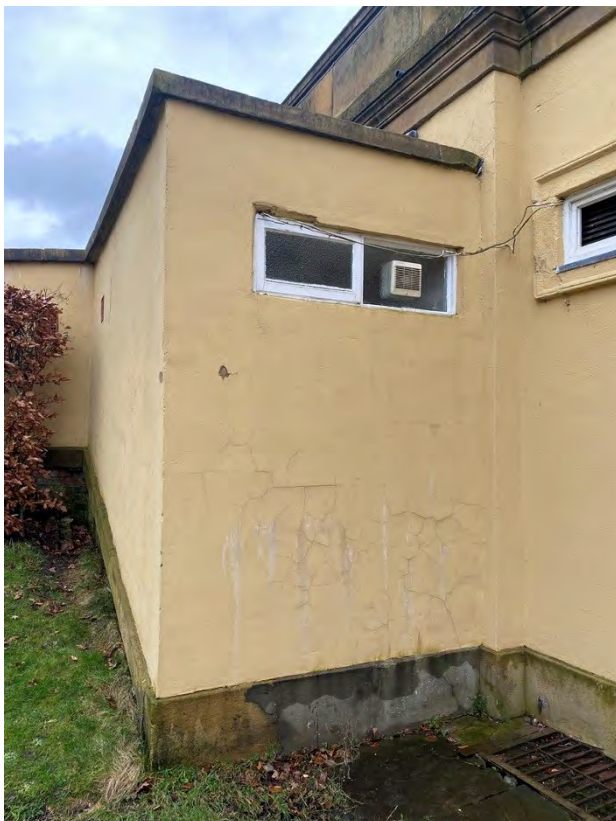
**Fig 50:**

West elevation; showing cracked render to the lower portion of wall. This may be due to the lack of a window sill to this window, resulting in water penetration behind the render

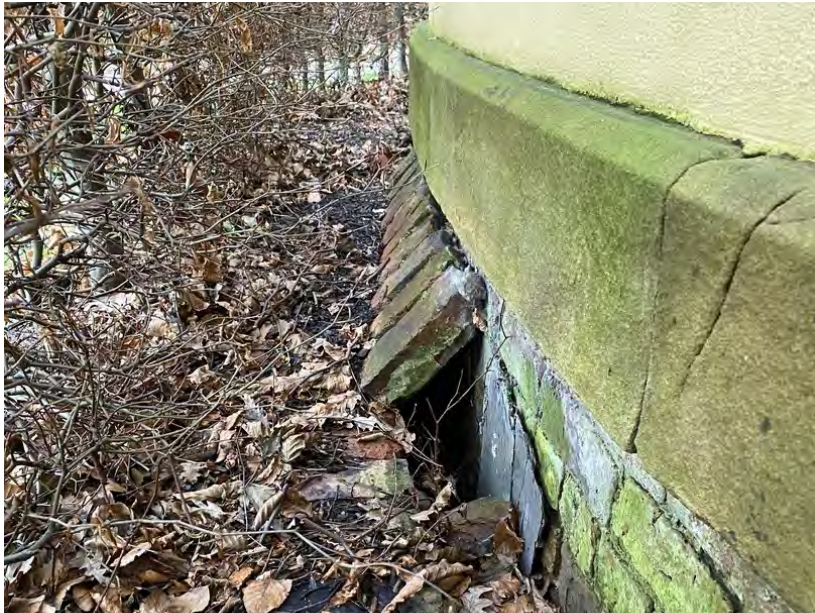
**Fig 51:**

North elevation of Northeast extension; showing angled bricks supported from an earth retaining wall. The bricks span a ventilated trench

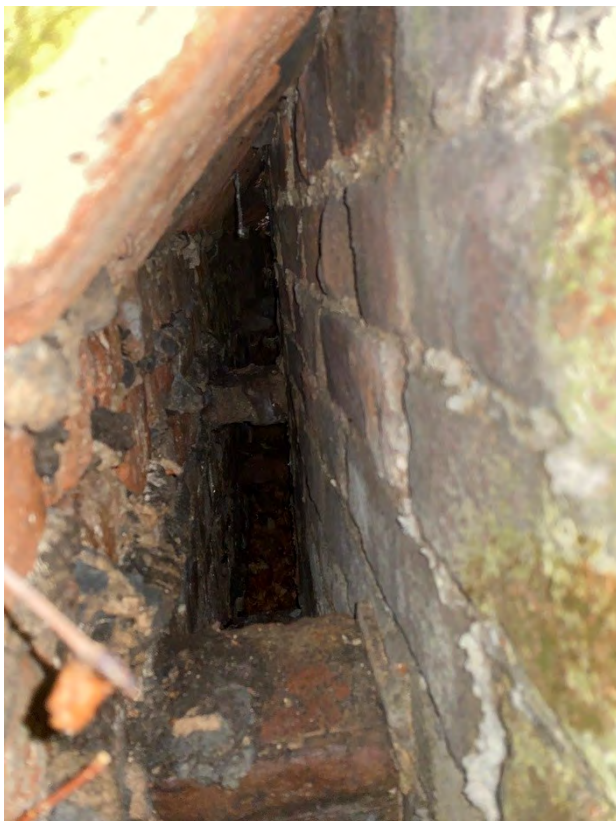
**Fig 52:**

North elevation of Northeast extension; showing a view inside the ventilated trench. Note the earth-retaining wall is tied to the external wall with brick ties. It is unclear whether this detail is original to the building or was constructed in response to damp

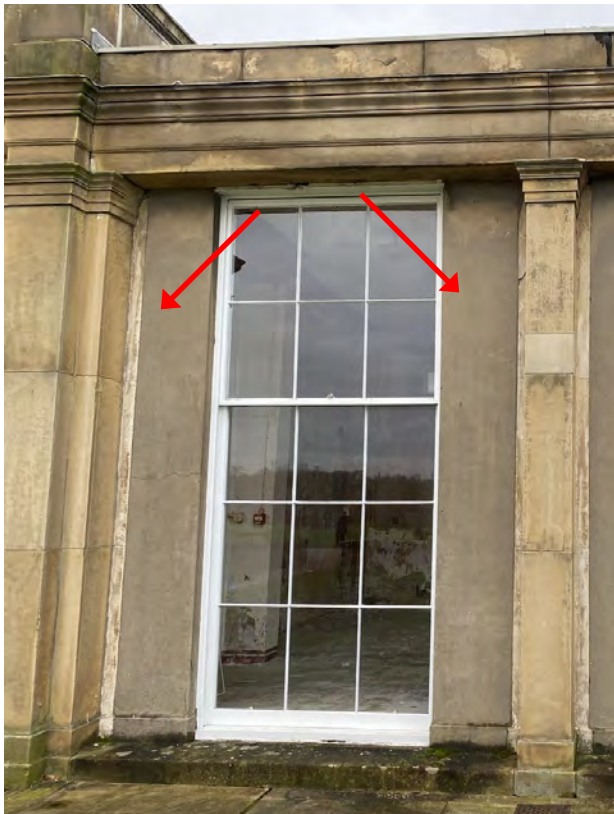
**Fig 55:**

South elevation; showing an example of a recently installed single glazed timber sliding sash windows. The rendered panels to either side are understood to date from the 1970's

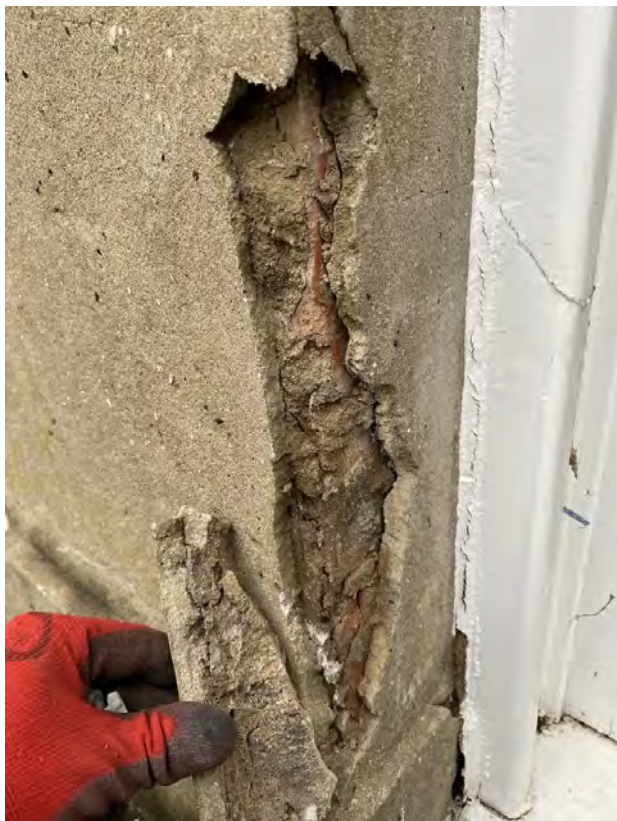
**Fig 56:**

South elevation; showing area of locally de-bonded render to brick infill panelling

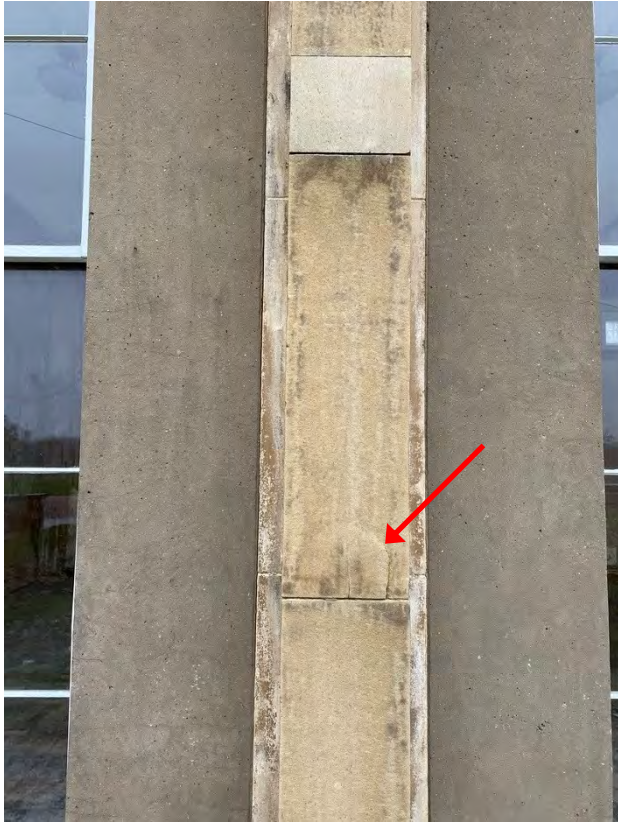
**Fig 57:**

South elevation; showing an indent stone repair to the pilaster with a contrasting stone. Repair can be attributed to corrosion of a metal dowel

Note the cracking directly beneath caused by corrosion of a ferrous metal dowel

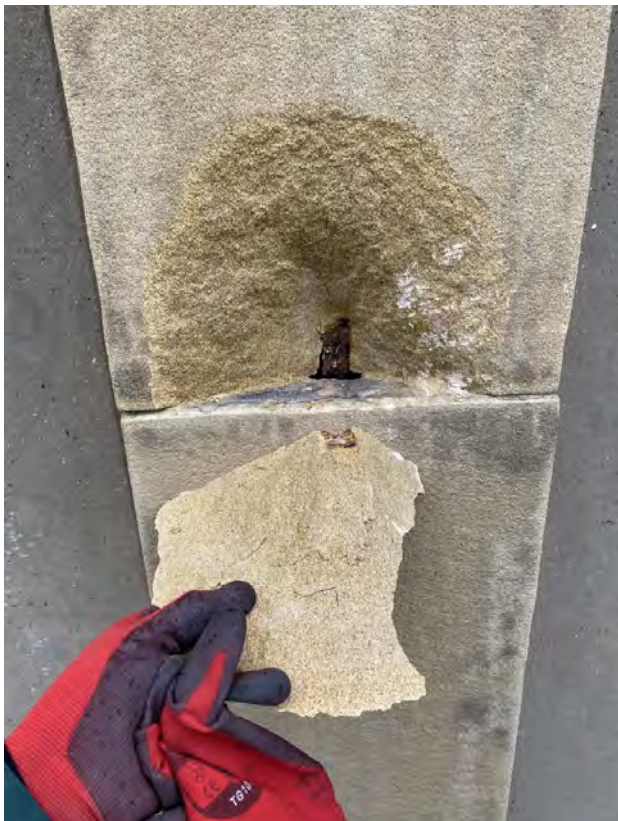
**Fig 58:**

South elevation; showing failure of the stone caused by corrosion of the metal dowel

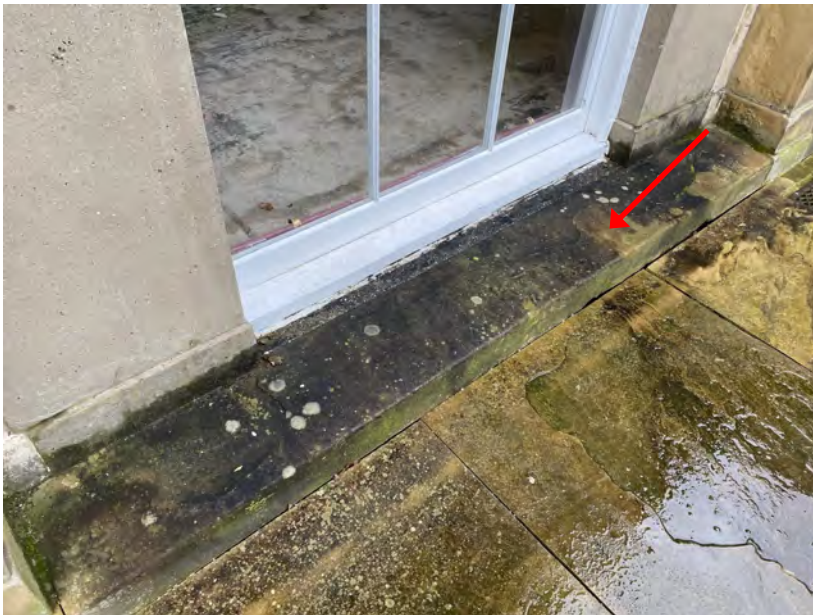
**Fig 60:**

South elevation; showing weathering and previous mortar repairs to the delaminating stone sill

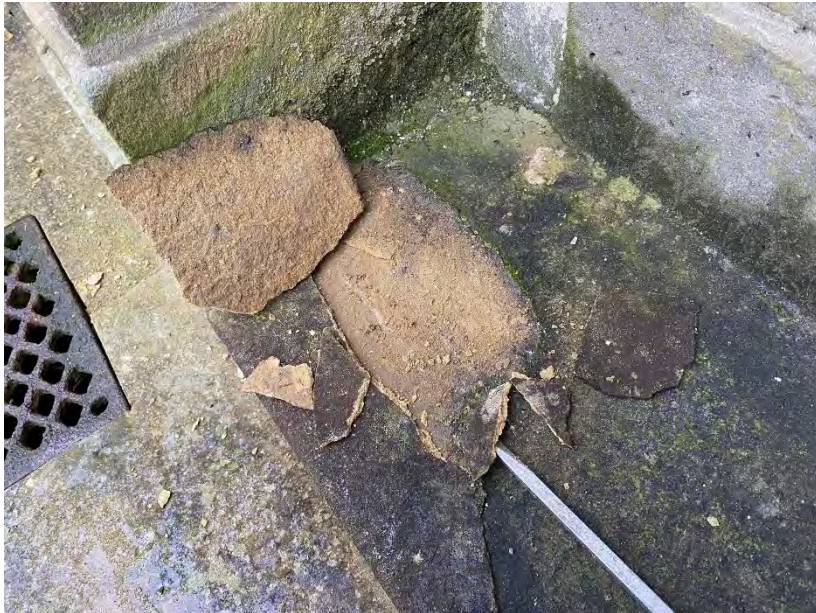
**Fig 61:**

South elevation; showing delaminating stone sill

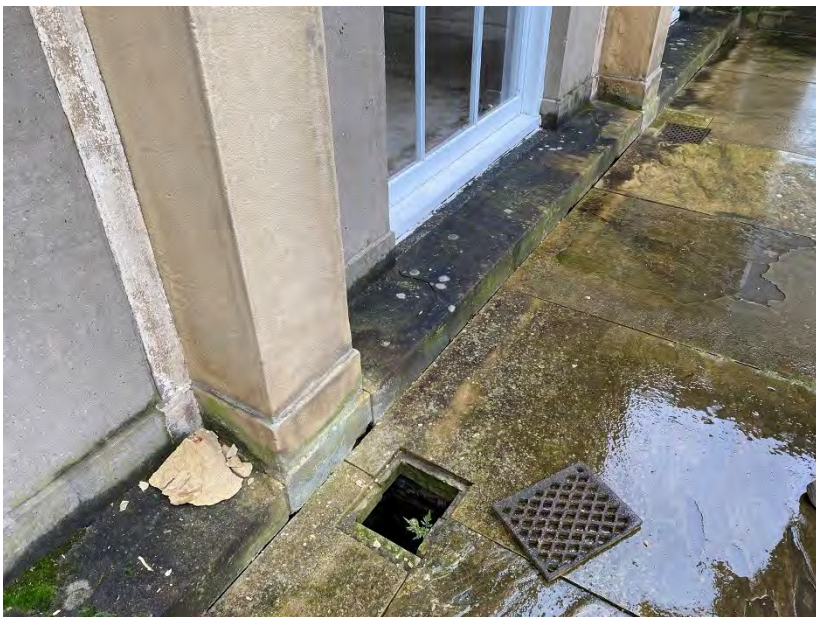
**Fig 62:**

South elevation; showing a surface drain which drained into the brick culvert network

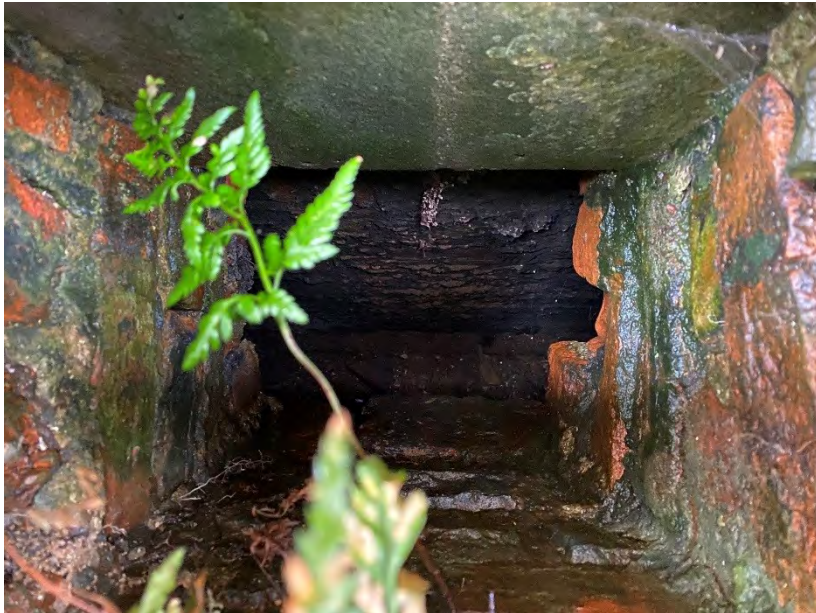
**Fig 63:**

South elevation; showing brick culvert system visible through a surface drain

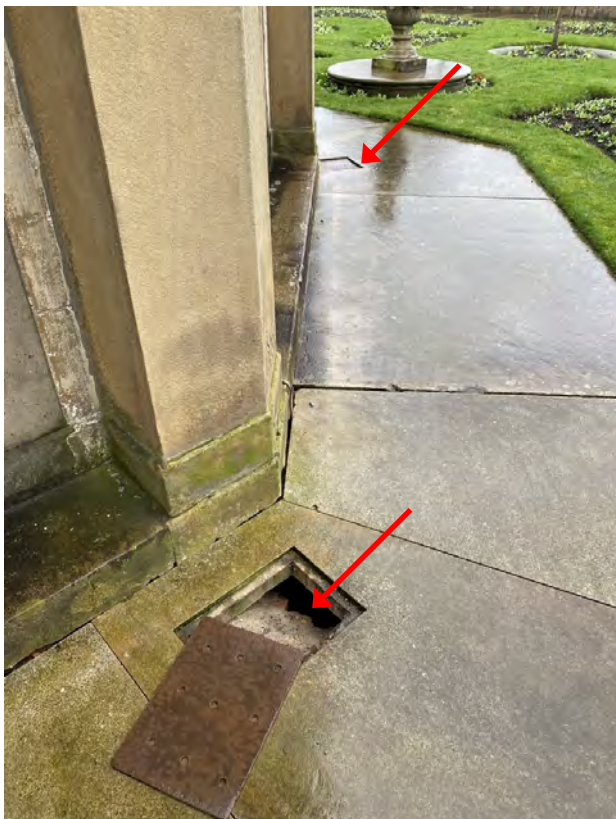
**Fig 64:**

South elevation; showing surface drains which drained into the brick culvert network

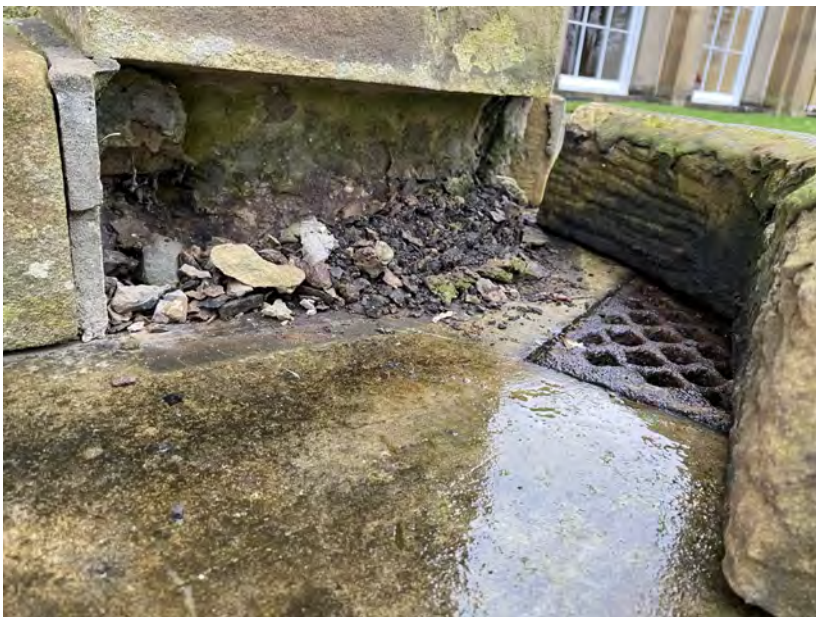
**Fig 66:**

South elevation; showing a loose plinth stone to the corner of the bay

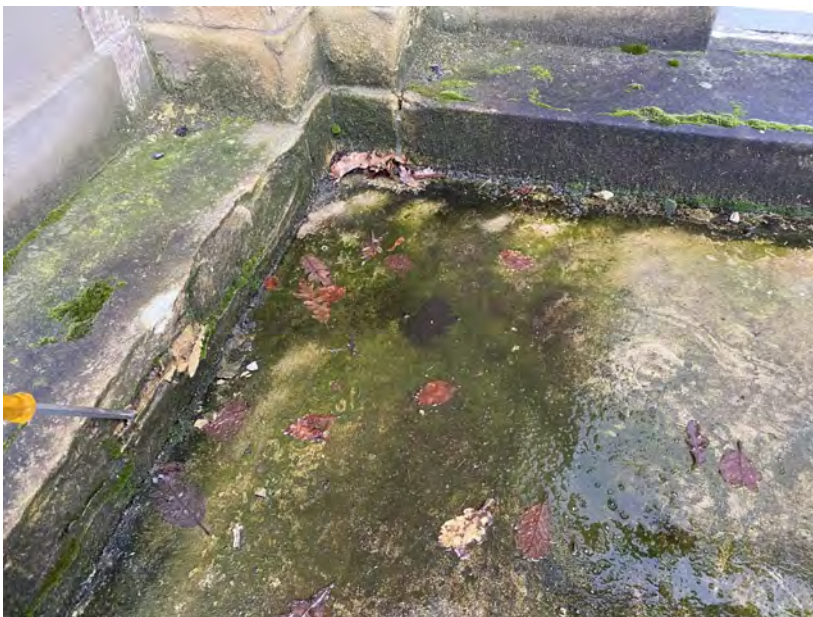
**Fig 68:**

South elevation; showing delamination of the stone sill where surface water is able to pool

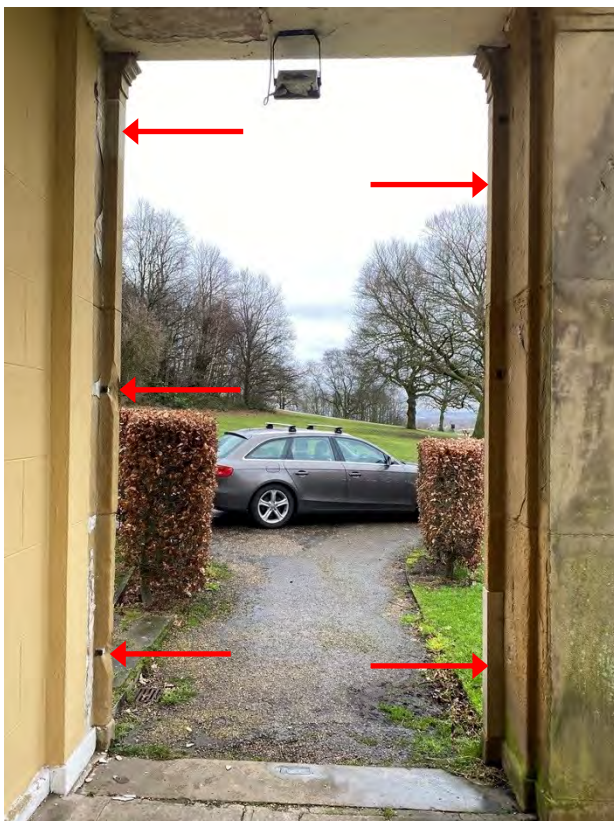
**Fig 70:**

East colonnade; showing degraded sandstone caused by corrosion of the former door fixings. Note stone indent repairs which probably indicate the locations of former corroded fixings

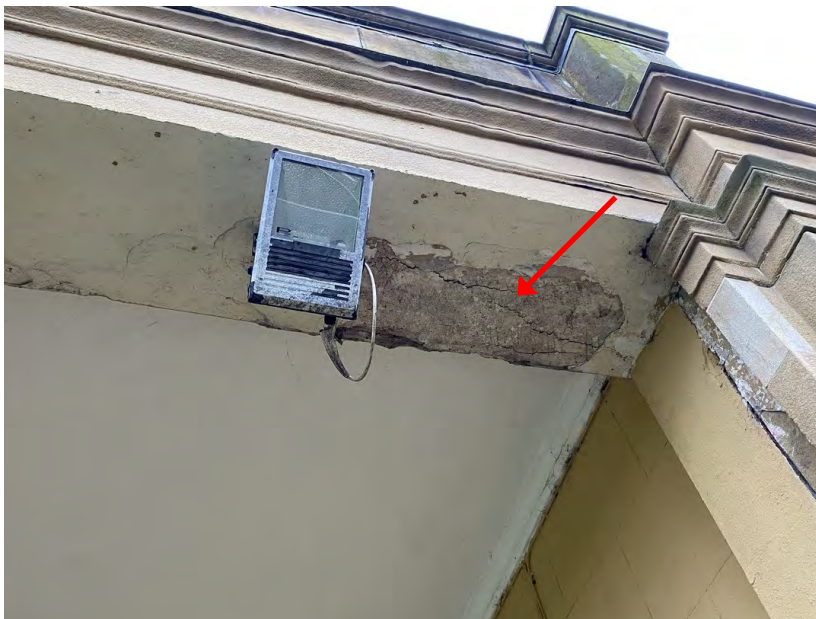
**Fig 72:**

East colonnade; showing cracking through the rendered lintel

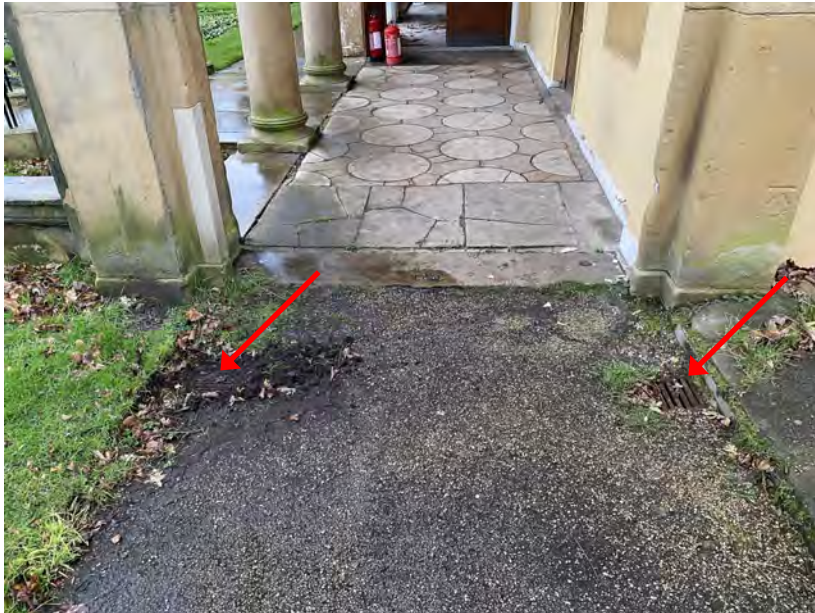
**Fig 73:**

East colonnade; showing blocked surface water drains

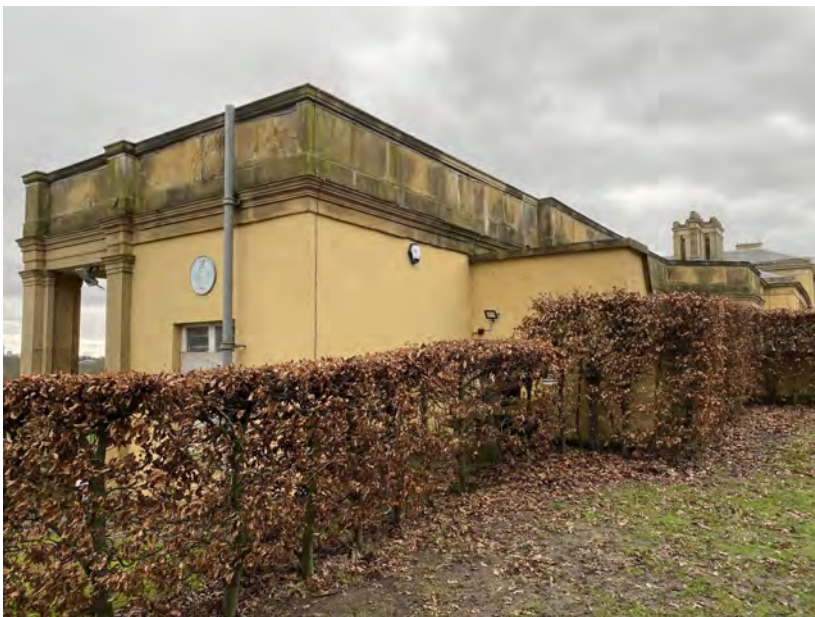
**Fig 74:**

East elevation; showing a view of the north-east corner of the building where external walls were partially earth-retaining. The arrow indicates the location of the door into the kitchen

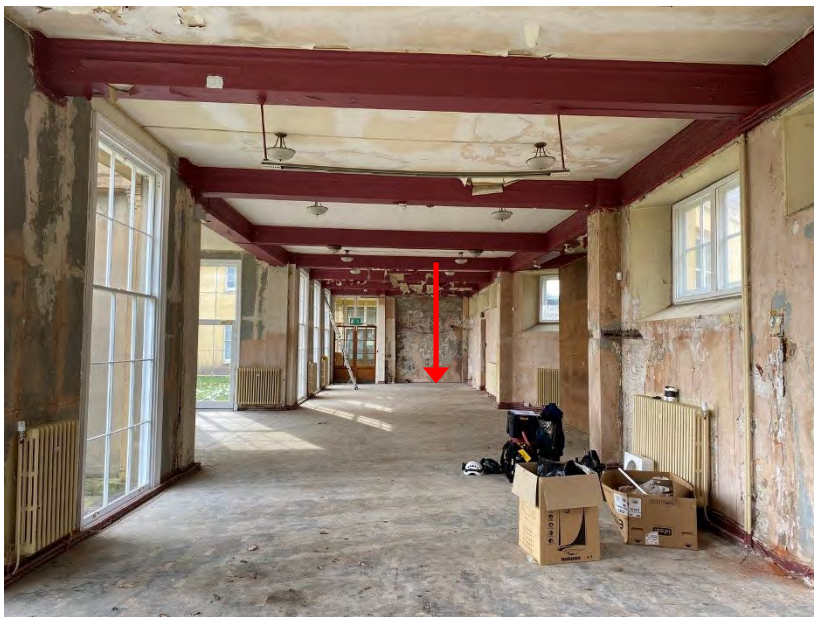
**Fig 76:**

Main gallery; showing a general view of the concrete beam and decked roof/ceiling. Beams were plastered and finished with paint. Note that the west end of the solid floor appeared to slope south
