## PRELIMINARY INVESTIGATION OF DAMP

HEATON HALL ORANGERY, HEATON PARK, MANCHESTER

JOB NO. 212.97

16 FEBRUARY & 15 MARCH 2022

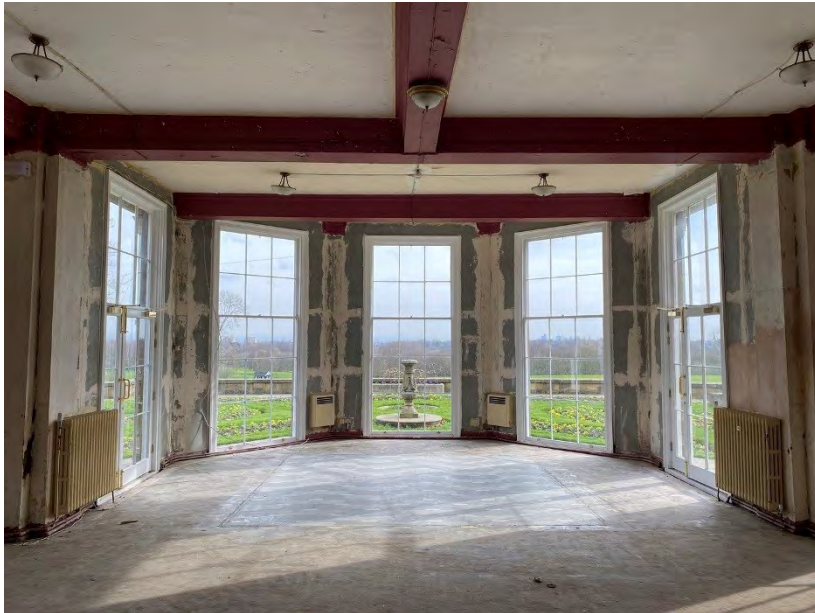
**Fig 77:**

Main gallery; showing a general view of the south bay. Note the wet system column radiators and additional electric fan heaters

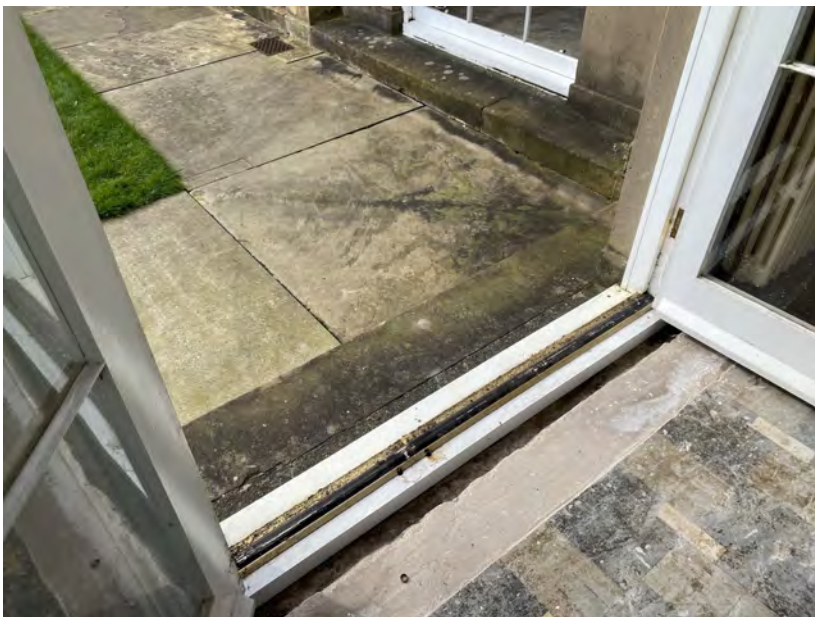
**Fig 78:**

South elevation; showing double door which was extremely stiff and difficult to open, evidencing lack of use

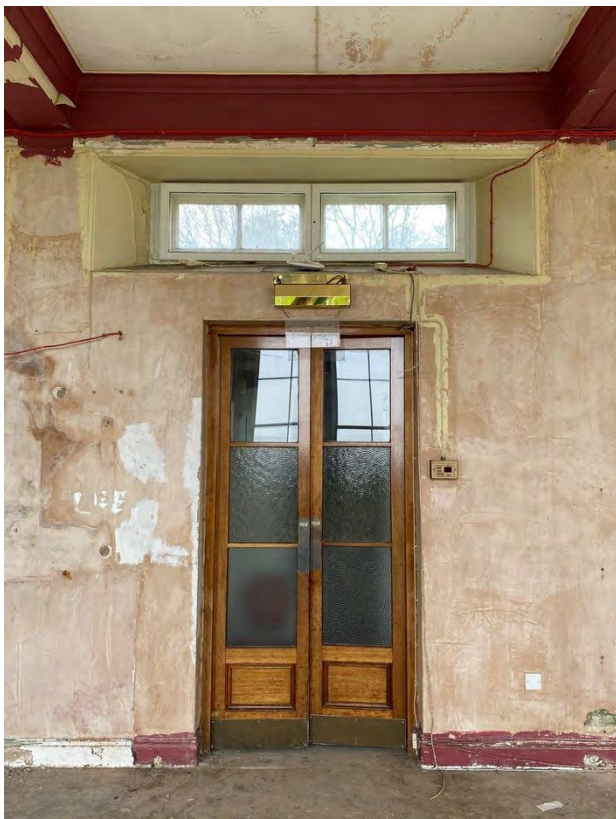
**Fig 80:**

Main gallery; showing double doors to the northwest extension. These and other internal doors were closed during inspection, restricting airflow between different areas of the interiors

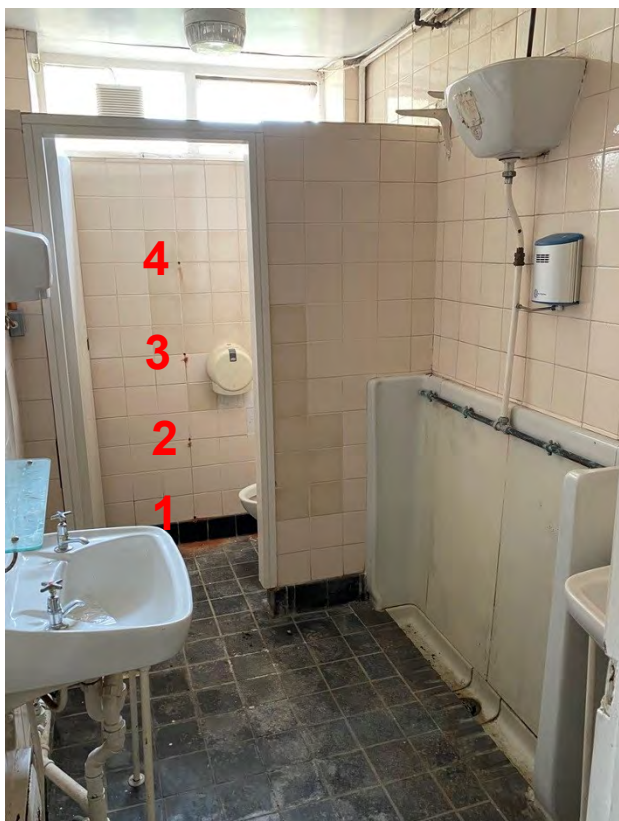
**Fig 82:**

Northwest extension; showing existing internal finishes. Note masonry samples no. 1-4 taken from the west wall

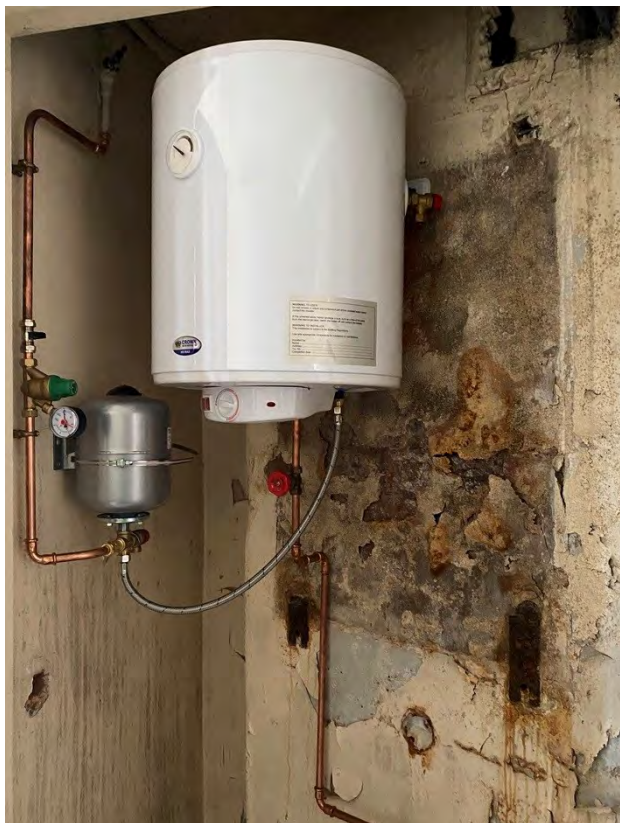
**Fig 83:**

Northwest extension; showing the relatively recently installed hot water cylinder and expansion vessel

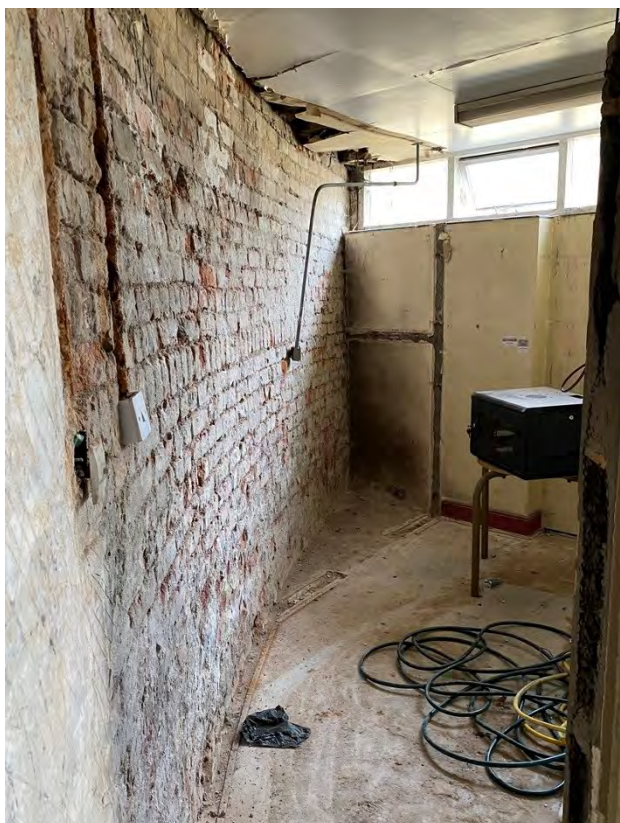
**Fig 84:**

Northwest extension; showing curved, external brick wall. Note the lower portion of this wall was earth-retaining. Masonry moisture contents in this area were high and timber skirting boards were generally damp and partially decayed

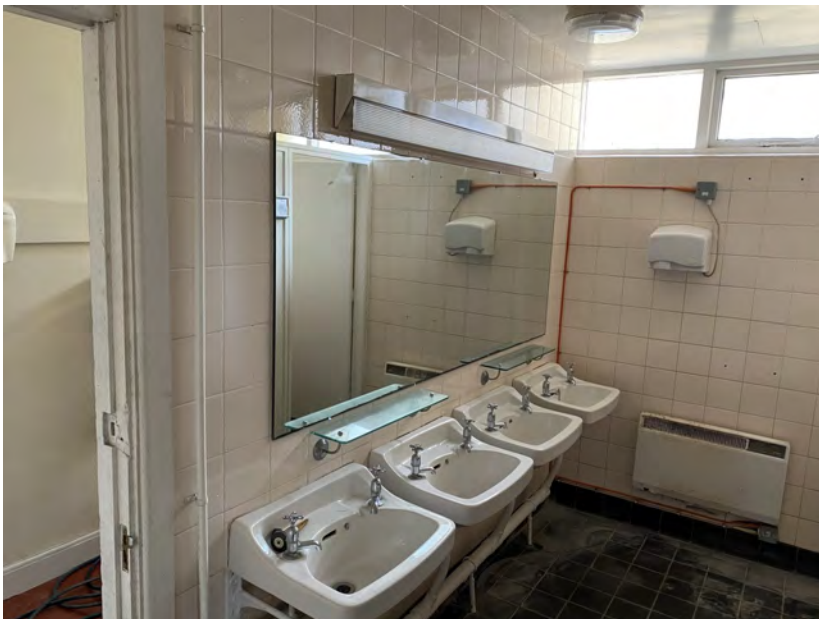
**Fig 86:**

Northwest extension; showing a general view of the Female WC

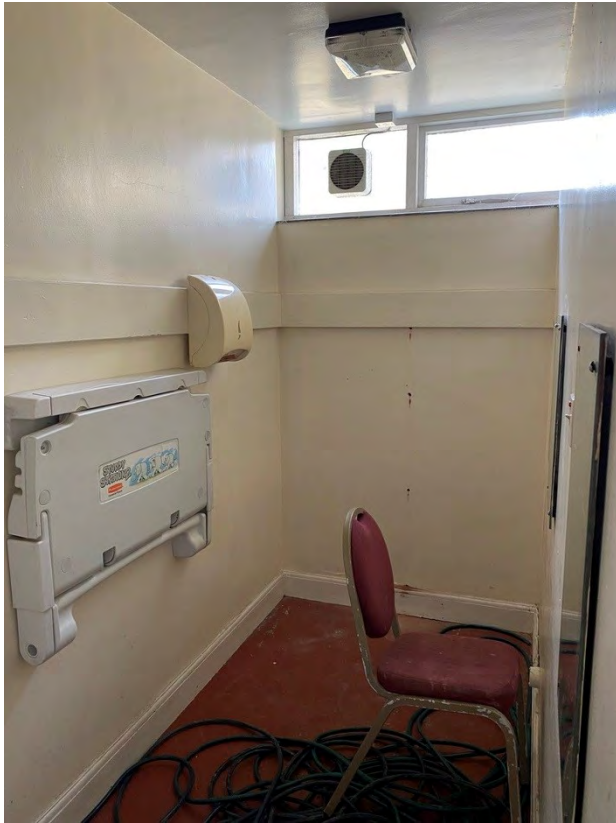
**Fig 87:**

Northwest extension; showing a mechanical extract fan to the Baby Change Room. There was no background ventilation to this room

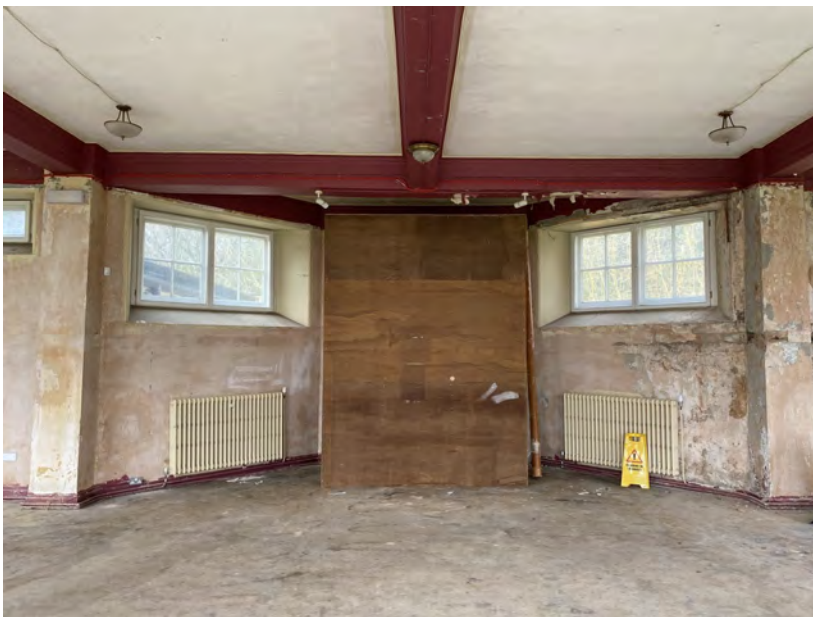
**Fig 88:**

Main gallery; showing an example of the secondary glazing to the double-glazed windows to the north elevation

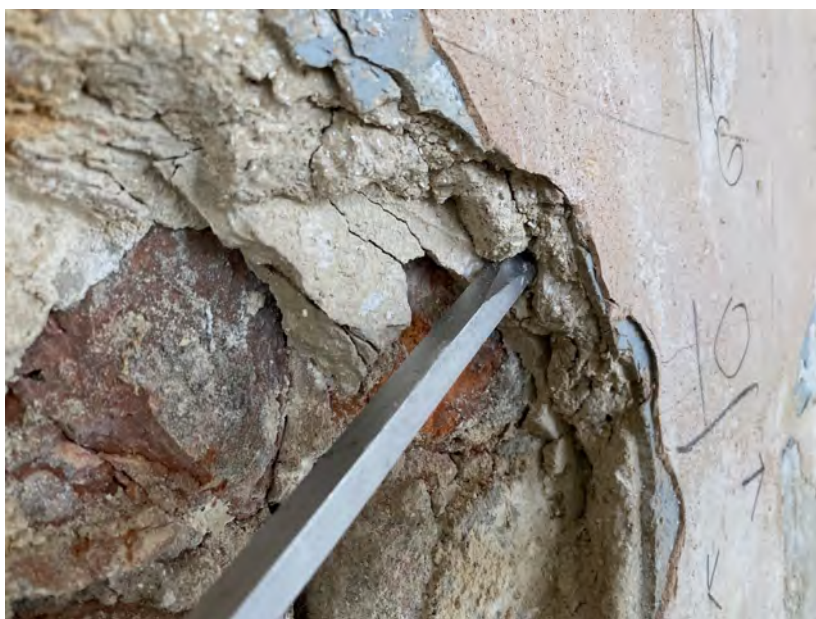
**Fig 90:**

Main gallery; showing modern gypsum plasters over earlier lime plasters

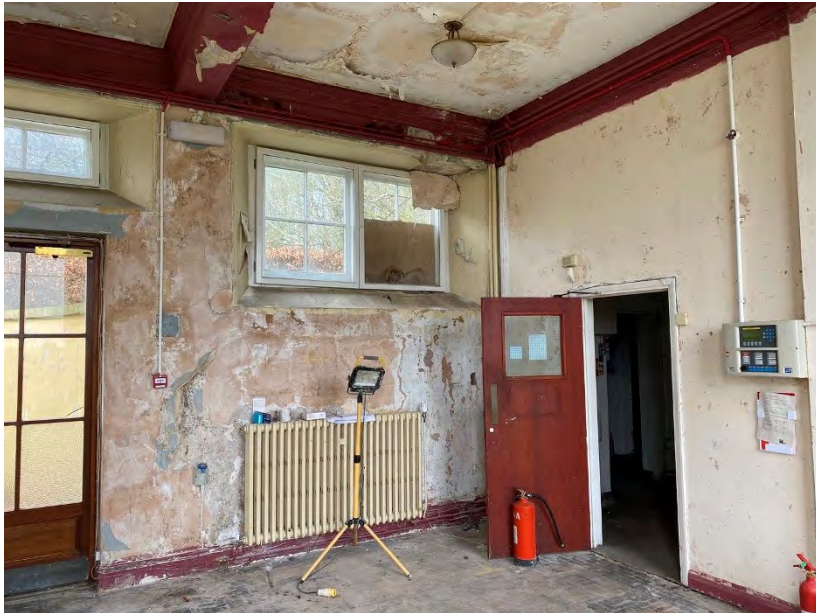
**Fig 91:**

Main gallery; showing replastering with gypsum in the north-east corner. Note the internal wall was a timber stud partition lined with plasterboard and included a timber skirting board

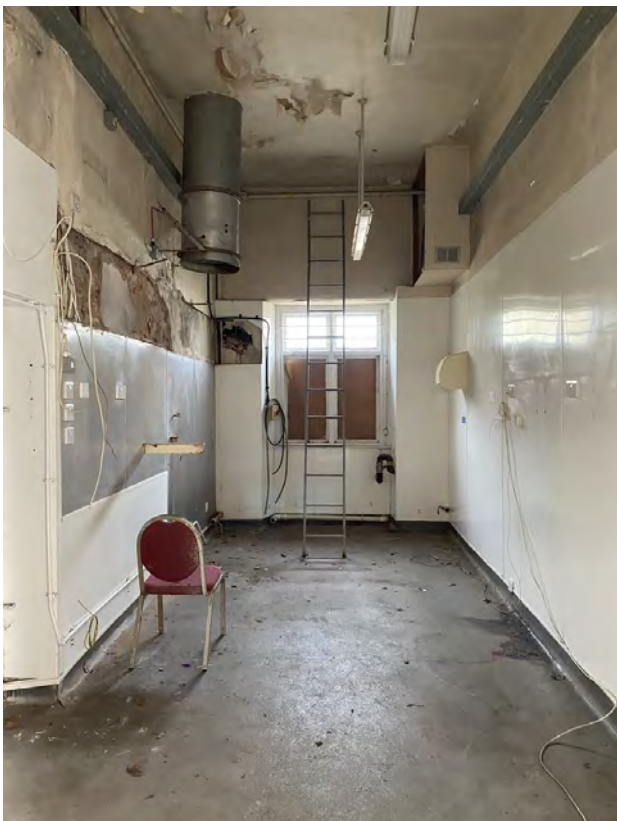
**Fig 92:**

Northeast extension; showing plastic sheet wall coverings which prevented access for masonry moisture profiling

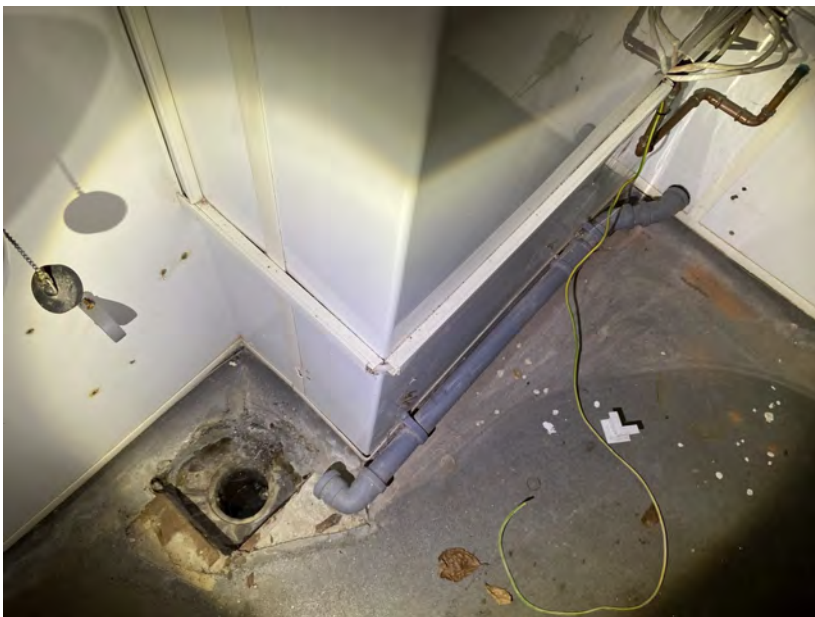
**Fig 94:**

Northeast extension; showing an internal drain that was draining water penetration via the leaking valley gutter and where entering beneath the external door

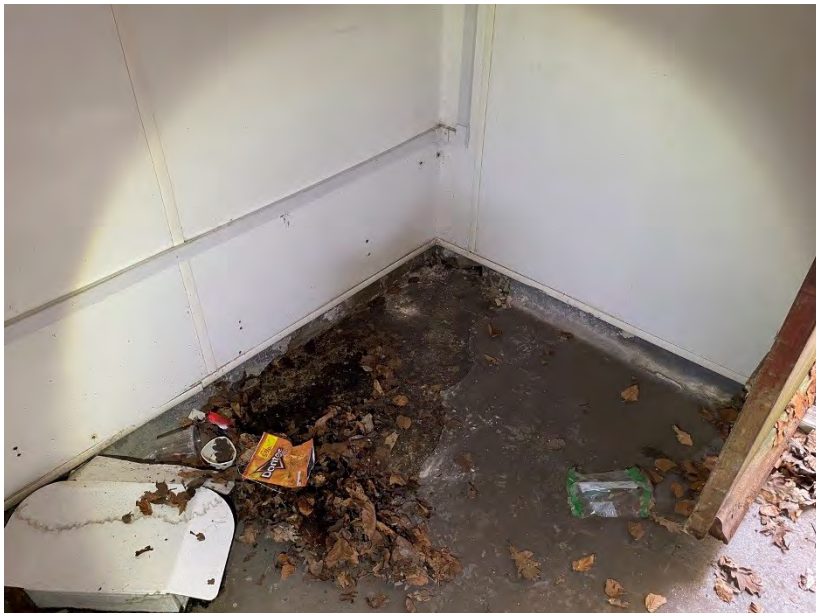
**Fig 95:**

Northeast extension; showing debris build-up and evidence of water pooling in the north-east corner of the Kitchen

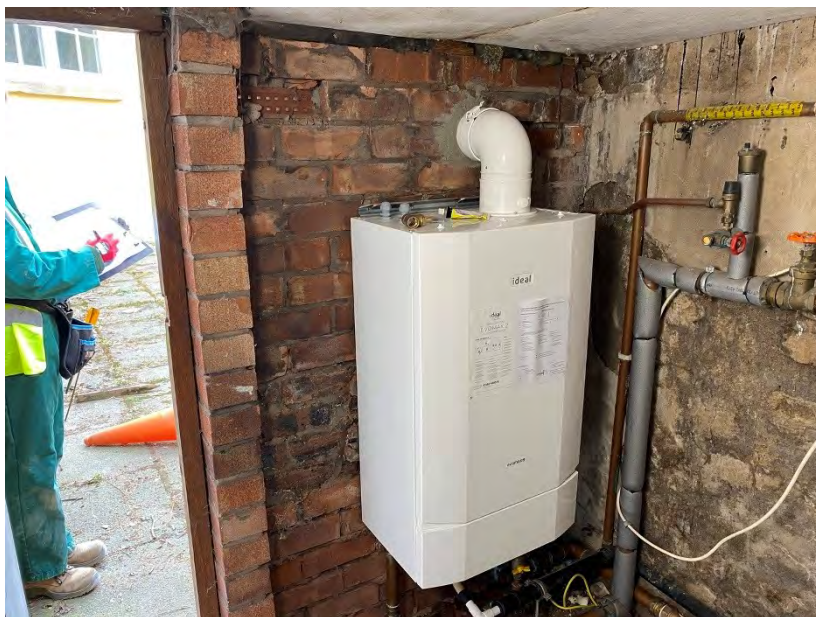
**Fig 96:**

Northeast extension; showing the relatively recently installed gas combi boiler

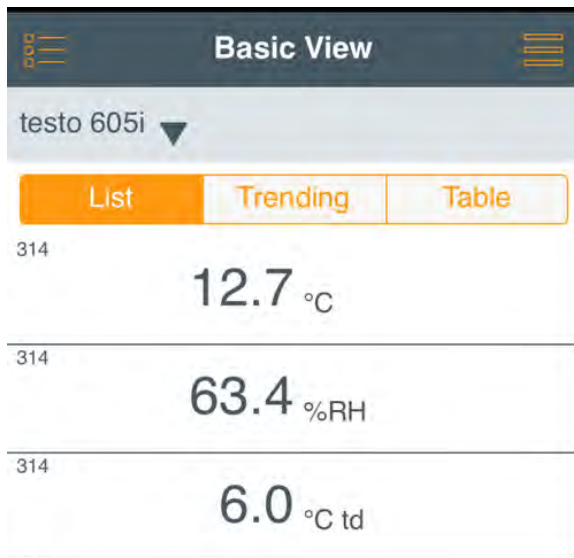
**Fig 97:**

Main gallery; showing hygrothermal readings taken within the room:

63.4% - Relative humidity

6.0°C - Dew point

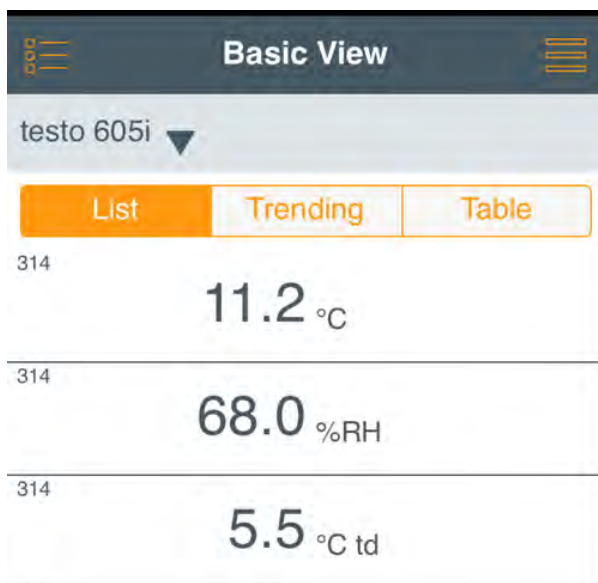
**Fig 98:**

Northwest extension; showing hygrothermal readings taken within the room:

68.0% - Relative humidity

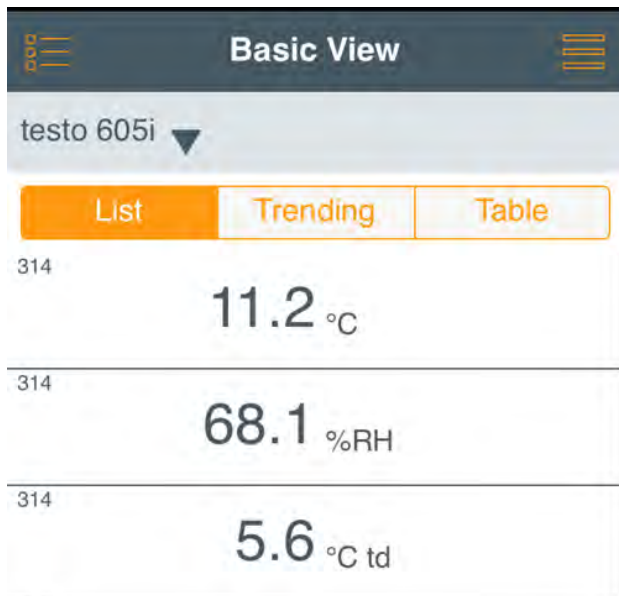
**Fig 99:**

Northeast extension; showing hygrothermal readings taken within the room:

68.1% - Relative humidity
