**SIM - Sitewide Capital Works**

**Stage 3 Structural Report – Viaduct Repair Planning Submission**

**SIM-BHE-XX-XX-RP-S-0101**

Revision P02

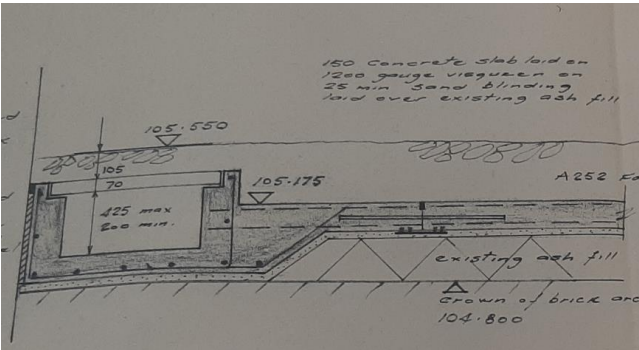
Figure 2-3 Section through 80's slab and drainage channel

At track level, the original build-up has been capped with a new concrete slab and drainage channels to the north and south, which were constructed in the 1980s. This slab includes extensive expansive and construction joints, the failure of which may be a cause of water ingress. The details for slab and channels appear to be well-documented, and a selection of details are included below.
