# Site 2 at Gorton Lane, Manchester

## Verification and Drainage maintenance report

Curtins Ref: 8790-CUR-00-XX-RE-C-003

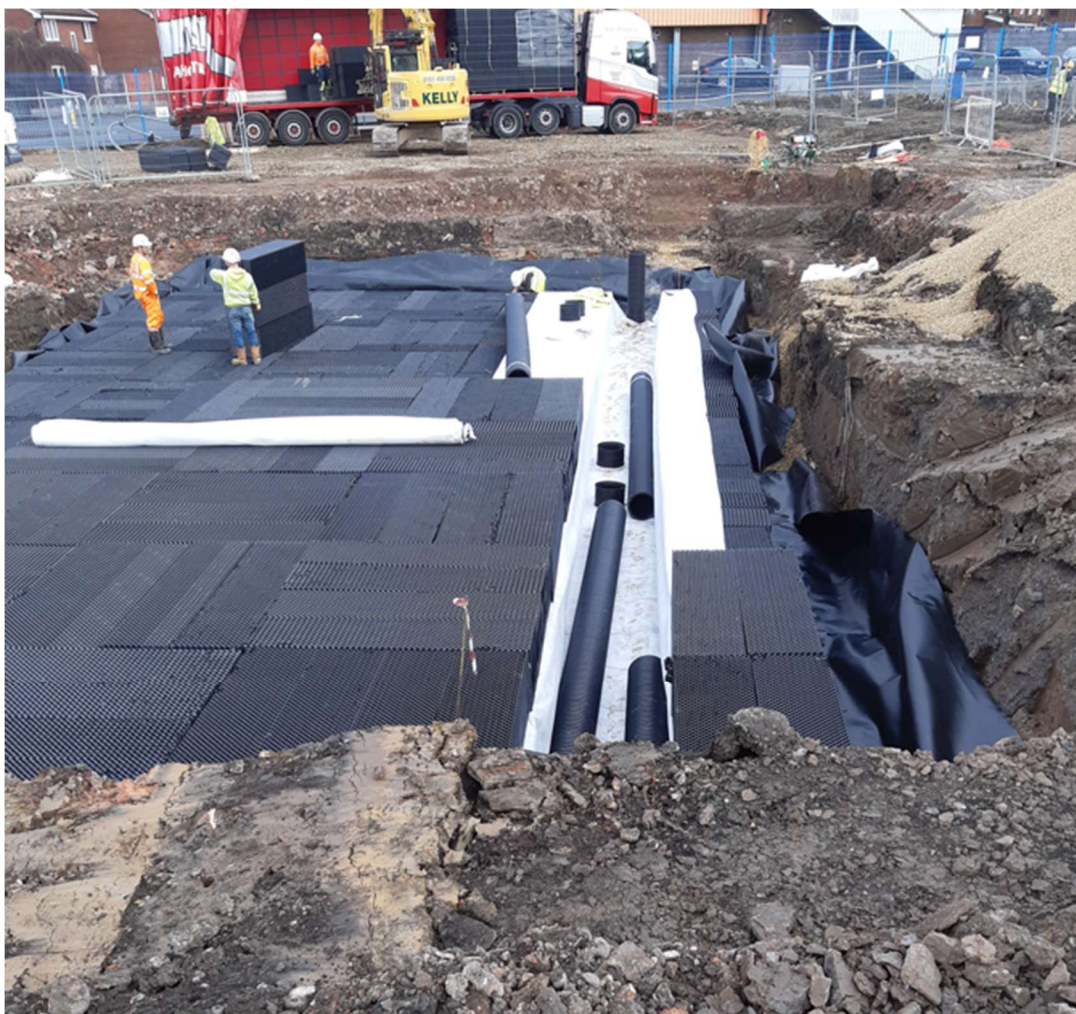
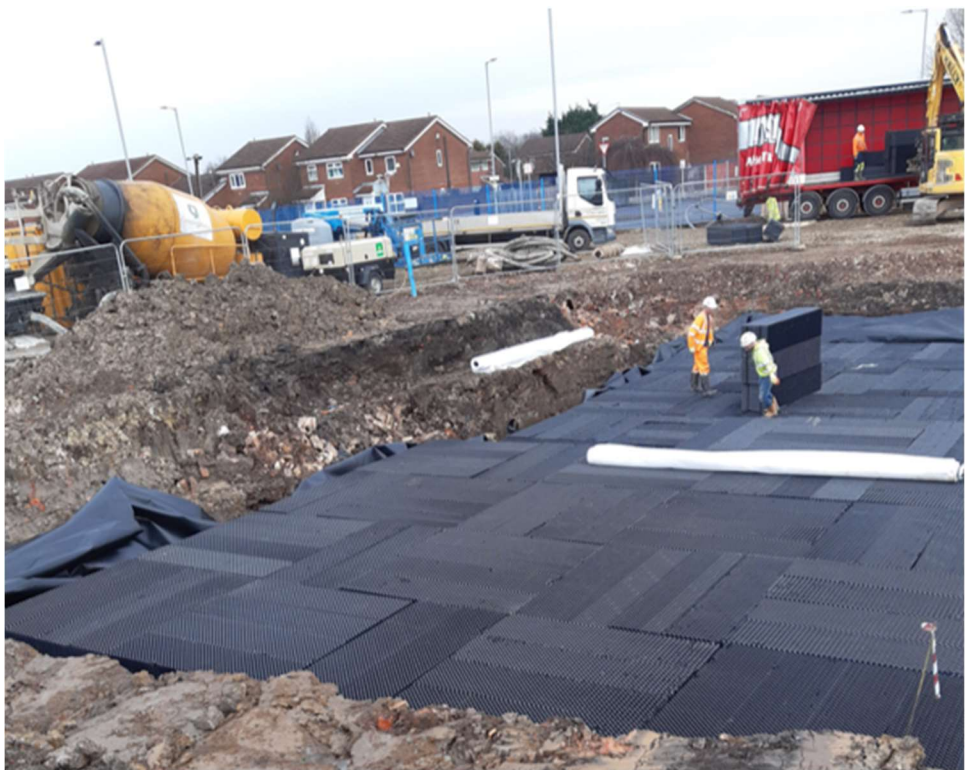
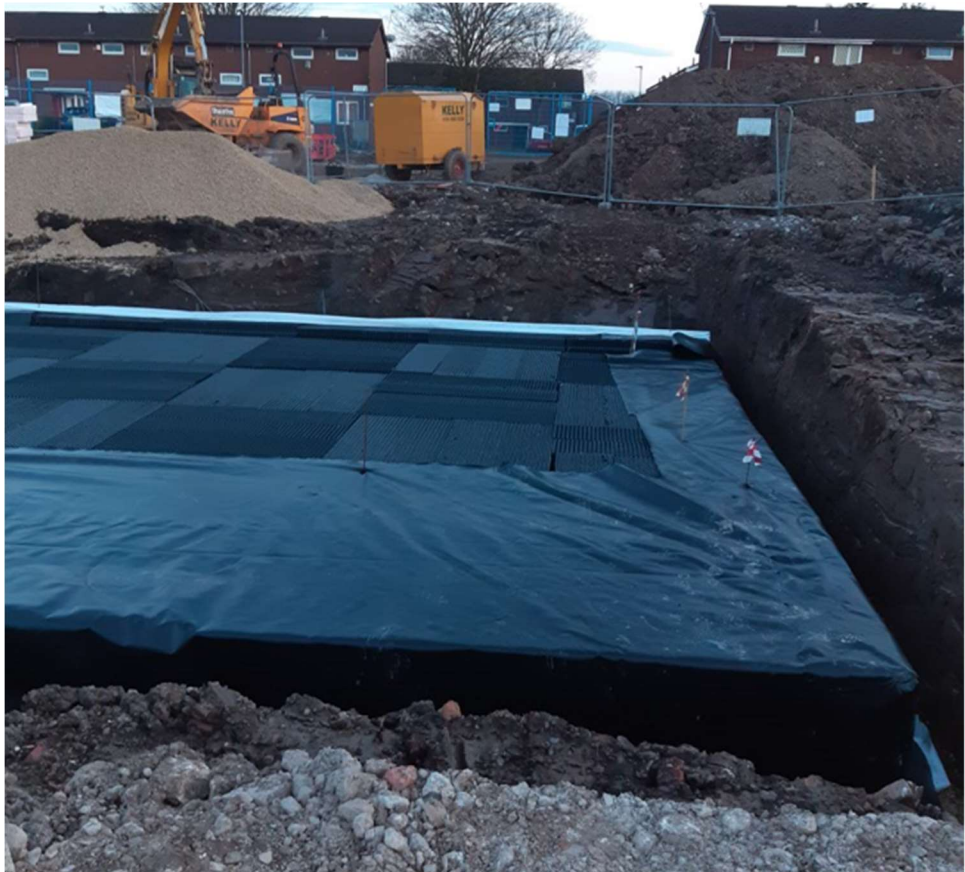
- 1.1.1 The surface and foul water as built CCTV drainage survey have been reviewed.
- 1.1.2 The foul and surface water drainage has been built to Curtin's design.
- 1.1.3 The CCTV survey report indicates the foul and surface water drainage has been installed correctly and has been cleaned.
- 1.1.4 Pictures from tank installation below.
