**Job Title**  
Hotspur Press, Cambridge Street,  
Manchester

**Report Type**  
Structural Appraisal, Condition  
and Proposals Report

**Date**  
Sept 2023

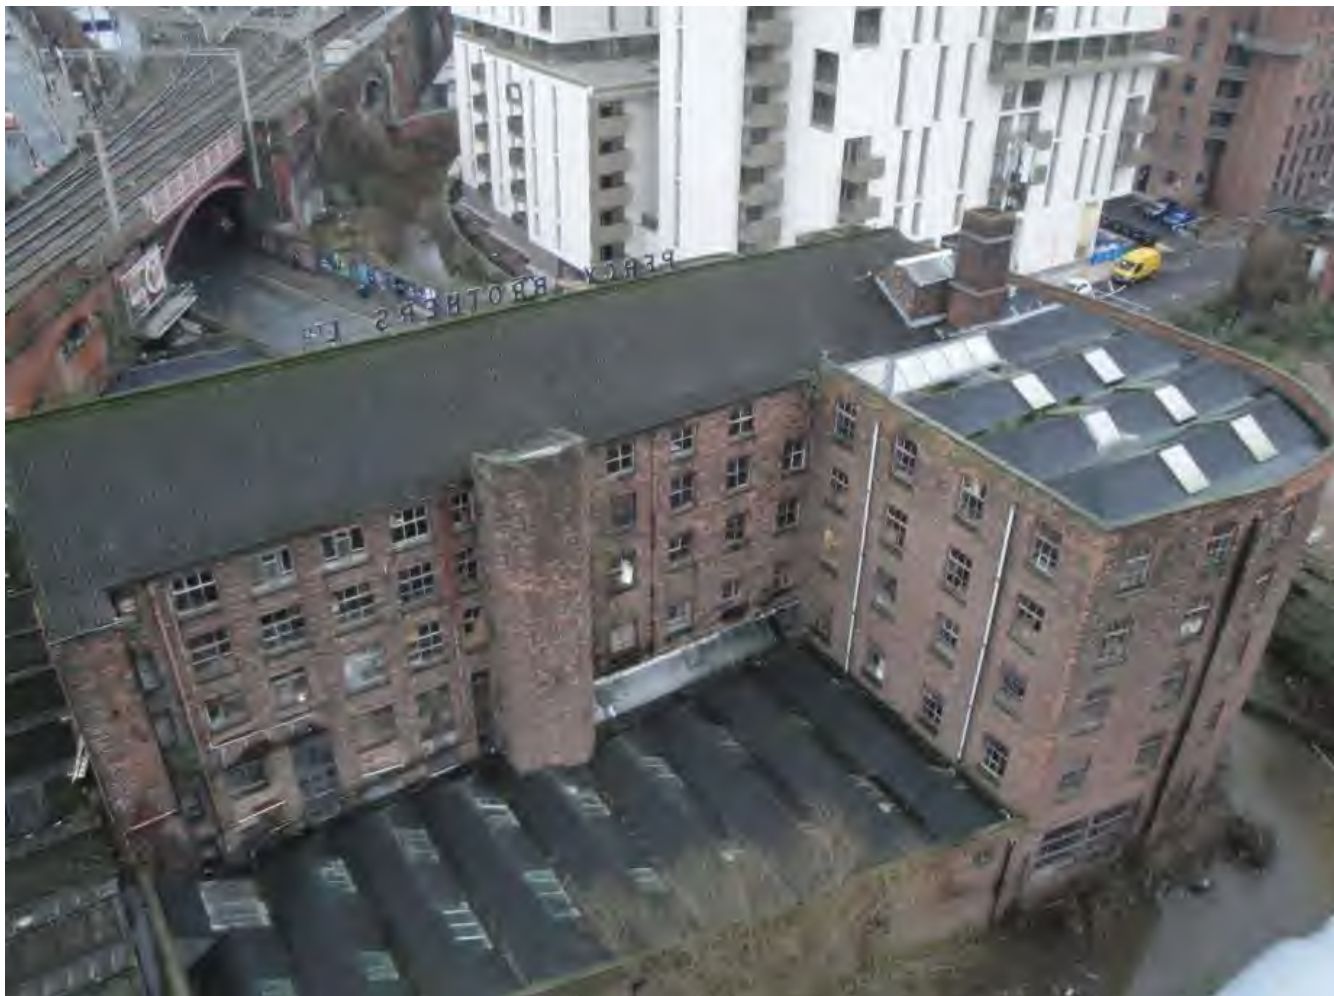
Figure 9 - Building Aerial View

While conducting the visual survey, Civic Engineers was not able to gain access to the external roof of the Warehouse. From aerial photos, refer also to Figure 9, it appears as though the roof has a bituminous covering and some vegetation growth is visible within the troughs of the pitched roof. The roof structure features a pitched timber roof with primary timber beams spanning between load bearing perimeter brickwork masonry walls with intermediate circular cast iron columns. The primary timber beams feature two primary softwood timber sections back to back, with staggered bolts connecting them. From visual survey, it was not possible to determine whether a central fitch plate existed between the two back-to-back timber members.

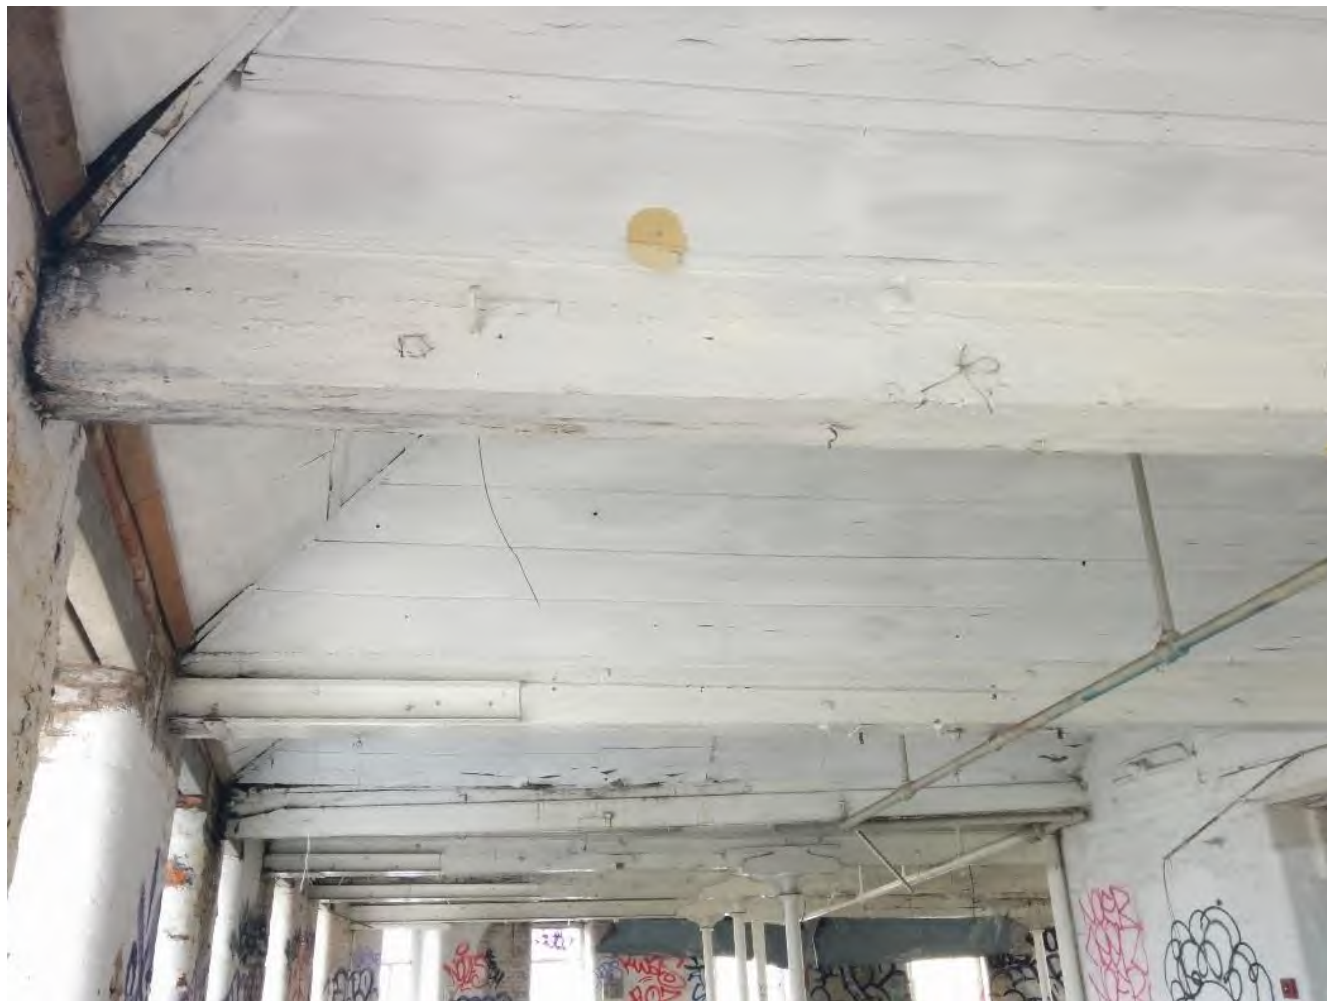
Roof timber rafters are typically located at 400mm centres (approx. as measured from floor level) and span between the timber ridge beam at the apex and the primary timber beams in the trough of the roof. The roof construction in the southern section was obstructed from view during the surveys due to the roof being internally under-boarded with timber boards as shown in Figure 11.

*Figure 11 - False ceiling at roof level (taken 2018)*

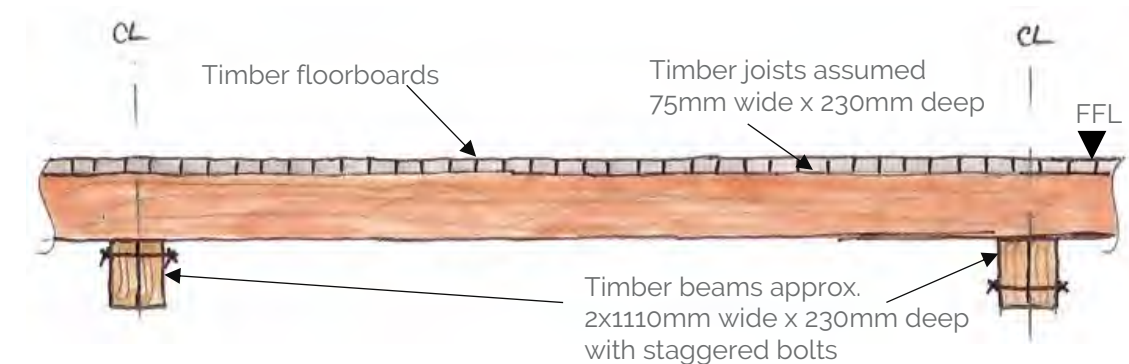
Figure 14 - Timber joisted floor at third floor level

The primary timber beams feature two primary softwood timber sections back to back, with staggered bolts connecting them, as per Figure 14. From visual survey, it was not possible to determine whether a central flitch plate existed between the two back-to-back timber members. Most of the timber beams at third floor levels have a paint covering. False ceiling present to the underside of third floor level obstructed the inspection of the timber joists. It is assumed the timber joists at second floor level are similar to the timber joisted floor at lower levels. The timber joists are assumed to be approximately 75mm wide and 230mm deep at 400mm centres, as illustrated also in drawing S-EX-105, Appendix A.. Timber floorboards are overlaying the timber joists.

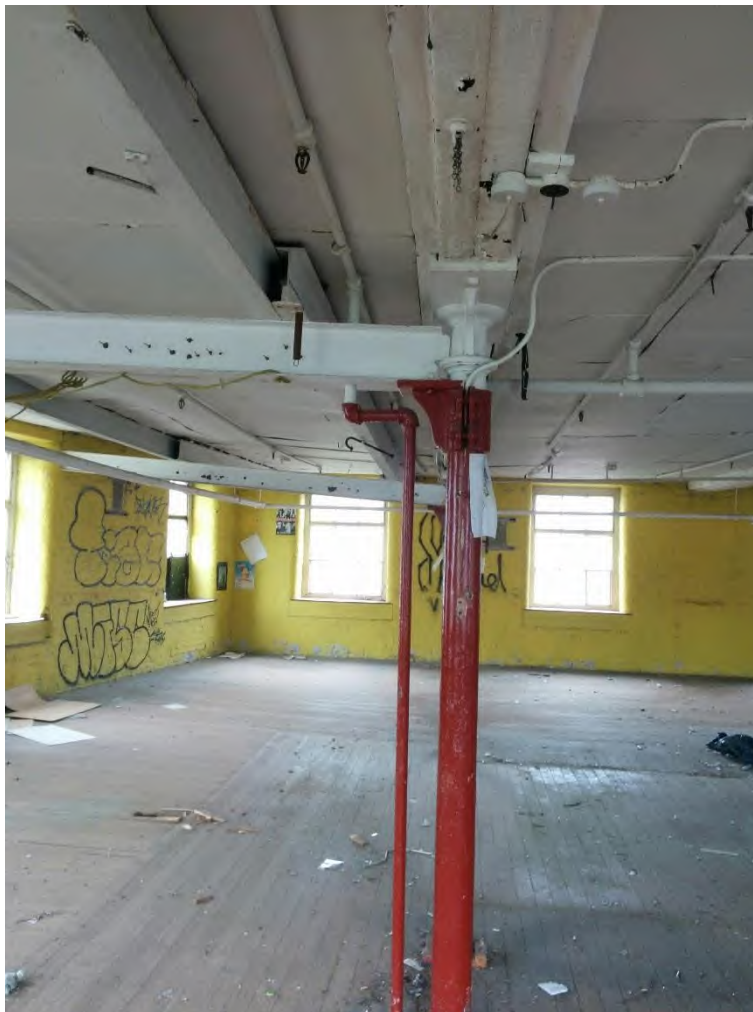
At the western section of the Warehouse, more recent steel beams have been introduced most probably to provide support for several lifting hoists. The steel beams span between the cast iron columns and masonry elevation walls, as per Figure 15. It appears the steel beams are supported directly on the masonry elevation walls with no signs of any padstones.

*Figure 15 - New steel beams (taken 2018)*

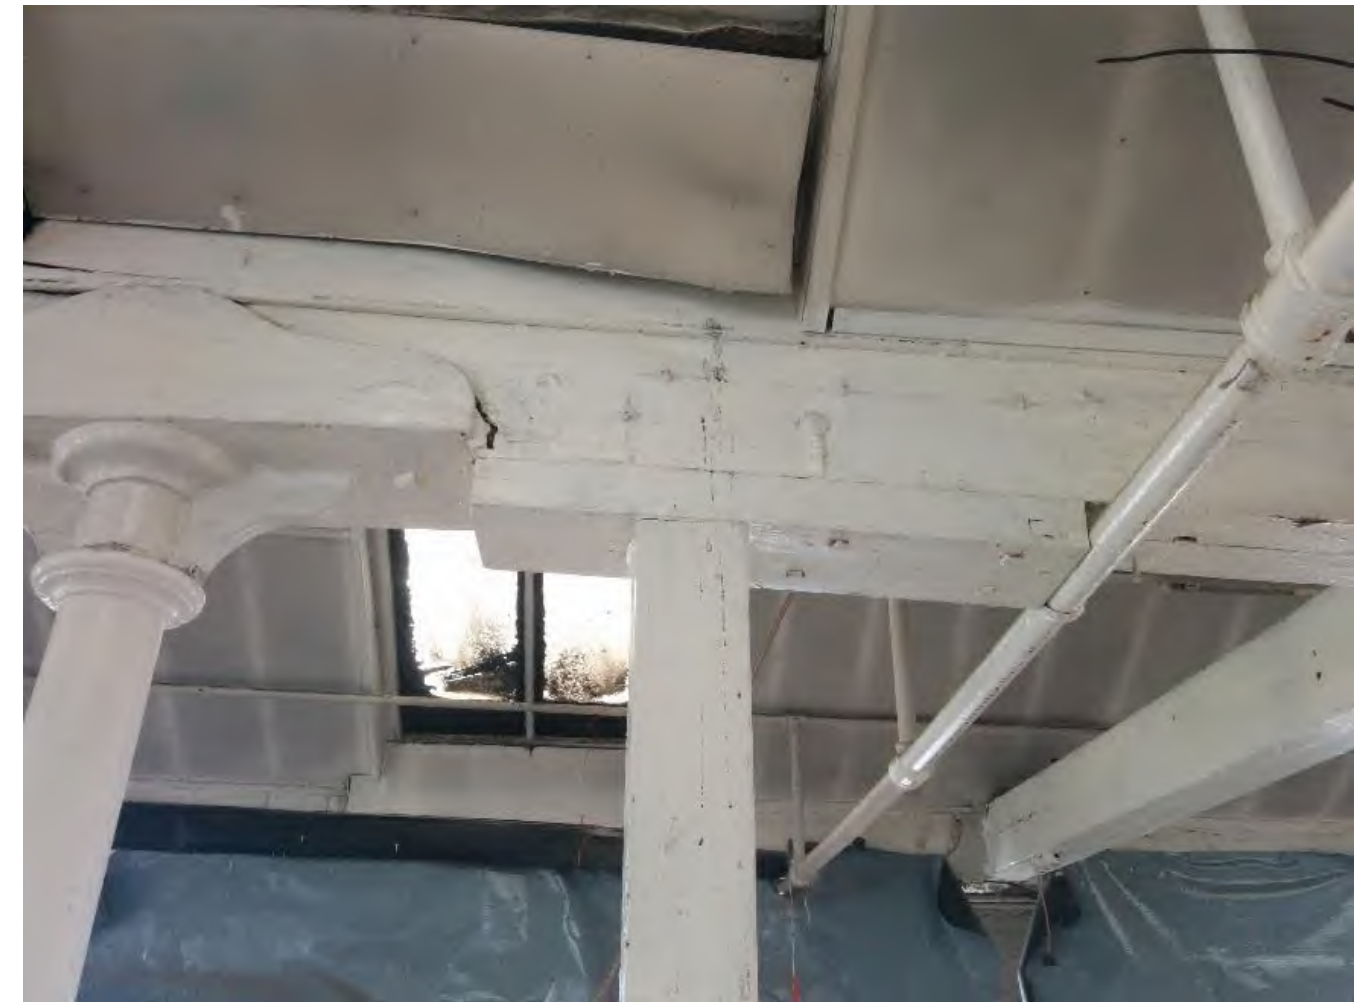
*Figure 16 - Timber board introduced with the timber posts (taken 2018)*

It appears that several timber posts have been introduced at third floor level to offer additional propping to the roof timber beams. A timber bearing member is located between the roof timber beams and the timber posts, as per Figure 16

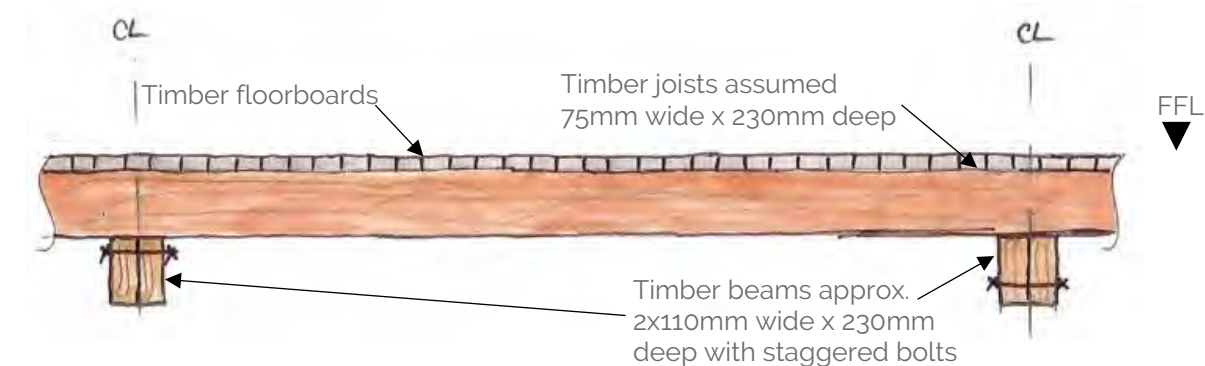
Figure 24 - Timber joisted floor at second floor level

The primary timber beams at second floor level are similar to third floor level. The timber beams feature two primary softwood timber sections back to back, with staggered bolts connecting them, as illustrated in Figure 24. From visual survey, it was not possible to determine whether a central flitch plate existed between the two back-to-back timber members. The timber beams are approximately 110mm wide and 230mm deep.

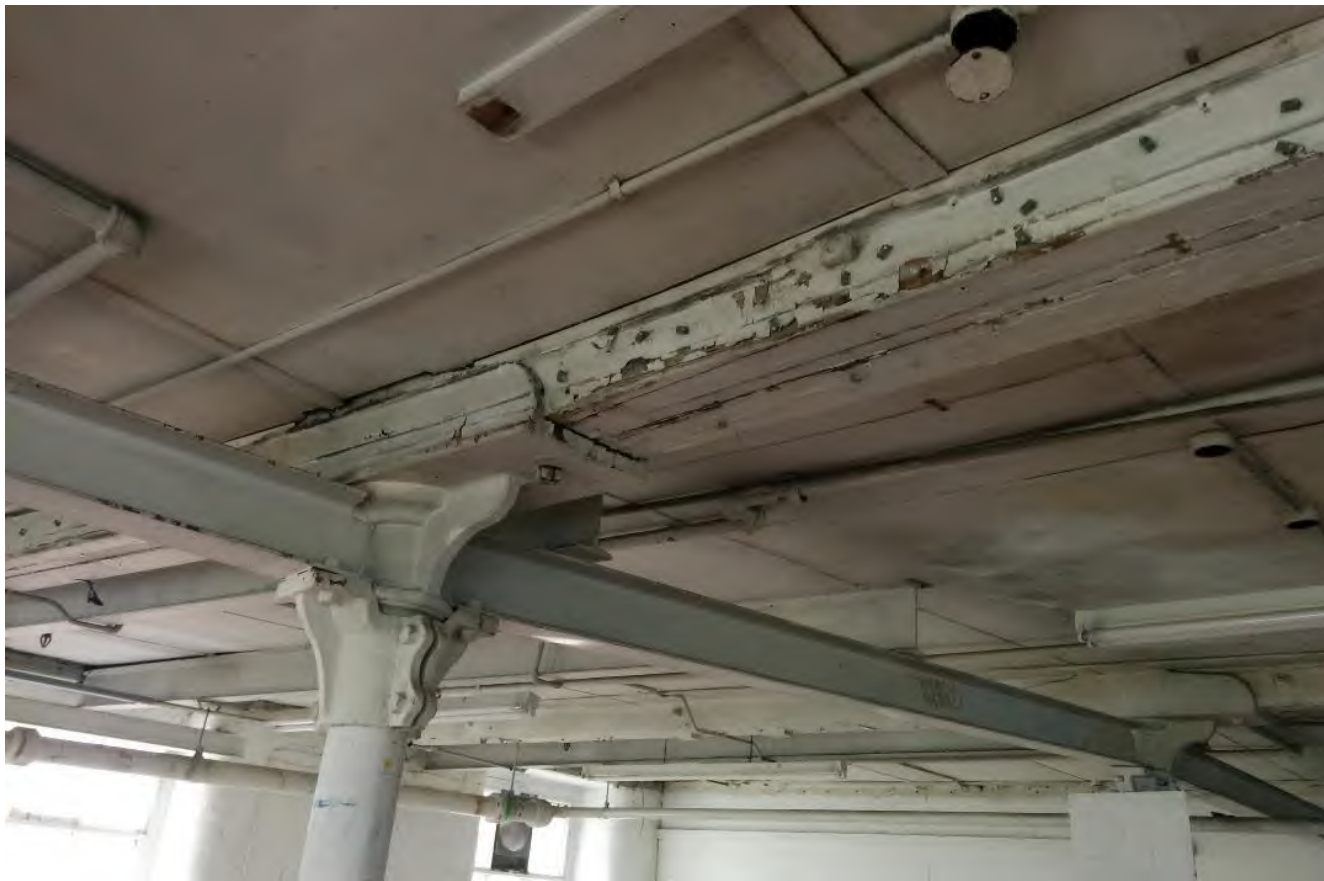
Several steel beams have been added to the underside of the timber floor at second floor level most probably to provide support for different lifting hoists during the previous use of the building. Primary steel beams span from west to east directly onto the cast iron columns, as per Figure 25. A bracket around the column head has been later added to support the primary steel beam. The secondary steel beams span from north to south between the primary steel beams and masonry elevation walls. The end supports of secondary steel beams are built into the external walls, with no padstone supports observed.

Figure 25 - Primary steel beams bearing onto cast iron columns (taken 2018)

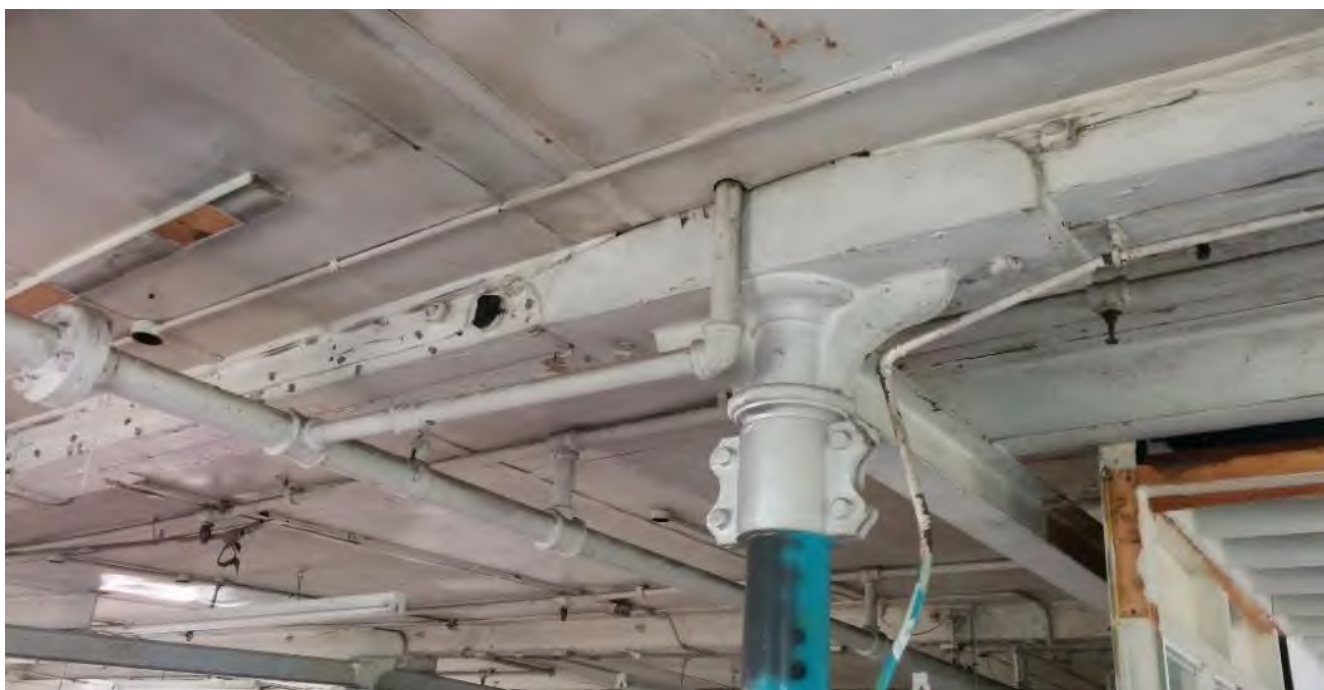
Figure 26 - Secondary steel beams bearing onto primary steel beams (taken 2018)

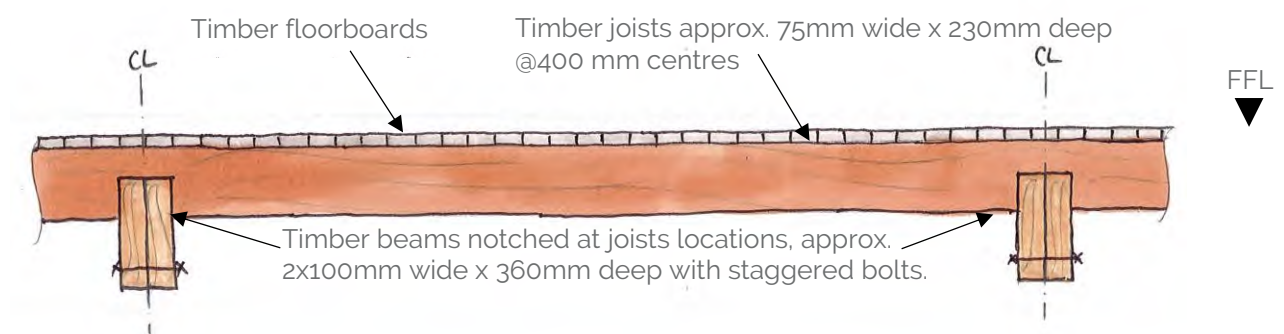
Figure 29 - Timber joisted floor at first floor level

The primary timber beams at first floor level feature two primary softwood timber sections back to back with staggered bolts connecting them. From visual survey, it was not possible to determine whether a central flitch plate existed between the two back-to-back timber members. Each of the two timber beam sections is approximately 100mm wide and 360mm deep with notches at joists locations, as delineated in Figure 29. Timber joists approximately 75mm wide and 230mm deep span between the timber beams, as illustrated in drawing S-EX-103, Appendix A. Timber floorboards overlay the timber joists.

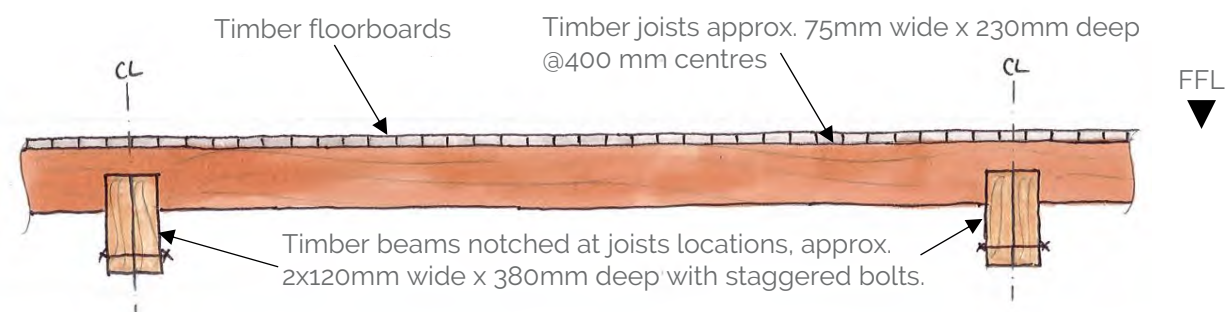
Figure 32 - Timber joisted floor at ground floor level

The primary timber beams at ground floor level feature two primary softwood timber sections back to back with staggered bolts connecting them. From visual survey, it was not possible to determine whether a central flitch plate existed between the two back-to-back timber members. Each of the two timber beam sections is approximately 120mm wide and 380mm deep with notches at joists locations, as delineated in Figure 32. Timber joists approximately 75mm wide and 230mm deep span between the timber beams. Timber floorboards overlay the timber joists.

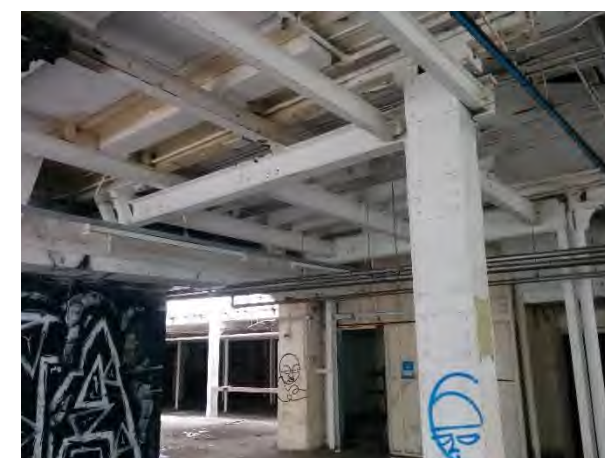
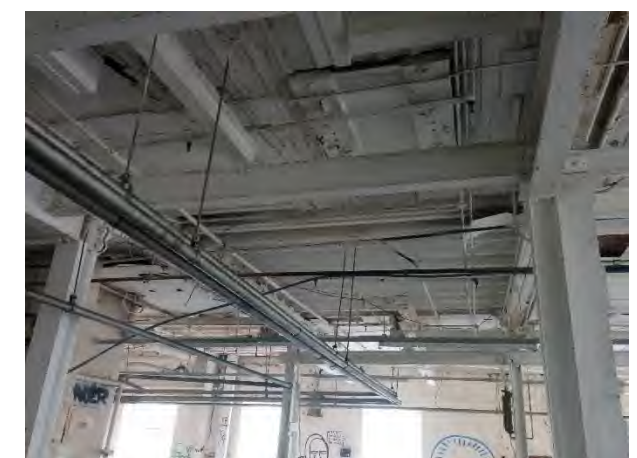
Supplementary steelwork structure in place supporting ground floor level at numerous locations across floor plate, as illustrated in Figure 34.

Figure 34 - Supplementary steelwork supporting ground floor level (taken 2018)

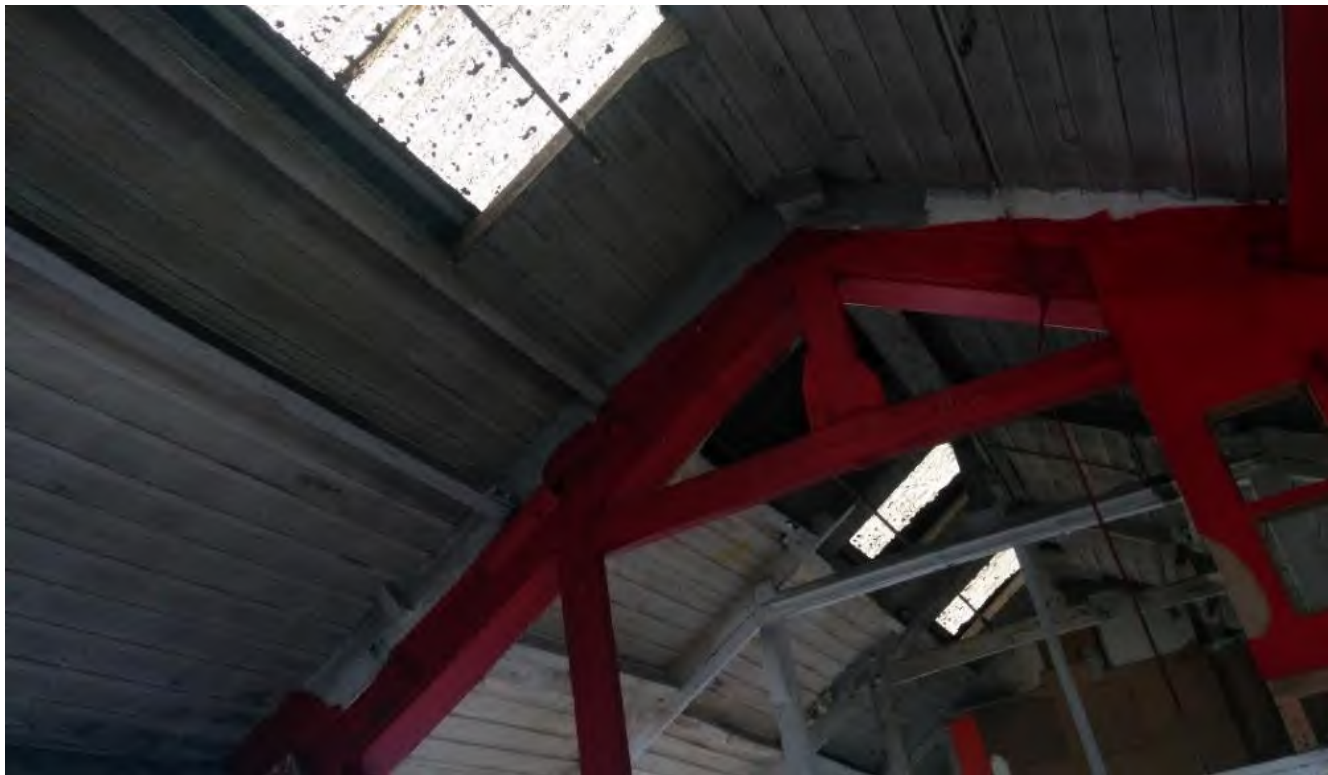
The timber ring post is not evident for several trusses which would suggest that previous works to the timber roof trusses have been likely carried out as it appears the queen-post timber trusses look slightly different throughout the roof level, as delineated in Figure 39. It appears that previous strengthening works have been carried out to the timber roof trusses by replacing the timber web members located in close proximity to the eastern elevation with steel plate web members, as illustrated in Figure 40 and Figure 42. The steel plates web members appear to be approximately 200mm wide.

Figure 39 - Roof skylights and timber roof trusses (taken 2018)

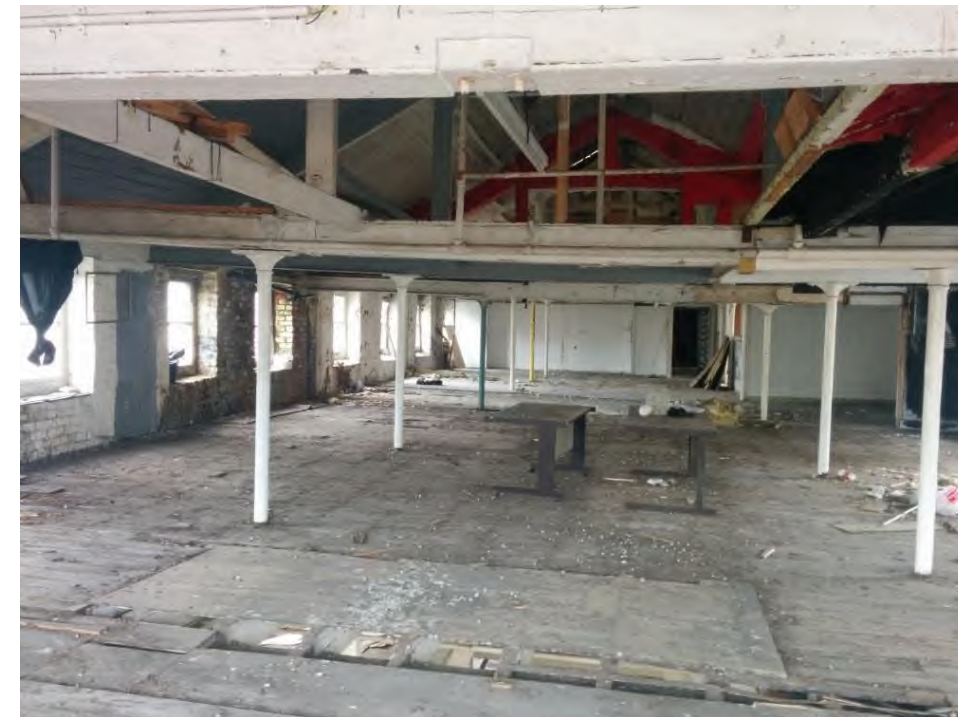
Figure 41 - Cast iron columns supporting timber roof trusses; damp timber floor at third floor level (taken 2018)

The timber floor at third floor level is significantly damp with areas of missing timber floor boards, as illustrated by Figure 41 and Figure 46. The timber finish is generally worn and uneven throughout.

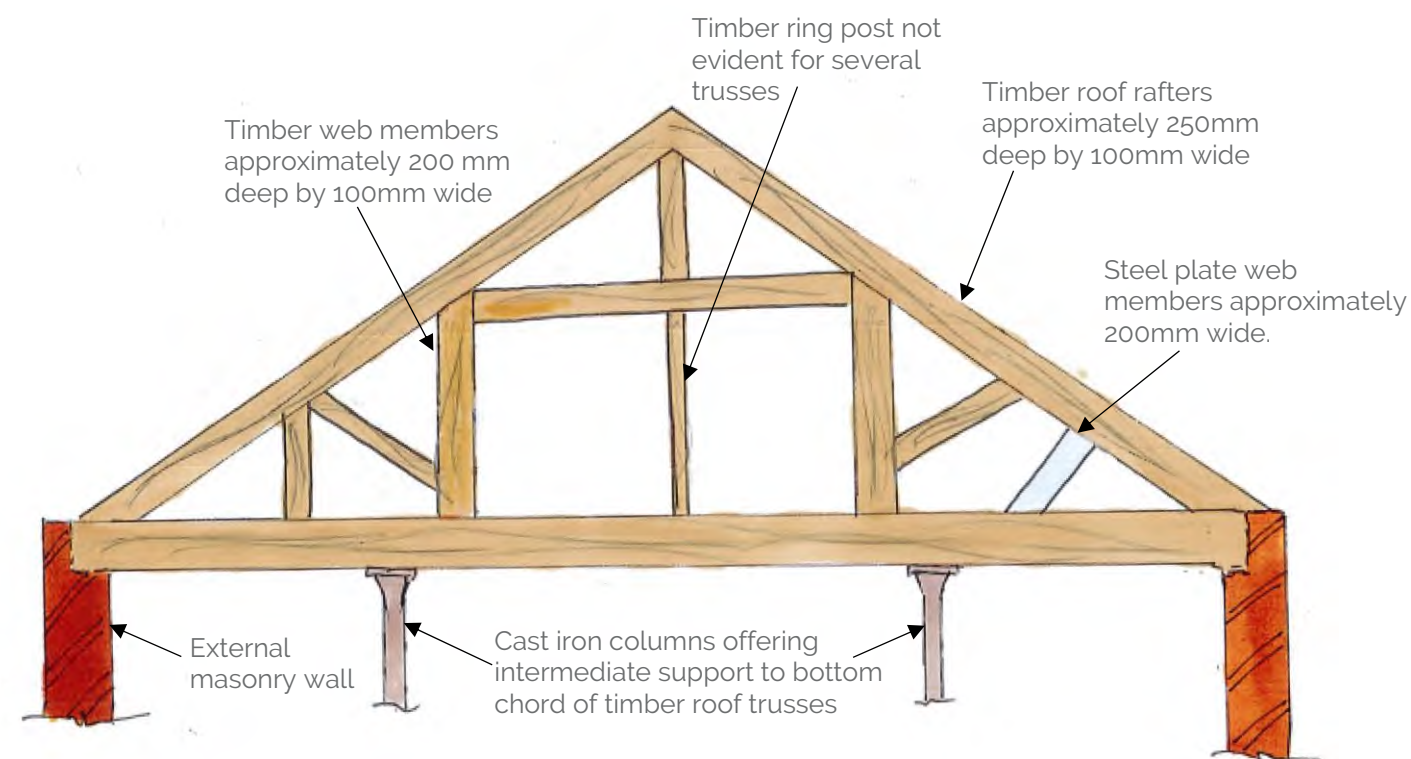
Queen-post timber roof trusses span between external load bearing masonry walls, as delineated in Figure 40. Two lines of cast iron columns, typically approximately 90mm in diameter, are offering support to the bottom timber chord, as delineated in Figure 40 and Figure 41. The roof trusses comprise of timber roof rafters approximately 250mm deep and 100mm wide and timber web members approximately 200mm deep and 100mm wide.

Figure 40 - Queen-post style timber roof trusses

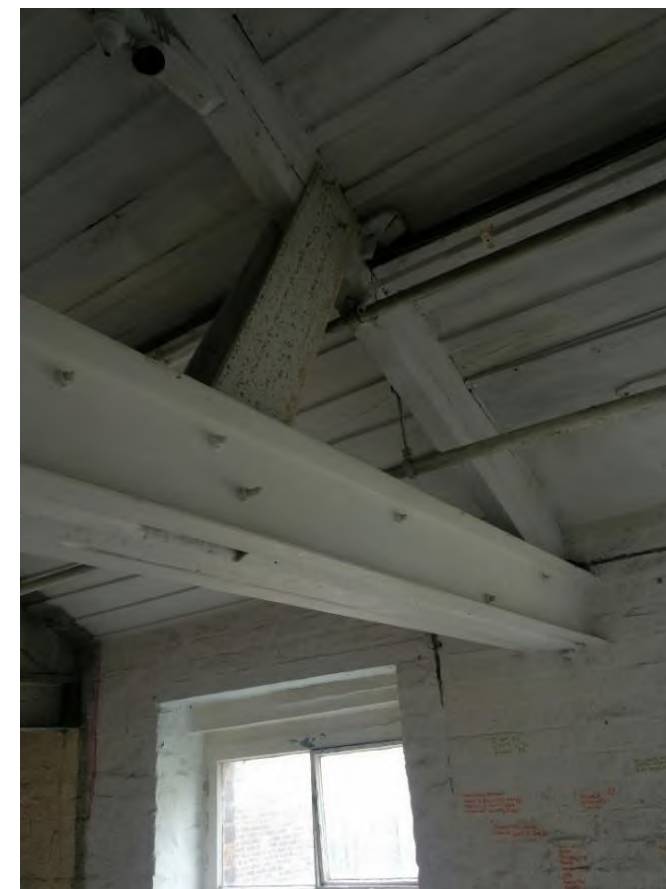
All bottom chord sections of the timber trusses have been previously strengthened with parallel flange channels (PFC) sections towards the eastern section of the Mill, as delineated in Figure 42. The PFC sections are bolted in a staggered arrangement to each vertical face of the timber elements. It is possible that the PFC strengthening has been installed due to the poor condition of the bearing ends of the timber roof trusses, which has likely been caused by water ingress.

Figure 42 - Timber beam strengthening with PFC sections and steel plates (taken 2018)

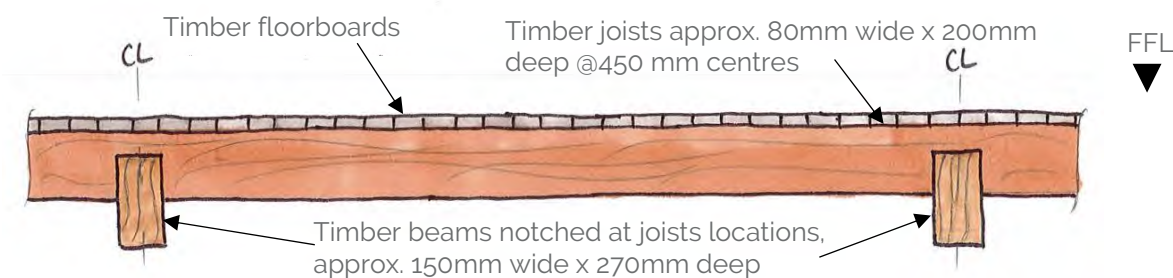
Figure 43 - Timber joisted floor at third floor level

At third floor level, timber beams span between the external masonry load bearing walls with cast iron columns offering intermediate support. The timber beams at third floor level are typically 150mm wide and 270mm deep (approx.), as illustrated in drawing S-EX-105 in Appendix A of this report. Timber joists approximately 75mm wide and 180mm deep span onto the timber beams at 450mm centres, as illustrated in Figure 43. Timber floor boards span between timber joists.

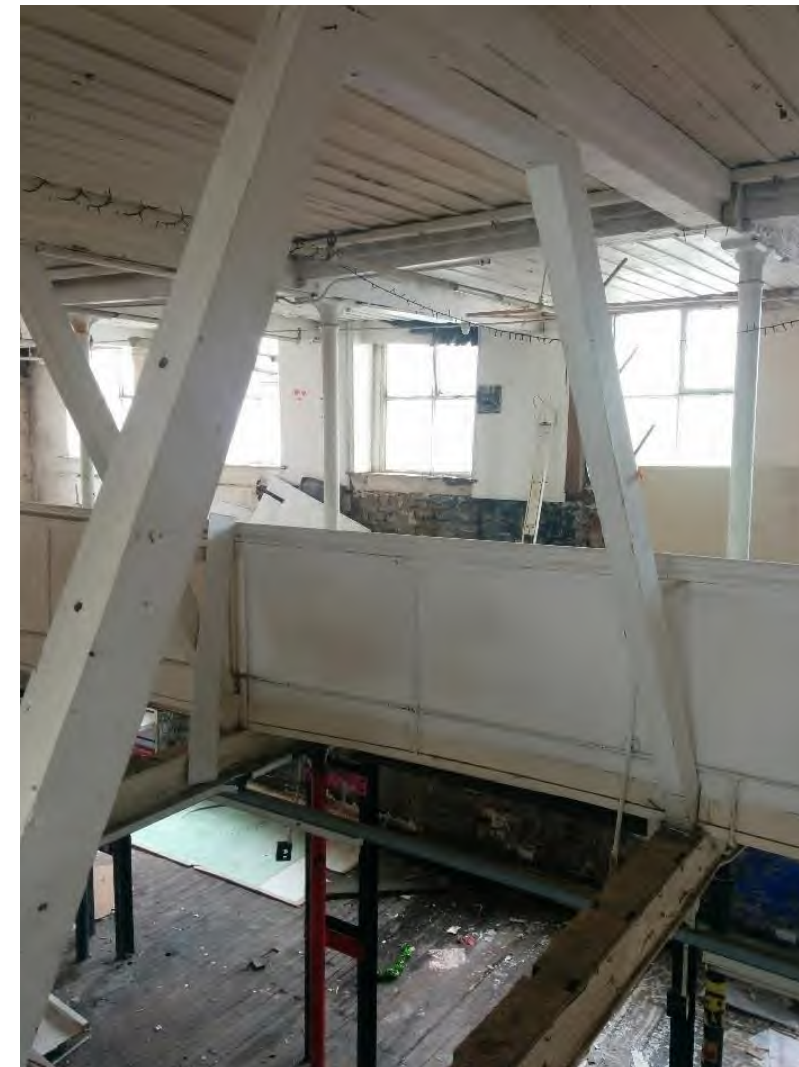
Simple timber truss arrangements, located in the mezzanine area of the building, support the third floor level, also see Figure 44. In the first and second bay from the northern elevation, as well as in two central bays, timber truss top chords and diagonal members are missing.

Figure 44 - Simple timber truss arrangement at mezzanine level supporting underside of third floor (taken 2018)

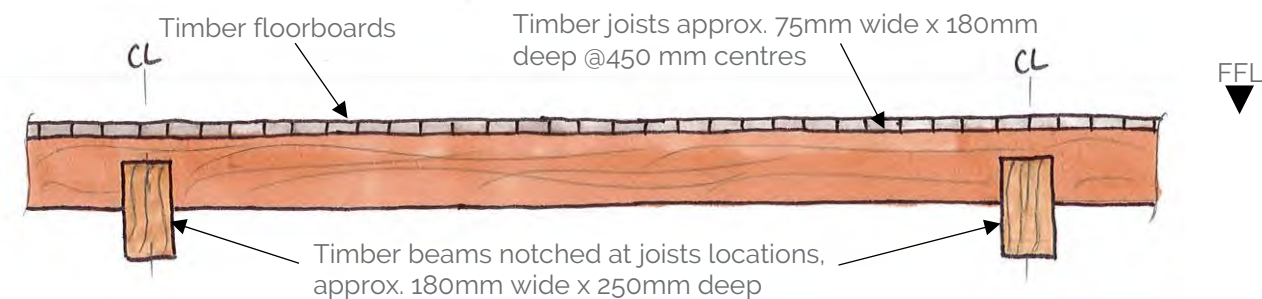
Figure 47 - Timber joisted floor at second floor level

Timber beams at second floor level span onto the masonry walls from east to west with intermediate cast iron columns supporting the timber beams. The timber beams are typically 180mm wide and 250mm deep (approx.) with timber joists spanning over. The timber beams are typically notched at joists locations, as illustrated in Figure 47 and drawing S-EX-104 in Appendix A. The timber joists are approximately 75mm wide and 180mm deep located at about 450mm centres.

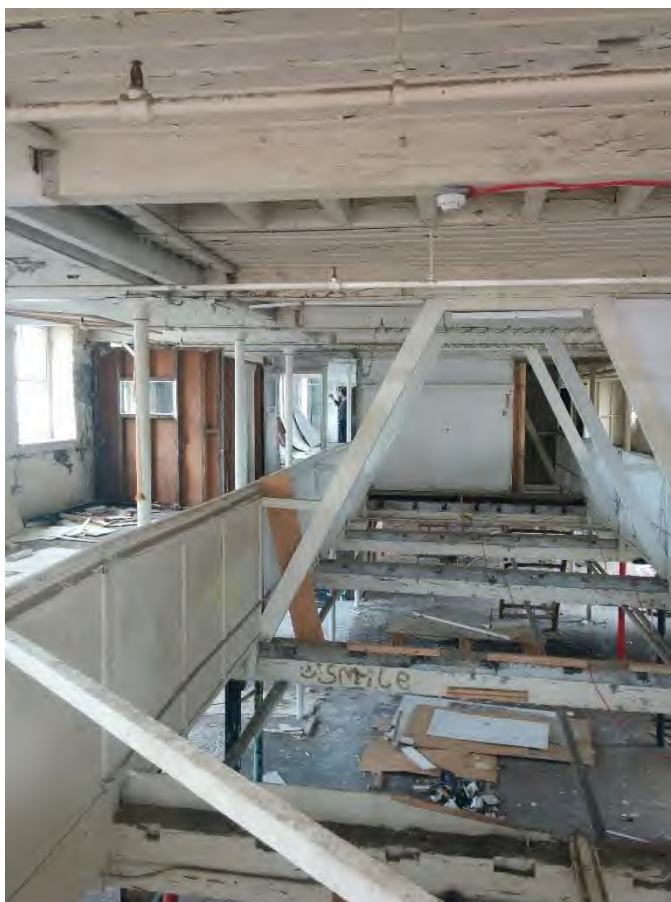
Figure 48 - Mezzanine along central part (taken 2018)

The second floor is noted as a mezzanine level, though a central void space within the floor has historically been created by removing floor joists as per Figure 48. Timber beams span between the external masonry walls and supported at intermediate points by cast iron columns are supporting the mezzanine level. The cast iron columns are approximately 110mm in diameter. A timber parapet is located at mezzanine level. From visual inspection it could not be established how the parapet is fixed to the floor at first level.

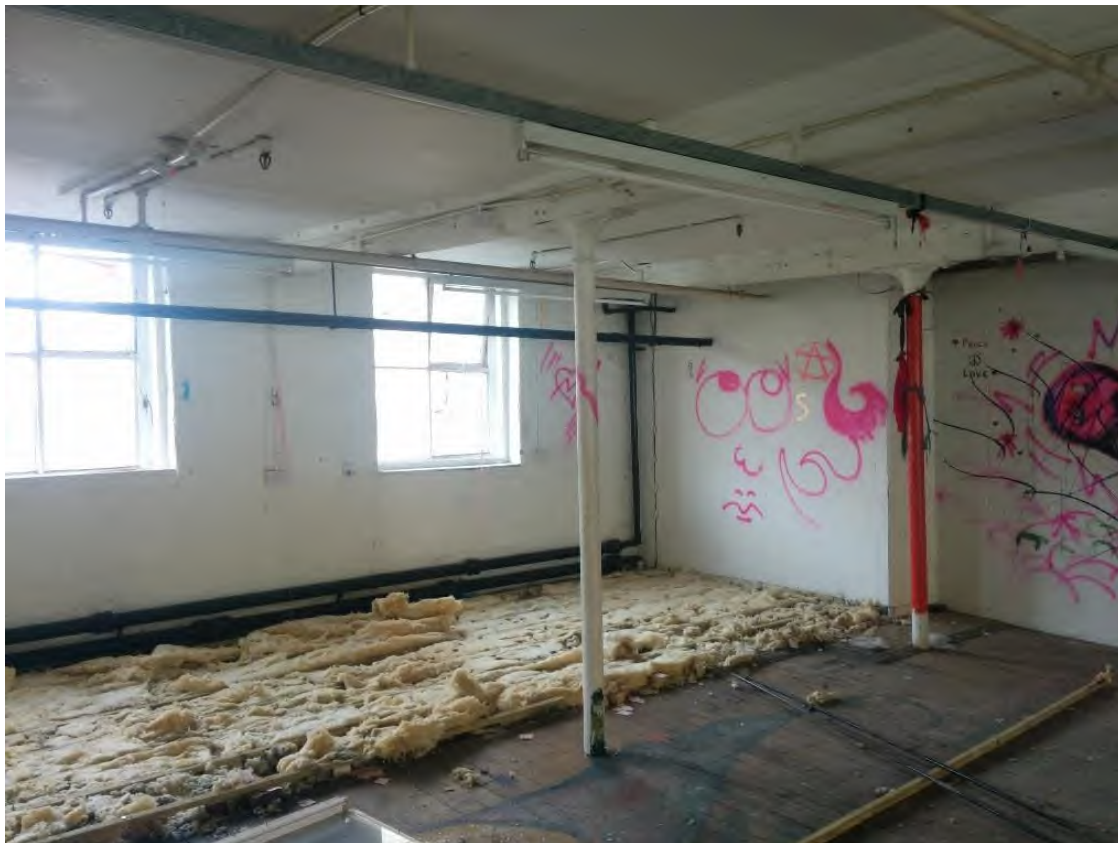
Overlaying the timber floor at first floor level are materials that seem to be mineral fibre insulation, as shown in Figure 51. These materials are obstructing an inspection of the condition of the timber floorboards in these areas.

*Figure 51 - Fibre materials overlaying timber floor at first floor level (taken 2018)*

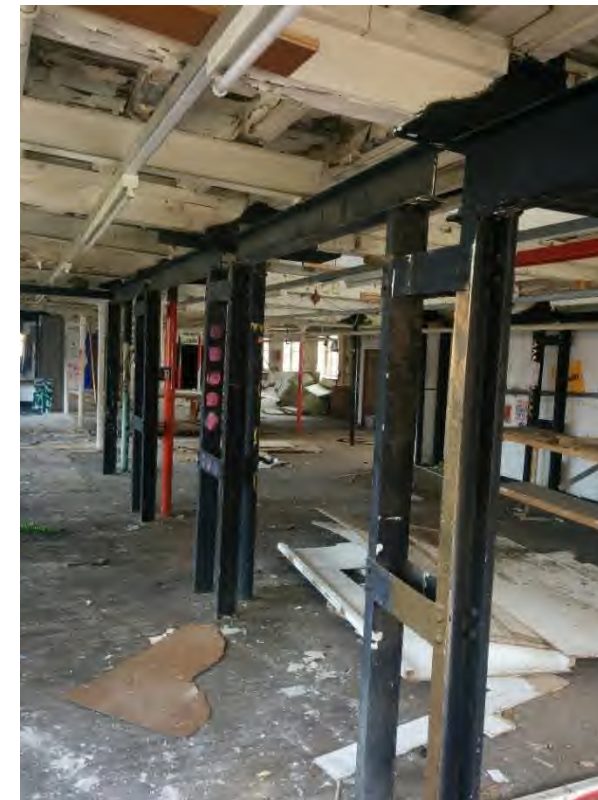
Supplementary steelwork structure is located in the northern section of the building at first floor level, as per Figure 52 and is offering support to the second floor timber beams.

*Figure 52 - Supplementary steelwork structure at first floor (taken 2018)*

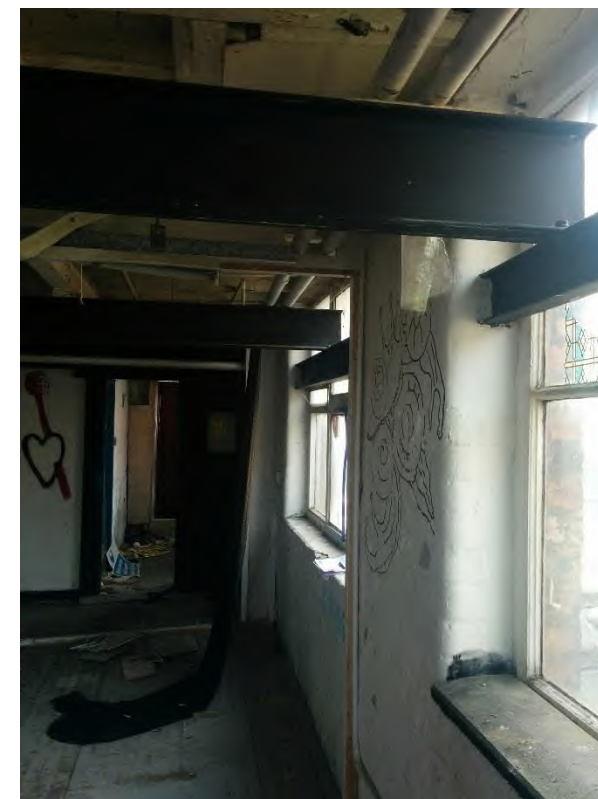
Three rows of steelwork columns and beams are present across the four eastern bays of the Mill building. Towards the eastern part of the building, the beams are spanning onto lintels which had been positioned across the window openings in the external western elevation, as per Figure 53.

*Figure 53 - Steel lintels at windows in first floor level (taken 2018)*

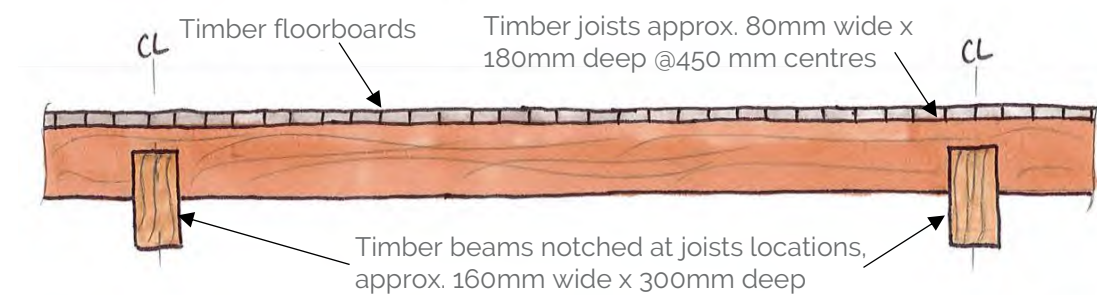
The timber joisted floor located towards the southern section of the building could be partially inspected. Timber beams are spanning between the load bearing masonry elevation walls with cast iron columns offering intermediate support. Timber joists approximately 80mm wide and 180mm deep are spanning onto the timber beams at 450mm centres. The timber beams are approximately 160mm wide and 300mm deep in section.

Figure 56 - Timber joisted floor at upper ground floor level (southern section of the building)

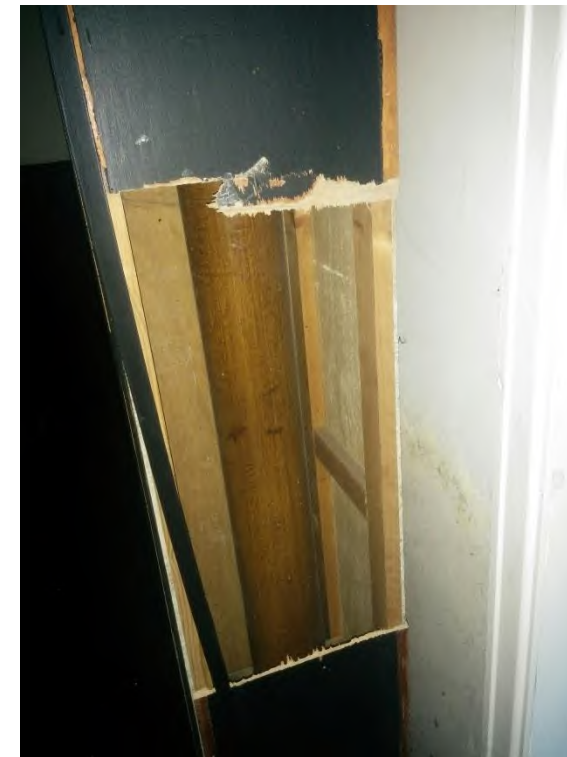
Existing finishes to the upper ground floor level are obscuring the inspection of several cast iron columns. Some finishes to the cast iron columns have been previously removed, as delineated in Figure 57, exposing the structural elements. The columns that could be inspected at upper ground floor level are typically about Ø110mm in diameter.

Figure 57 - Previous opening up works around cast iron columns at Upper Ground Floor Level (taken 2018)

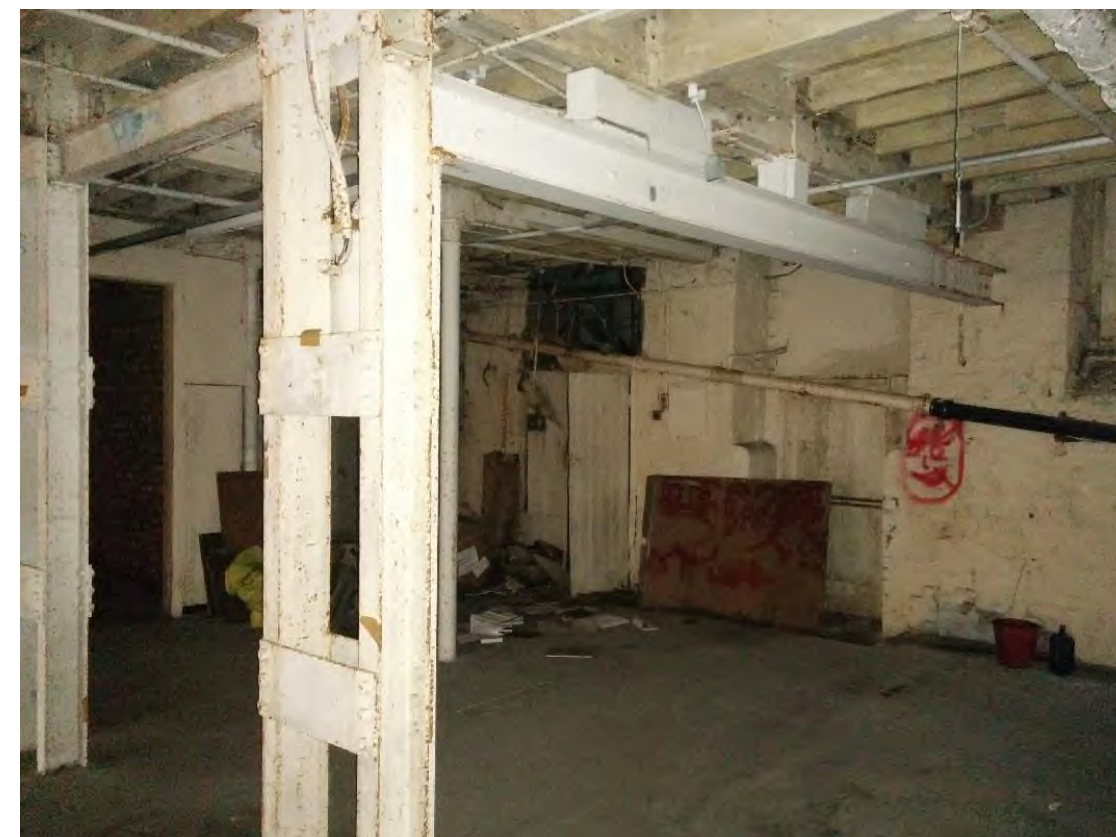
Supplementary steelwork structures have been previously added in the basement to offer support to the first floor level. Several steel beams are spanning between PFC steel columns and load bearing masonry wall, as per Figure 59.

Figure 59 - Supplementary steelwork in basement (taken 2018)

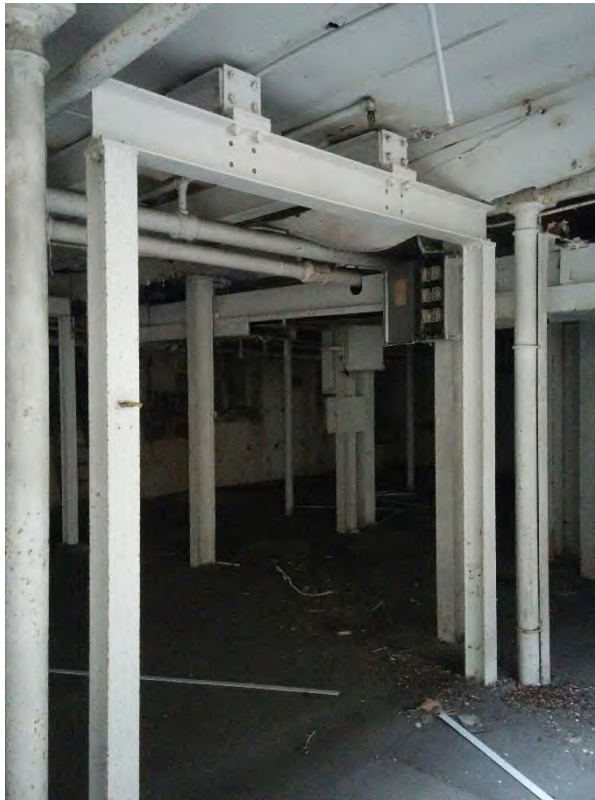
Steel frames located in basement have been most probably added to offer support to lifting hoists associated with the previous use of the building, see also Figure 60.

Figure 60 – Steelwork frame in basement (taken 2018)

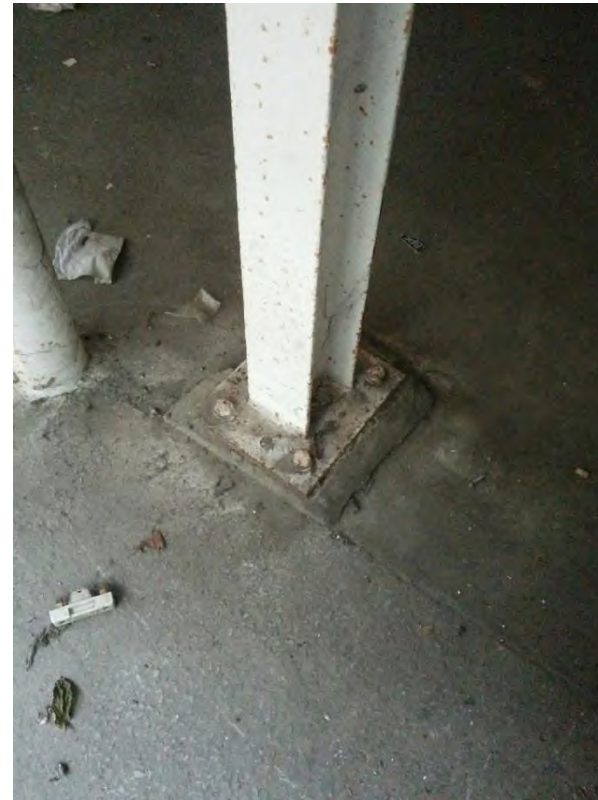
Figure 61 - Column baseplate detail (taken 2018)

It appears the steel column baseplates have been added directly on top of the existing concrete slab with a bedding layer of grout, as per column baseplate detail in Figure 61.
