**Job Title**  
Hotspur Press, Cambridge Street,  
Manchester

**Report Type**  
Structural Appraisal, Condition  
and Proposals Report

**Date**  
Sept 2023

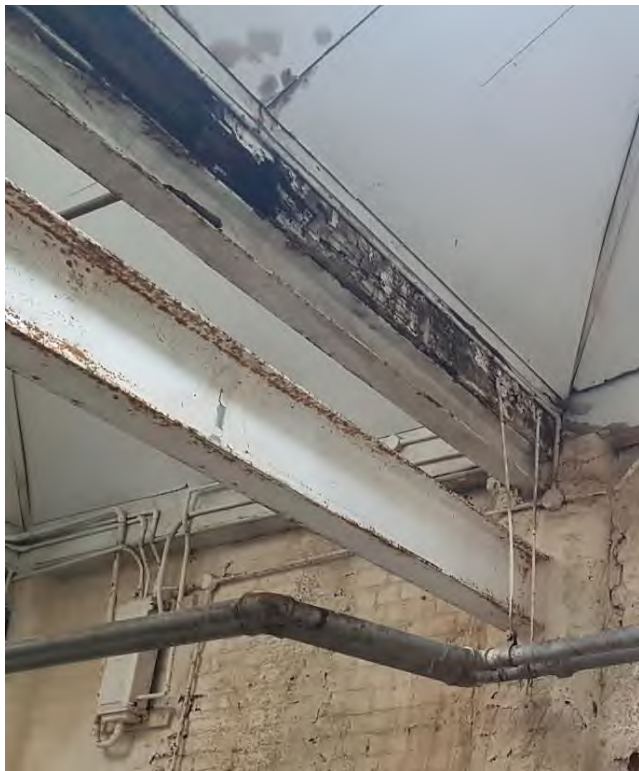
Figure 62 - Additional steel beams supporting timber beam (taken 2018)

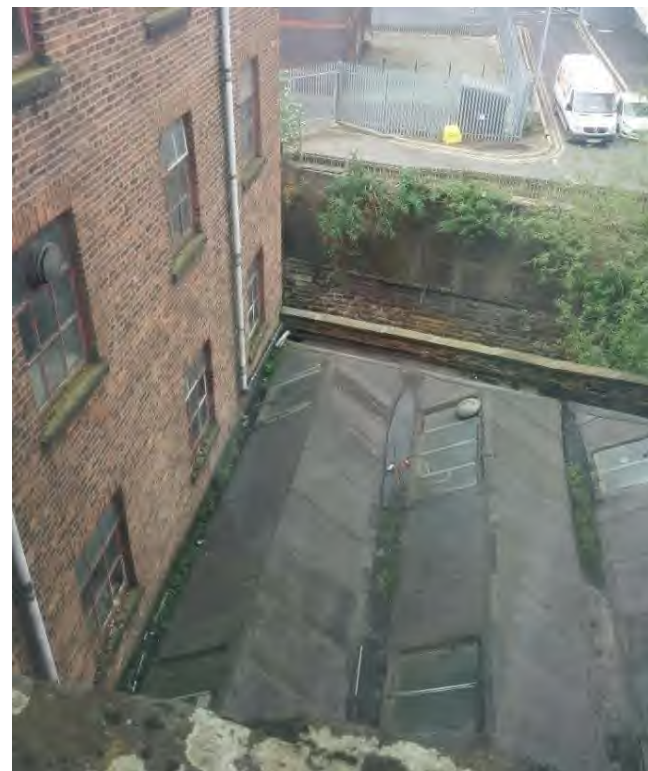
The roof of the shed has been inspected visually from high level inside the 1801 mill building and internally from ground floor level. The roof appears to be covered in a bituminous coating, as delineated in Figure 63. Roof skylights are offering natural light to the shed. Vegetation growth and debris appears to have been building up in the valley gutters of the roof. Ponding of surface water is evident in the gutter, which is likely attributed to poor falls and/or blocked rainwater goods.

Figure 63 - Roof and vegetation growth in gutters (taken 2018)

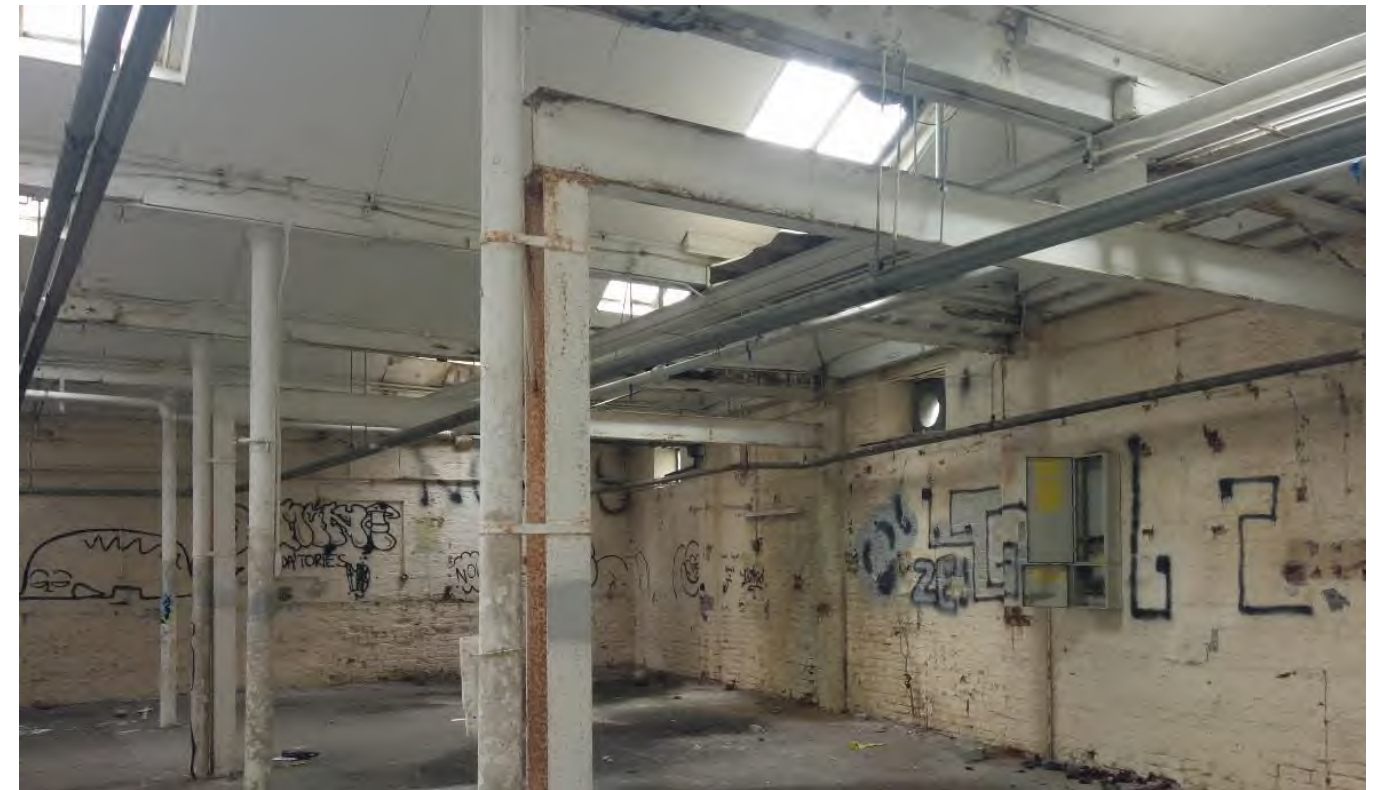
Additional steelwork structures have been previously added in every other bay to offer supplementary support to the decayed roof timber beams, as delineated in Figure 65.

Figure 65 - Portal frames at every other bay offering support to timber roof (taken 2018)

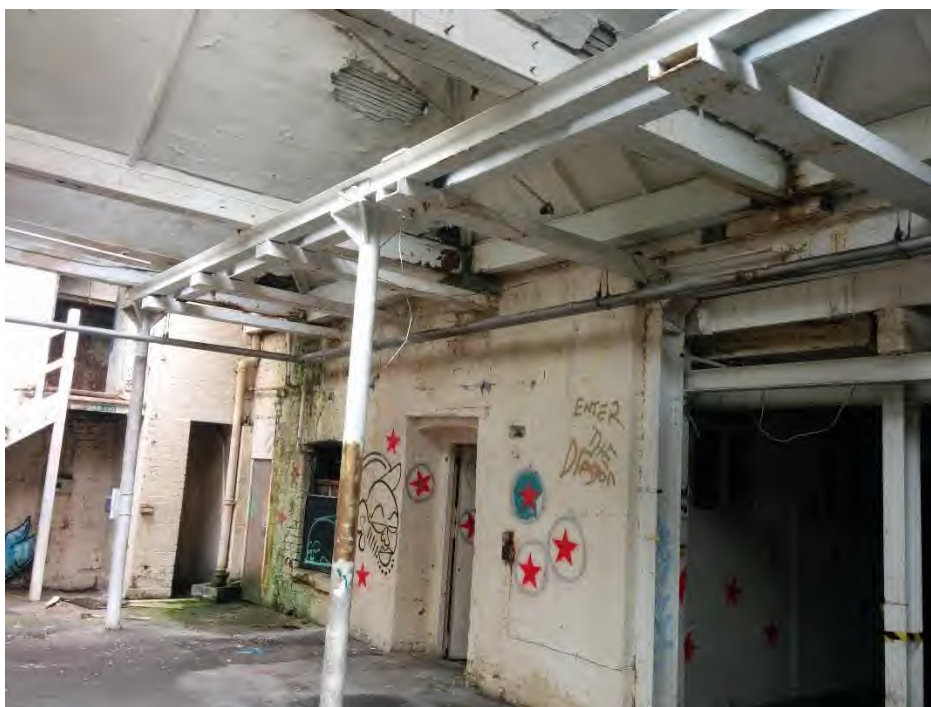
Towards the north-east part of the building several parallel flange channels (PFC) sections appear to have been introduced as a newer addition, as delineated in Figure 64. The PFC sections were most probably introduced to offer additional support to previous hoisting equipment. The 200x75mm PFC sections are generally corroded.

Figure 64 - Additional steelwork PFC sections (taken 2018)

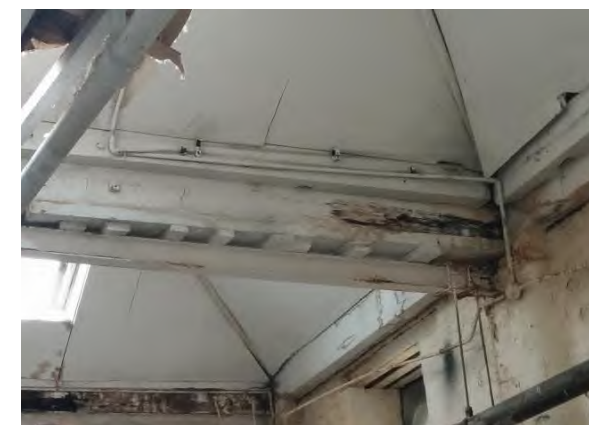
(A)

The roof valley timber beams are typically showing signs of decay, while the bearing ends of the valley timber beams have significant signs of decay with rot possibly building up, as illustrated in Figure 66.

Figure 66 - Decayed roof valley timber beams (taken 2018)

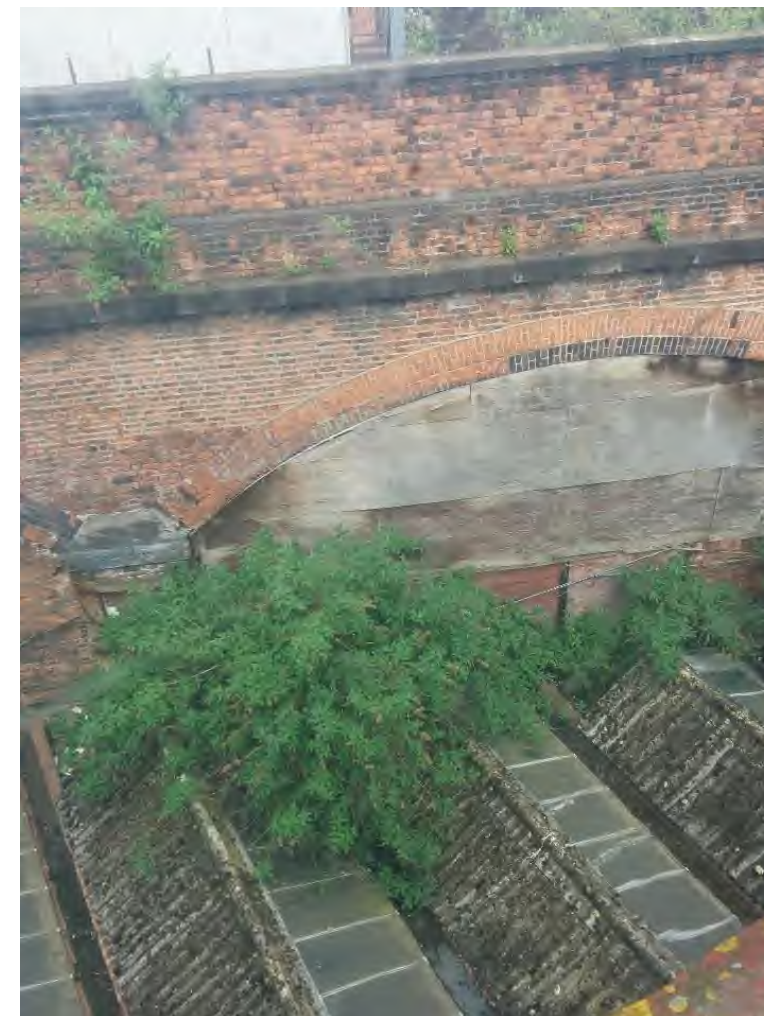
The roof of the shed has been inspected visually from high level inside the Mill building and internally from ground floor level. The roof appears to be covered in roof slates. Roof skylights are offering natural light to the shed. Significant vegetation growth is present on the roof of the shed adjacent to the train line viaduct, as shown in Figure 70. Some water and debris accumulation are present in the roof valley gutters.

Figure 70 - External roof structure of the shed (taken 2018)

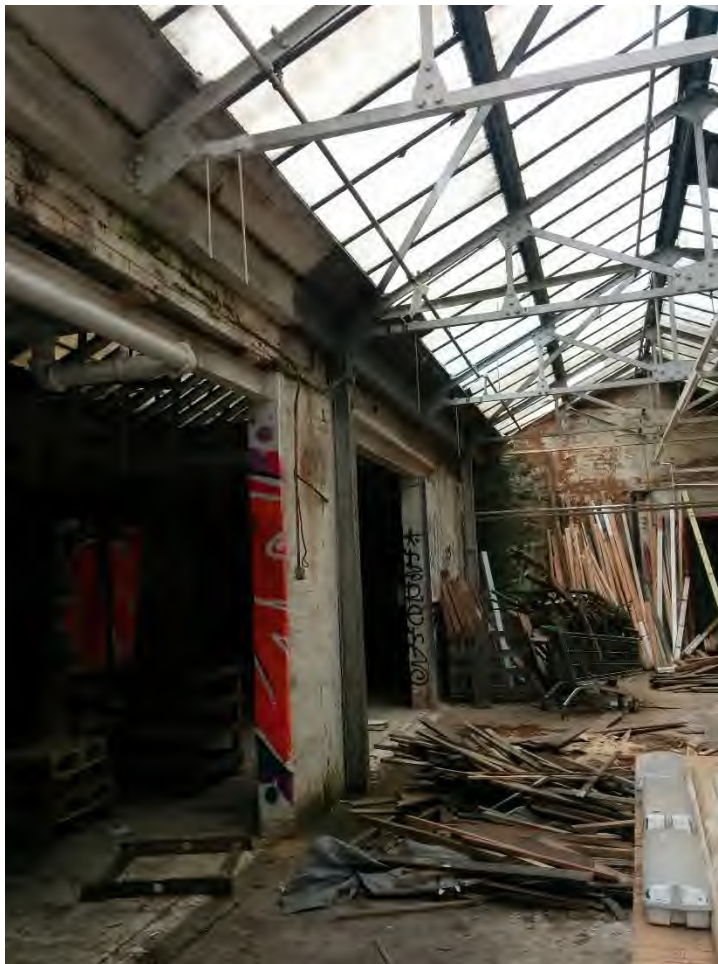
*Figure 71 - Galvanised steel roof trusses and masonry piers (taken 2018)*

The roof structure in the central part of the shed comprises of newer galvanised steel roof trusses, spanning between primary steel beams, as delineated in Figure 71. Newer galvanised trusses appear to be in good condition, and to have been installed at a much later date than the original pitched timber framed roof. There is potential to reuse these newer trusses in another capacity in the proposed landscaping should this be desired.

Masonry piers, typically approximately 225mm wide, are dividing the central part and the eastern section of the shed with steelwork beams spanning between these masonry piers, as shown in Figure 71. These steels are approximately 178x12 UB sections and are offering support to the roof timber beam.

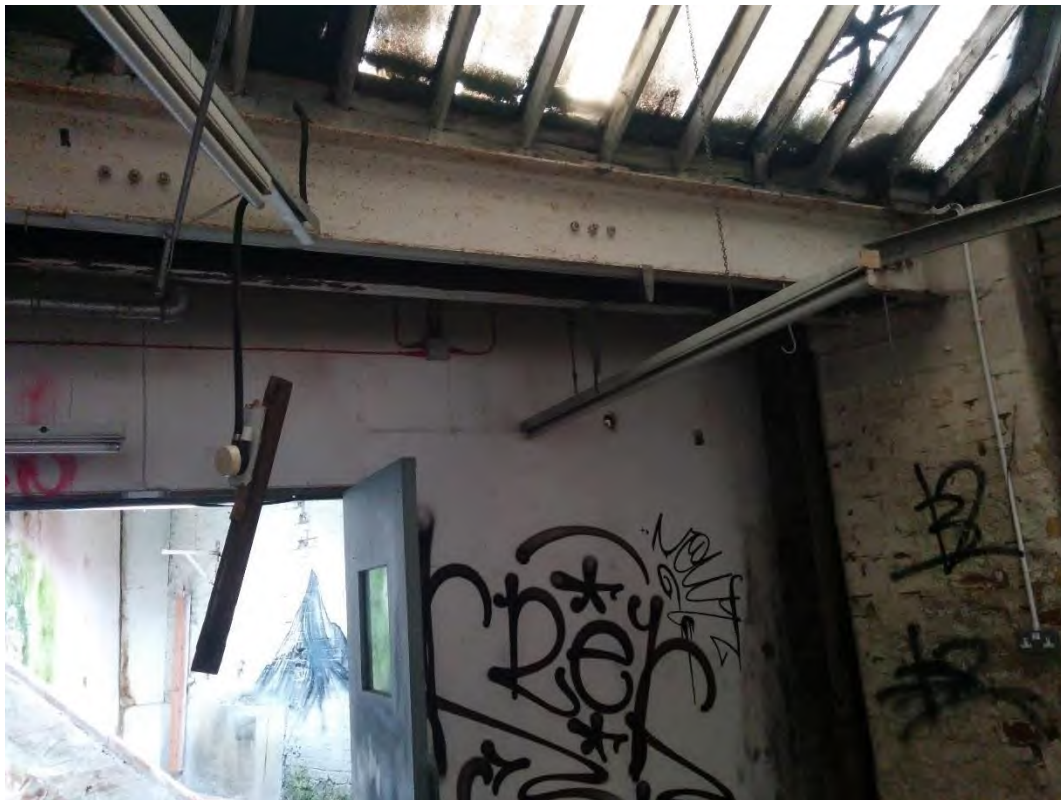
Towards the far eastern end of the shed, one of the timber beams has been previously strengthened with two parallel flange channels (PFC) sections, as shown in Figure 73. The two PFC sections are fixed to the timber beam with three bolts at approximately 1500mm centres. The condition of the timber beam could be inspected from below. The timber beam is showing significant signs of damp and decay while the PFC sections are generally corroded.

Figure 73 - Timber beam strengthened with two PFC steel sections (taken 2018)

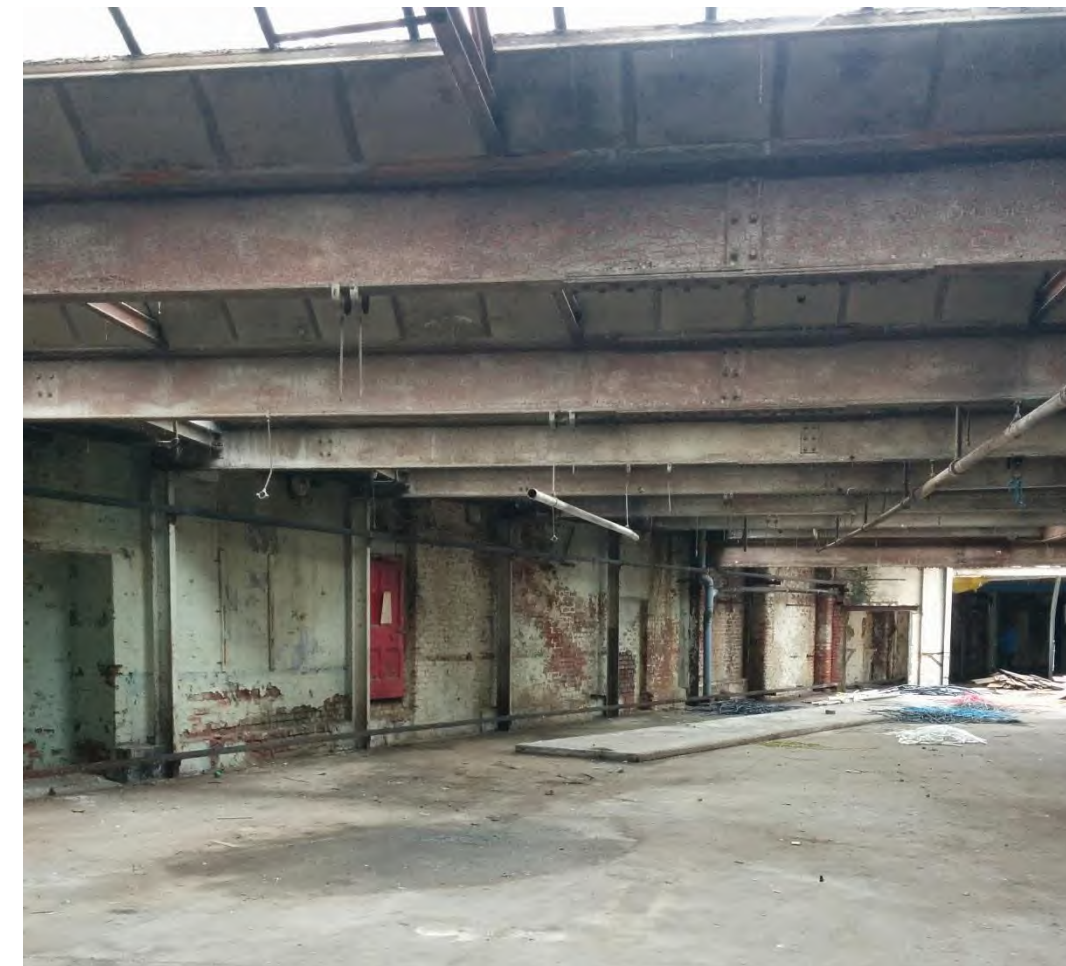
The roof structure of the western section of the shed comprises of steelwork beams spanning from north to south. The steel beams appear to have been spliced at approximately midspan, as there is a bolted splice joint connection visible, as shown in Figure 75. The steel beams are approximately 356x127 UB sections.

A concrete plinth approximately 1600mm wide and 30mm high appears to have been built directly off the basement concrete slab, as illustrated in Figure 75 (far end).

Figure 75 - Western section of the shed (taken 2018)

There appears to be some form of horizontal tie between the steelwork beams, as delineated in Figure 75 (upper left side of image).

Several damp areas are visible on the concrete slabs, as shown in Figure 75, due to water ingress from the decayed roof.

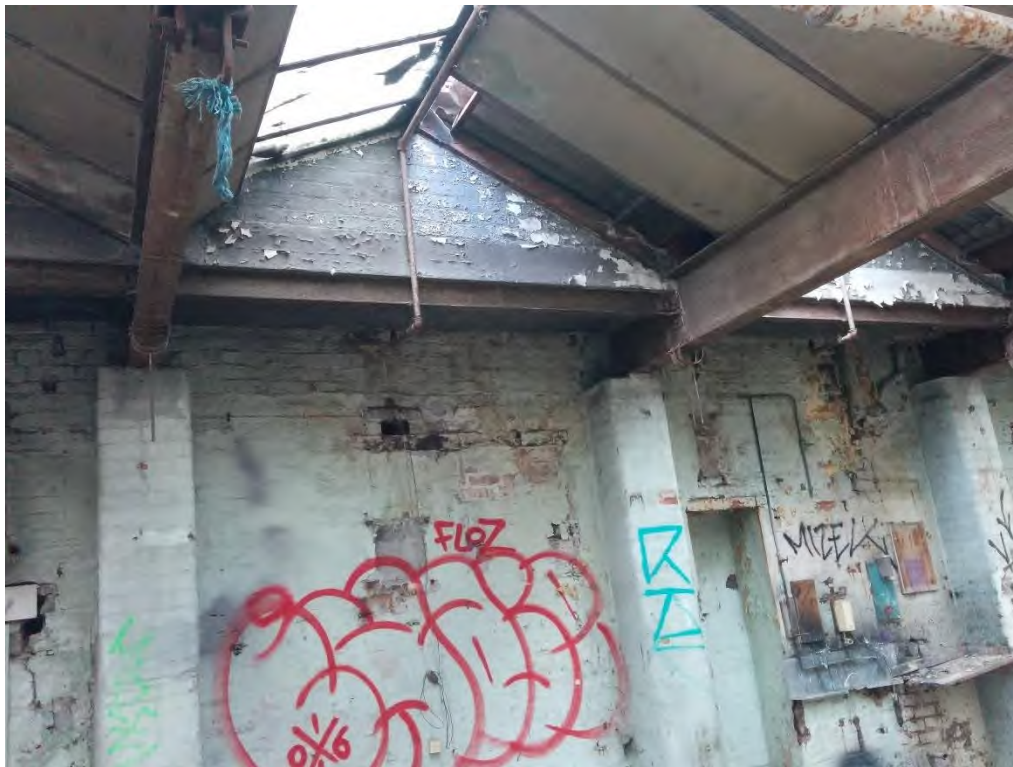
Steel columns adjacent to the trainline viaduct are supporting the steelwork beams at one end while brickwork piers located near the external masonry wall of the Mill are offering support to the other steel beams end, as illustrated in Figure 75 (left side of image) and Figure 76. The steel columns are approximately 204mm deep and 126mm wide in section and are typically heavily corroded.

The pitch roof edge is typically infilled with brickwork as is also evident in Figure 76.

Figure 76 - Brickwork piers offering support to steelwork beams (taken 2018)

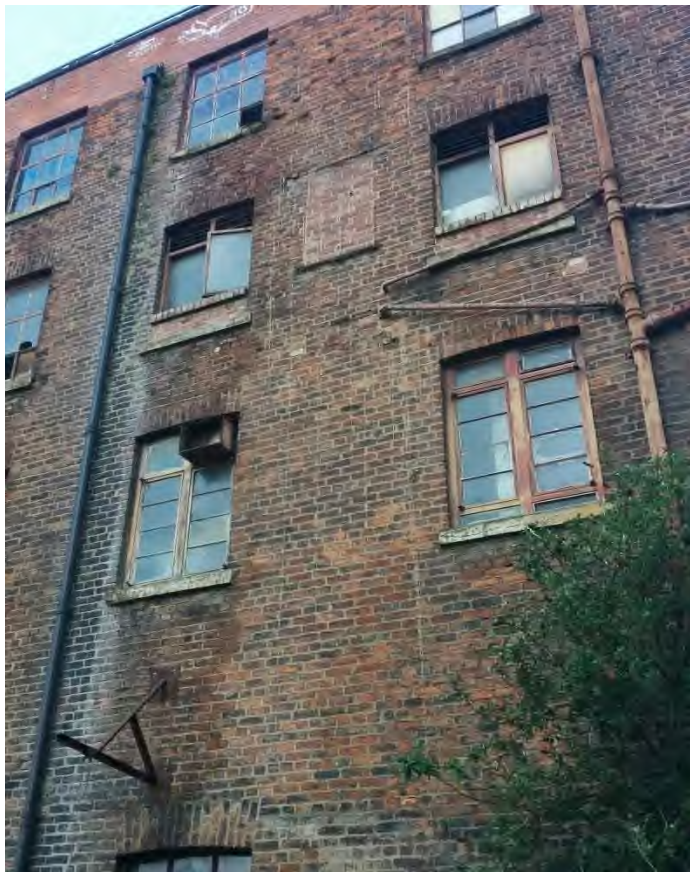
At second floor level it appears a former window opening was previously infilled with modern brickwork. The adjacent window openings have been reduced and the space between the previous sill and the new window sills has been previously infilled with modern brickwork as depicted in Figure 79. A protruding hoist structure is protruding over River Medlock between ground and first floor level, refer also to Figure 79.

Figure 79 - Modern brickwork infill at second floor (taken 2018)

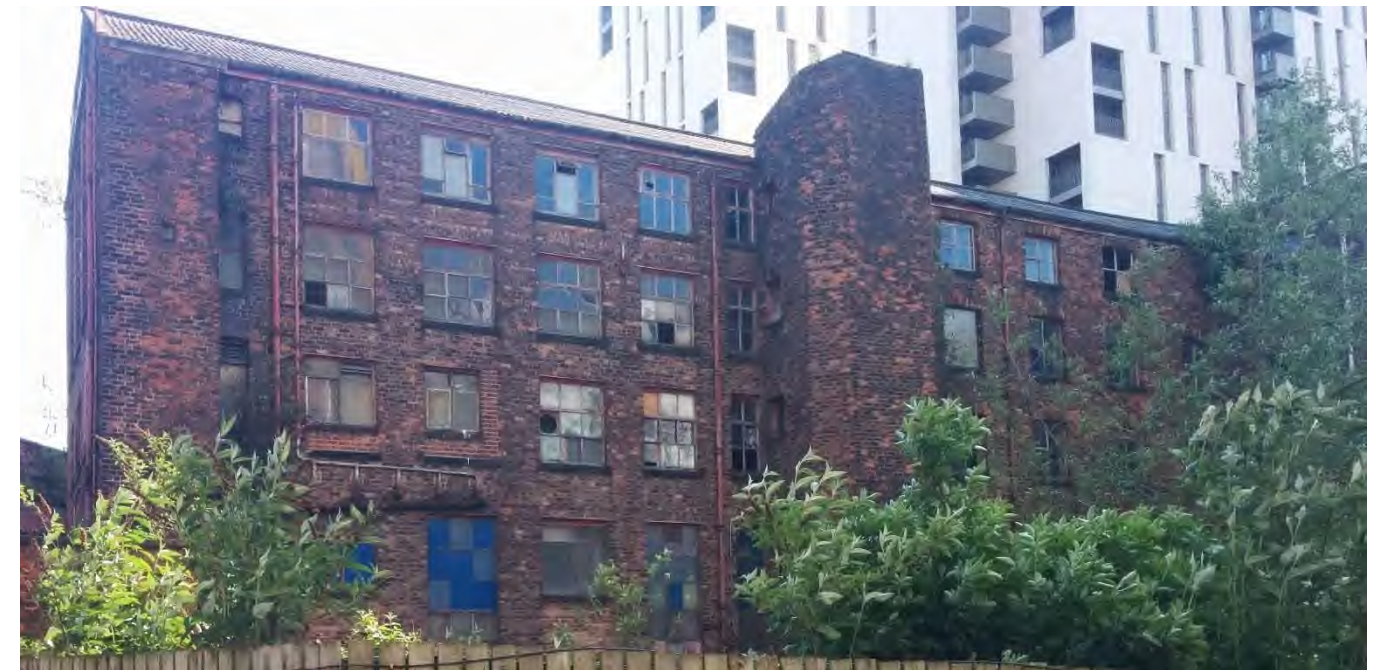
Figure 80 - Western elevation (adjacent to River Medlock) (taken 2018)

Severe weathering of the western elevation brickwork walls is evident, with areas of brickwork with significant discolouration, as illustrated in drawing S-EX-202, Appendix A of this report.

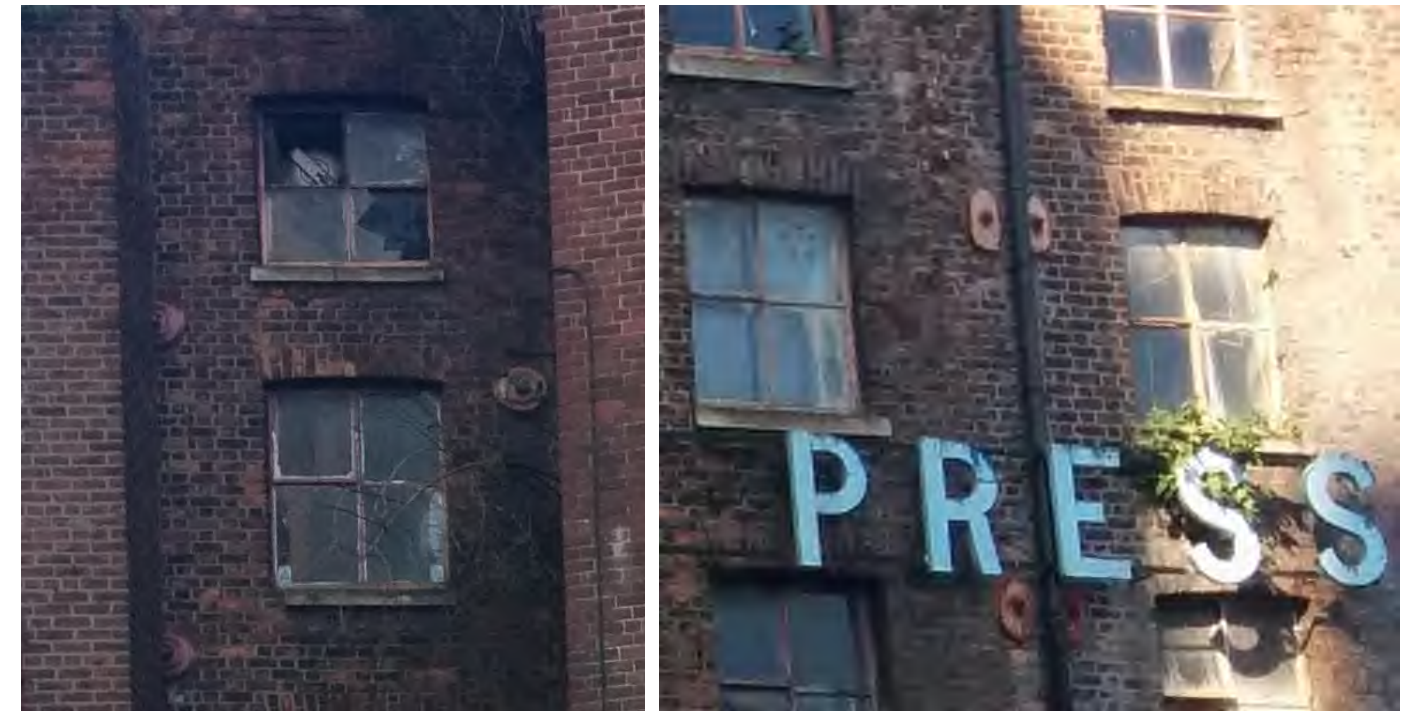
As viewed from the Cambridge Street level it appears that there are several pattress plates visible along the eastern elevation, as illustrated in Figure 82 and drawing S-Ex-203, Appendix A. The pattress plates in Figure 82 (A) might be connected through steel tie rods to the pattress plates in the lift shaft, Figure 18, connecting the Warehouse building to the Mill structure. Traditionally, pattress plates are added later to restrain the lateral movement of the facades. The head of the first-floor and second-floor windows, as is evident in Figure 82 (B). The plates in Figure 82 (B) are not visible on the opposite elevation, thus indicating that they do not pass through the entire structure, although ties could be hidden from view

within the floor build up. Since there are no visible corresponding pattress plates on the western elevation, the pattress plates indicated in Figure 82 are likely to be restraining only the eastern elevation from bowing laterally.

Figure 82 - Pattress plates on eastern elevation (taken 2018)

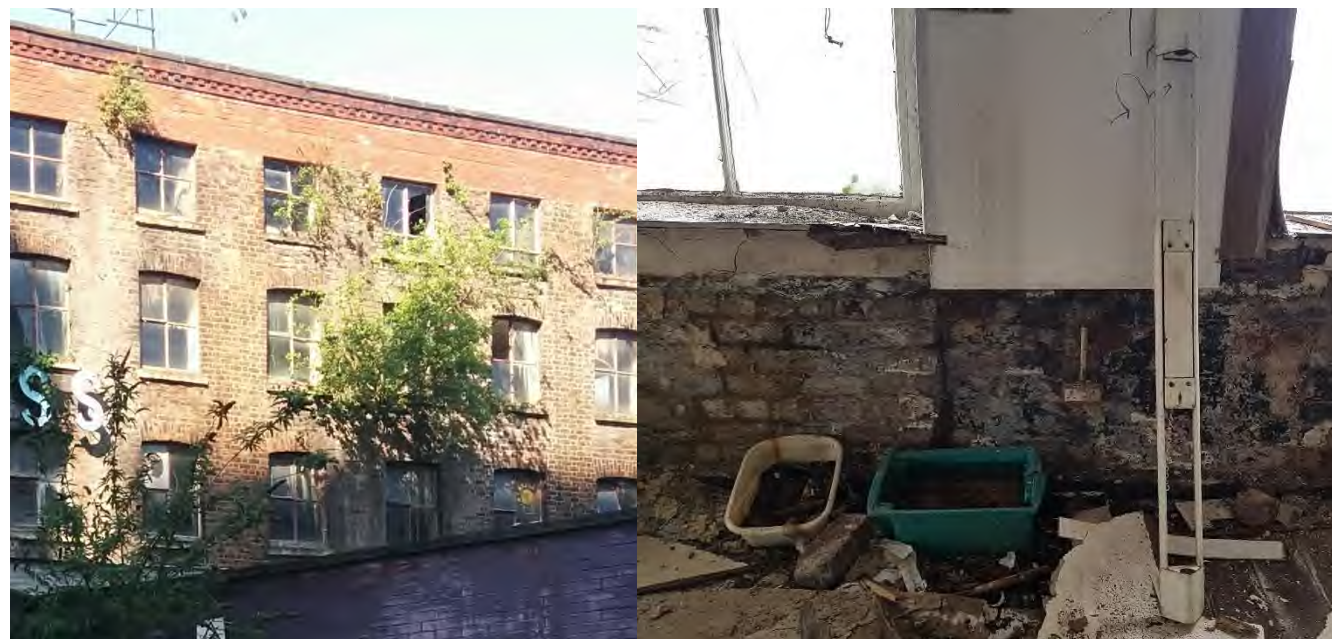
In some instances, at the head of the second-floor windows, as per Figure 83 (A), the surrounding brickwork has become dislodged as the vegetation root system expands and forces the brickwork out of alignment. Cracking has also been induced due to the expansion of the root system. Internally, severe water penetration has led to the crumbling and spalling of the masonry, as illustrated in Figure 83 (B).

The root cause of this growth is most likely due to open mortar joints in the stonework, allowing spores within the air to take root.

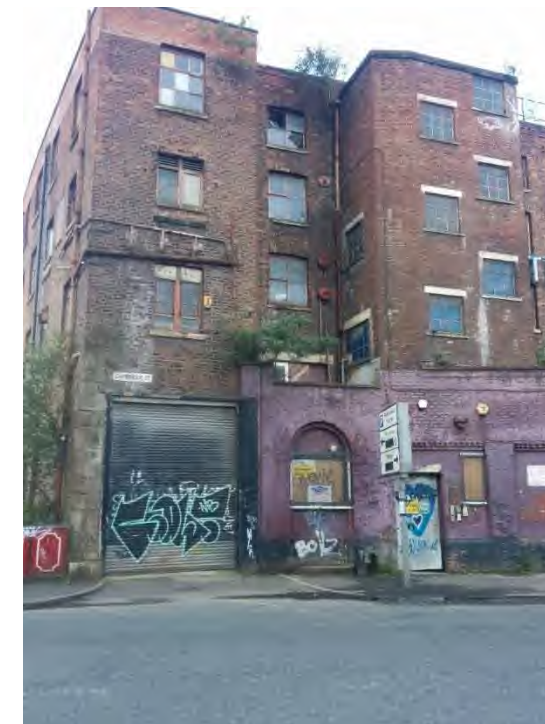
The window openings on the eastern elevation have typically brickwork lintels, while the window openings of the staircase (which was a later addition) have stone lintels, as illustrated in Figure 84. There was no access possibility near the staircase to establish whether the staircase has been effectively tied in into the external walls of the Mill.

There are signs of vegetation growth at the top of the third-floor window located at the corner with the staircase structure, as per Figure 84.

There are no evident signs of lintels present at the top of the first row of window openings on the eastern elevation, as per Figure 84.

Figure 84 - Stone lintels above staircase windows (taken 2018)

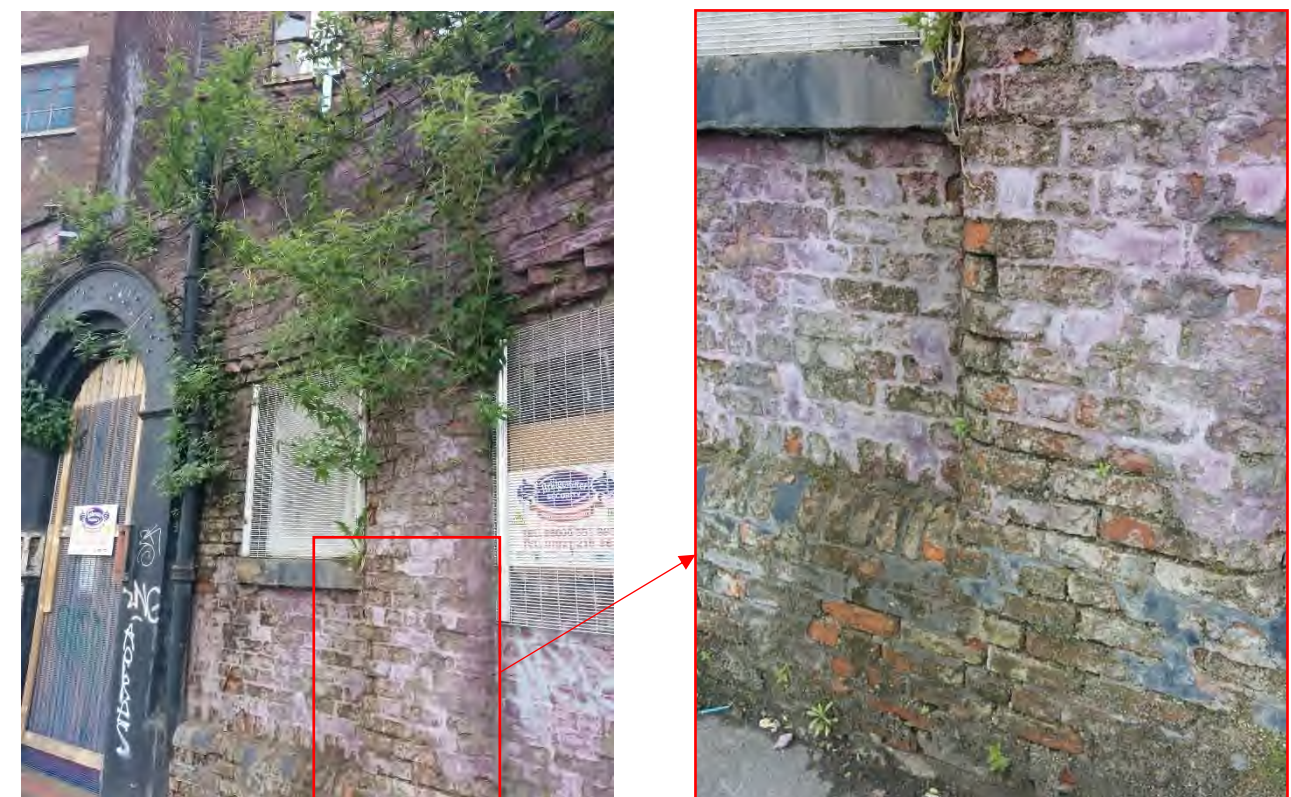
The single storey building elevation along Cambridge Street is in poor condition with significant vegetation growth evident in several places along the wall, as delineated in Figure 85 (A). There is a loss of mortar within the brickwork joints and some discoloration of the brickwork, as per Figure 85 (B). There are several brickwork units that appear to be crumbling, with significant build-up of mosses and lichens on the brickwork wall. The wall has been previously painted, with paint chipping off due to weathering of brickwork.

During visual inspection it appeared that the wall is inclining towards Cambridge Street at its top. The inclination was not recorded but was visible to the eye.

Figure 85 - Wall following the curve comprising both of Cambridge Street and Cambridge Street (taken 2018)

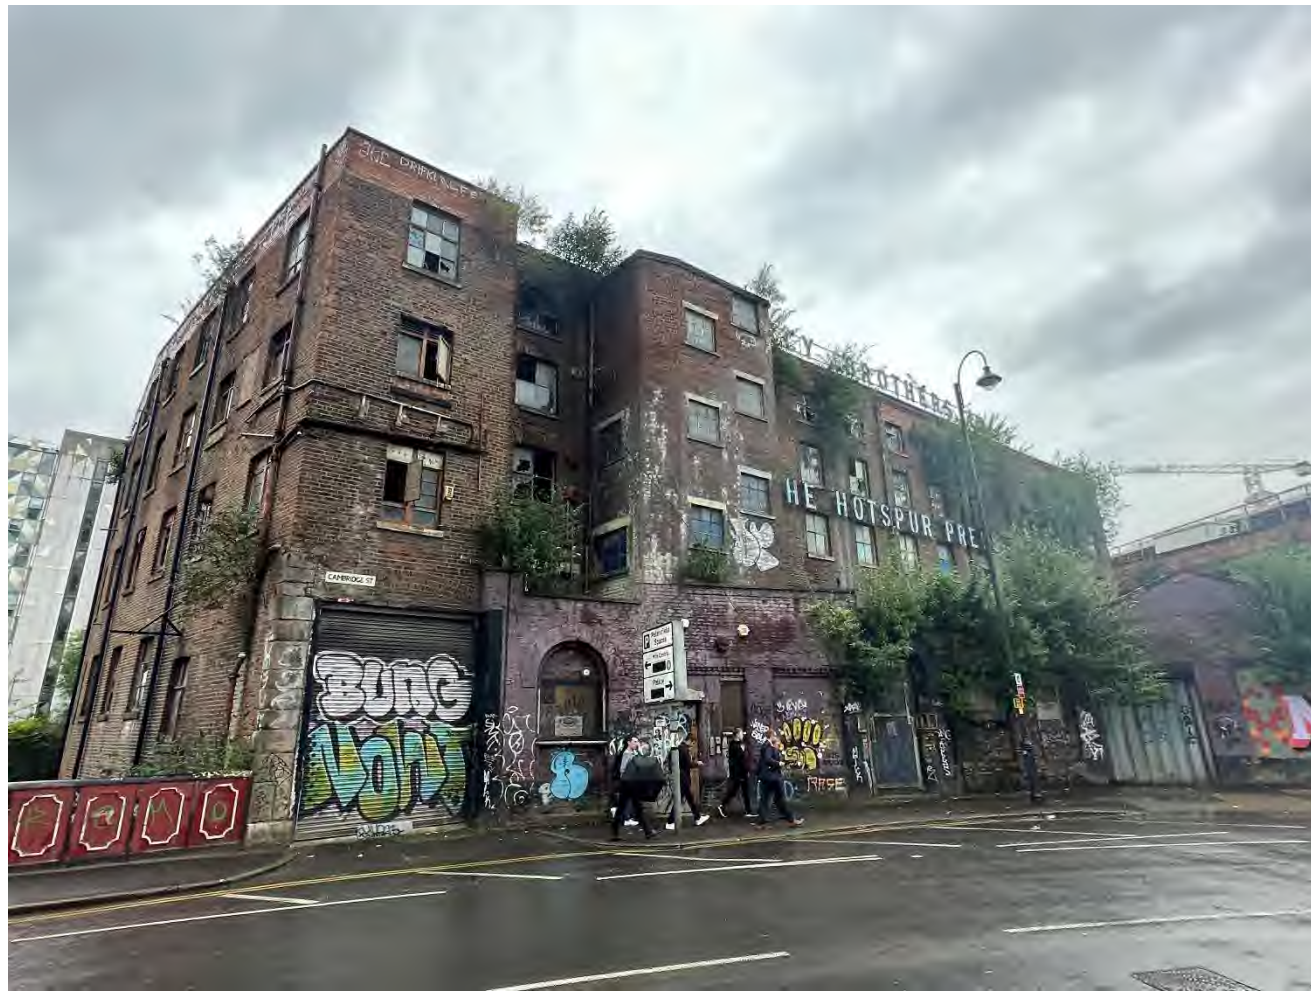
*Figure 86 - Severe vegetation growth on eastern elevation has continued since previous survey (taken 2023)*

During the most recent site visits in 2023, it was evident that vegetation to the elevation had continued to grow and intrude into the building façade and structure. It is likely this continued growth will have further penetrated the façade masonry and disturbed the bed joists of the brickwork. It wasn't possible at the time of survey to inspect the façade at touching distance to confirm this assumption.

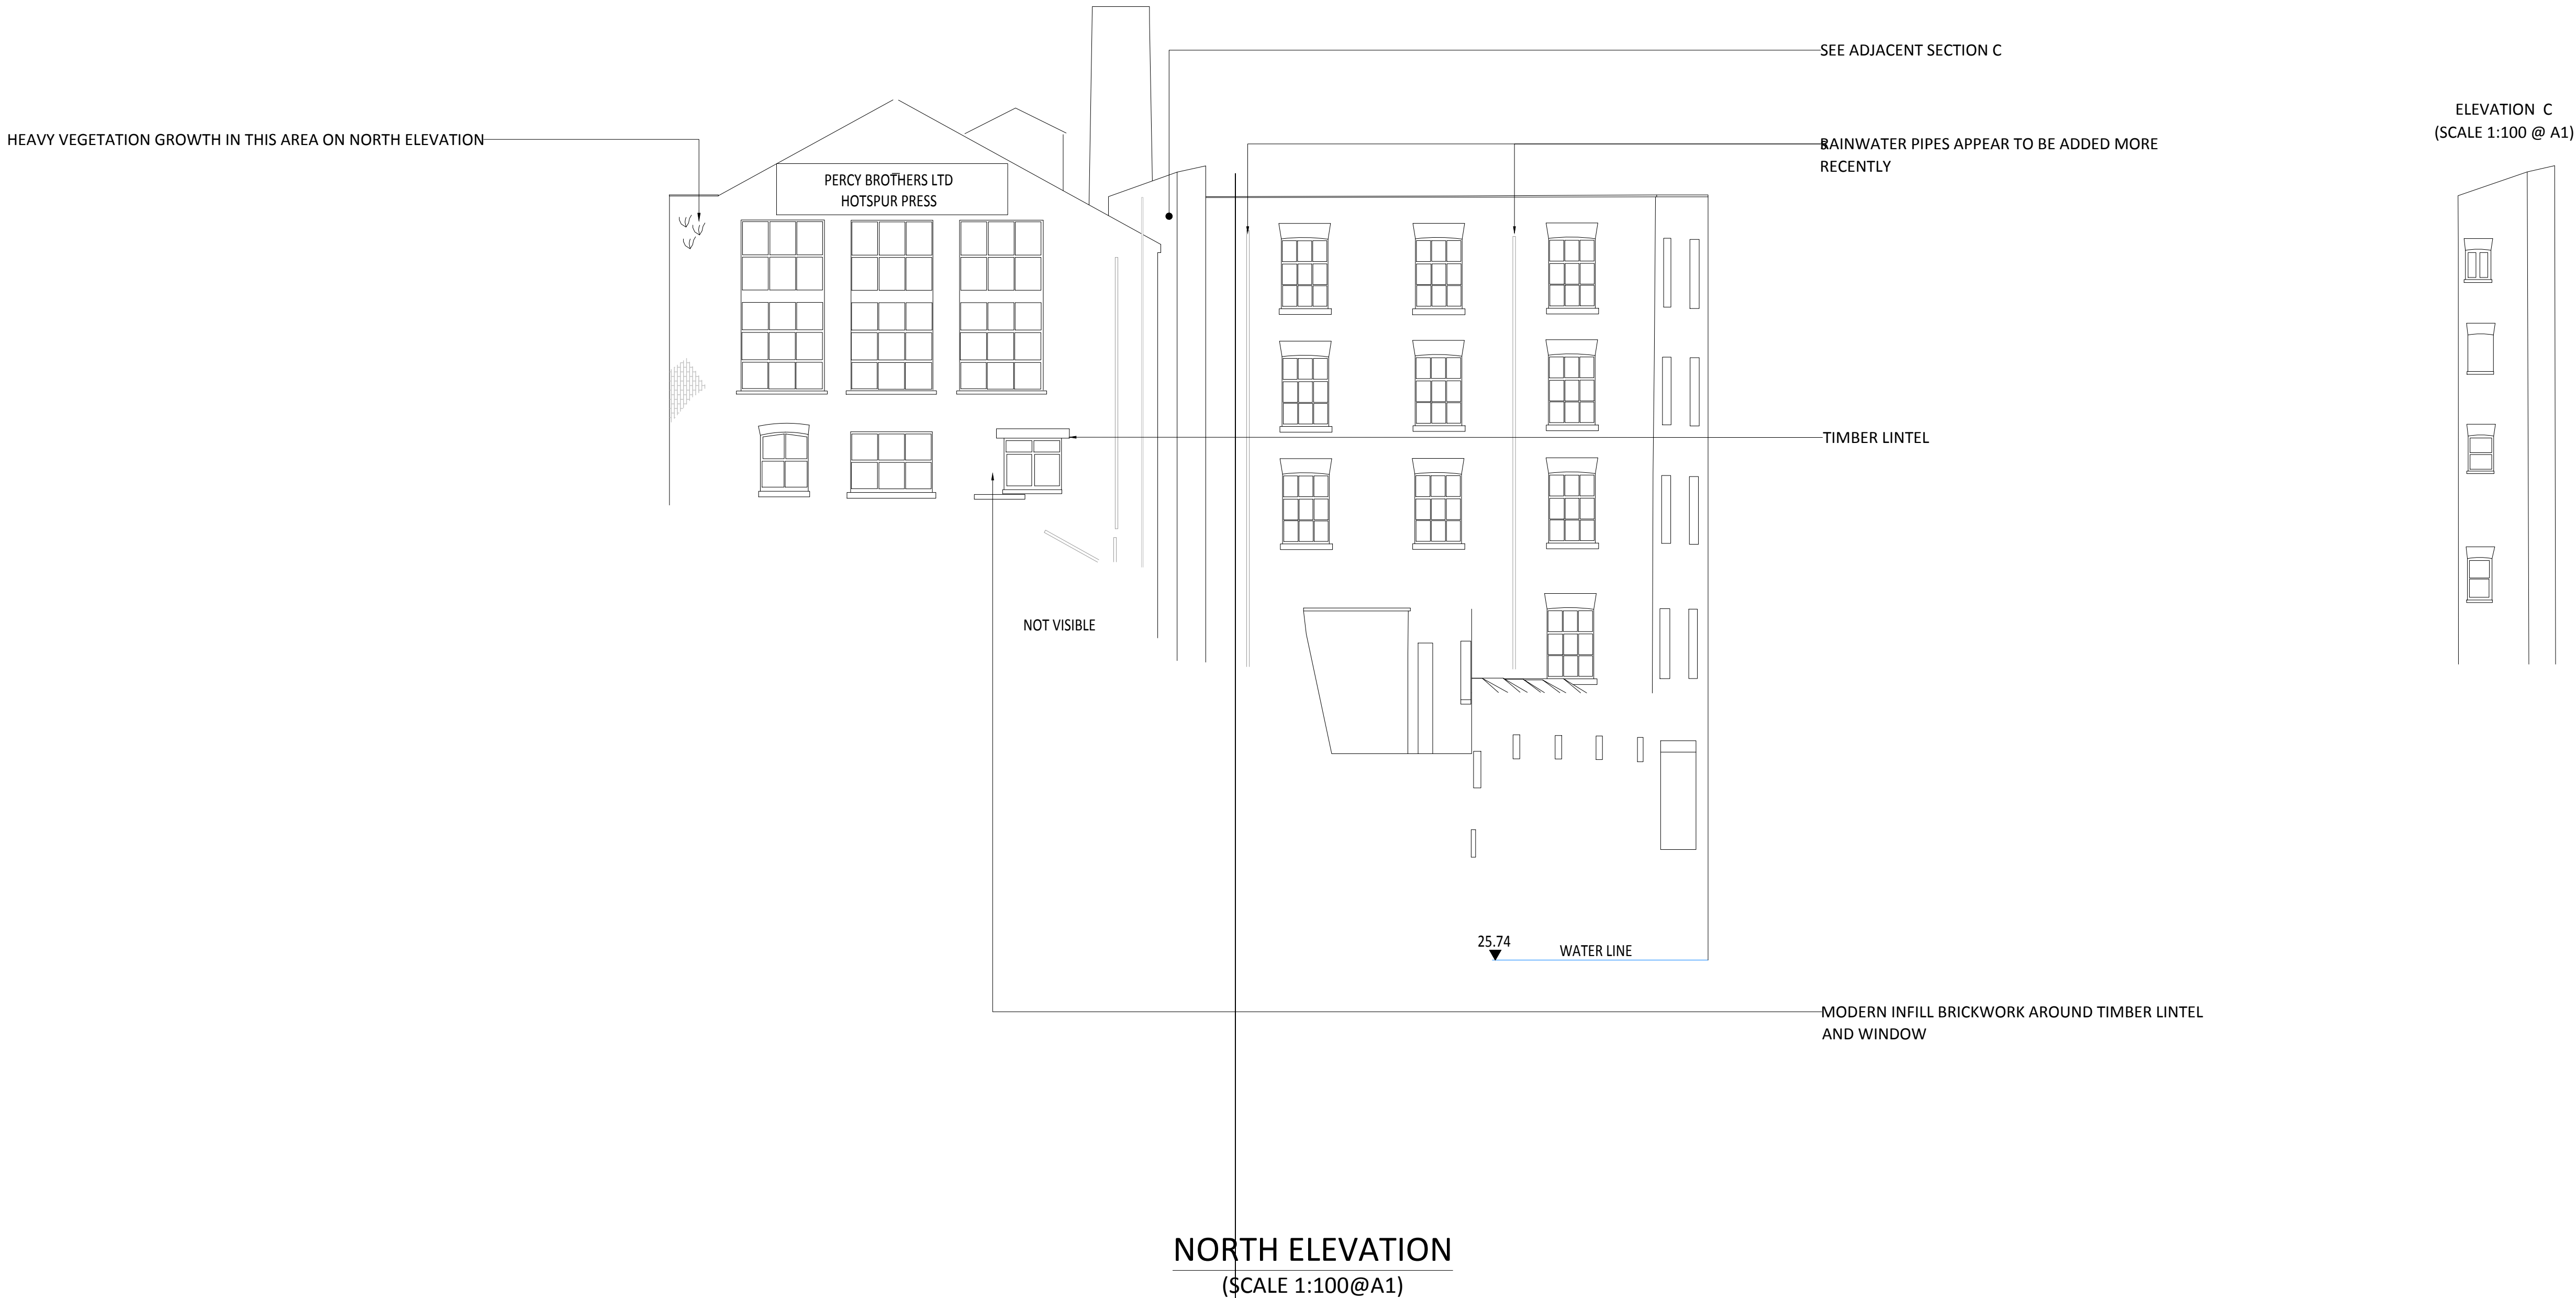
| Project Number<br>1006-01 | Originator<br>CIVIC | Discipline<br>S | Drawing Number<br>EX-200 |

BRICKWORK ON THIS ELEVATION IS GENERALLY WEATHERED. LOCAL REPAIRS TO AREAS OF WEATHERED BRICKWORK AND AREAS OF OPEN MORTAR JOINTS AND MORTAR LOSS. TYPICAL ALONG ELEVATION.

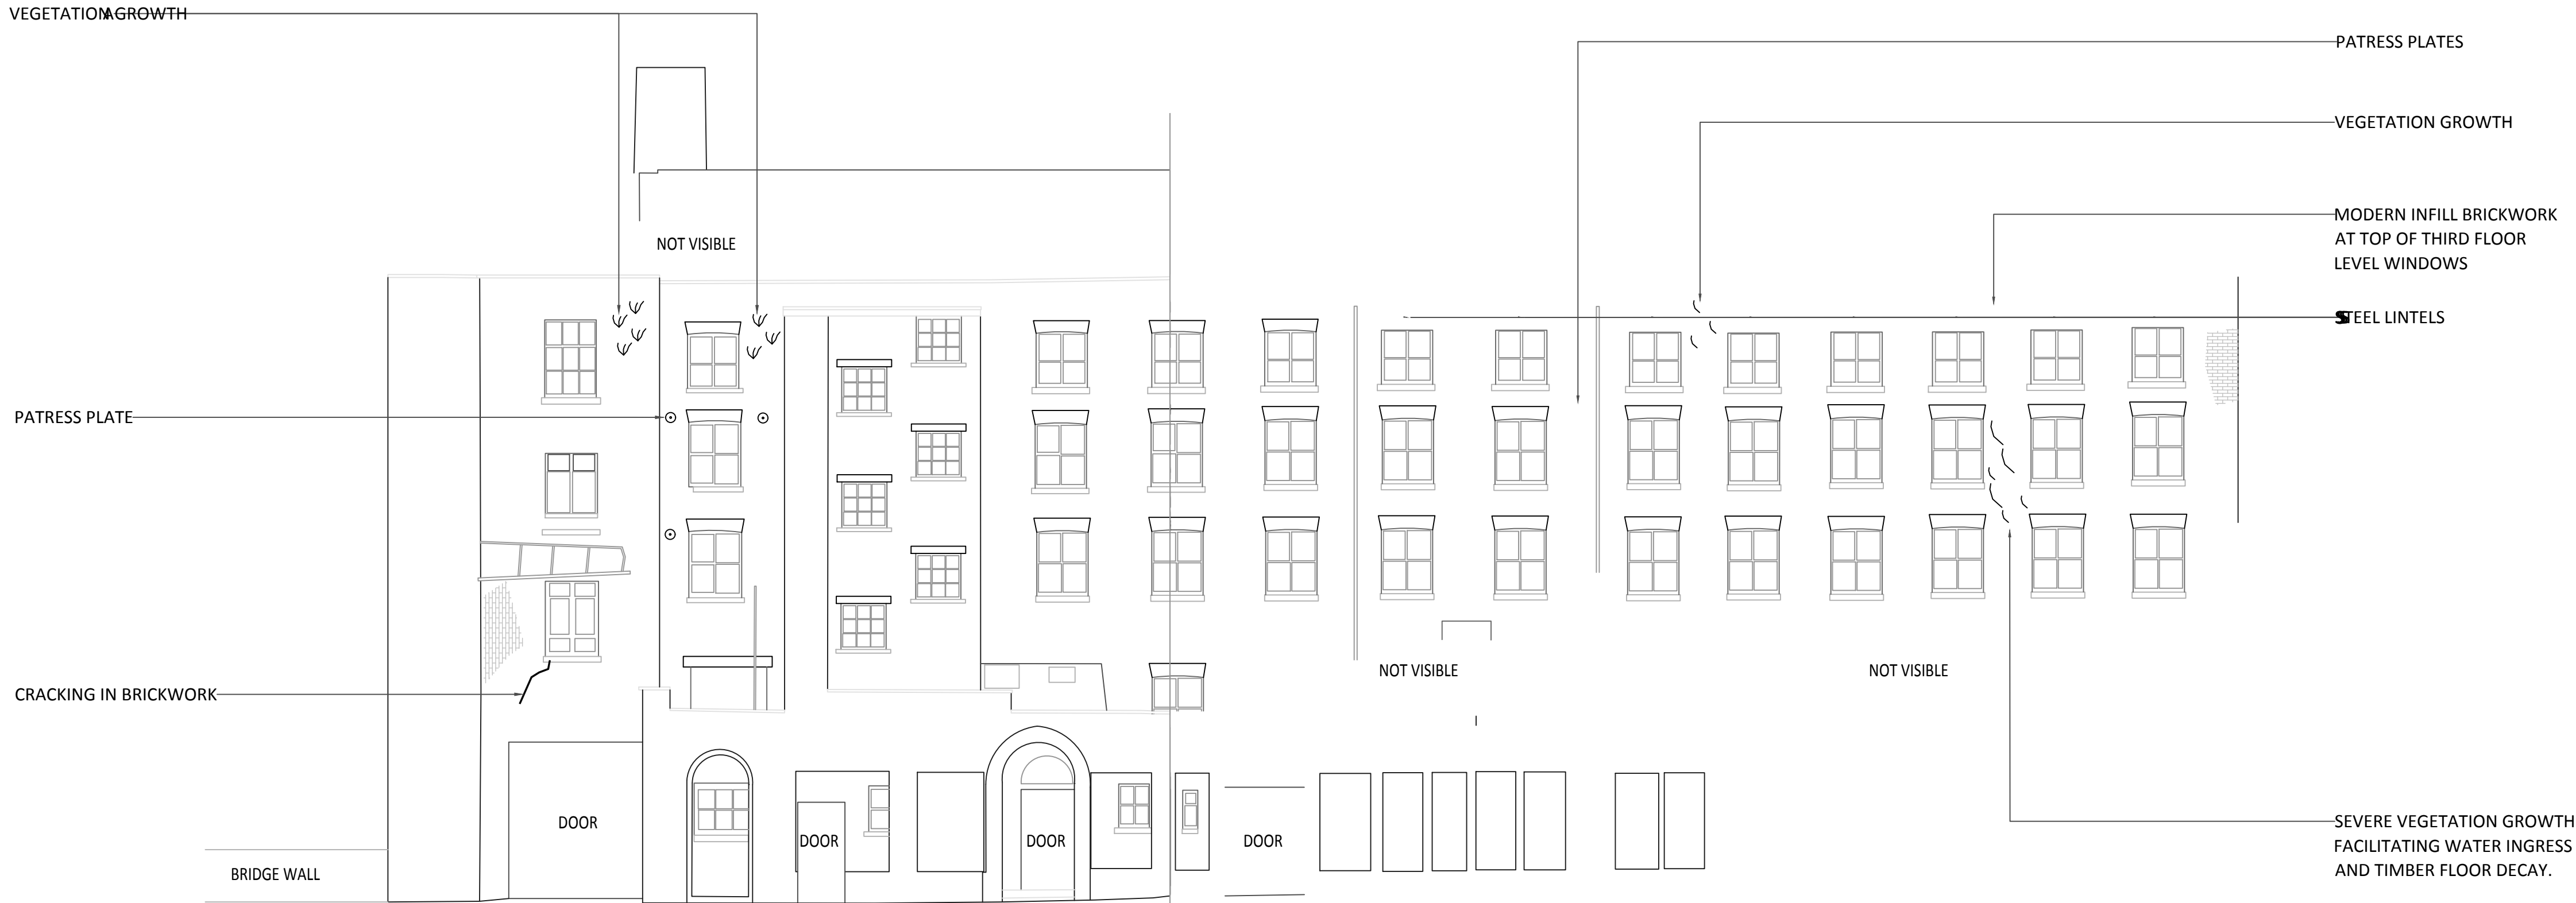
EAST ELEVATION  
(SCALE 1:100@A1)

BRICKWORK ON THIS ELEVATION IS BADLY WEATHERED. LOCAL REPAIRS TO AREAS OF WEATHERED BRICKWORK AND AREAS OF OPEN MORTAR JOINTS AND MORTAR LOSS. TYPICAL ALONG ELEVATION.
