Phase II Geoenvironmental Site Assessment  
Vine Street, Gorton

Reference: 14-944-R1-3  
Date: October 2023

## **PHASE II GEOENVIRONMENTAL SITE ASSESSMENT**

Land off Vine Street  
Gorton  
Manchester  
M18 8SR

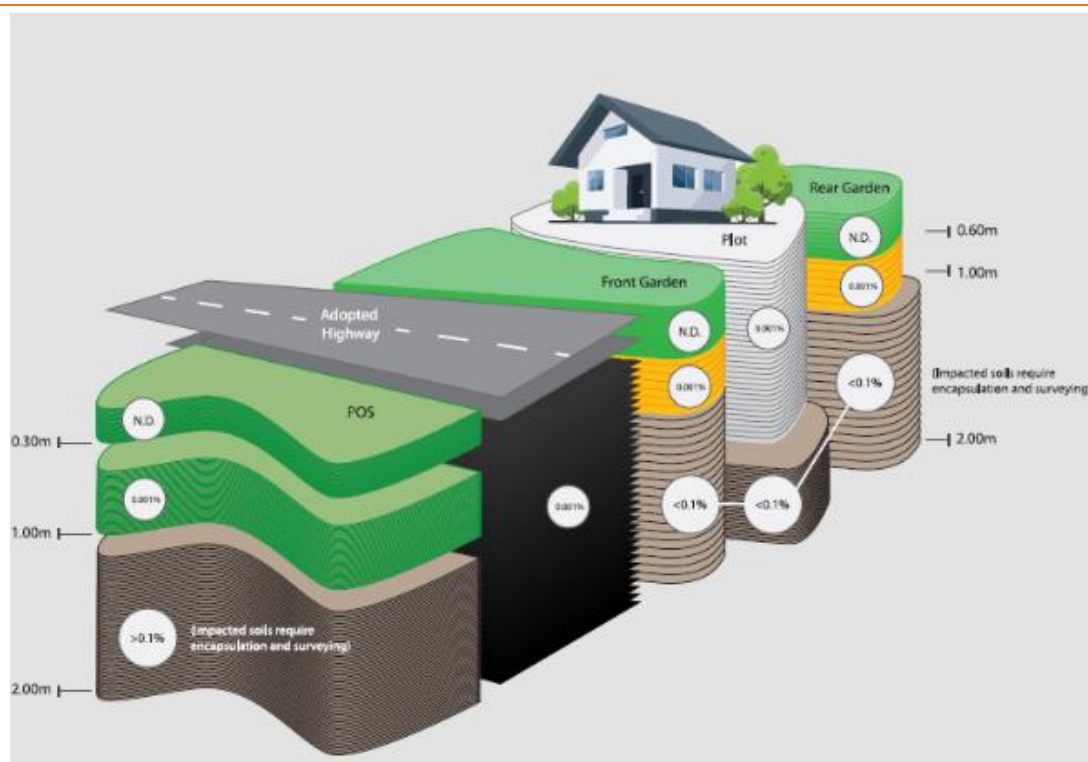
FIGURE 4.1 ASBESTOS RISK MITIGATION CONCEPTUAL SITE MODEL

The asbestos impacted Made Ground should be managed in accordance with CIRIA 733 (Asbestos in soil and made ground: a guide to understanding and managing risks) and placed in accordance with the Asbestos Risk Mitigation Conceptual Site Model shown in Figure 4.1 below.
