**SIM - Sitewide Capital Works**

**Stage 3 Structural Report – Gantry Planning Submission**

**SIM-BHE-XX-XX-RP-S-0102**

14 September 2023

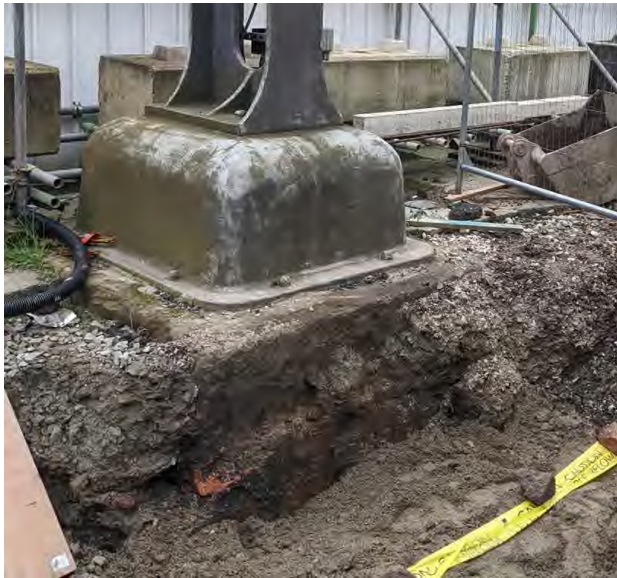
- At their base columns are bolted into a cast iron plinth which is assumed to be hollow and either internally stiffened or infilled. The plinths are in turn bolted to stone pads onto masonry pier foundations. These are assumed to sit onto the underlying rock but this has not been confirmed.

Figure 2-9 Plinth / foundation detail

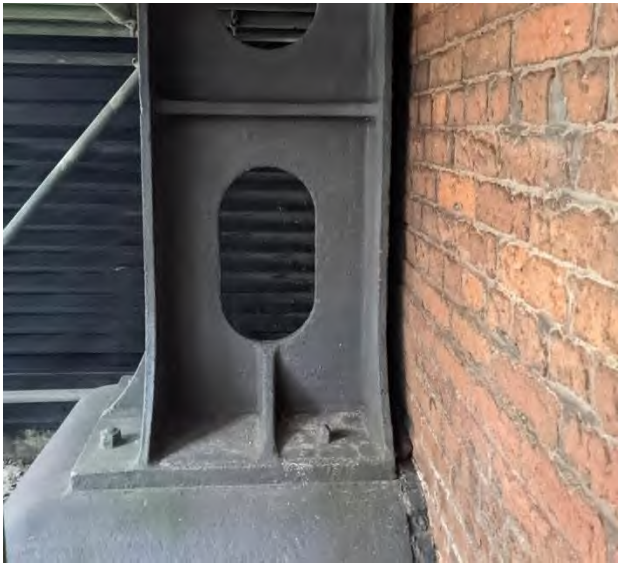
- #### Foundations, plinths, and columns
- Plinths are in good visual condition,
  - Columns appear to be in generally good condition, with no sign of significant corrosion. However it is possible to crevice corrosion is occurring at the interface between the cast iron and steel elements. There is some evidence of minor surface corrosion.

Figure 2-11 Column base

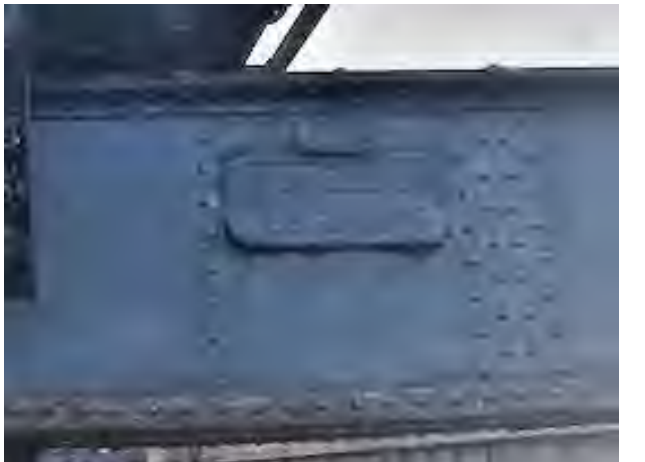
- Original Lifting capacity of the crane beams appears to be 10tons, based on a plaque noted at the visit.
- #### 2.2.2 Condition
- A high-build paint finish, thought to be micaceous iron oxide containing, has been applied to visual surfaces, but this has now failed in several locations. Inaccessible areas such as the rear face of the southern columns and beams do not appear to have been coated.

Figure 2-41 – Historic lifting capacity

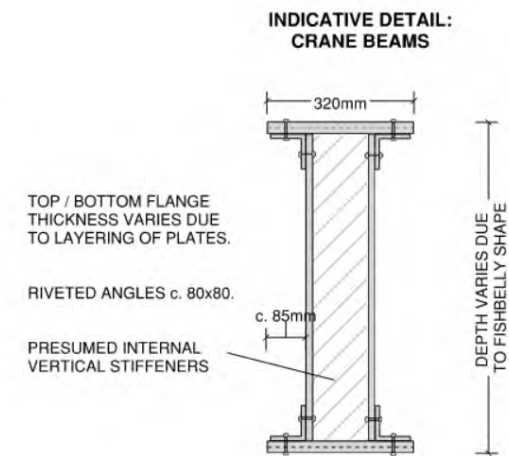
- Crane beams are constructed as per the Gantry beams, but appear to be hollow with two separate webs. It is assumed that internal vertical stiffeners are present due to vertical lines of rivets being visible on the beam faces. Crane beams are c. 320mm wide with a fish belly profile meaning that the depth increases towards the midspan (Figure 2-45).

Figure 2-45 Crane beam details

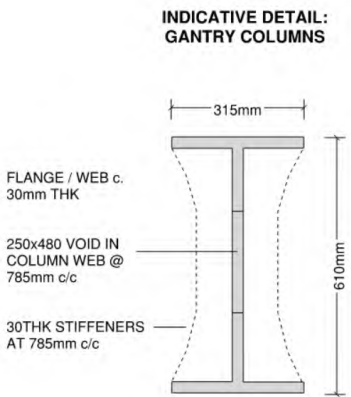
- Gantry columns are c. 7m tall and measure c. 610 x 315mm with intermediate web stiffeners and penetrations through the web (Figure 2-43). Columns appear to be single-piece cast elements.

Figure 2-43 Gantry column details

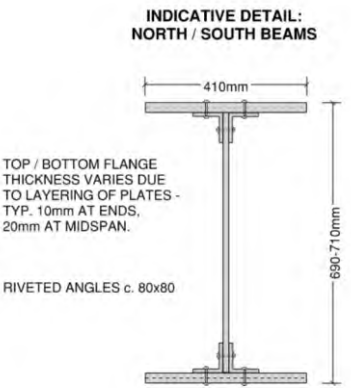
- Gantry beams vary in depth due to the plated construction, but measure c. 410mm wide x 700mm deep. The Gantry beams are compound sections – formed from separate plates held together with angle sections and rivets (Figure 2-44). Where beams meet at the column heads, they appear to be bolted to each other via end plates as well as being bolted into column heads.

Figure 2-44 Gantry beam details
