# Science & Industry Museum Viaduct

Viaduct  
Design and Access Statement  
September 2023

Project name: Viaduct  
Project number: 9488  
Client: Science & Industry Museum, Manchester

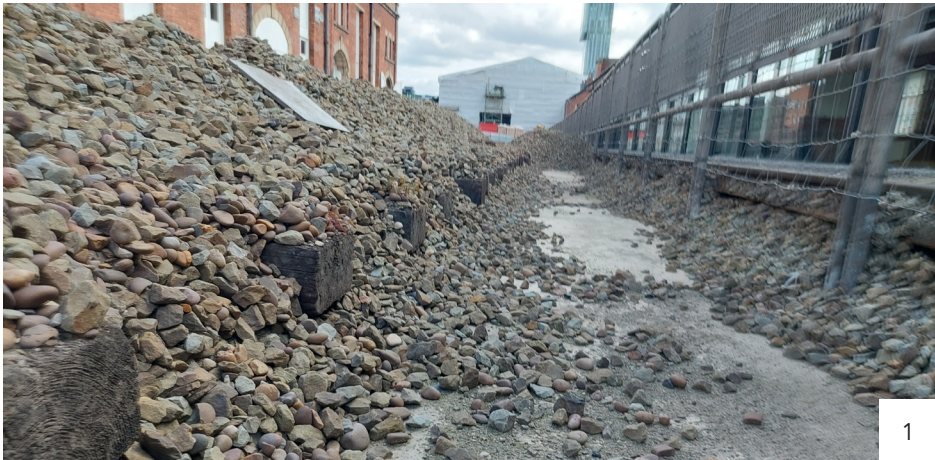
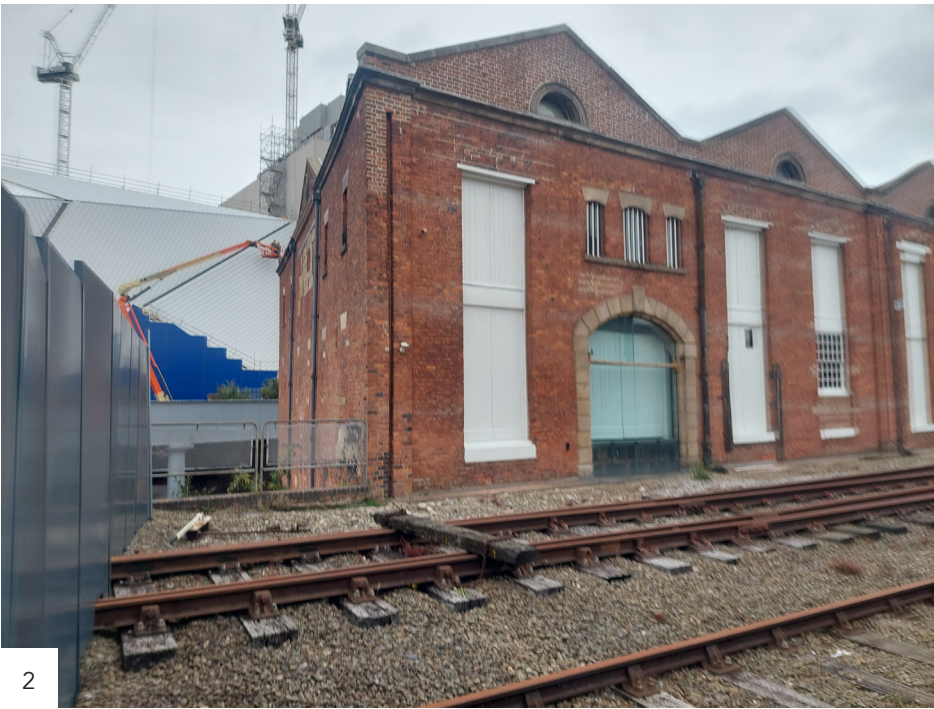
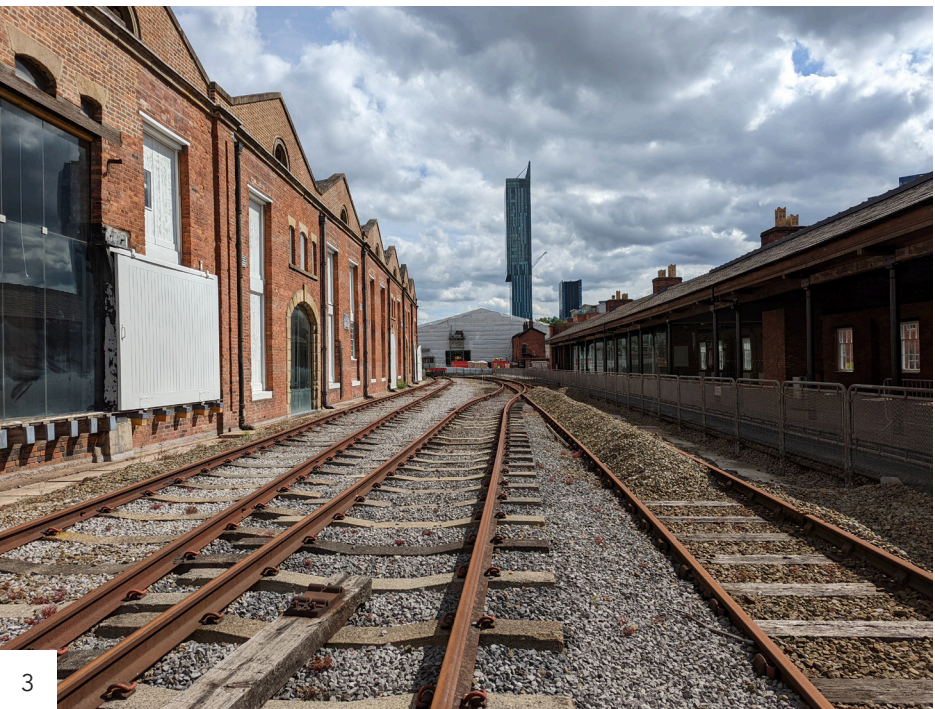
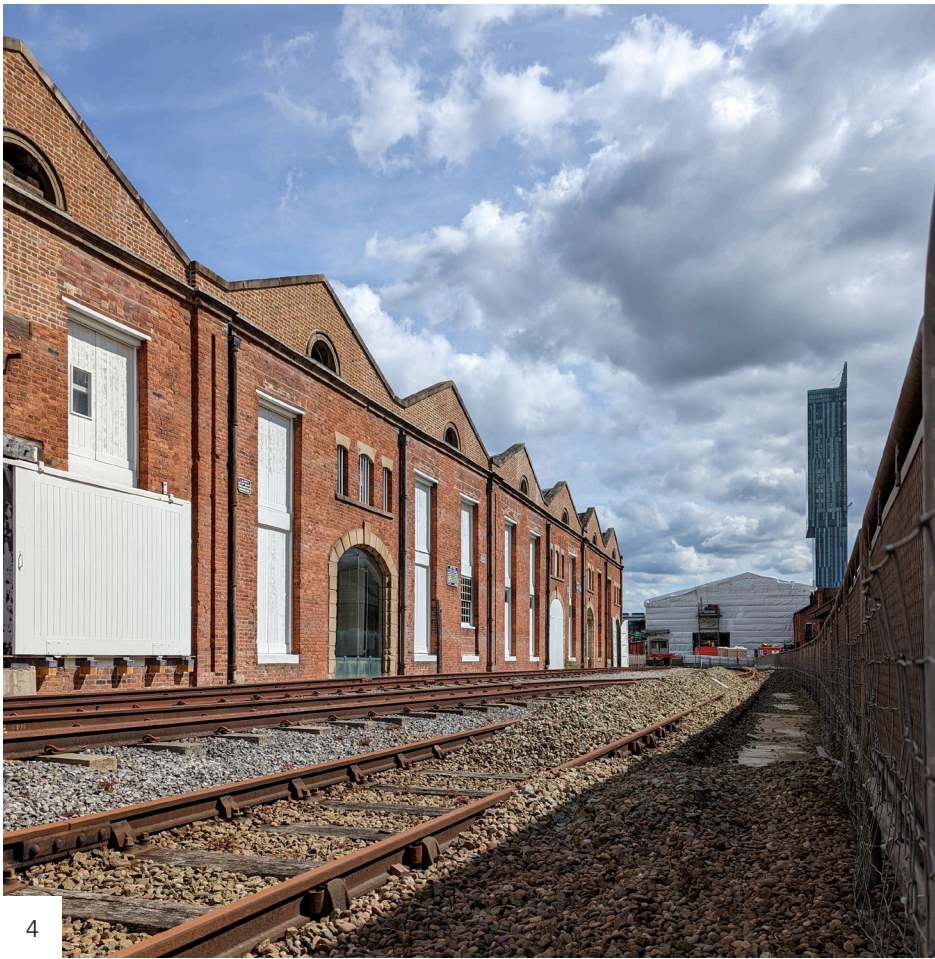
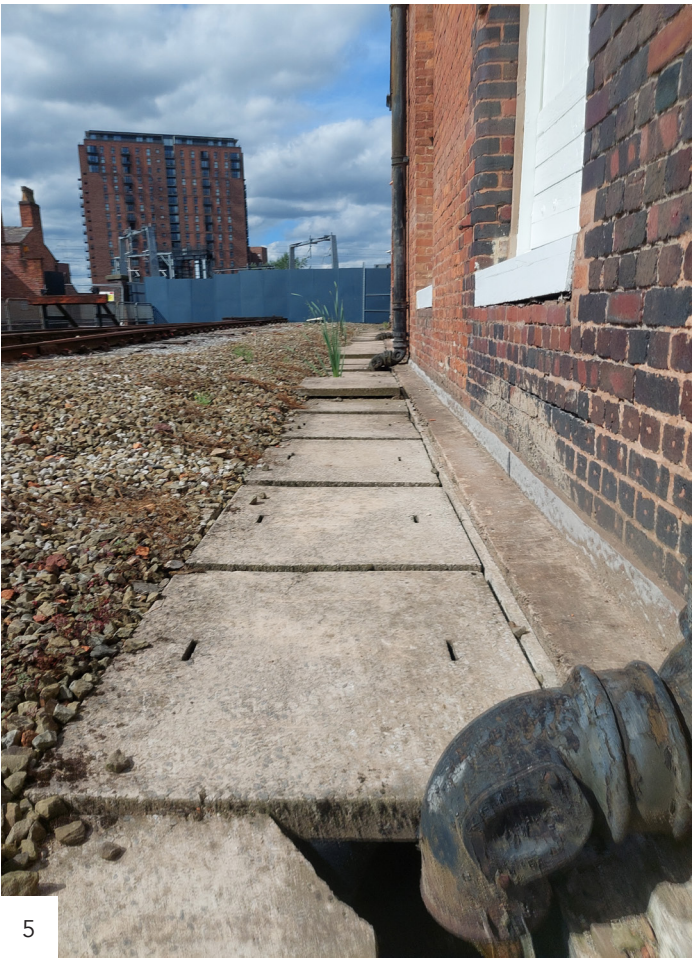
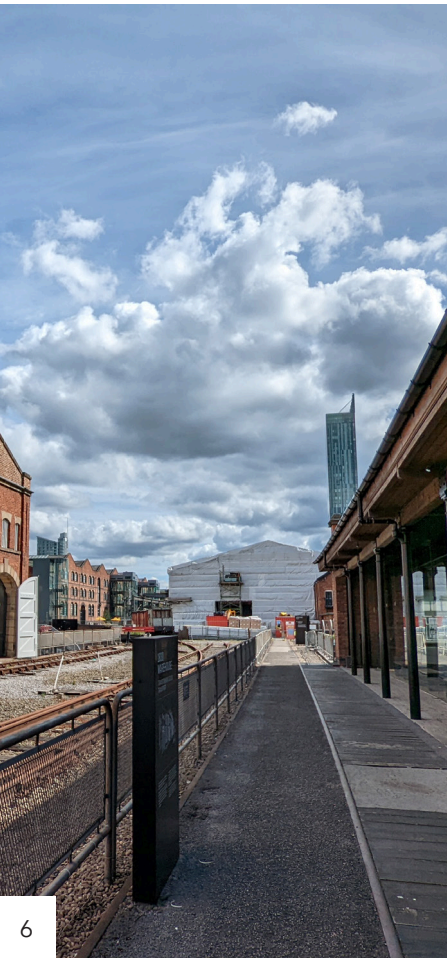
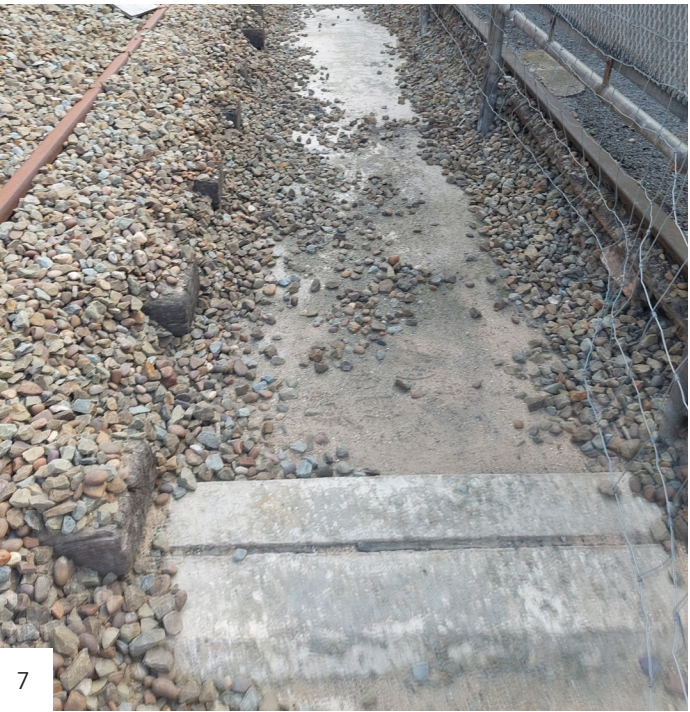
- 1. 1830's Viaduct at track level - concrete revealed beneath ballast
- 2. View onto the tracks and 1830's Warehouse from the platform
- 3. View east along the tracks
- 4. 1830's Warehouse, tracks and station platform
- 5. North trough along the 1830's warehouse
- 6. 1830's Station Building Platform
- 7. Concrete slab exposed beneath the ballast

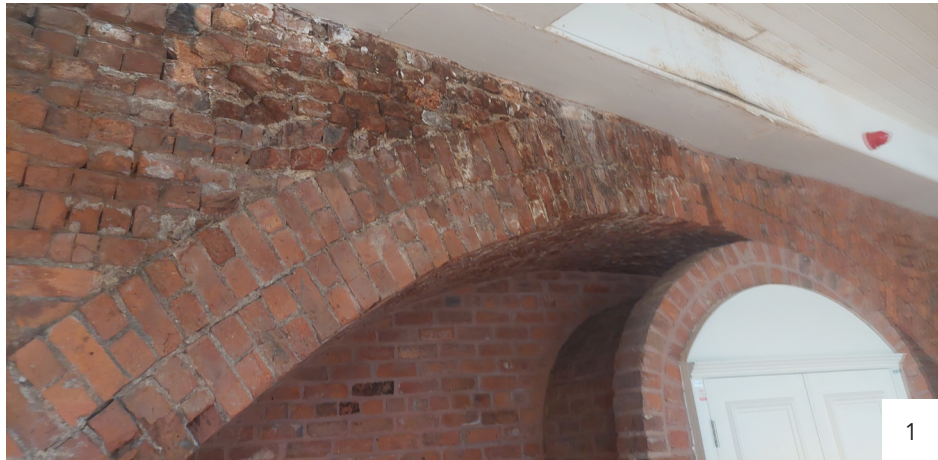
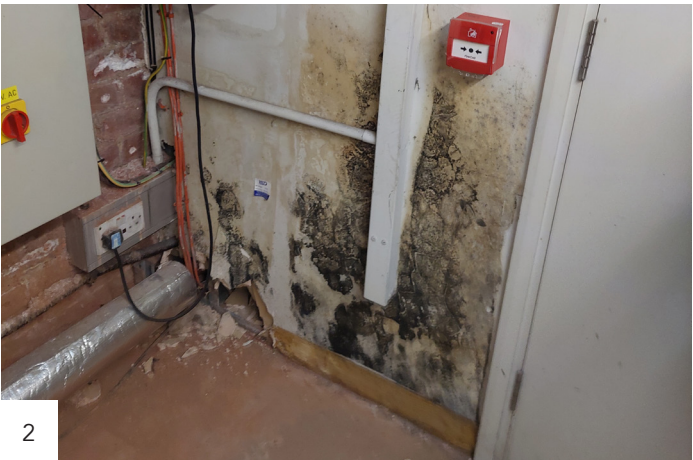
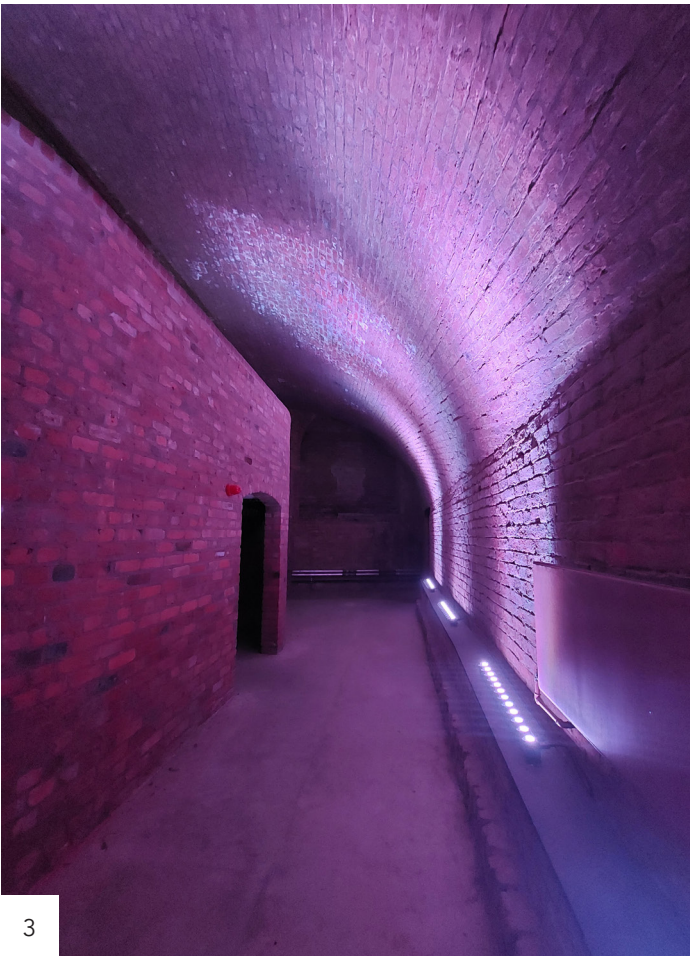
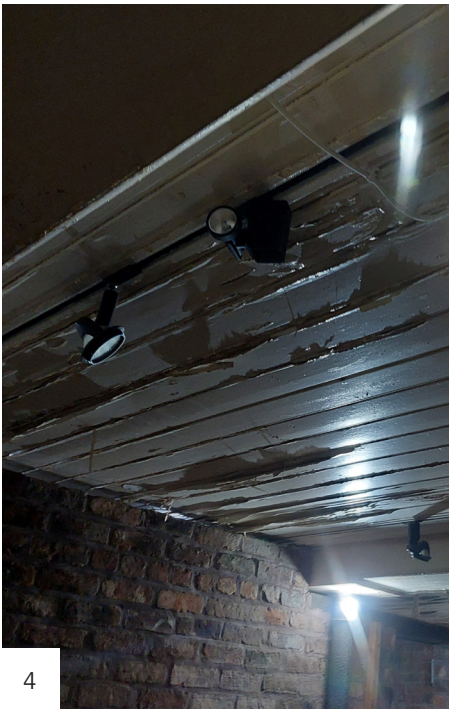
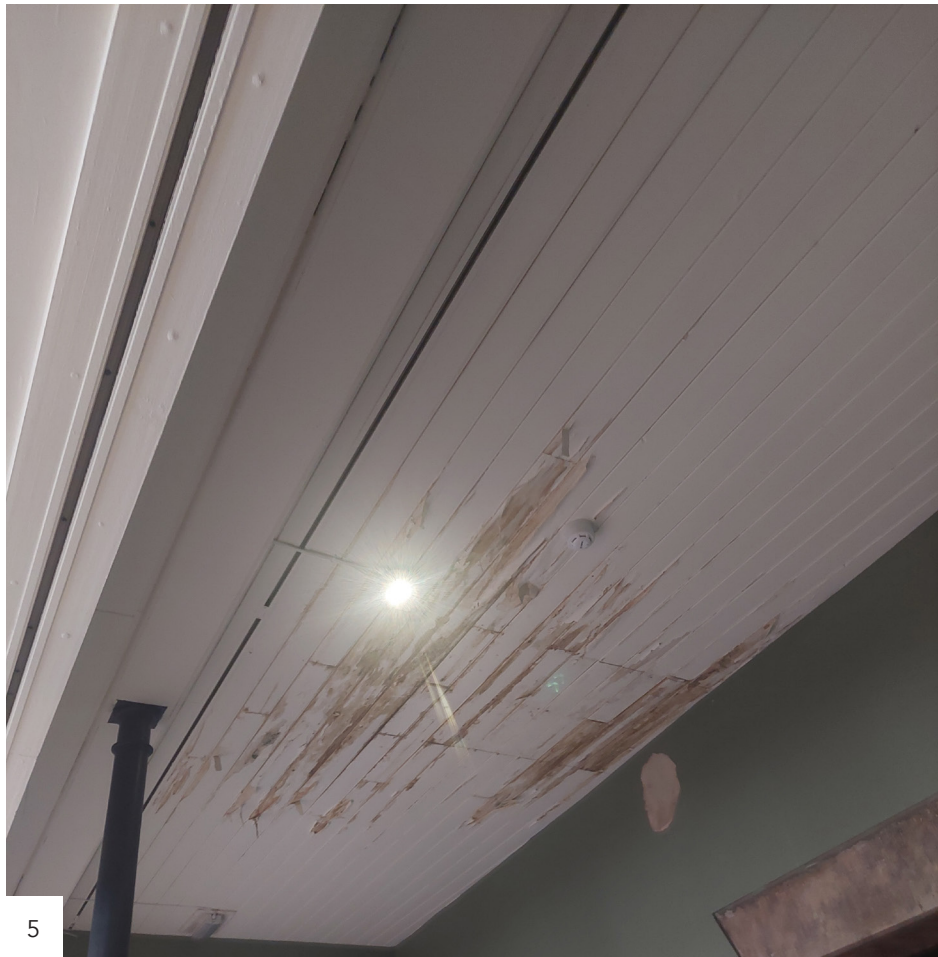
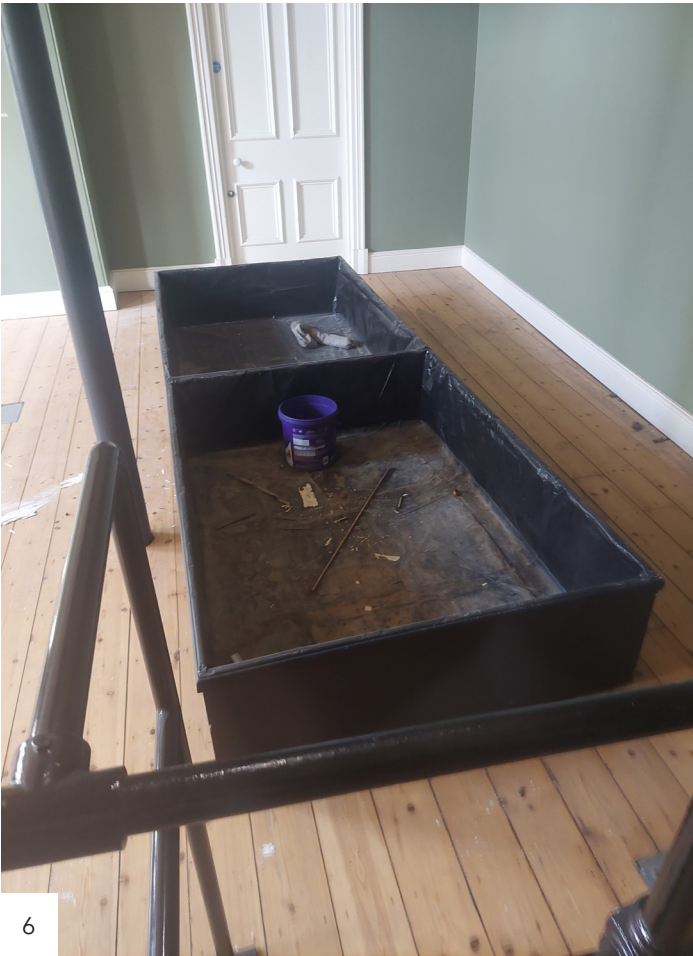
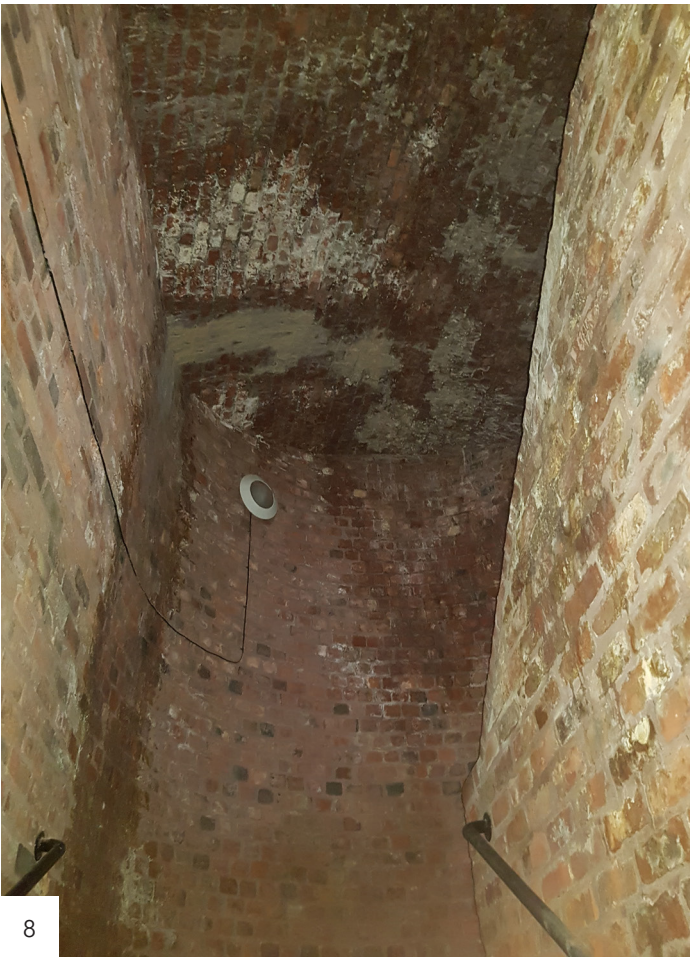
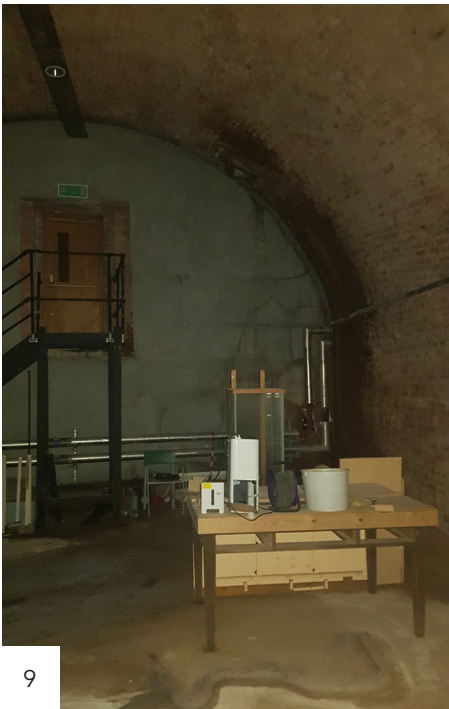
1. Water ingress - junction between the Viaduct & Station Building
2. Damp issue - Plant room - Station Building
3. Link between the Station Building & 1830's Warehouse
4. Water ingress - LG-Station Building
5. Water ingress GF - Station Building
6. Water catchment pools GF -Station Building
7. Paint and plaster defects - junction between the Station Building & Viaduct
8. Evidence of water ingress into the stair well
9. Example of water ingress issues into the Viaduct Arches

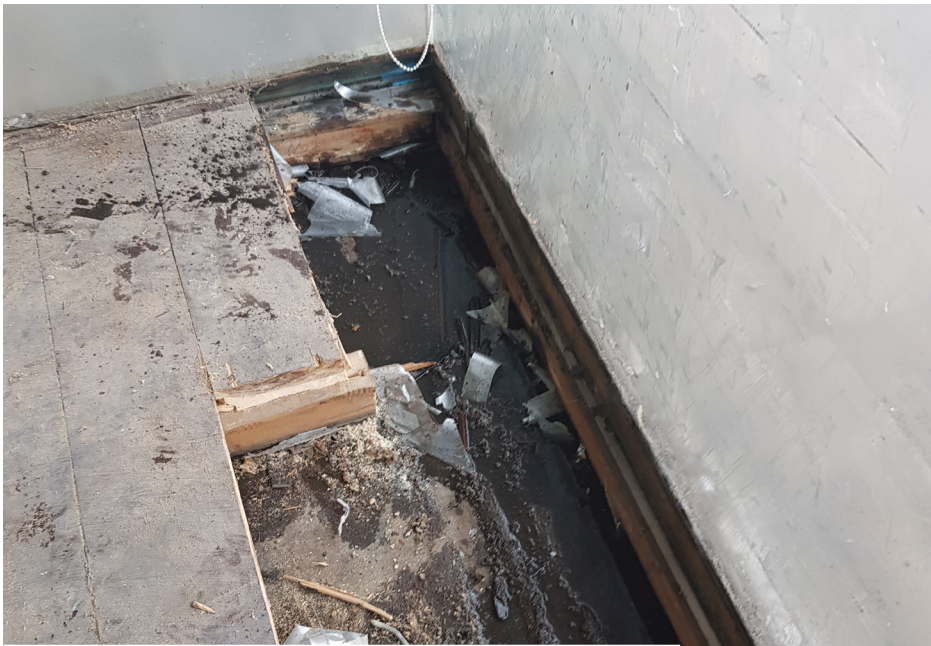
4.5.6.32 Water migrates from the covered platform and underneath the exterior glazed screens, with evidence of ponding water internally, below the timber floor boards and battens.

Carriage works interior - water ponding under floor boards

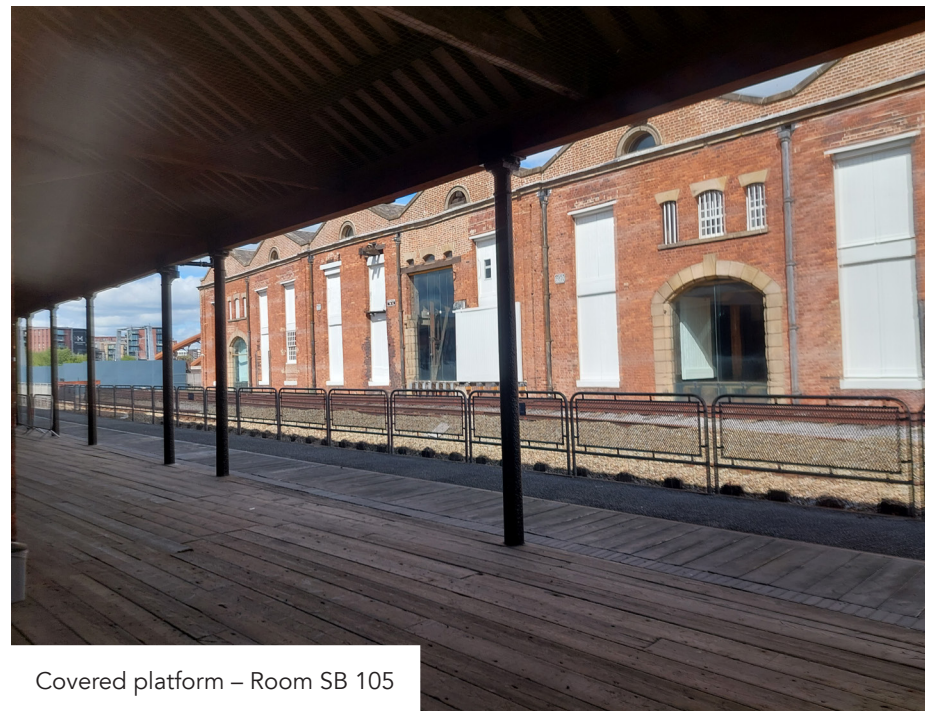
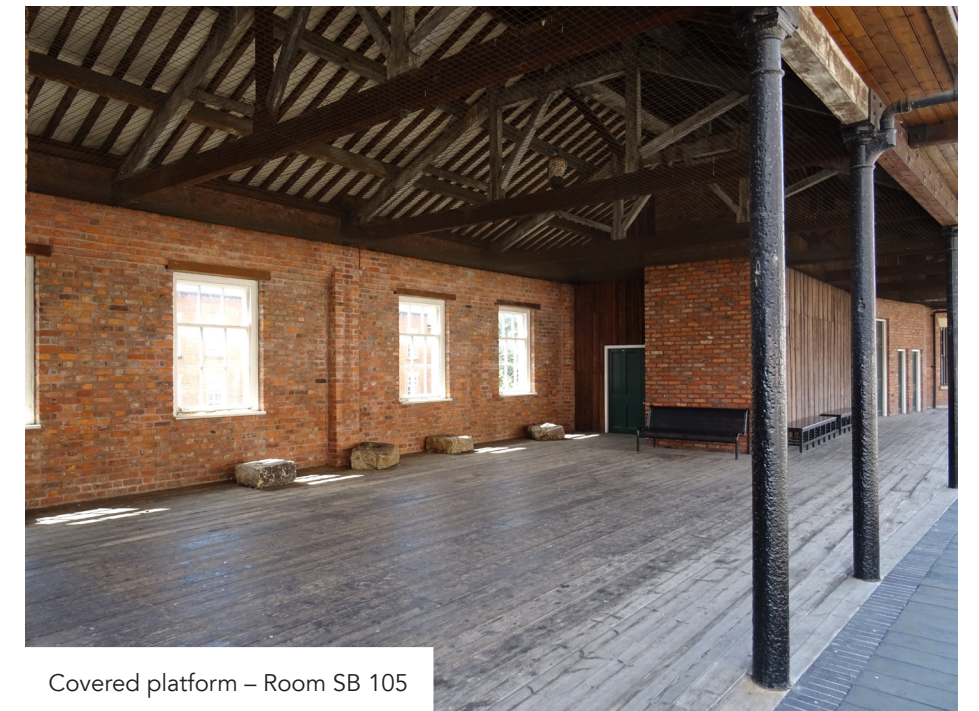
Covered platform – Room SB 105

4.5.7.13 The external covered area within the Station Building platform is open to the elements. A high percentage of the planks are visibly saturated, with localised vegetation noted.

4.5.7.14 The planks abut tight and there appears to be no cross ventilation offered to the underside, concealed voids

4.5.7.15 There was no evidence of any flashings or weathering's at the interface or abutment of the external walls or glazed screens

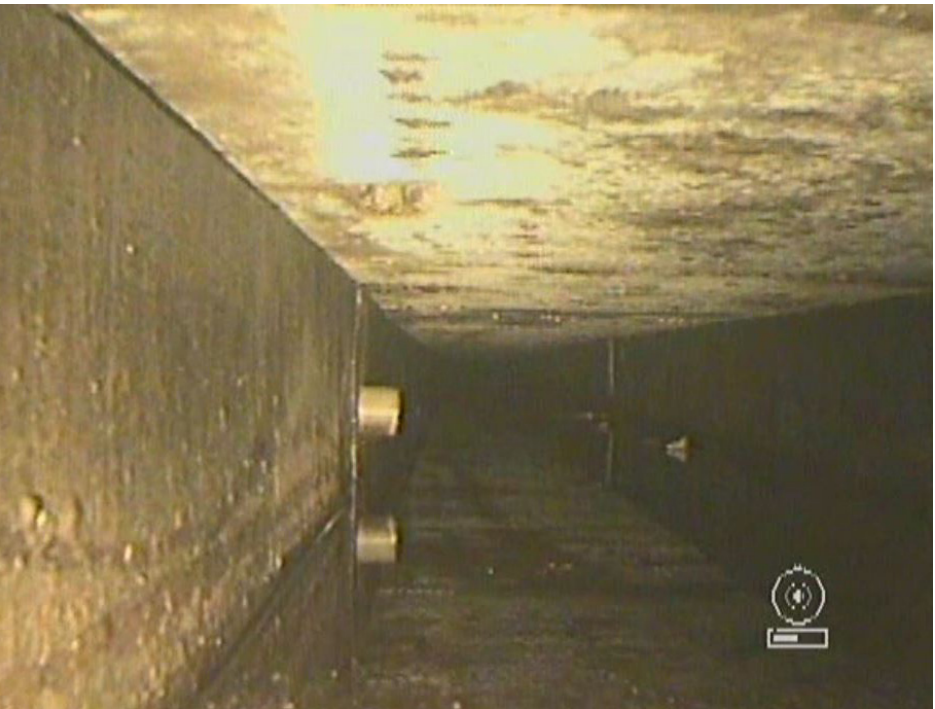
CCTV inspection showing 50mm pipe, suspected to be connected to internal rainwater downpipe which connects into the north cast iron gutter

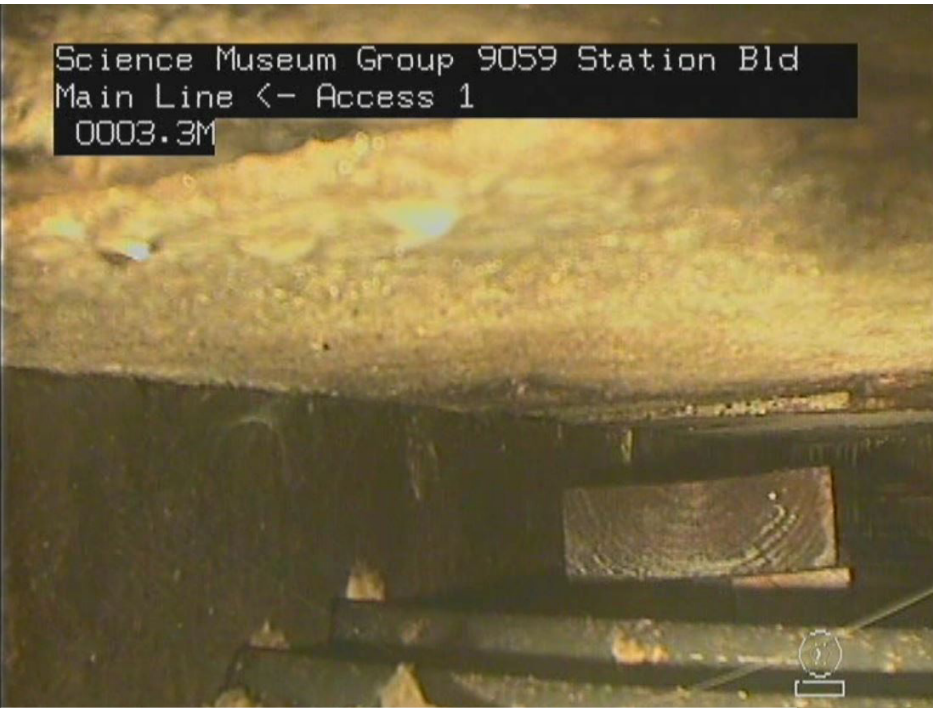
CCTV inspection showing pipes / cables penetrating concrete trough, debris to background.

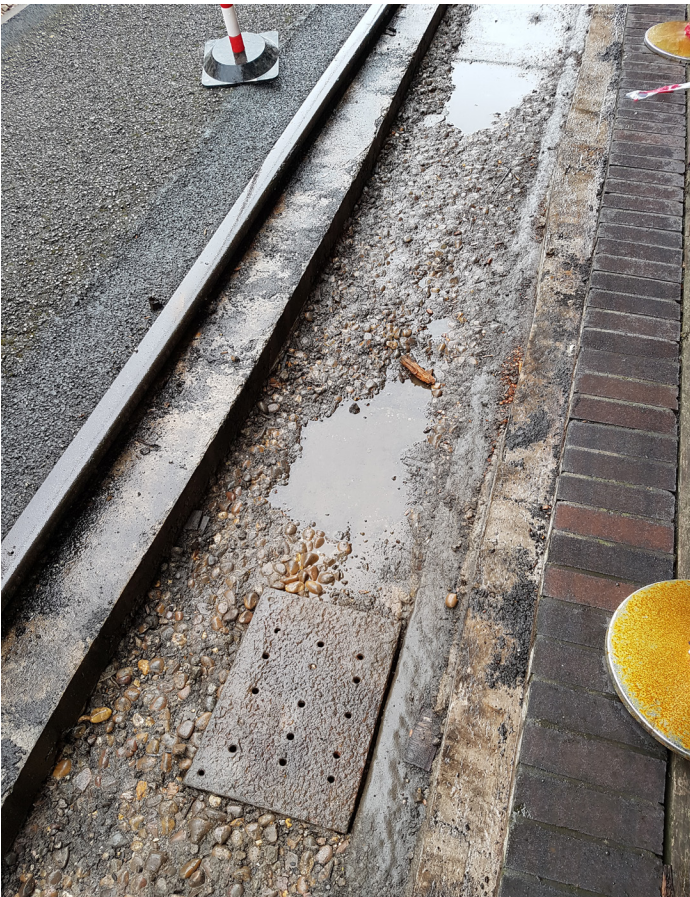
- 6.2.16 Several timber planks were lifted along the length of the platform to allow for investigation of the southern upper trough chamber.
- 6.2.17 The underside of the planks were found to be sweating / moist, likely due to the fact that the void below is unventilated with stagnant air. It is understood that the

Upper chamber visible following temp removal of timber planks

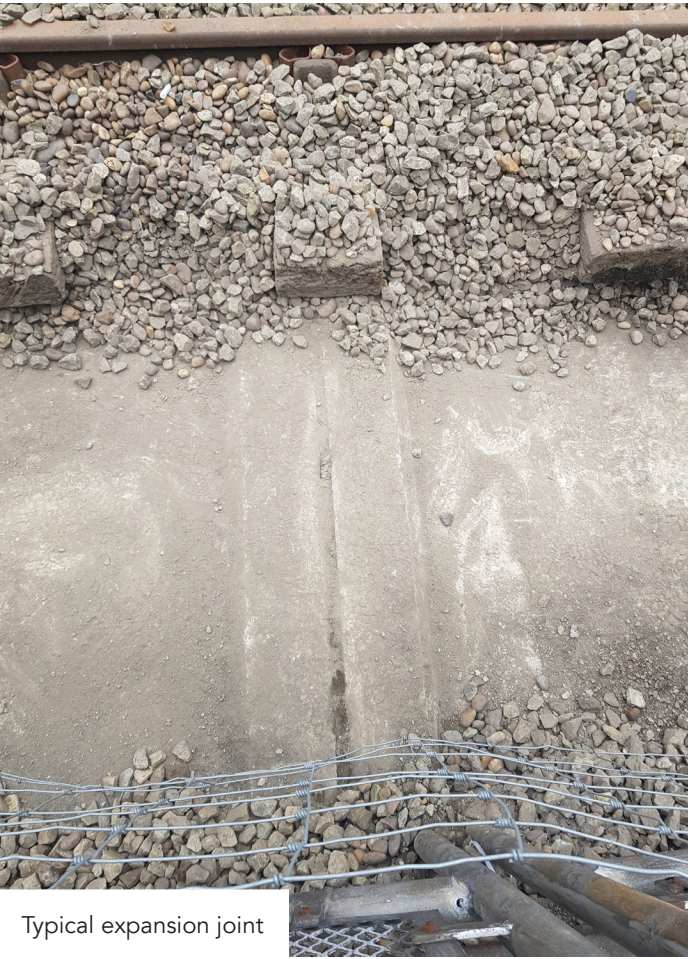
Typical expansion joint

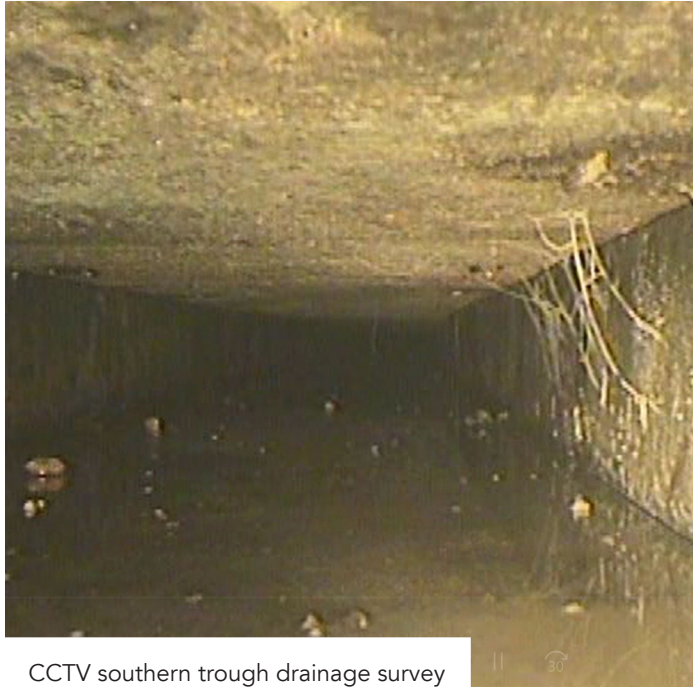
6.3.21 Following the formation of manhole covers providing access into the lower chamber, a drainage CCTV survey was commissioned. The survey extended from the east end of the trough, working towards the west. The survey was abandoned in both directions due to obstructions found within the trough.

CCTV southern trough drainage survey

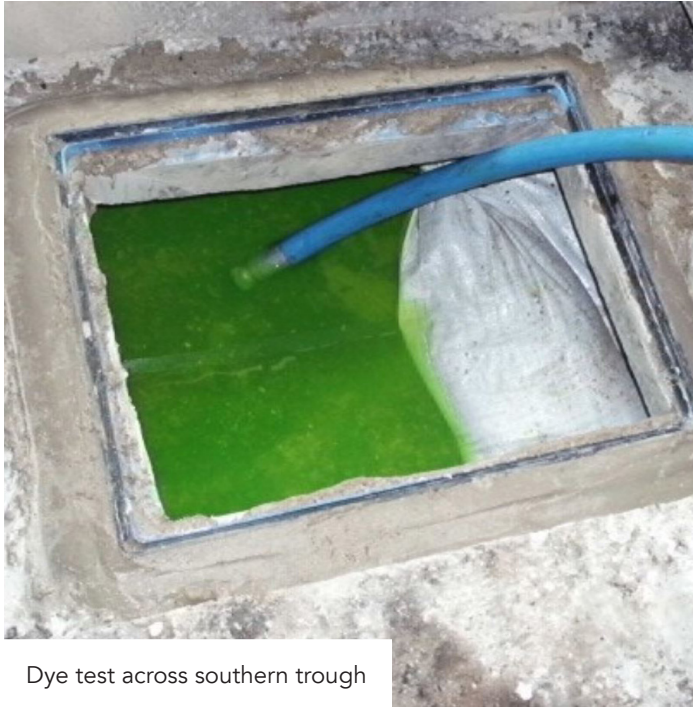
6.3.25 Following the dye test there was no evidence found of any coloured dye within the interior of the viaduct or Station Building.

Dye test across southern trough

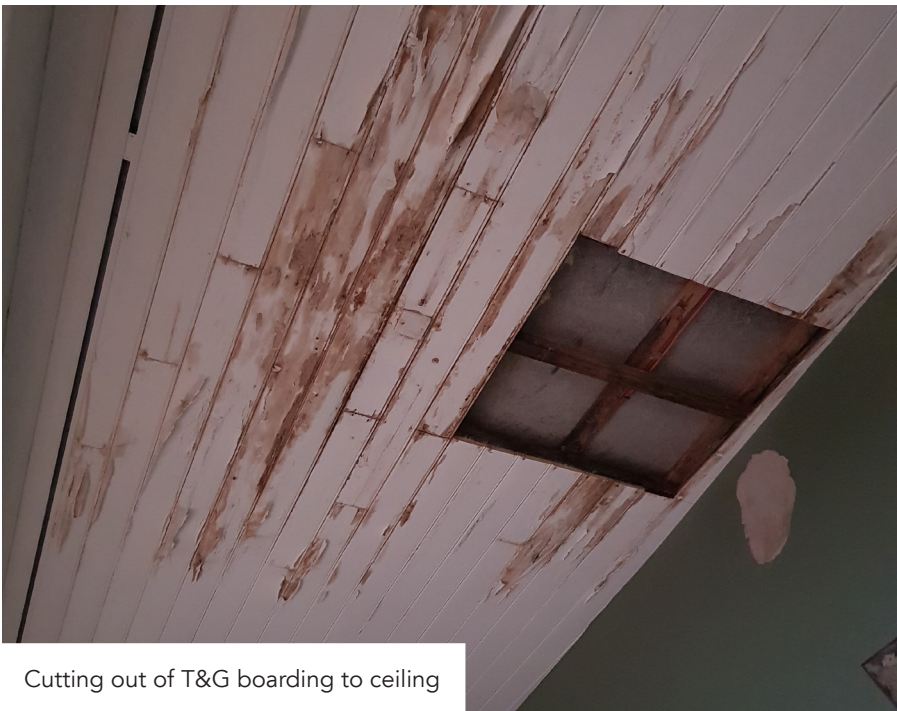
6.3.34 Following removal of the boarding, a layer of mineral wool was found packed between timber battens and counter battens, with what appeared to be the concrete planked floor structure above. The void appeared to be circa 50-75mm in depth.

6.3.35 The insulation was soddened, the timber visibly wet and soiled with evidence of moisture being held to the underside of the planks. Suggesting issues potentially linked with condensation and water migrating through the slab.

Cutting out of T&G boarding to ceiling

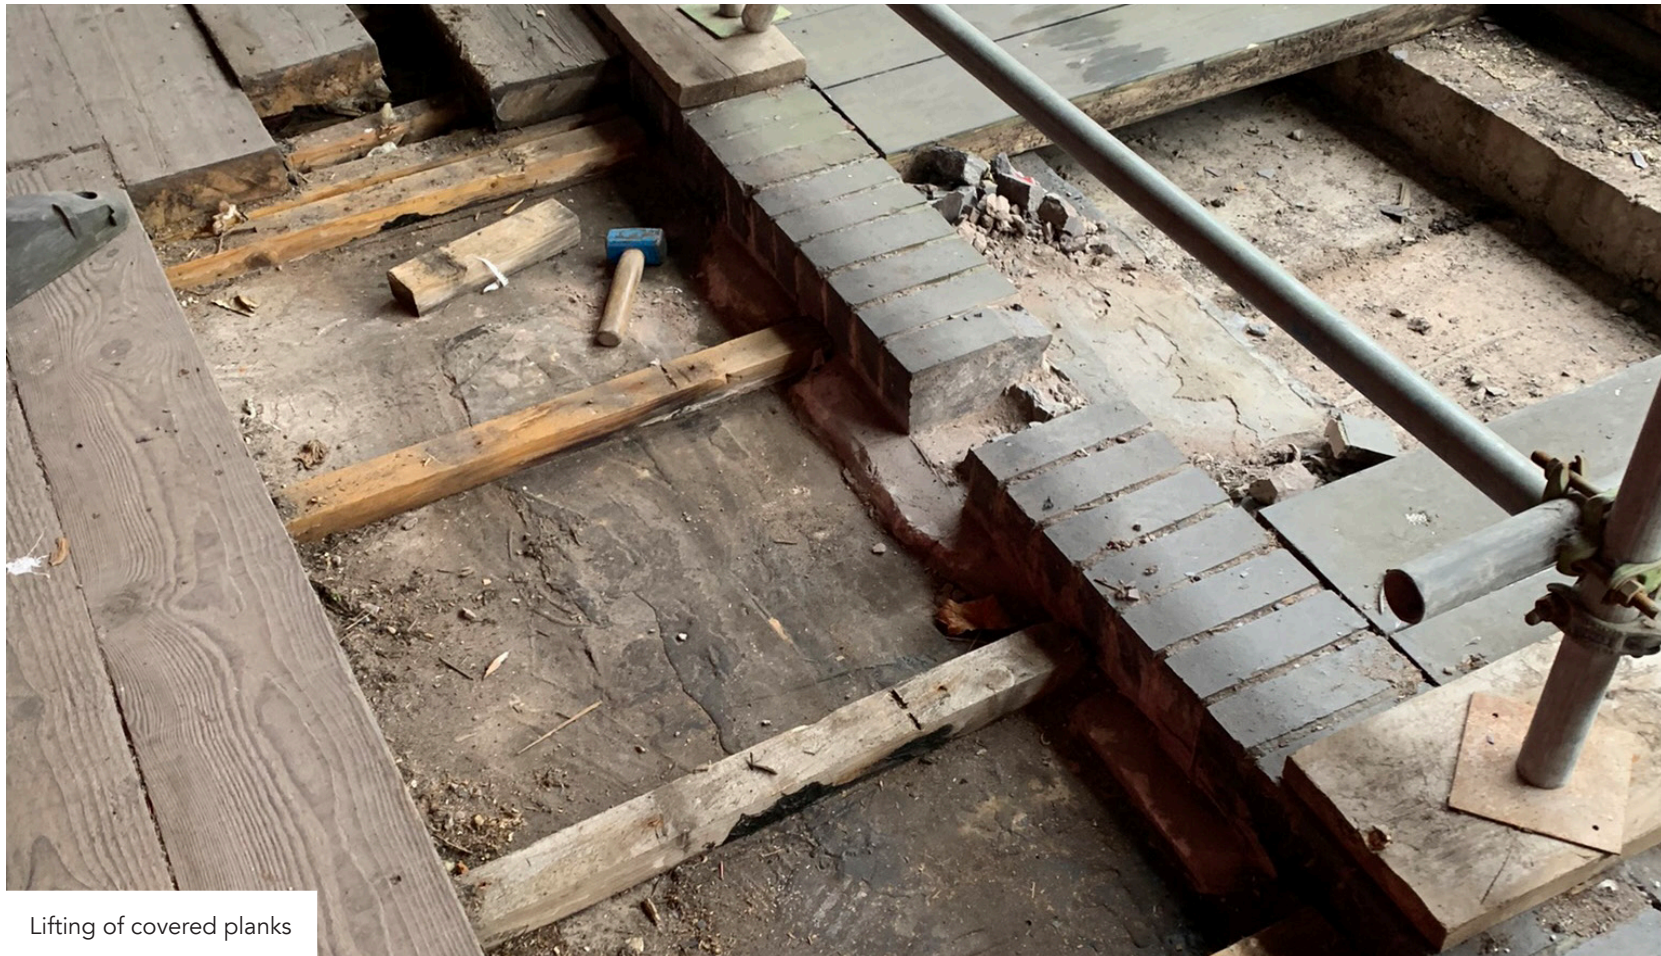
The timber planks within the covered platform are fixed tightly with traditional nails, abutting adjacent planks. The planks sit upon timber battens directly upon the sloped substrate beneath. The boards lifted were typically saturated to the underside with signs of wet rot, decay. The battens were also found to be severely decayed. There was no evidence of cross ventilation.

- 6.2.6 The substrate did not appear to be linked to the southern trough. From the areas inspected, it appeared that any moisture within these locations to the underside of the boards, would be trapped. There was evidence of localised soft vegetation in areas, suggesting that there was a constant source of moisture available.

Lifting of covered planks

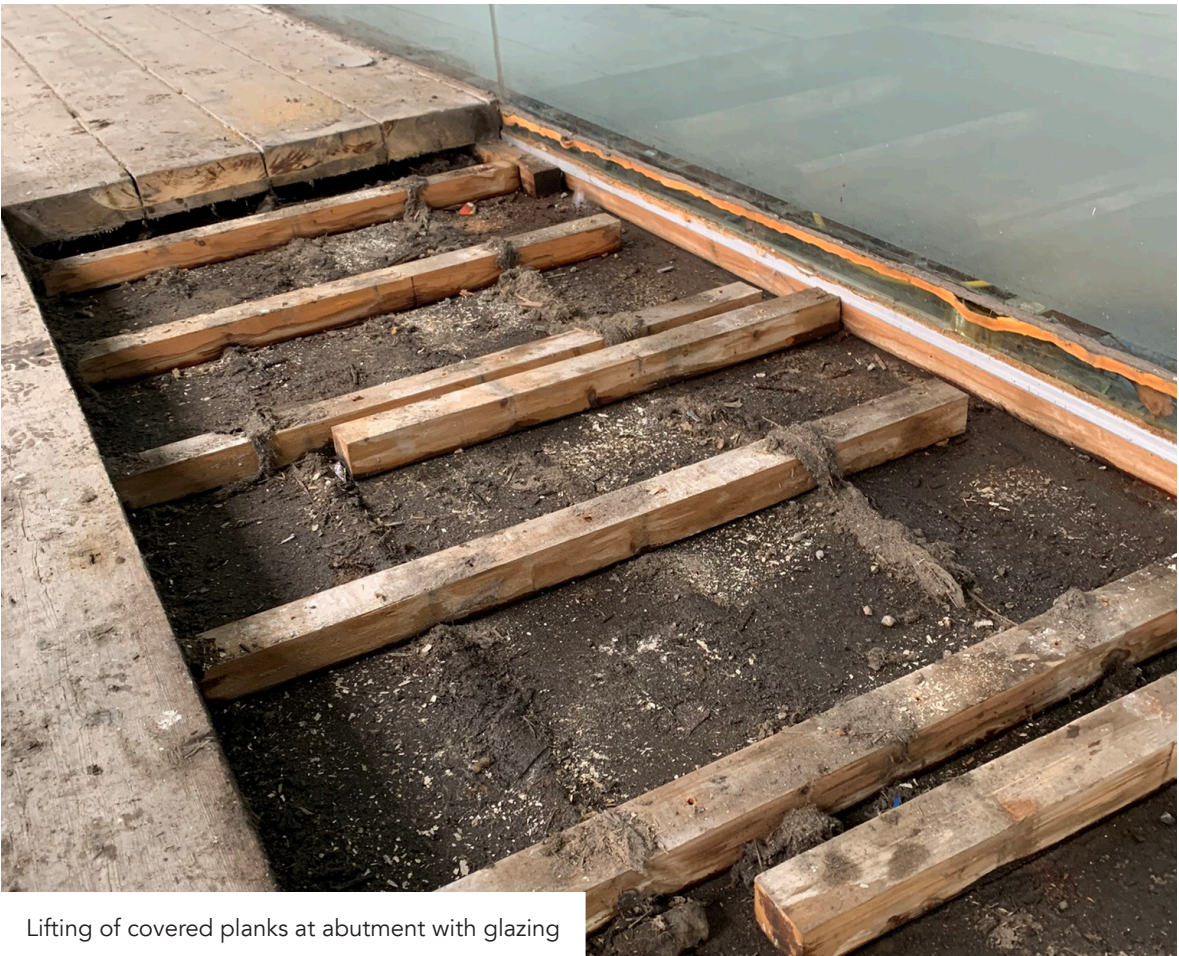
- 6.2.7 b. Lifting of covered planks at abutment with glazed screen
- 6.2.8 Similarly to item (a), the build-up and condition was found to be similar. However, there was no weathering or flashing detail at the abutment / interface with the platform glazed screen.

- 6.2.9 Any trapped moisture which had penetrated the planks was simply allowed to migrate under the glazed screen to the internal space. The water has nowhere else to go as there were no visible connections or outlets evident with the southern trough.

Lifting of covered planks at abutment with glazing

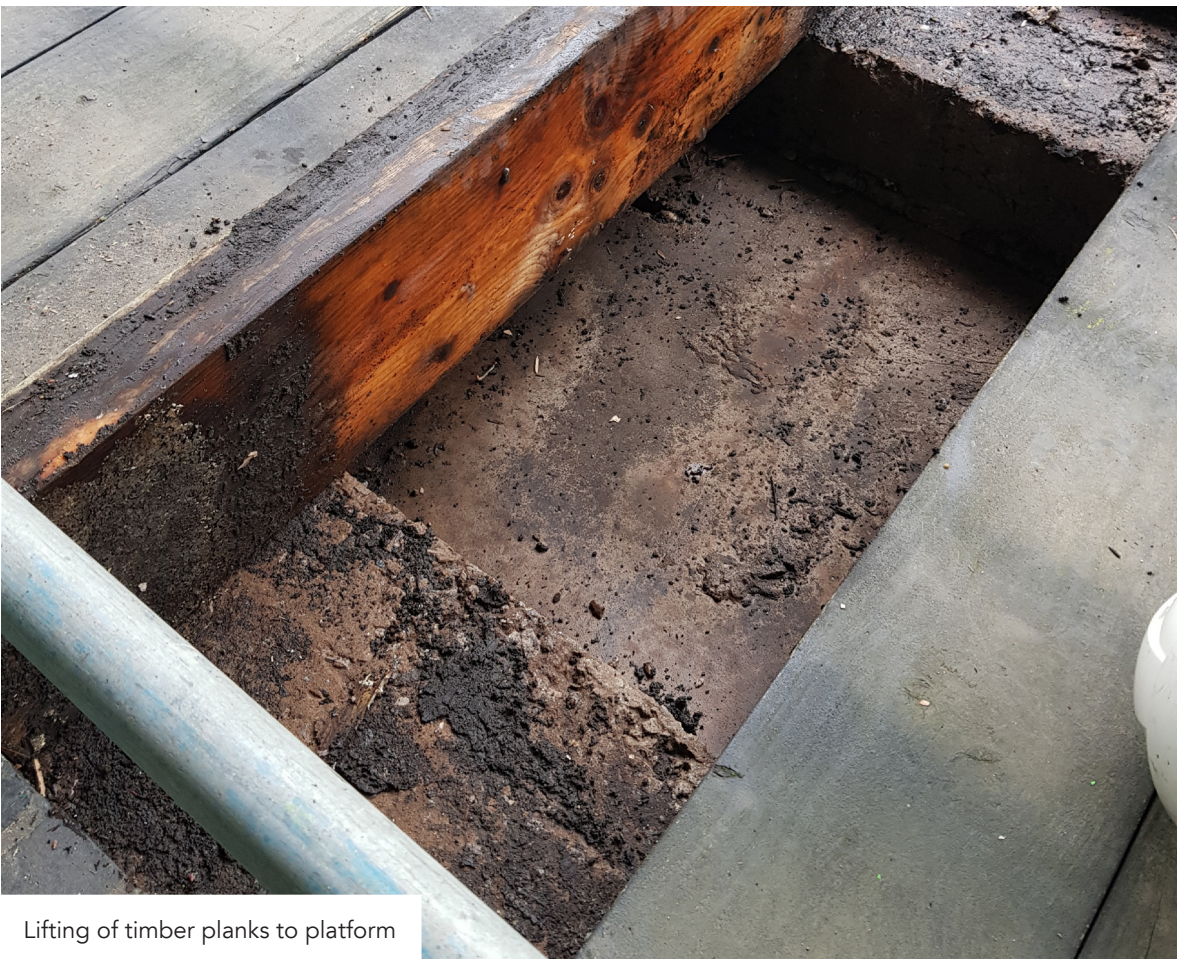
Lifting of timber planks to platform

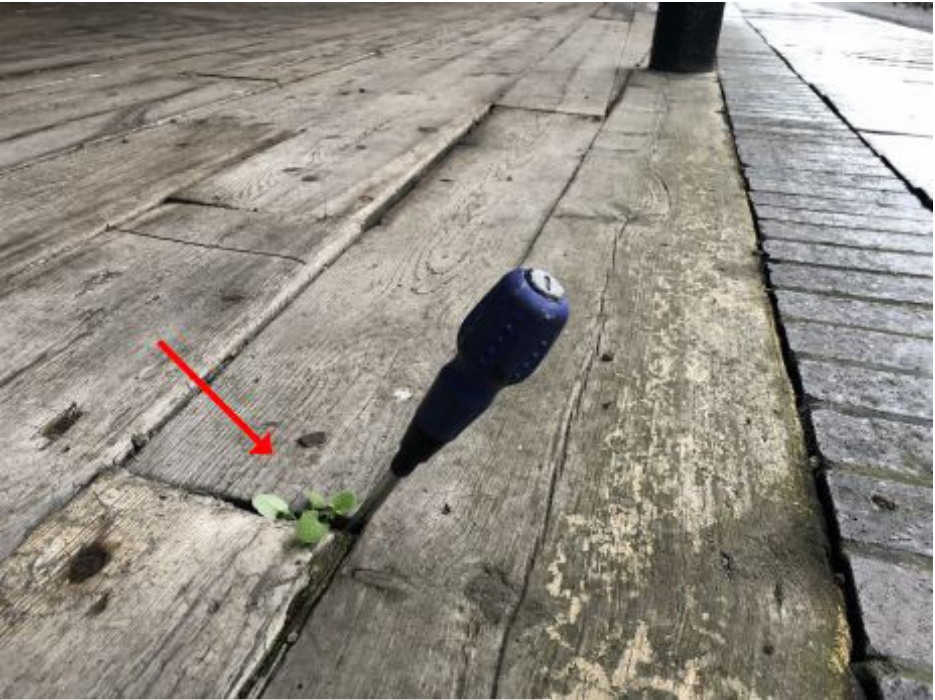
Vegetation growth between platform boarding

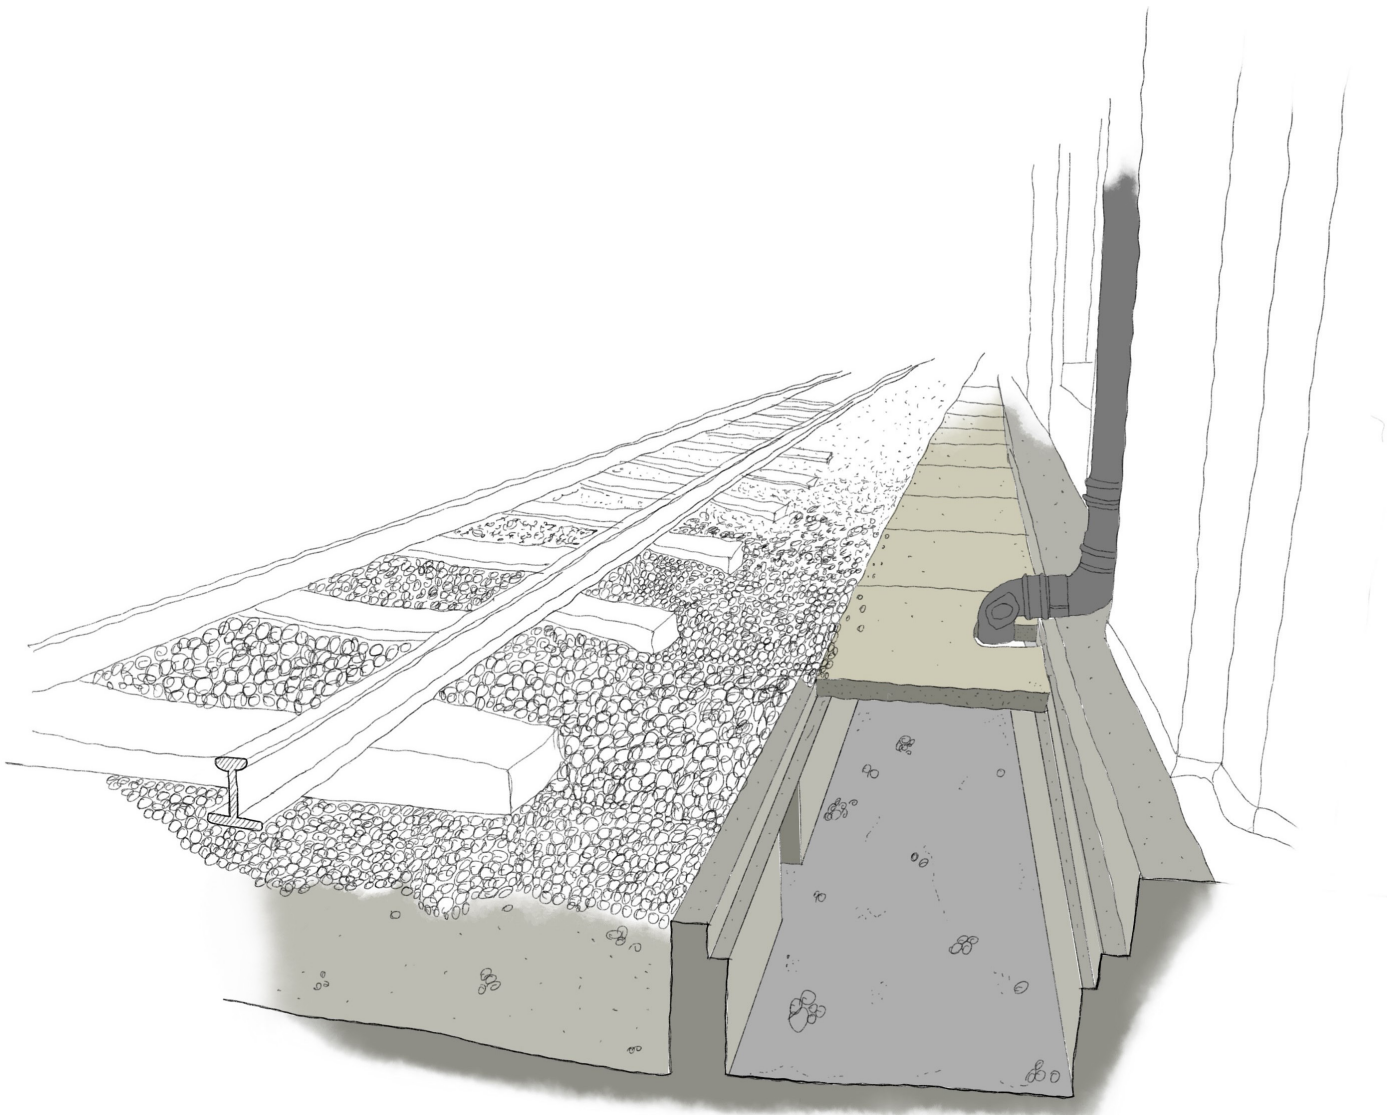
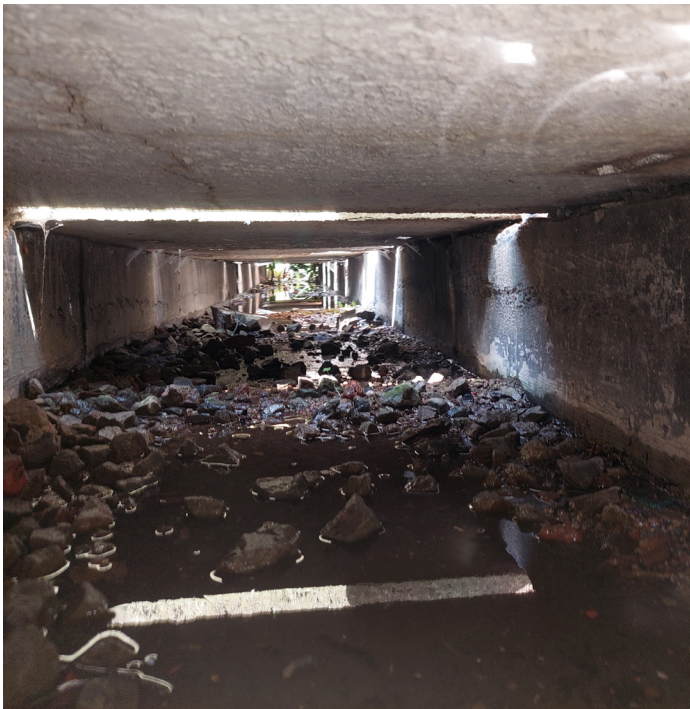
7.4.1 Northern Trough

- 7.4.1.3 The channel is capped by huge precast concrete covers, that are set within a rebated edge detail. The lids are tightly abutted in localized areas but typically have gaps between each unit. There are several defective lids with fissures evident. The lids are uneven, likely due to the presence of ballast in between the underside of the lid and edge rebate.

- 7.4.1.4 The covers have been locally broken out to allow for the rainwater downpipes from the 1830s Warehouse to discharge into the drainage channel.

- 7.4.1.5 The trough abuts the south elevation of the warehouse with a deep ledge (concrete screed) with a shallow upstand, which is flashed and taken into the first mortar joint.

- 7.4.1.6 The interior of the chamber is full of ballast which has worked its way through from track level, detritus and standing water observed, including well established vegetation growth in areas.
- 7.4.1.7 The adjacent graphic illustrates the current arrangement of the northern trough and its relationship with the 1830s Warehouse and railway tracks. A section of concrete covers has been removed to illustrate the profile and arrangement of the interior of the drainage channel. You can see the large diameter rainwater downpipes from the warehouse discharge directly into the channel.
