# Science & Industry Museum Viaduct

Viaduct  
Design and Access Statement  
September 2023

Project name: Viaduct  
Project number: 9488  
Client: Science & Industry Museum, Manchester

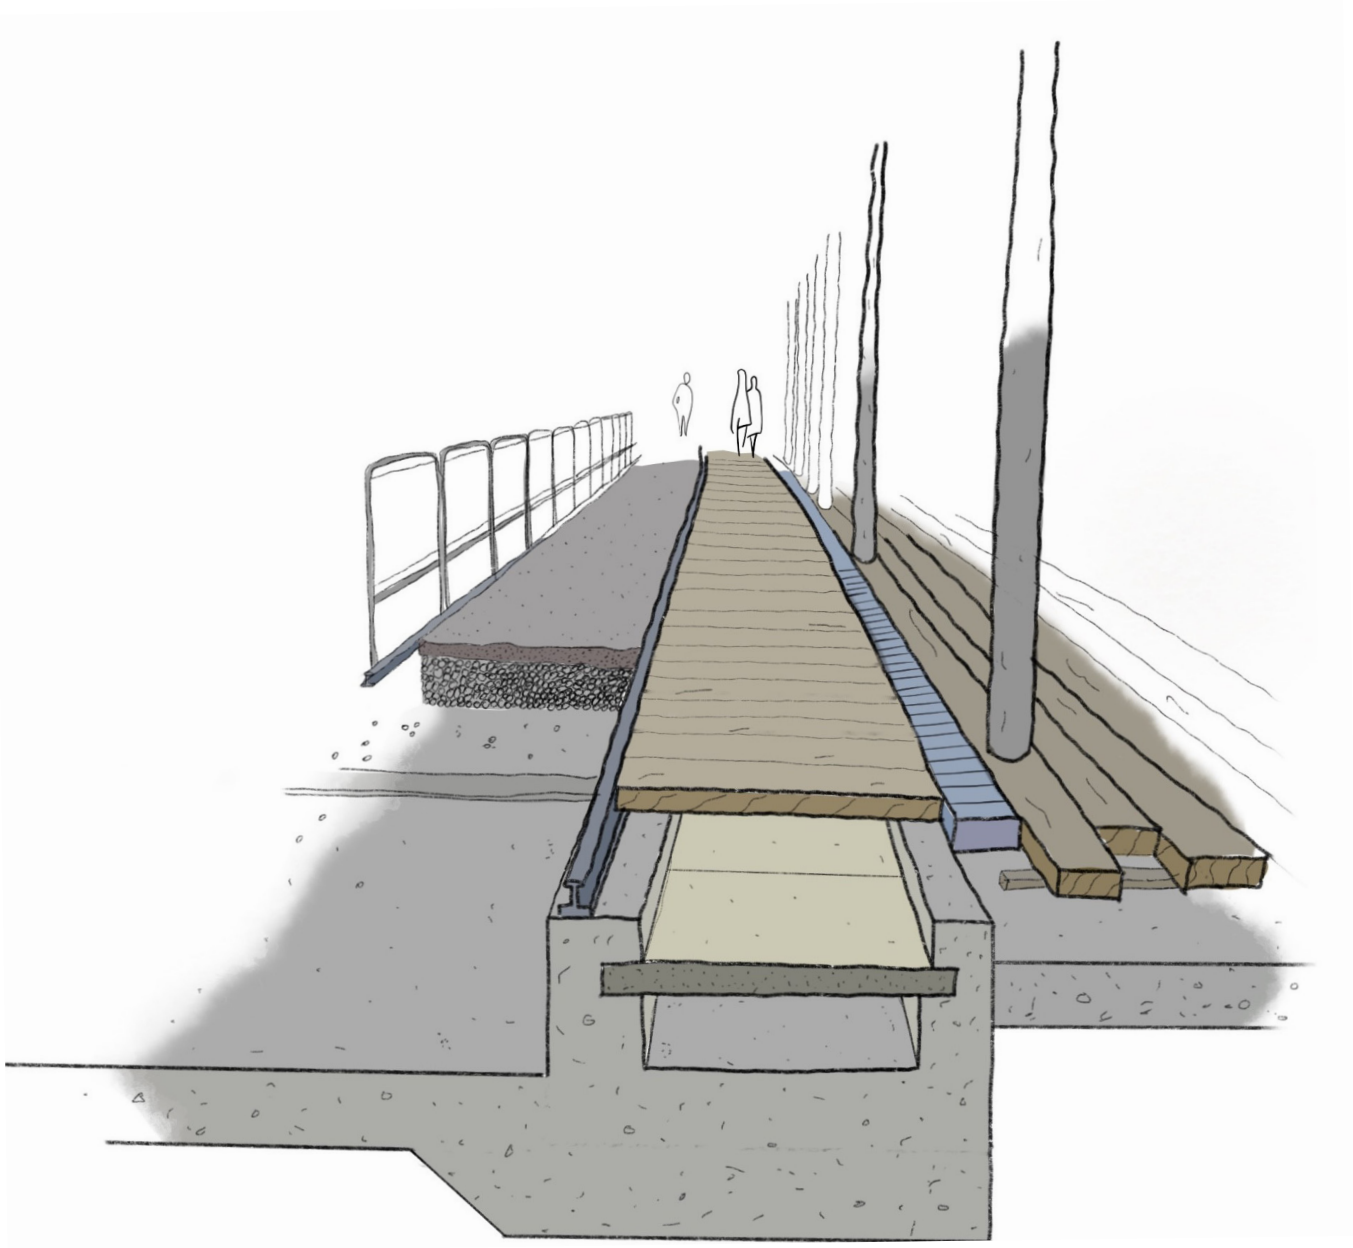
**7.4.2 Southern Trough**

- 7.4.2.5 The rainwater pipes to the Station Building penetrate the lower chamber and discharge directly into the trough.
- 7.4.2.6 It is understood that the trough is laid to fall towards the west of the site and discharges into a large 150mm diameter external vertical downpipe. The exact connection and arrangement of this detail is unknown.

- 7.4.2.7 The interior of the chamber is largely inaccessible, having only recently seen a series of manholes formed and installed at rainwater outlet locations to aid maintenance. The channel has standing water, silt and debris. Services penetrations have been observed on a north-south axis, running through the channel. The full extent of penetrations or defects across the concealed drainage channels are unknown.

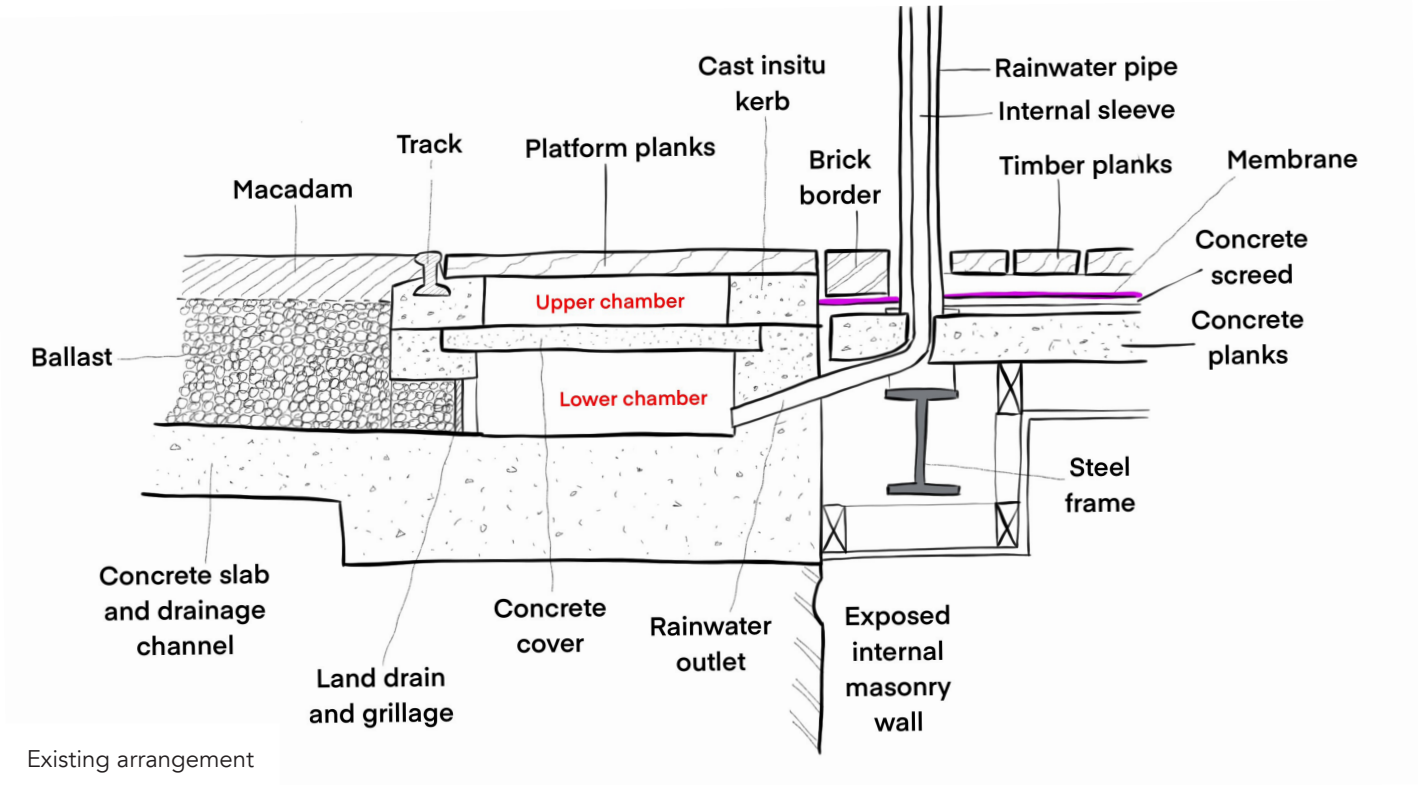
7.6.9 c. Trough outlets

7.6.10 According to the recently sourced archival material, both of the north and south troughs are connected via a transverse trough running on a north-south axis to the west end of the Viaduct. There is a single vertical outlet to the most southwestern corner, which is then subsequently connected into the main highway sewer. However, a second large diameter pipe is located to the north of the Station Masters House. It has yet to be proved but this may be a secondary outlet pipe to the below ground slab drainage network. Equally, there is a hopper and outlet to the west of the 1830s Warehouse, just north of the northern trough, which may also be connected to the below ground drainage network, potentially offering an overflow arrangement, however this has not been confirmed.

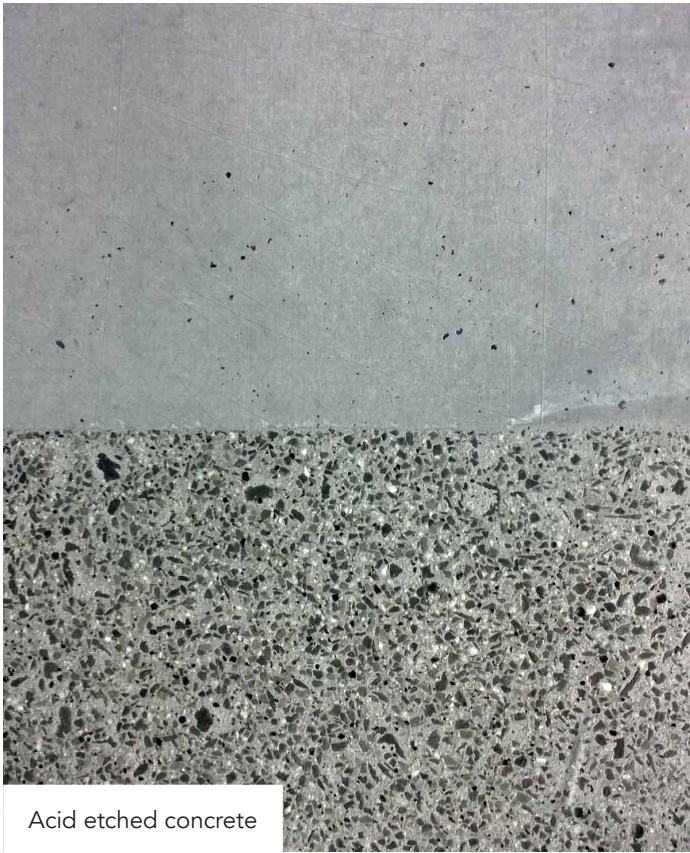
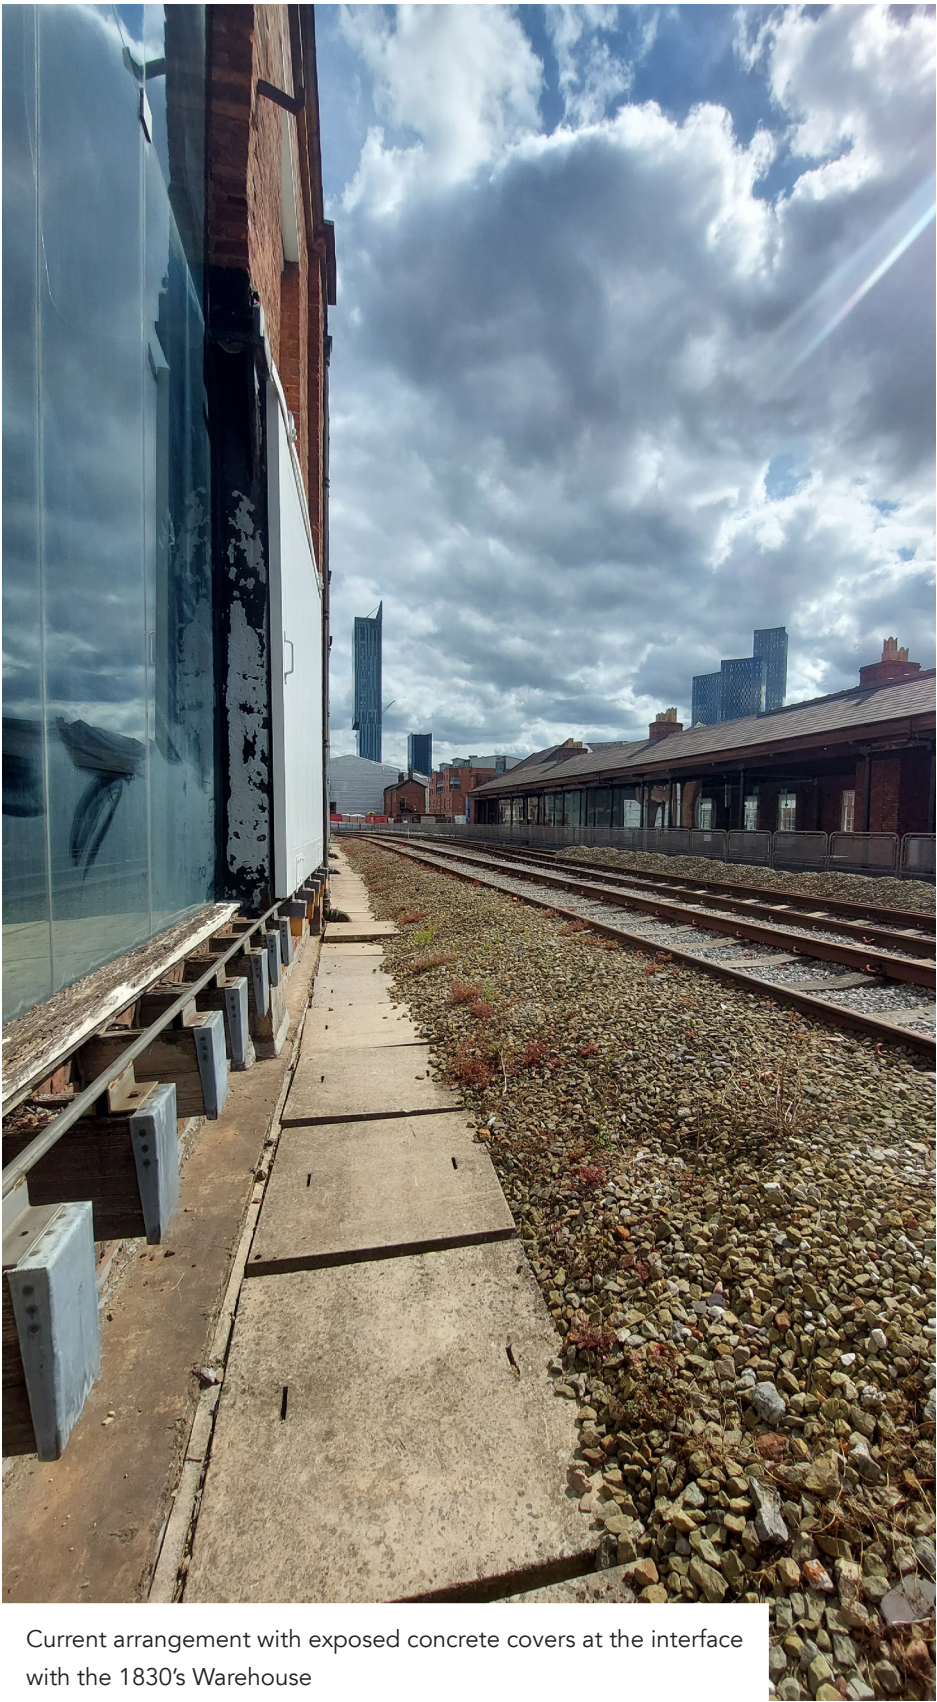
Current arrangement with exposed concrete covers at the interface with the 1830's Warehouse

- 8.3.6.1 All existing surface treatments are to be reinstated, following successful insertion of waterproofing system, with the exception of the modern timber planks which exist along the station platform.
- 8.3.6.2 It is proposed to replace the modern timber planks, which are susceptible to rot and not appropriate for light vehicular traffic with exposed concrete covers, to closely match the current exposed arrangement at the abutment with the 1830s Warehouse.
- 8.3.6.3 Product: Large format slab
- 8.3.6.4 Material: Reinforced precast concrete
- 8.3.6.5 Size: Varied length (to match arc of platform) x 600 x depth (tbc by engineer)
- 8.3.6.6 Colour: crème
- 8.3.6.7 Finish: acid etched, heavy
- 8.3.6.8 Accessories: to include lifting eyes and smaller access lids
