SEG - EXISTING STRUCTURE KEY.

| Client | SCIENCE MUSEUM GROUP | | |
| Project | SIM SITE WIDE CAPITAL WORKS | | |
| Org Title | SEG<br>STRUCTURAL GENERAL ARRANGEMENT | | |

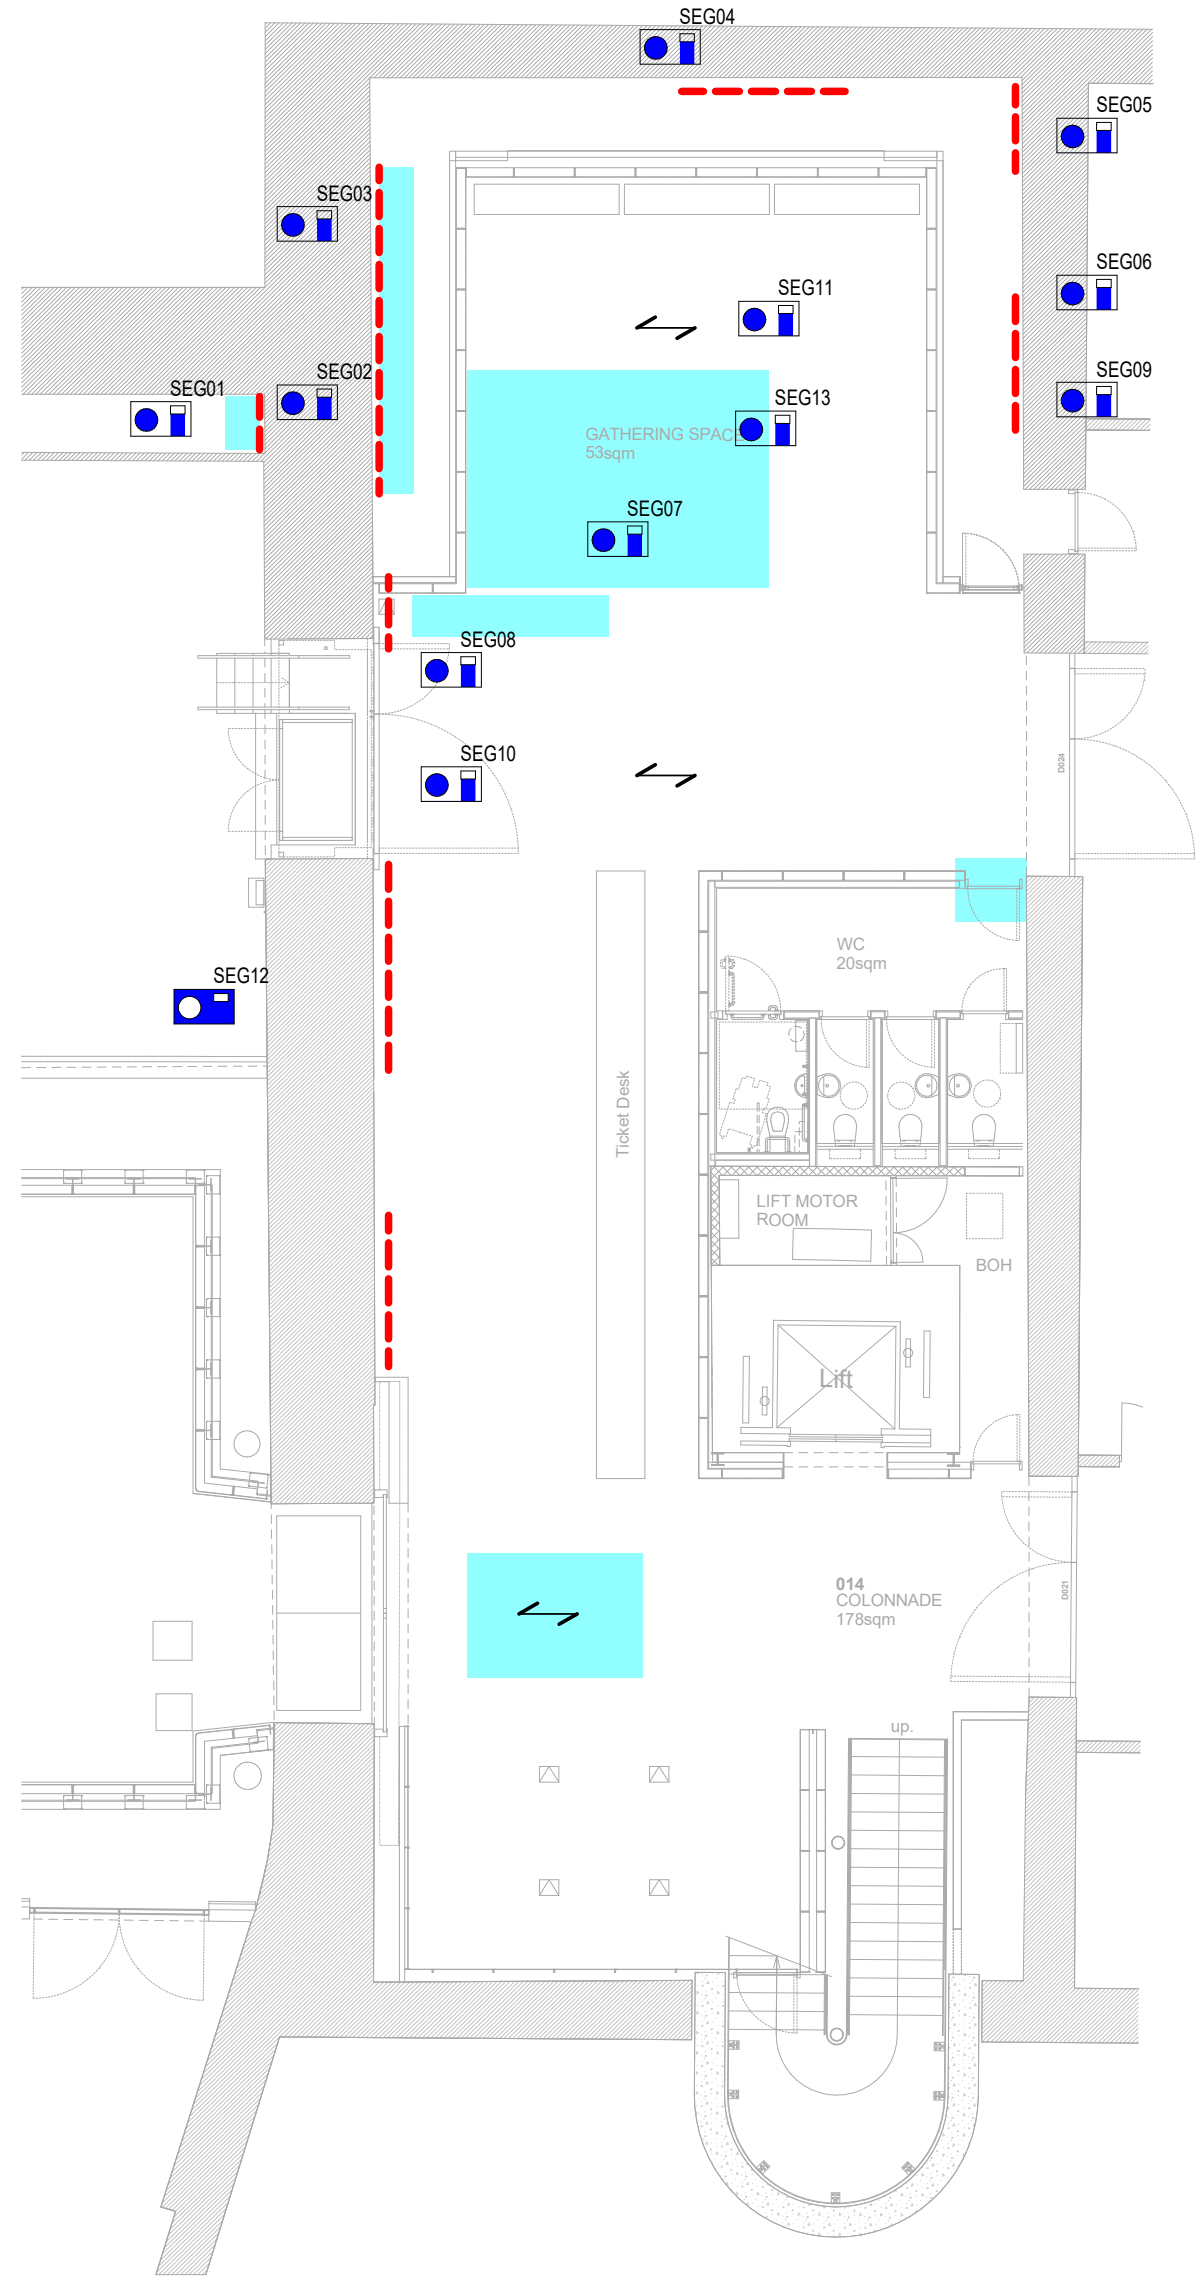
SEG - BASEMENT LEVEL GA - SKETCH  
SCALE 1 : 125

| PHOTO REF. | PHOTO | DESCRIPTION | COMMENTS | PHOTO REF. | PHOTO | DESCRIPTION | COMMENTS | PHOTO REF. | PHOTO | DESCRIPTION | COMMENTS | PHOTO REF. | PHOTO | DESCRIPTION | COMMENTS |
|---|---|---|---|---|---|---|---|---|---|---|---|---|---|---|---|
| SEG01 | | OTHER SIDE OF WEST WALL ADJACENT TO NEIGHBOURING BUILDING SHOWING SIGNIFICANT WATER DAMAGE AND CORROSION. | | SEG05 | | SALT BRICK DETECTED ON THE EAST WALL. | | SEG09 | | BEAMS EAST SUPPORT ARE IN GOOD CONDITION. | | SEG13 | | JACK ARCH BEAM FLANGE THICKNESS INCREASES AS MOVES TOWARDS MIDSPAN. | |
| SEG02 | | CORROSION AND POOR CONDITION OF JACK ARCHES INTERFACES WITH WALL. | | SEG06 | | CORRODED PIPE OBSERVED WITHIN JACK ARCH BAY. | | SEG10 | | SECONDARY STEEL ADDED LATER TO PICK UP THE LOAD FROM THE LINTELS. | | | | | |
| SEG03 | | EVIDENCE OF CONTINUOUS WATER INGRESS RESULTING IN A DAMP WALL AND ADDITION OF A DRAIN WHERE WATER HEADS DRAINS FROM THE WALL. | | SEG07 | | CORROSIONS SEEN AT AREAS ON THE CAST IRON FLANGES. | | SEG11 | | BEAMS GENERALLY IN GOOD CONDITION WITH CORROSION POINTS. SALT BRICK IDENTIFIED IN AREAS OF JACK ARCHES. | | | | | |
| SEG04 | | SALTBRICK MINERAL DEPOSITS OBSERVED AS A RESULT OF WATER INGRESS. WALL SURFACE DRY. | | SEG08 | | MISSING MATERIALS AT THE CENTRE WEB OF CAST IRON BEAM LINTEL. | | SEG12 | | CORROSION OF CAST IRON PLATES LEAVING THIN FLANGE THICKNESS. | | | | | |
