The northern elevation was also constructed in a three-course English Garden Wall bond consisting of two central recessed windows with a steel ladder to the eastern end (Plate 52; Fig 5). The ladder had been fixed to the outer face and afforded access to the roof. As with the windows to the eastern elevation, the windows were set within a cast-iron housing with a pointed arch head. The cast-iron doors had been removed and exposed a four-light cast-iron window with modern wired obscured glass panes (Plate 53).

Hammerstone Road Depot, Gorton, Manchester

Hammerstone Road Depot, Gorton, Manchester  
Figure 5: Ambulance bay plan & elevations

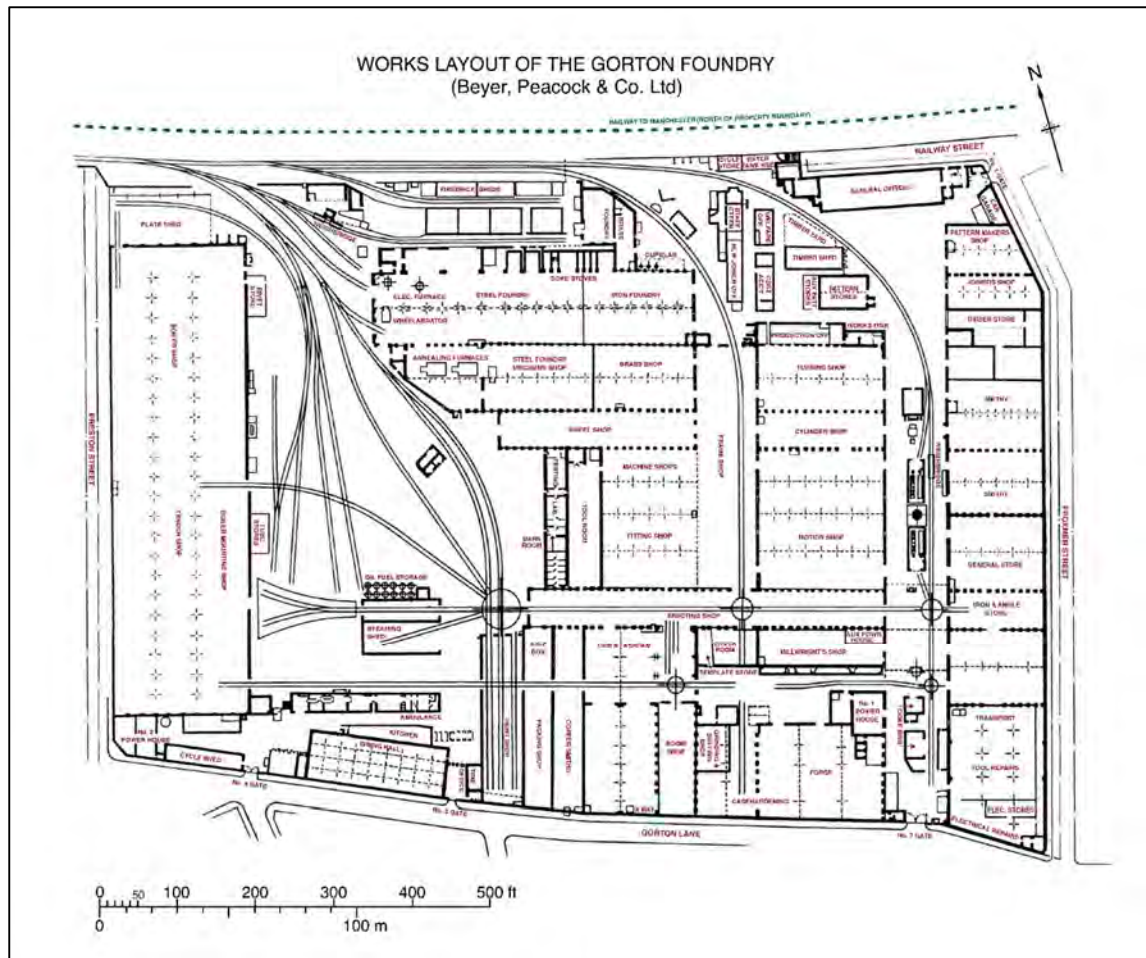
*Plate 101: Plan of the expanded works, date unknown*

However, it was the Beyer-Garratt articulated locomotive that made the foundry the most famous. This was originally patented by Herbert William Garret in 1908 with Gorton Foundry having sole manufacturing rights within Britain. Due to this influx of work the foundry had expanded to the west of the original site. The expansion included a new boiler shop with a riveting bay and ancillary buildings to the south included an attached substation with workshops to the south-east (Plate 101).

The boiler shop was a large three-bay brick building comprising the boiler mounting shop within the eastern bay and the tender shop within the central and western bays (Plate 101). Access was afforded into the boiler mounting shop via 12 doorways situated within the eastern elevation. The southernmost doorway had retained a set of narrow gauge rails within the floor with a set of standard gauge rails set within the central opening (Plate 101). Each of the rails led to a turntable to the centre of the complex which afforded access to the main rail line to the north, the erecting shop to the east and the paint shop to the south.

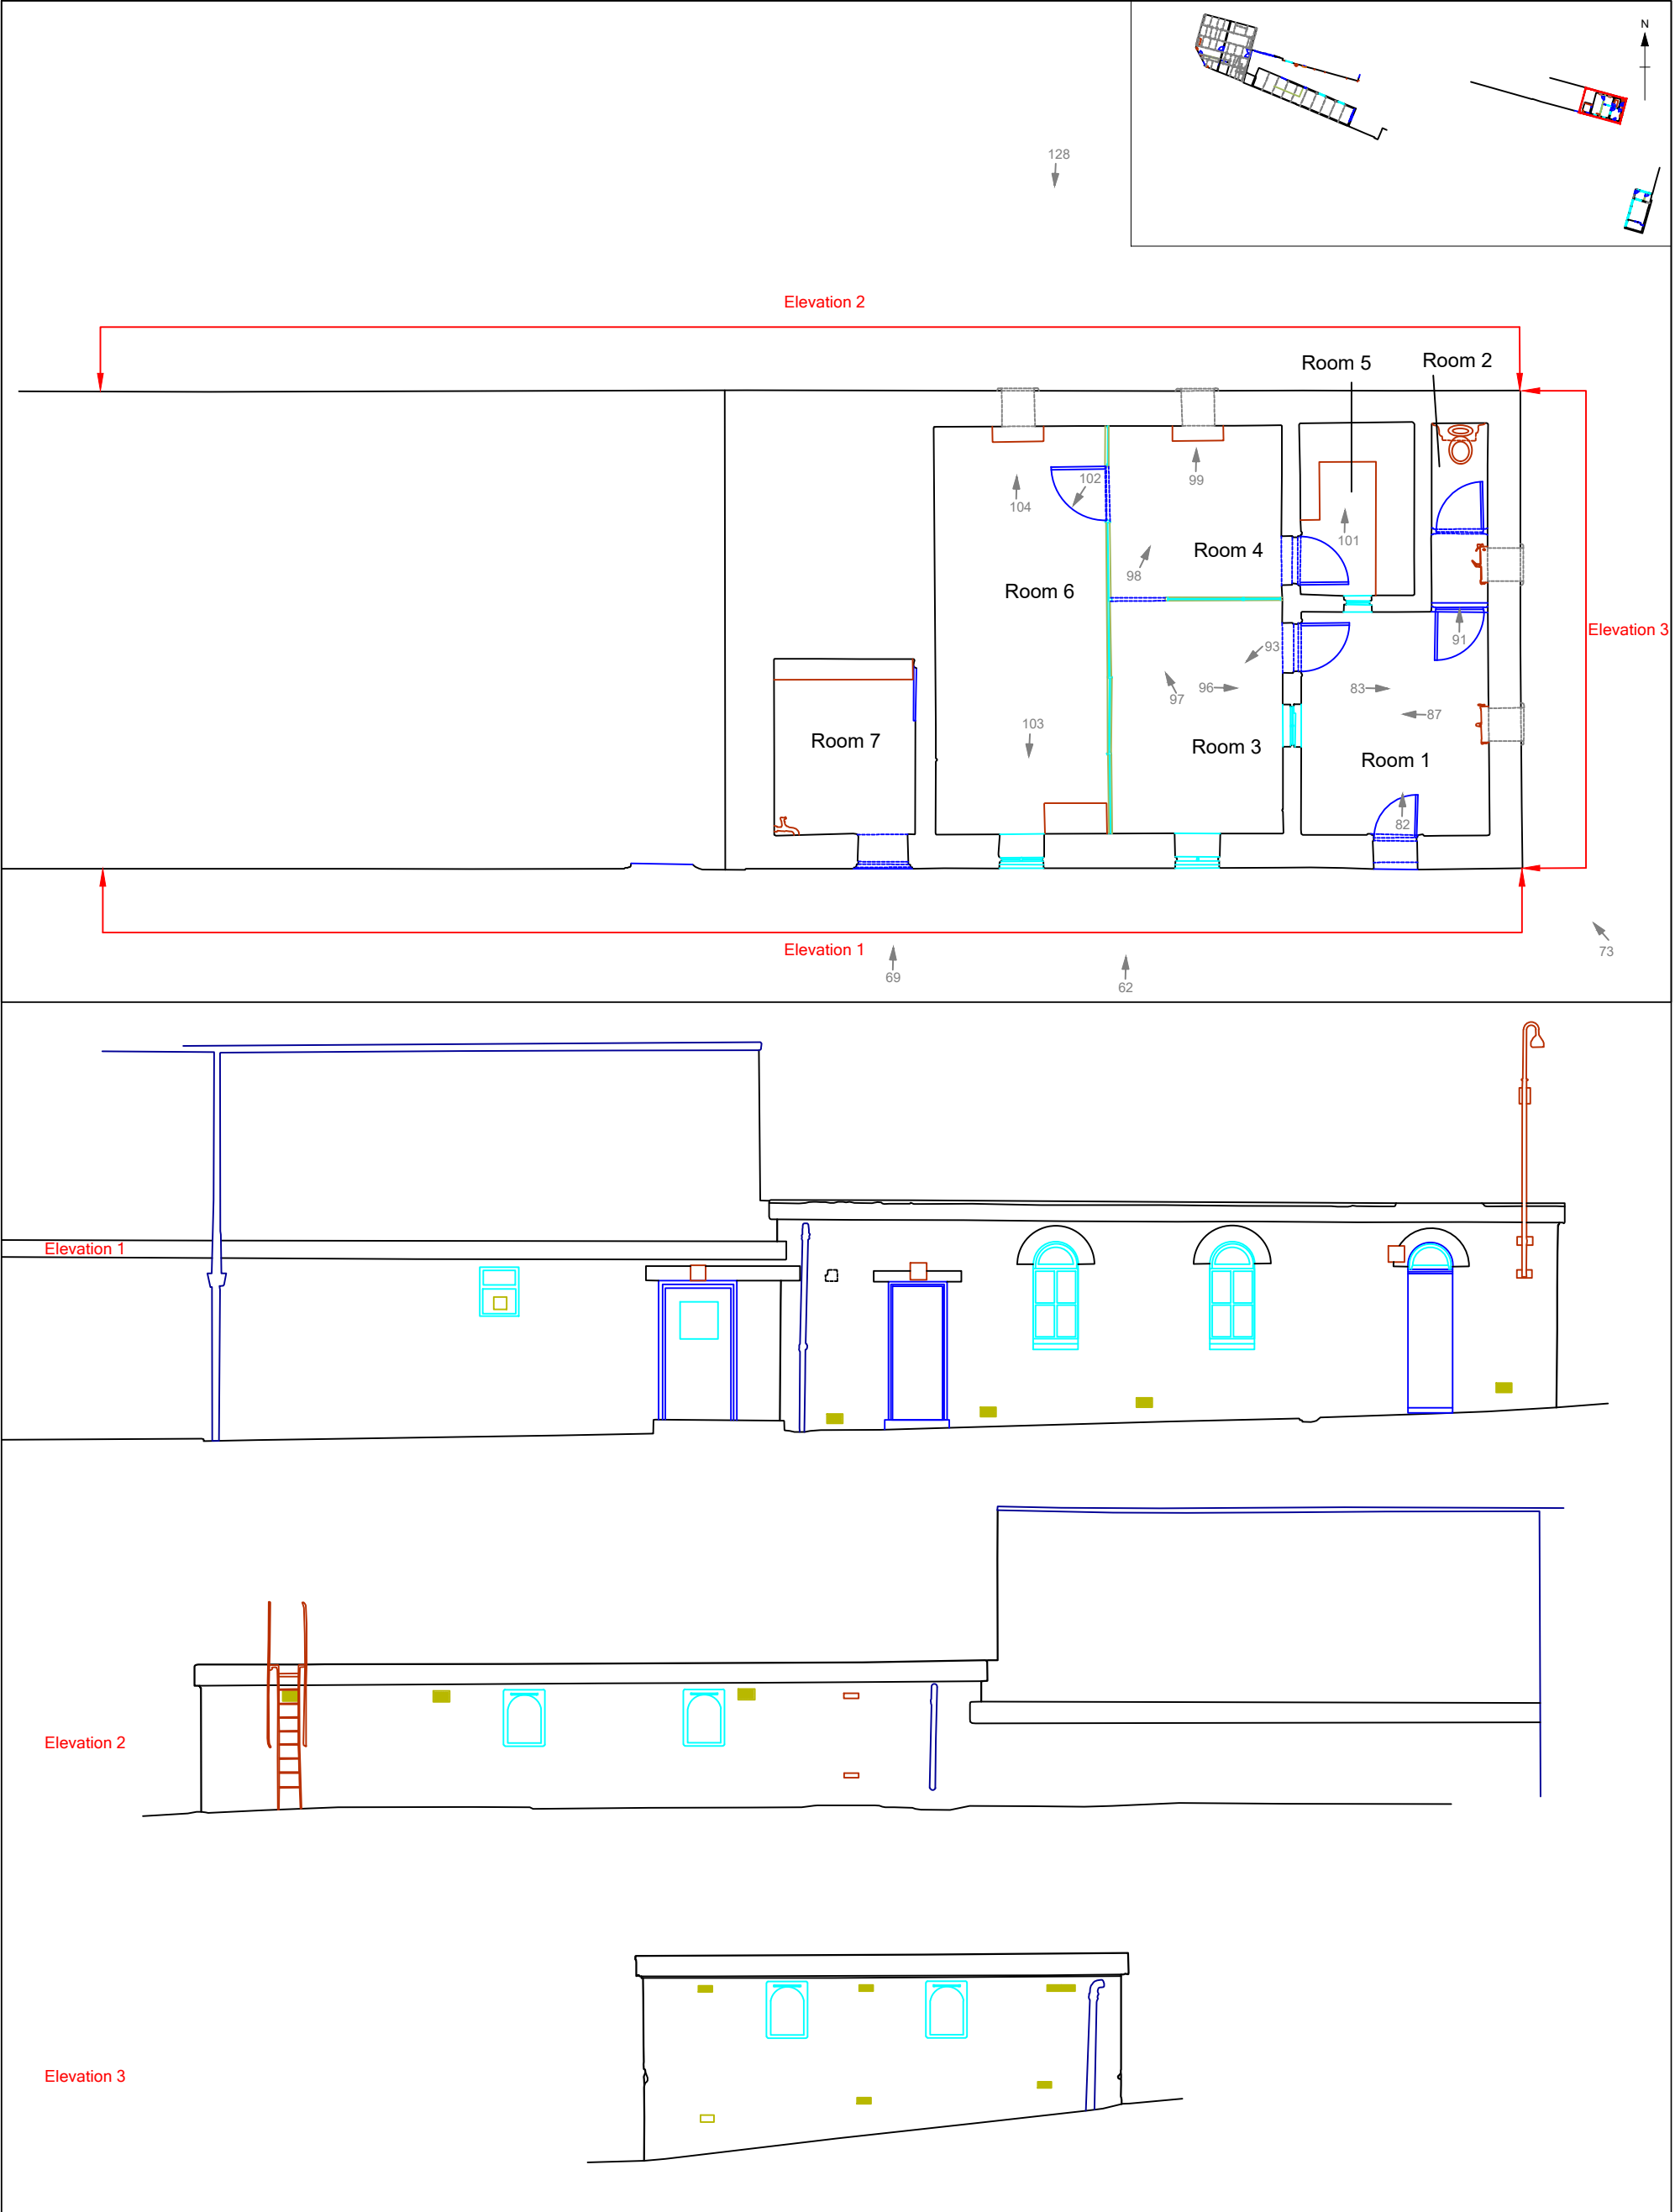
**Internal Description:** internally, the building had been divided into 7 rooms (Fig 5). Room 1 measured 11'5" (3.48m) by 9'7½" (2.93m) was afforded access by the eastern doorway within the southern elevation. The room consisted of painted plasterboard walls, a flat ceiling and linoleum covered floor (Plate 54). The northern wall contained a small window to the west and a doorway affording access into Room 2 to the eastern end. The window aperture housed a two-light timber framed window with clear glass panes. The doorway comprised rectangular timber architraves with a flush timber door containing a single obscured glass pane (Plate 54). The door furniture was modern including a late-20<sup>th</sup>-century Yale lock (Plate 54).

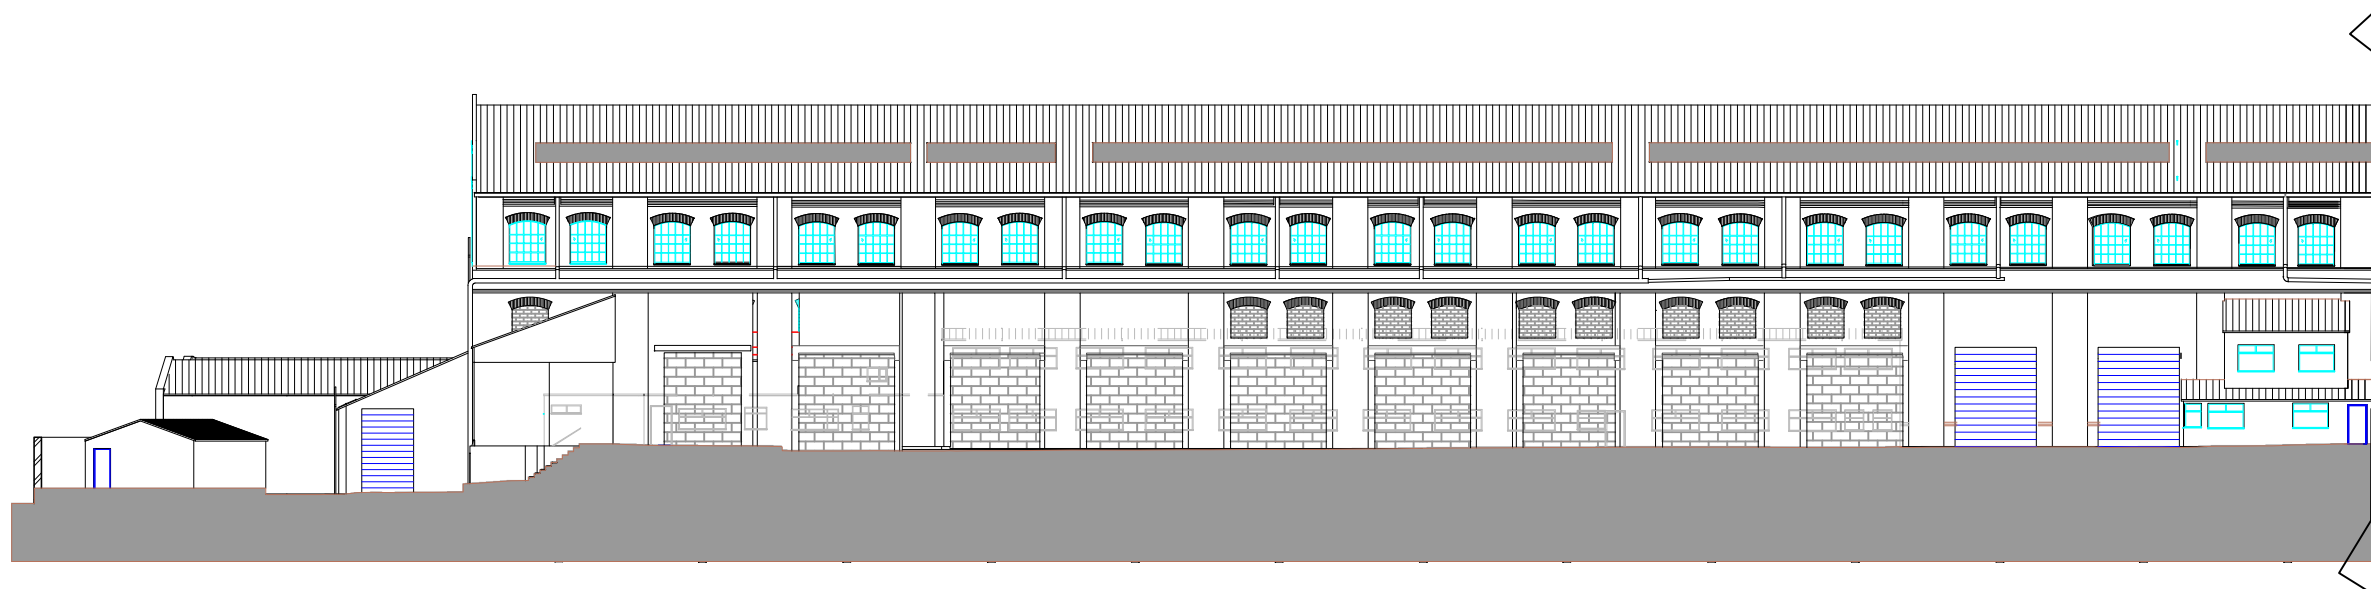
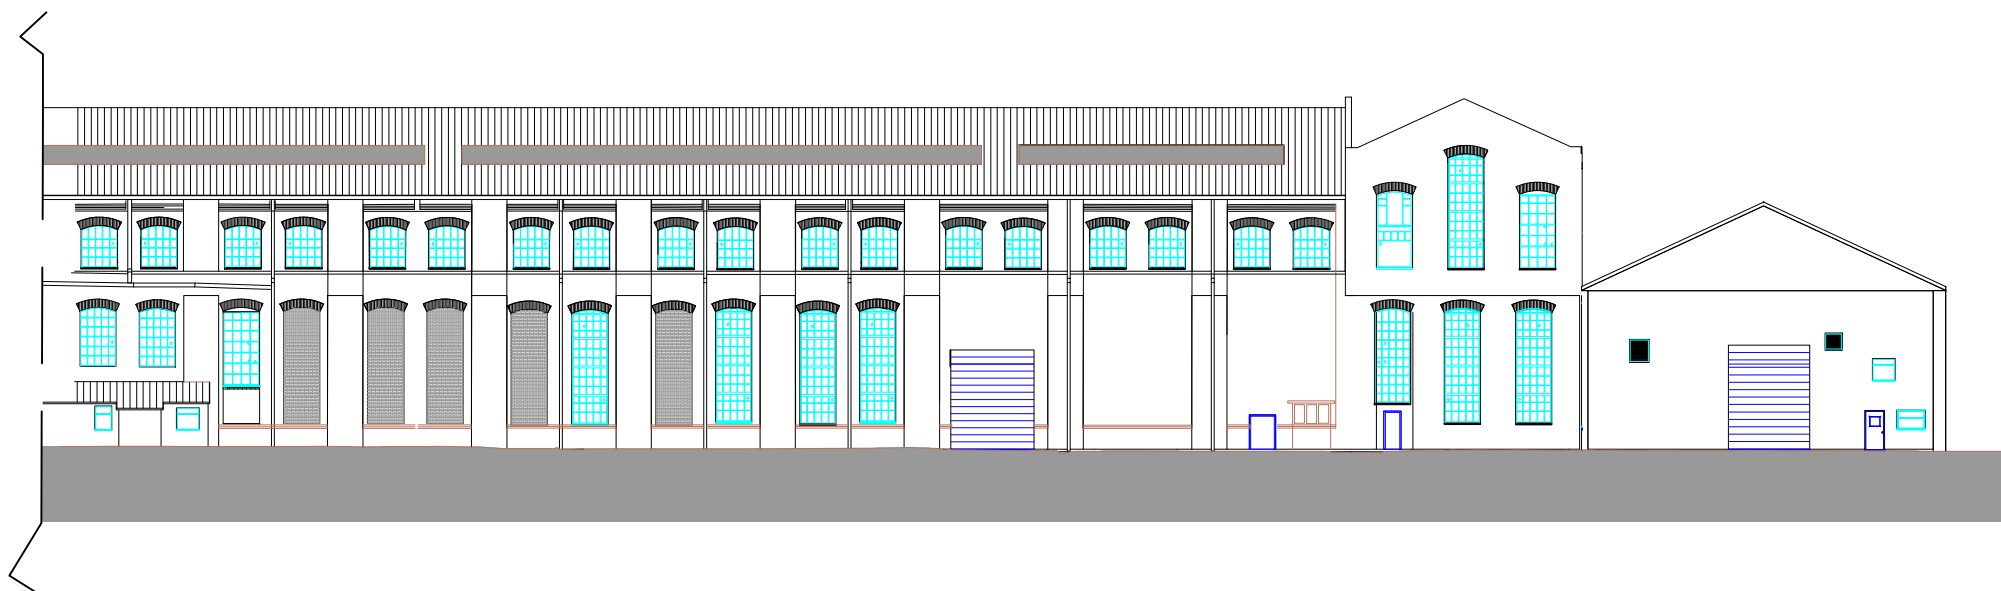
Hammerstone Road Depot, Gorton, Manchester  
Figure 6: Eastern Elevation of the 1920s Boiler Shop

The southern half of the elevation was obscured by the late-20<sup>th</sup>-century extensions; however, these had been demolished under a watching brief phase of the redevelopment of the site. The demolition revealed nine further doorways comprising large concrete lintels with the openings infilled with modern brick (Fig 6).

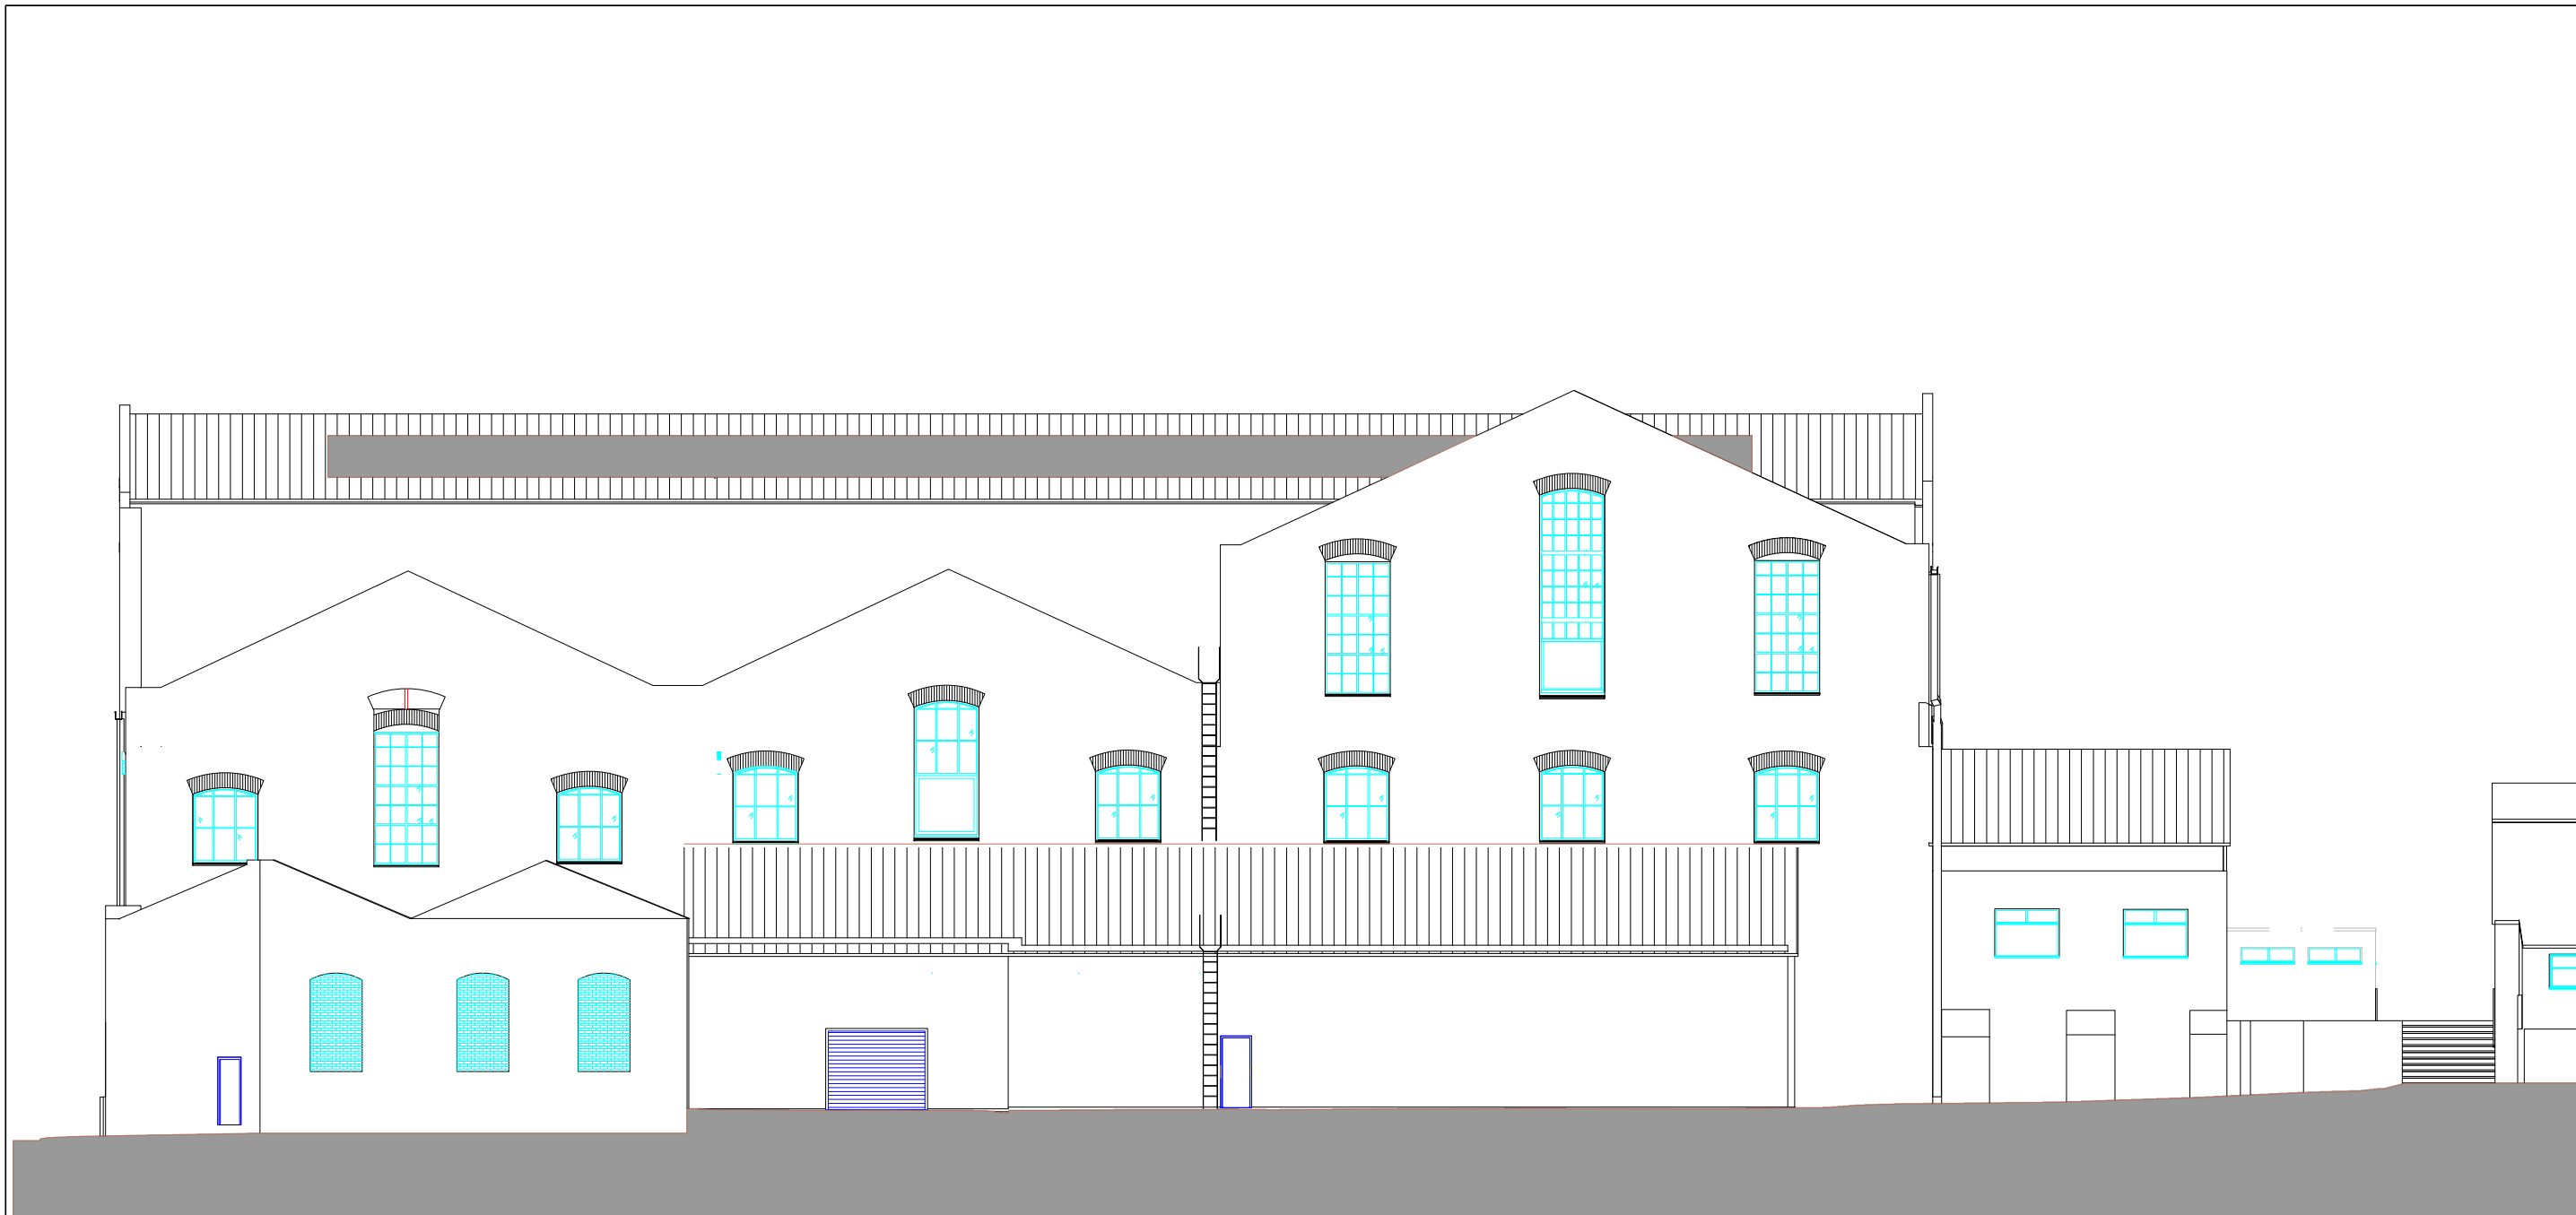
Hammerstone Road Depot, Gorton, Manchester  
Figure 7: Southern Elevation of the 1920s Boiler Shop

The southern elevation comprised three gables with the two western bays having a lower height to the eastern bay. Each had been constructed in a three-course English Garden Wall bond (Plate 71; Fig 7). The ground floor was obscured by a lean-to extension, Shed 3.

The eastern bay consisted of three window apertures to the ground floor and a further three above that maximises the amount of natural light entering the tall building (Fig 7; Plate 72). Each comprised 6'1 $\frac{3}{4}$ " (1.88m) wide openings with gauged brick heads and sloping sills. The ground floor openings were partially infilled with brick after the construction of the attached lean-to and housed a replaced six-light timber framed window with clear glass panes (Plate 72). The two outer apertures on the first floor housed a 40-light iron framed window while the central opening had a 45-light frame with an inserted louvered vent below (Plate 72).

The northern ancillary building was a long single-storey lean-to that butted the southern elevation of the boiler shop (Fig 7). The building was brick constructed with a mono pitched corrugated fibre cement roof (Plate 92).

The southern elevation was also built in a three-course English Garden Wall bond (Plate 92). This elevation comprised two doorways to the western end with a long horizontal window to the eastern end. This window was a later insertion with a steel I-section frame supporting the opening and corrugated clear uPVC sheeting (Plate 94; Fig 7).

The western doorway was a large vehicle entrance with a flush concrete lintel and afforded access into the western end of the shed (Fig 7). A large four-panelled timber sliding door with a steel door track was fixed to the outer face of the elevation (Plate 95). The eastern doorway was a pedestrian entrance affording access into the eastern half of the shed. This consisted of a timber lintel with rectangular architraves and housed a modern flush timber door with modern door furniture (Plate 96).

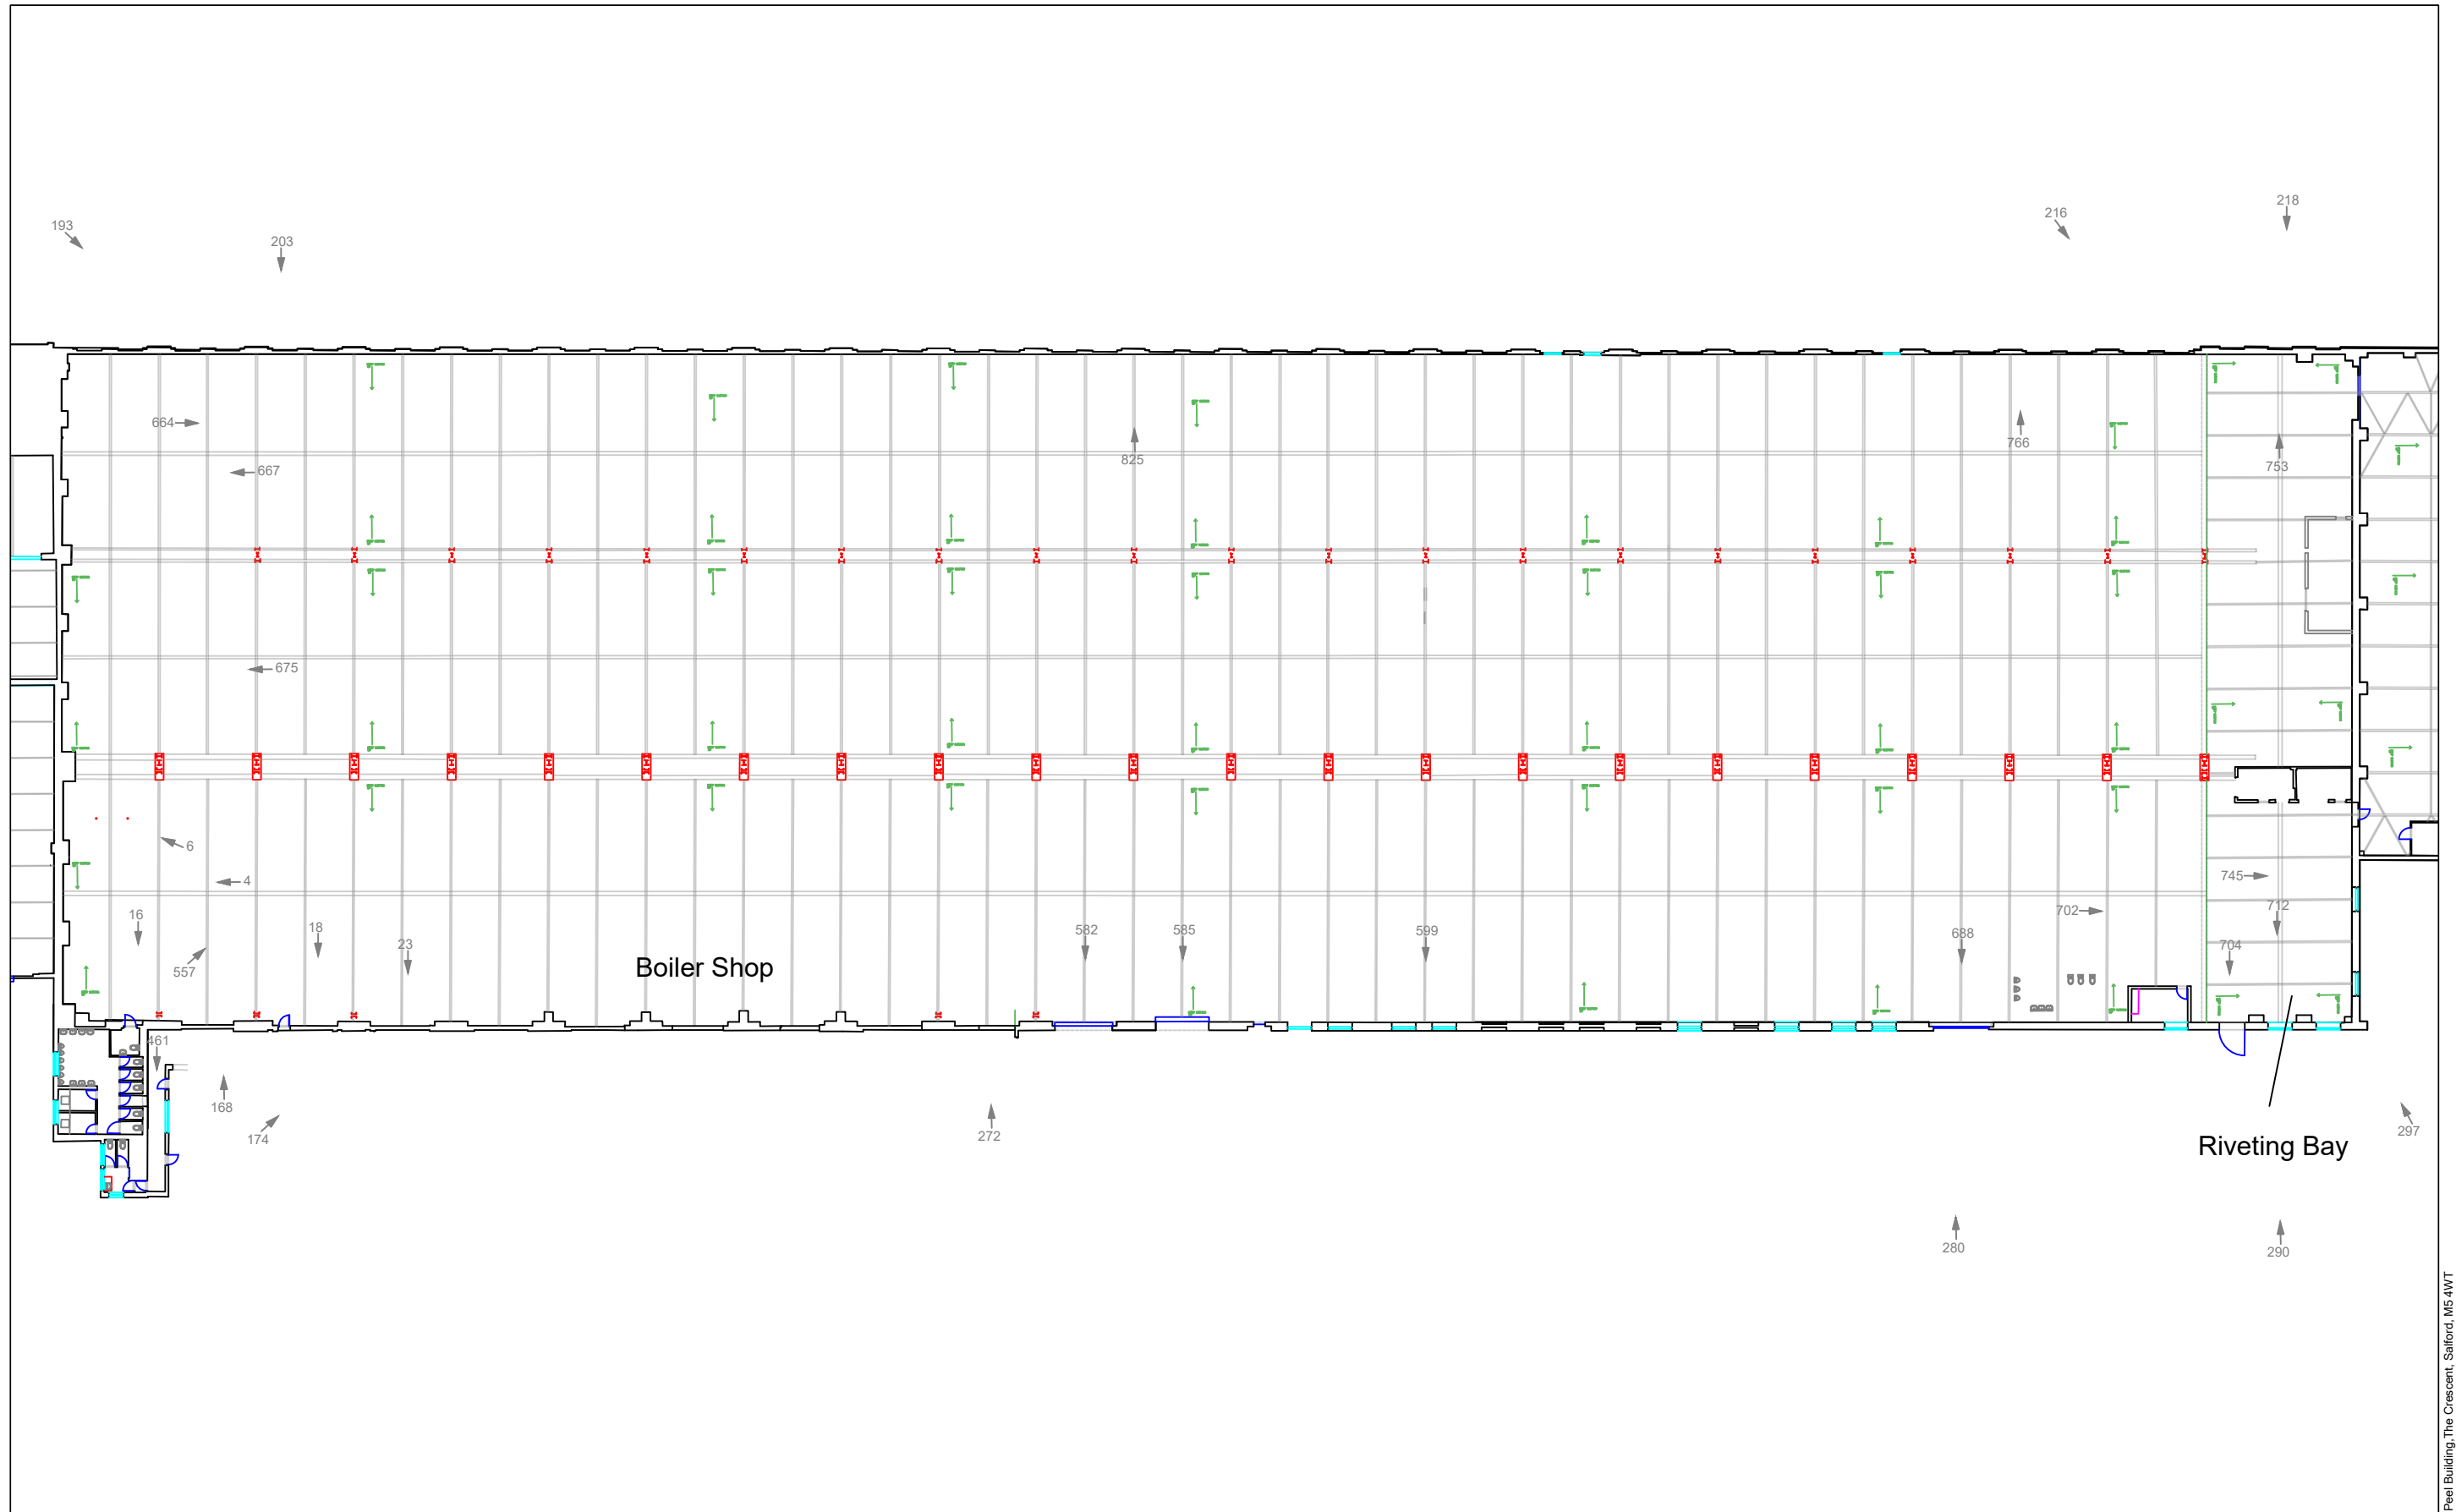
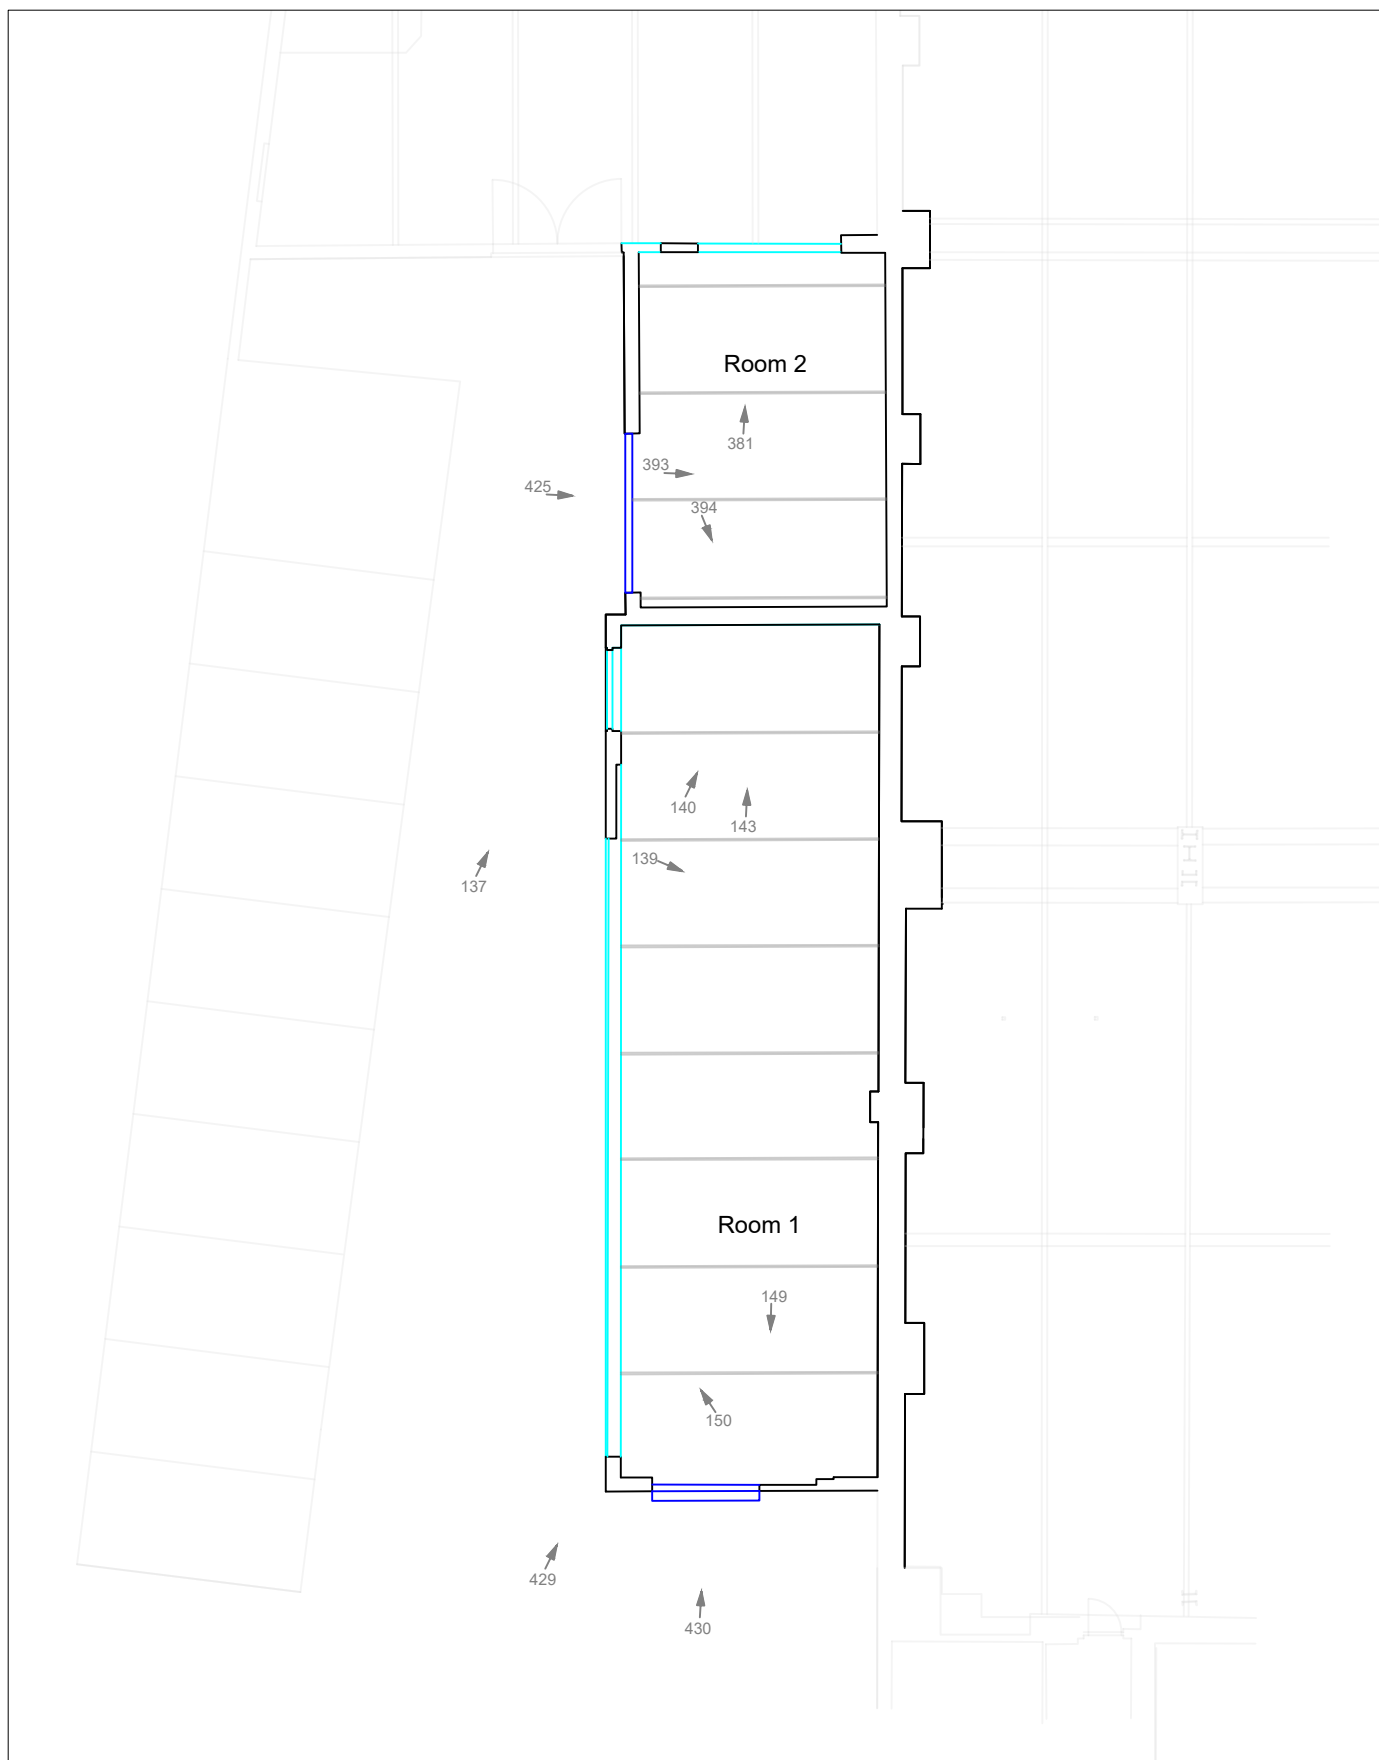
Figure 11: Plan of the lean-to (Shed 3)

**Internal Description:** Internally, the lean-to was divided into two sections (Fig 11). Room 1 measured 73'9" (22.5m) by 22'3" (6.8m) and consisted of a concrete floor, painted brick walls and an open ceiling that exposed the L-section angle iron mono truss (Plate 97). The room had been used as a storage shed with all historical features removed.

Room 2 was situated to the western end shed and measured 30'10" (9.4m) by 22'3" (6.8m) (Fig 11). The room consisted of a concrete floor, exposed brick walls and an open ceiling exposing the mono pitched L-section angle iron trusses (Plate 98). The northern wall of the building was formed by the external southern elevation of the boiler shop and contained several round tie rod plates (Plate 99).
