Phase II Geoenvironmental Site Assessment  
Vine Street, Gorton

Reference: 14-944-R1-2  
Date: January 2022

## **PHASE II GEOENVIRONMENTAL SITE ASSESSMENT**

Land off Vine Street  
Gorton  
Manchester  
M18 8SR

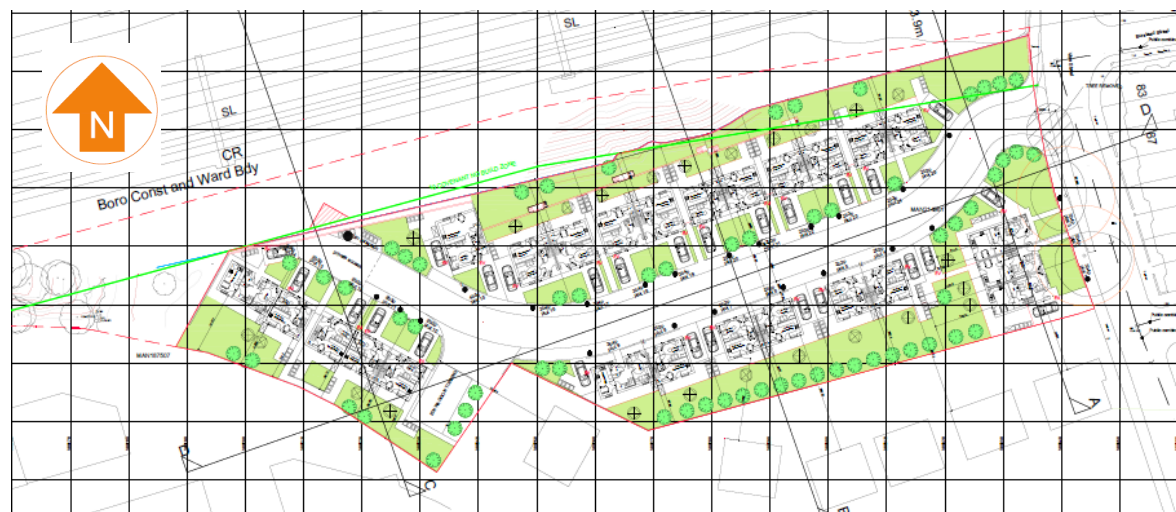
FIGURE 1.1 SNAPSHOT OF PROPOSED DEVELOPMENT

The Proposed Development Scheme is presented in Figure 1.1 (below) and Drawing 14-944-002 (Appendix III).

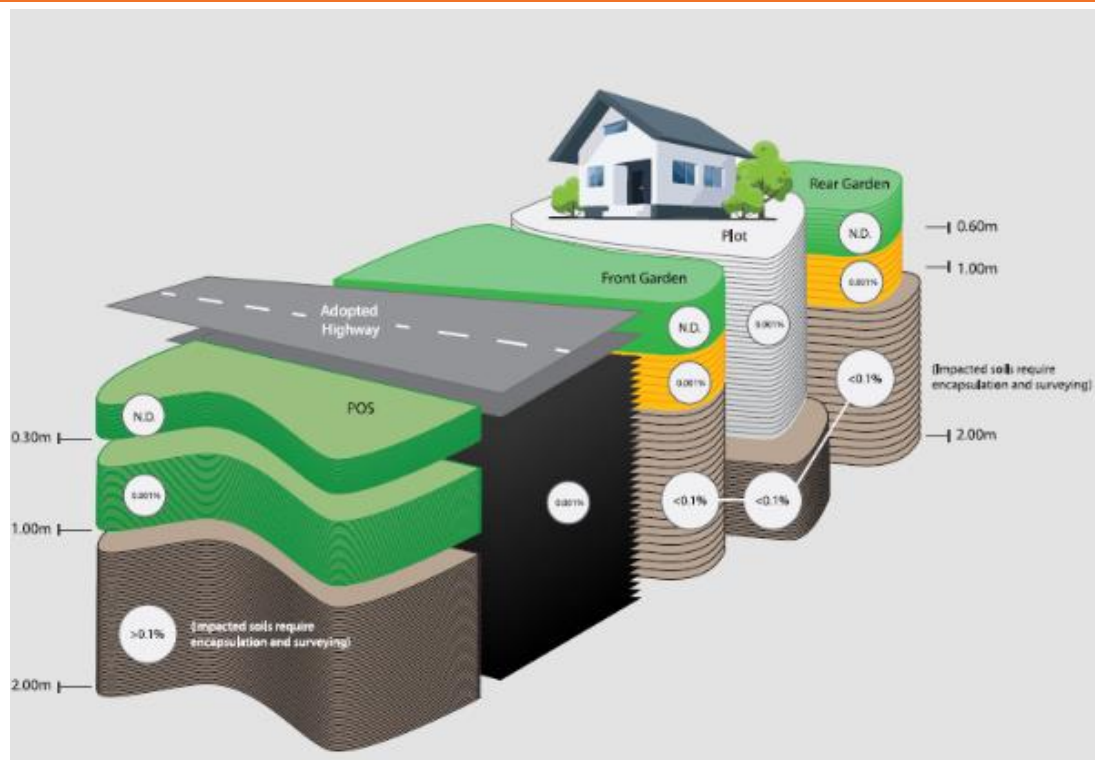
FIGURE 4.1 ASBESTOS RISK MITIGATION CONCEPTUAL SITE MODEL

The asbestos impacted Made Ground should be managed in accordance with CIRIA 733 (Asbestos in soil and made ground: a guide to understanding and managing risks) and placed in accordance with the Asbestos Risk Mitigation Conceptual Site Model shown in Figure 4.1 below.

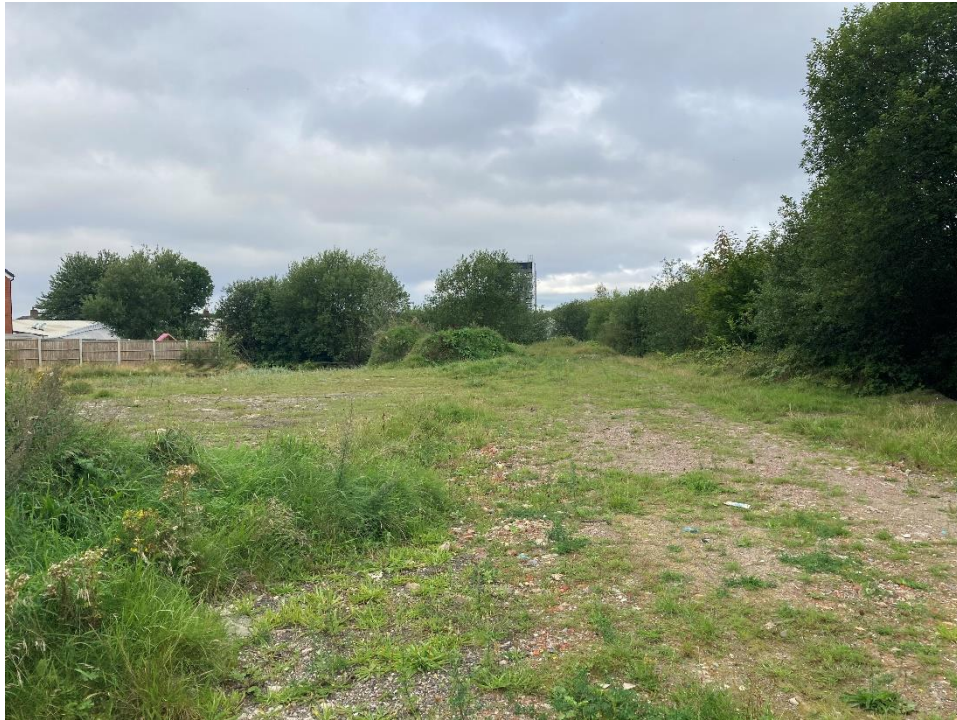
PLATE 1      SITE VIEWED LOOKING WEST
