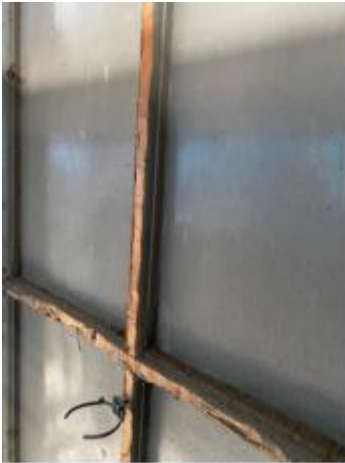
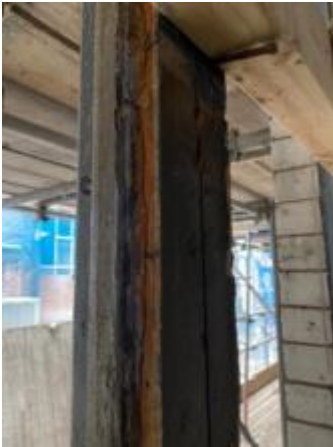
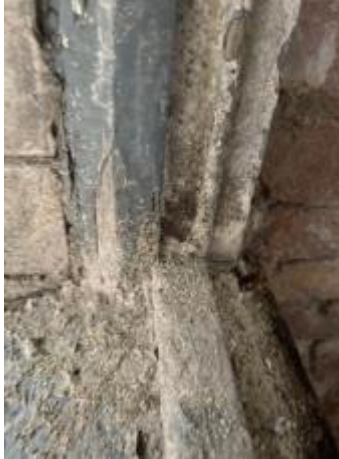
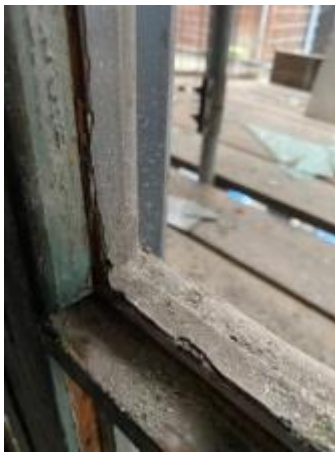
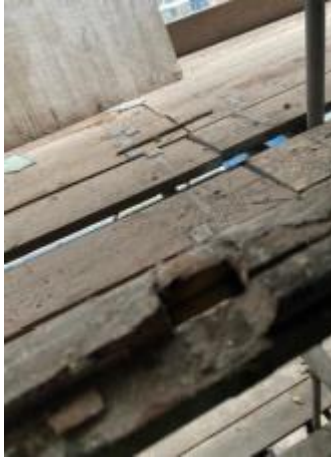
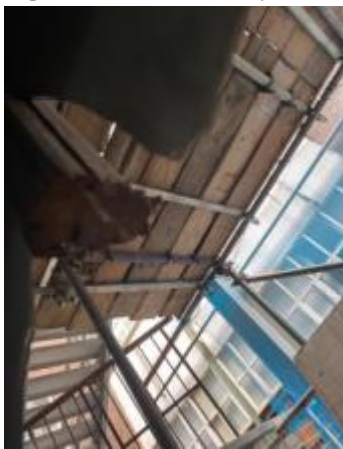
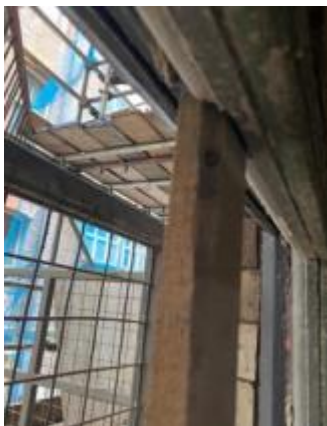
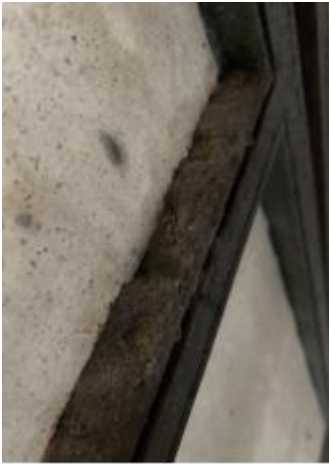
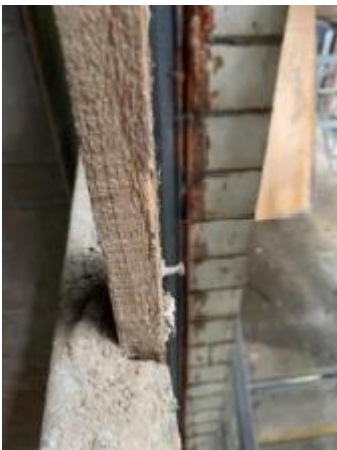
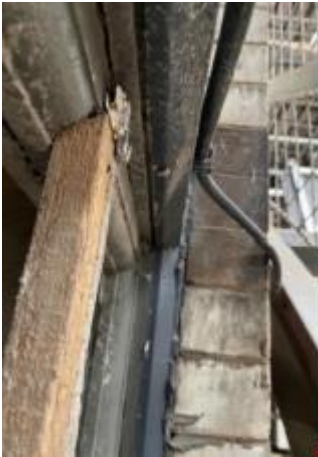
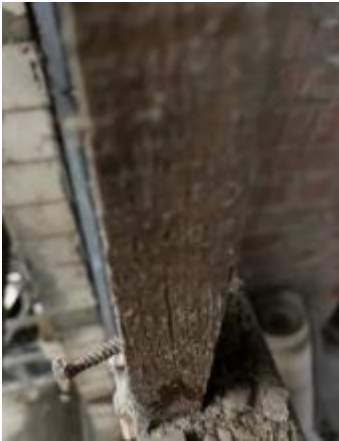
| WP.0.16 | <p>Five Panes of glass missing</p> <p>2 Sash stays missing</p> <p>6m of glazing bead missing</p> <p>External cill 1.5m rotten</p> <p>ng/damaged</p> | Black and Grey | TH | The Heritage Contractor has proposed that a replica timber casement windows, single glazed is solution for this window. | Repair |

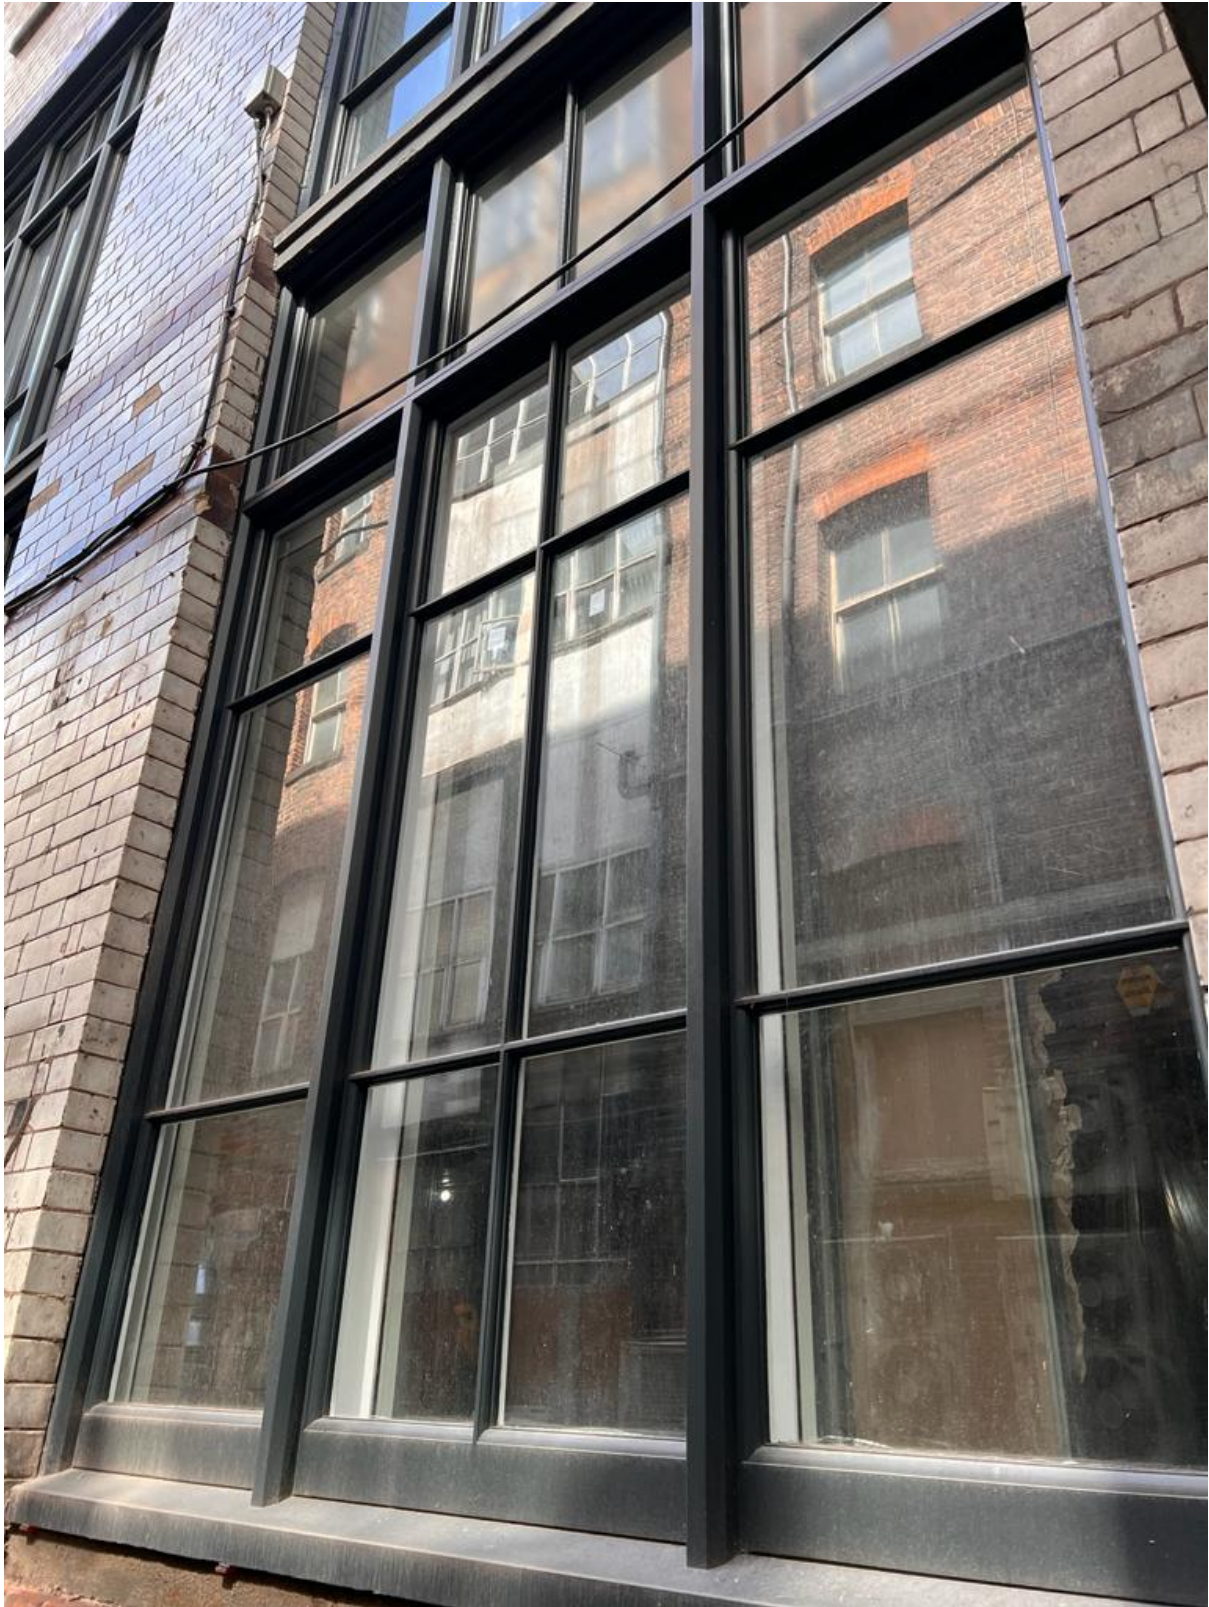
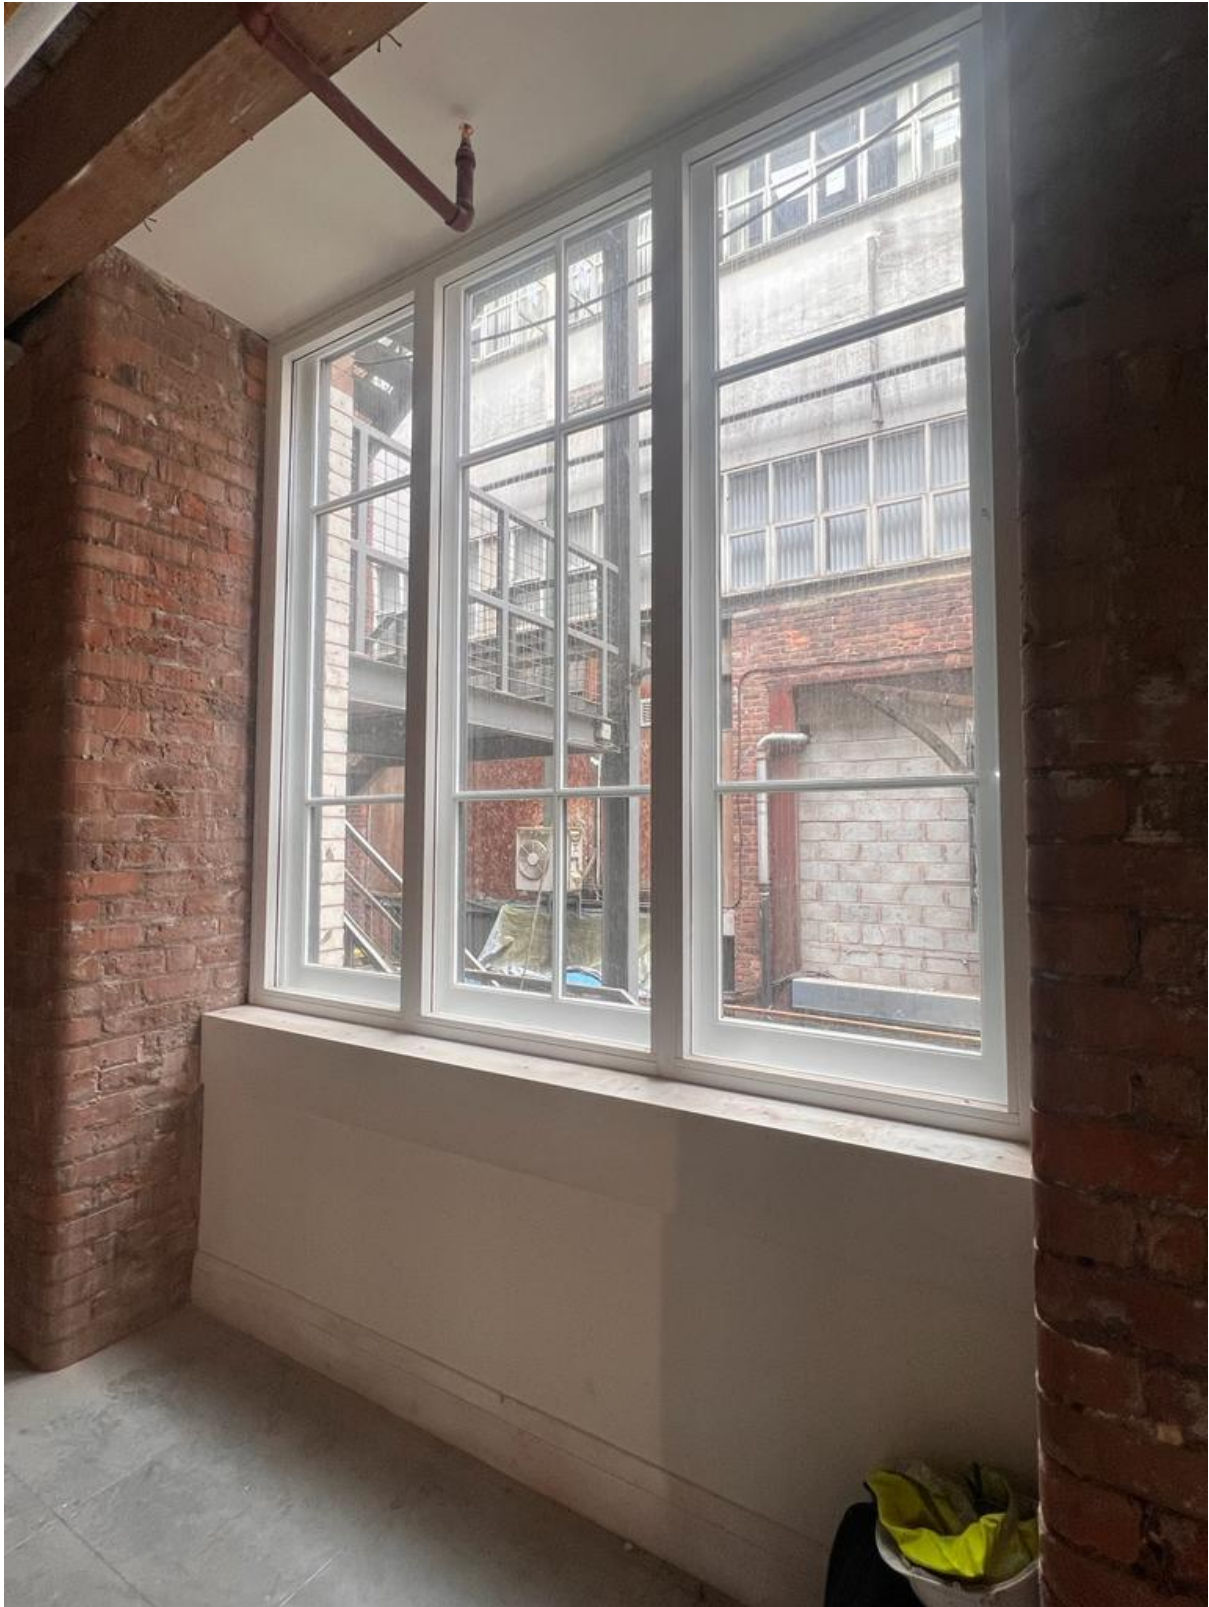
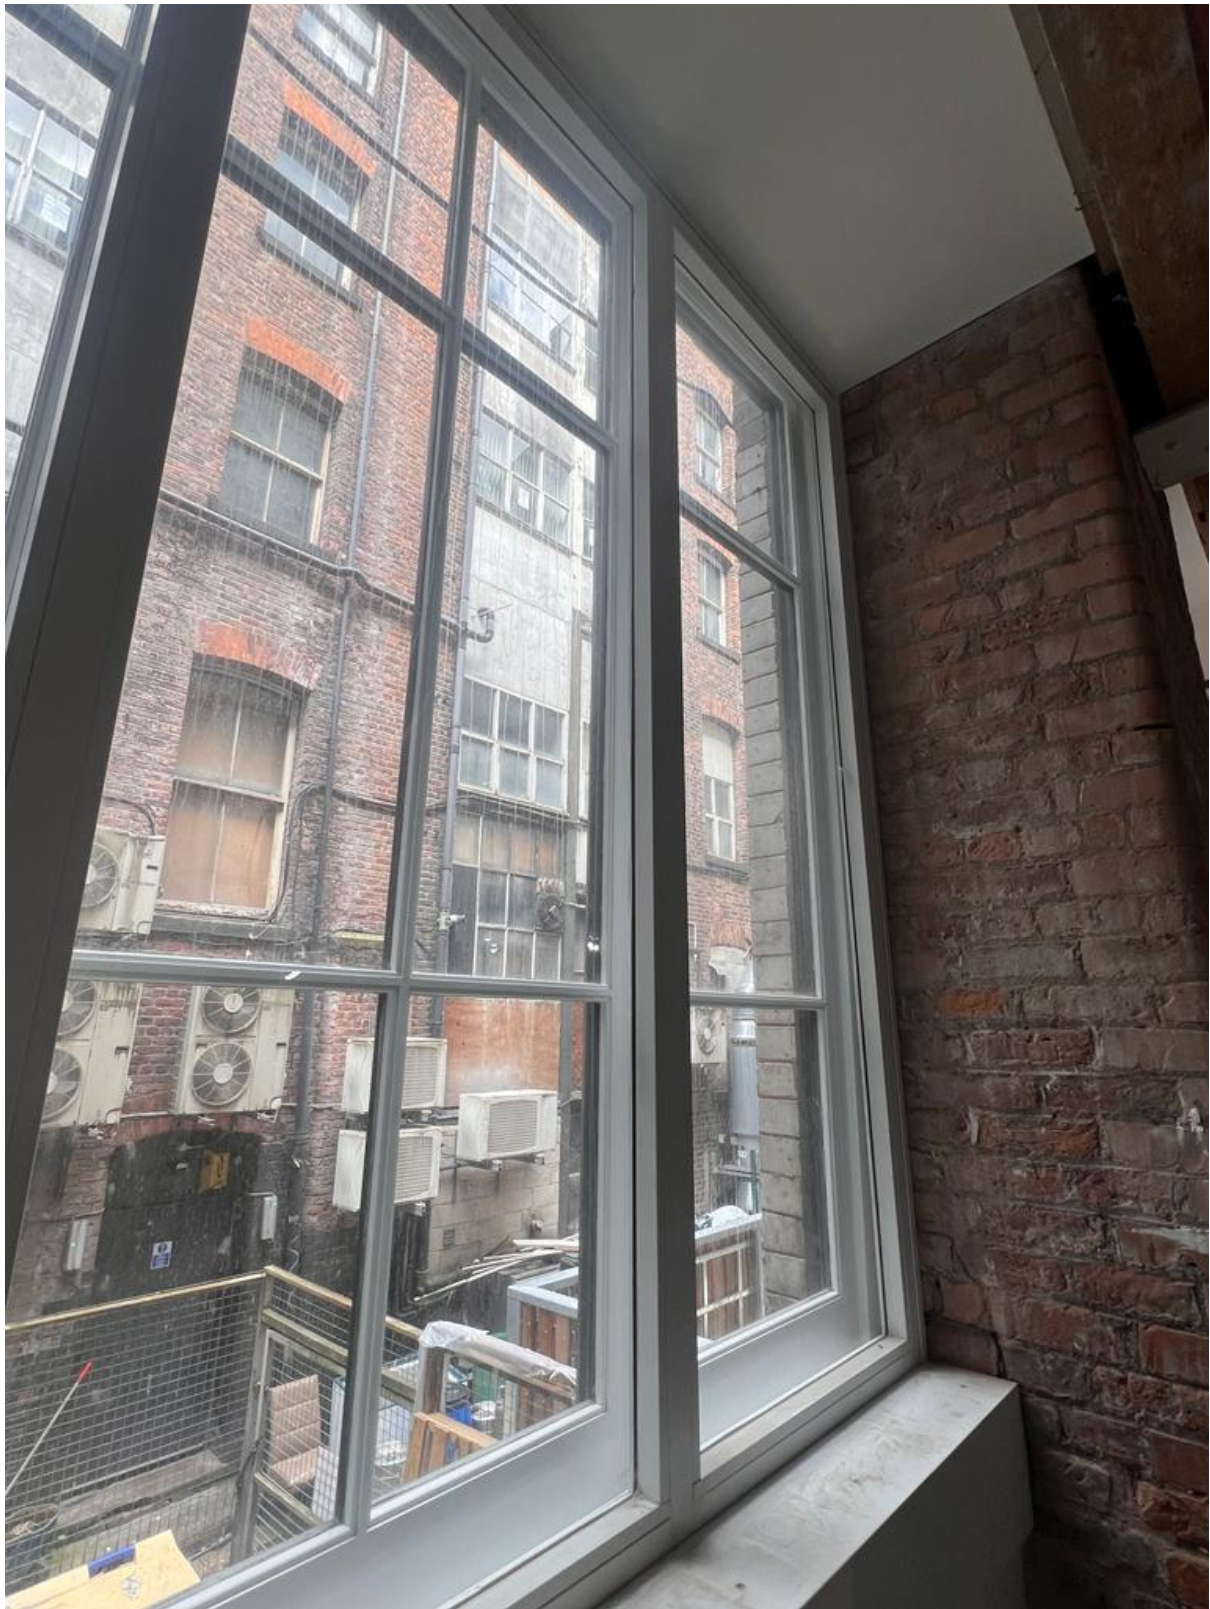
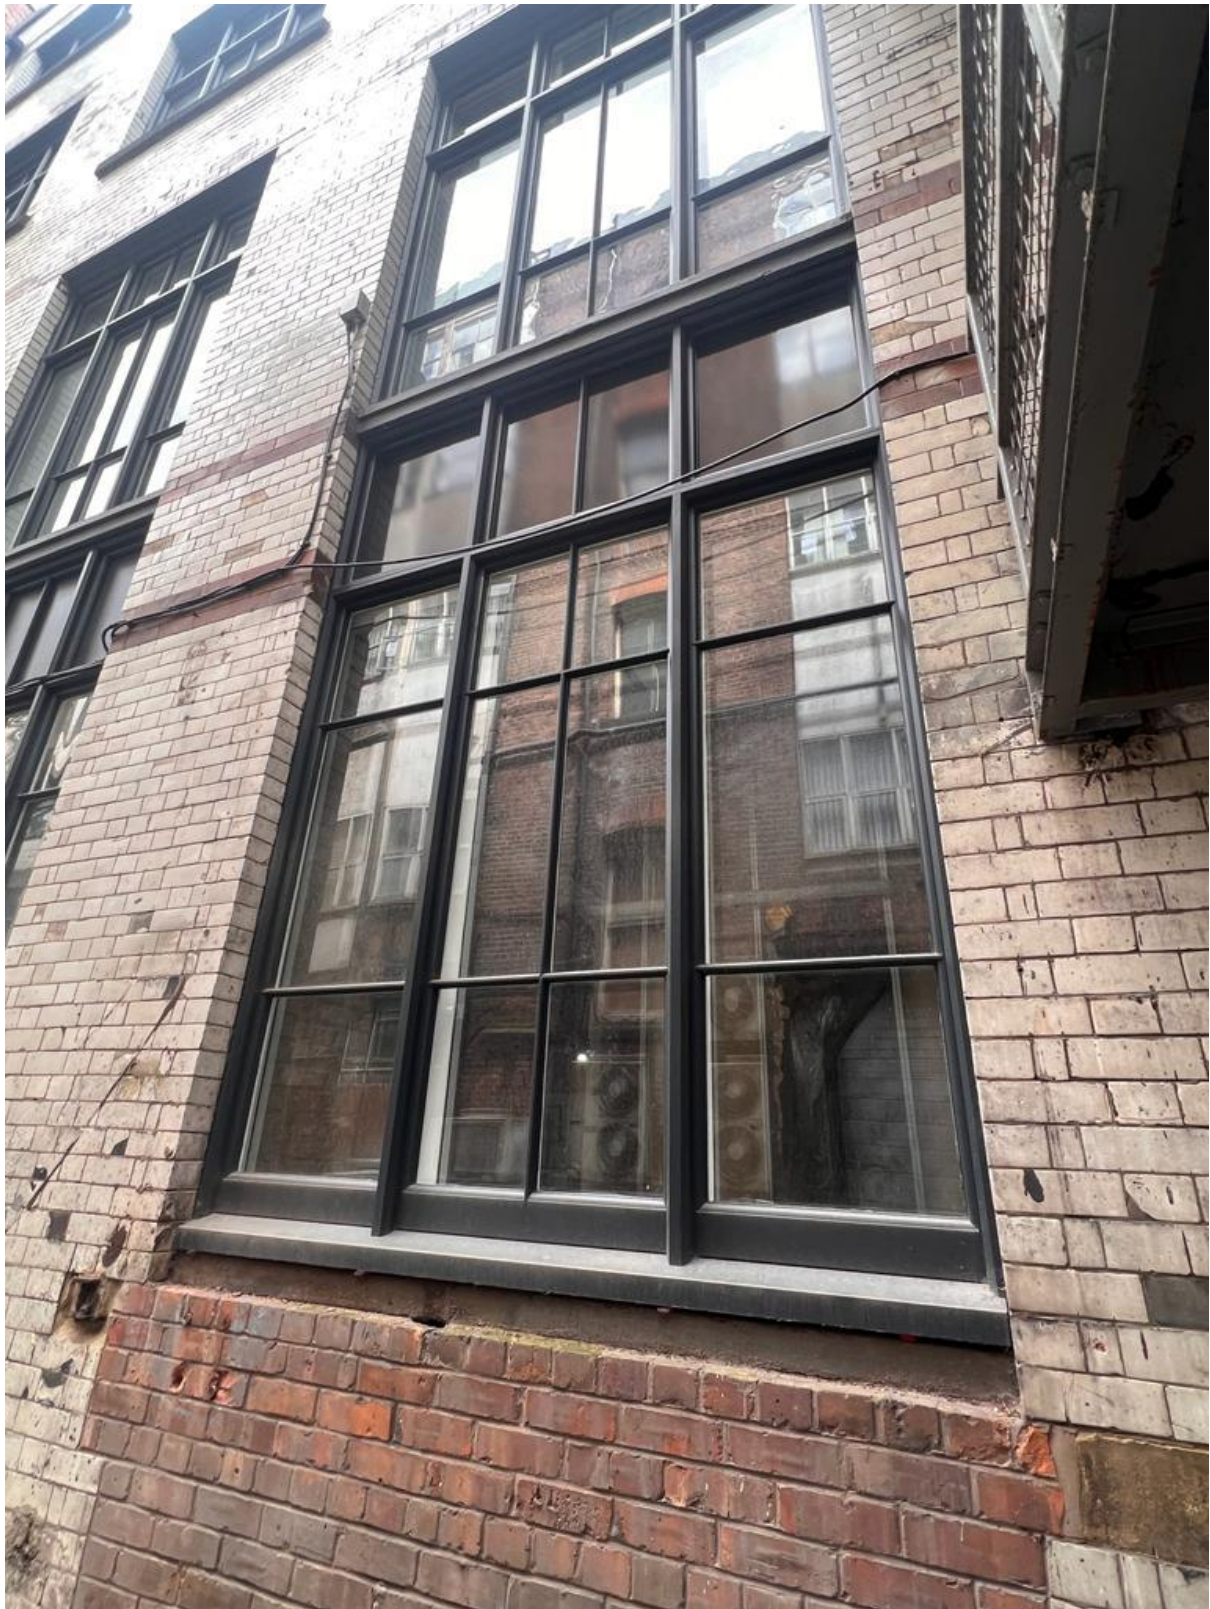
Figures 42 -45 below shows a visual representation of the 17th window located on the courtyard elevation, the bullet point below explains the current condition;

- 2no cracked panes of glass
- 4 no panes of glass missing
- 5m badly damaged glazing beads
- 2no sash stays missing
- External cill 1m rotten
- External window full of screws and nails

| WP.0.17 | <p>2no cracked panes of glass</p> <p>4 no panes of glass missing</p> <p>5m badly damaged glazing beads</p> <p>2no sash stays missing</p> <p>External cill 1m rotten</p> <p>External window full of screws and nails</p> | Black and Grey | TH | No Original comment no access at the time of original report – Revised report September 2022 this window is in a condition that can be repaired. | Repair |

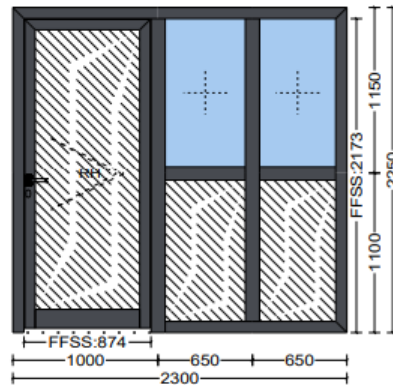
Figure 56: Replacement of WP.0.18 Specification

- Opening to receive new aluminum Door and Window

WP.0.18 Door Element 2300 mm x 2250 mm, Consisting of a Single Door and four Fixed Fields. 1 Pcs.

Exterior View  
System: Aluprof MB-70 MB-70  
Manual Swing Door  
Face Fixed Closer  
Lever Handles  
Face Fixed Flag Hinges  
Low Ramped Drainage Threshold Strip

CubicWorks have replaced WP.0.18 With an Aluminum slate grey 2300x2250mm manual swing door and four fixed field two of which are glazed.

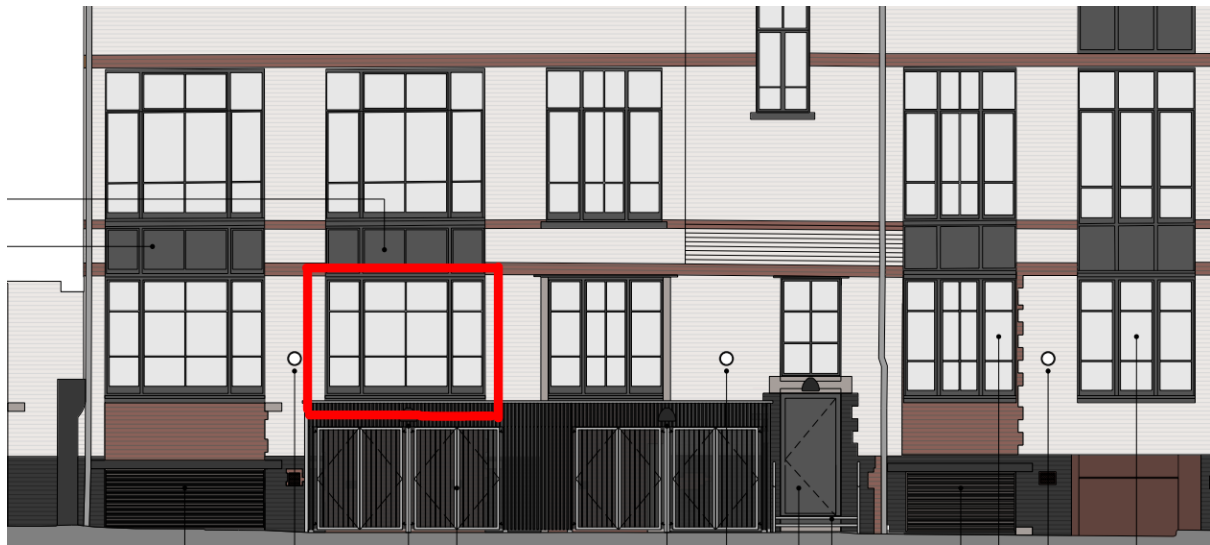
Figure 61: WP.0.08 Sample Repair location on Eastern Courtyard Elevation level 00 (Credit Bridge 2022)

This section shows the sample repair of window WP.0.08 located in the reception area of the Eastern Building. The location of this window is highlight in figure 49.

The section below shows the comparison of an approved repair on window WP.0.08 reviewed by the Conservation officer on Wednesday 14<sup>th</sup> September 2022, against a window that is beyond repair.

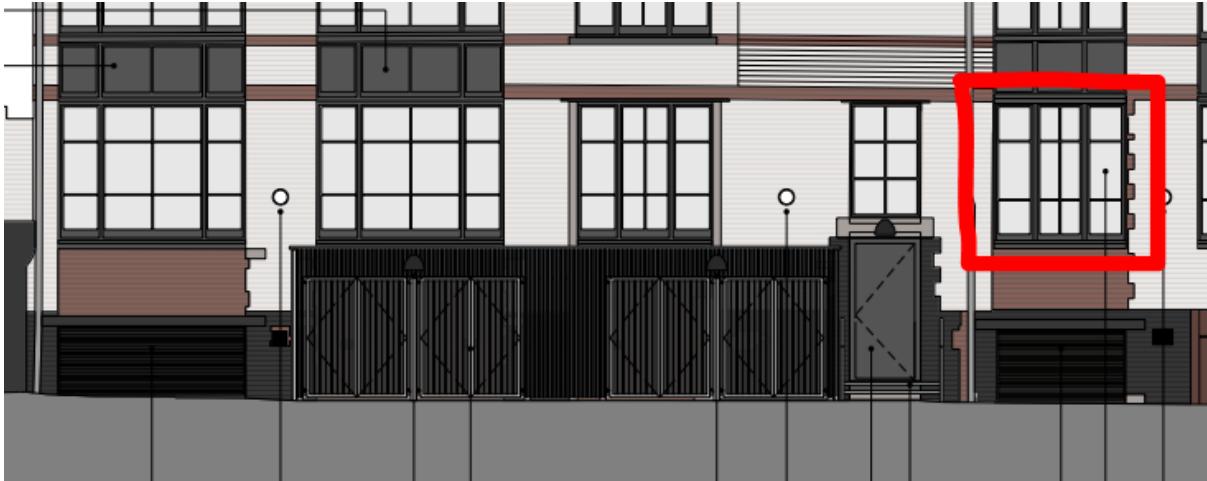
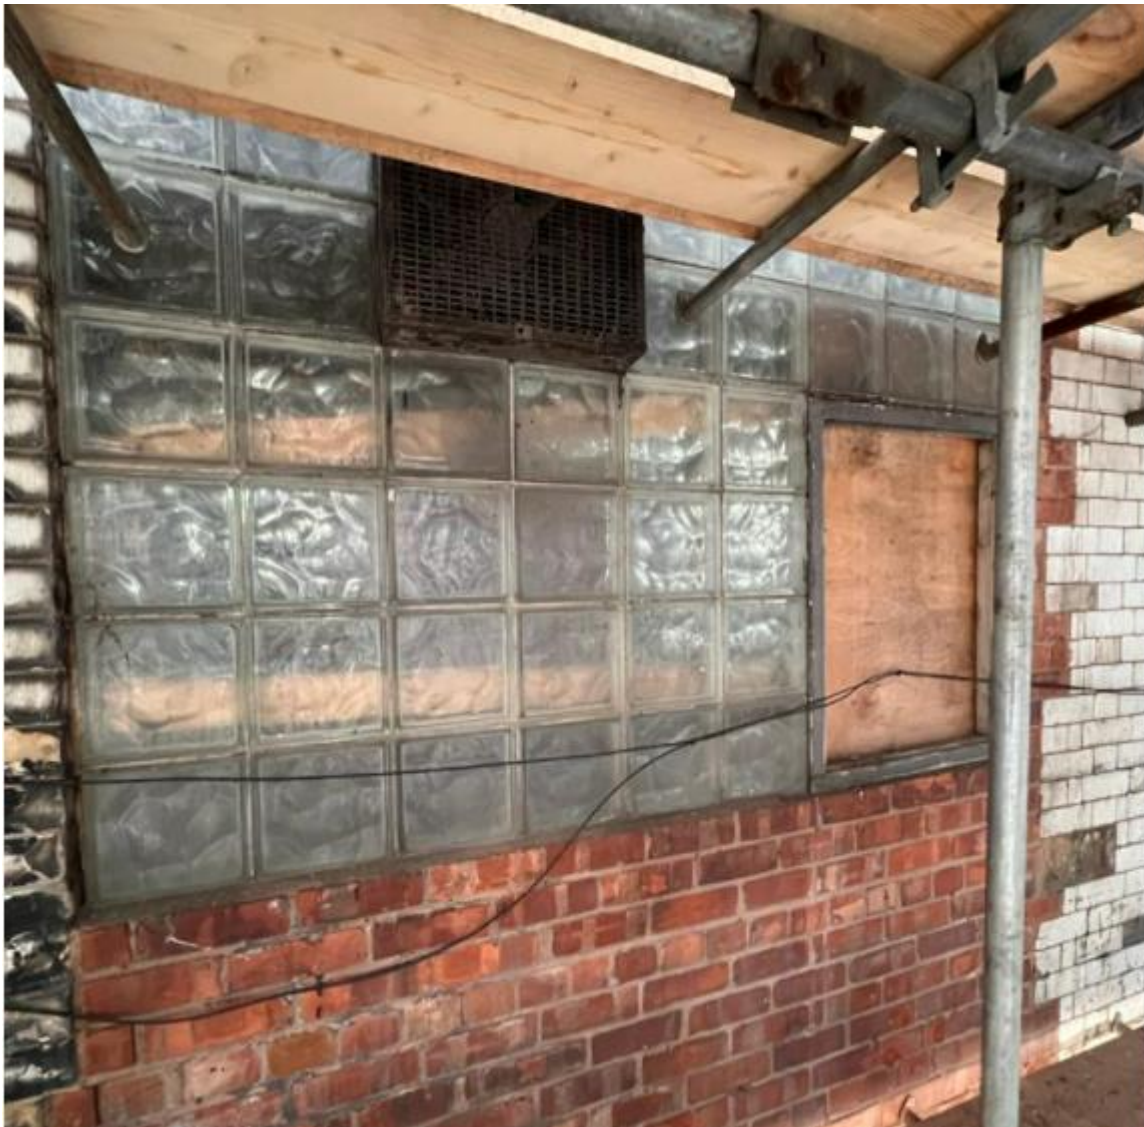
Figure 65: Location of WP.0.11 on Level 00 Courtyard Elevation (Credit Bridge 2021)

| WP.0.11 | Currently glass blocks window opening. | Black Externally | TH | The Heritage Contractor has proposed that a replica timber casement windows, single glazed is solution for this window. | Replace |

After the survey undertaken by the specialist heritage contractor, window WP.0.11 is used as an example in the comparison of repair vs replace as benchmark for the replacement of the windows that require replacement.

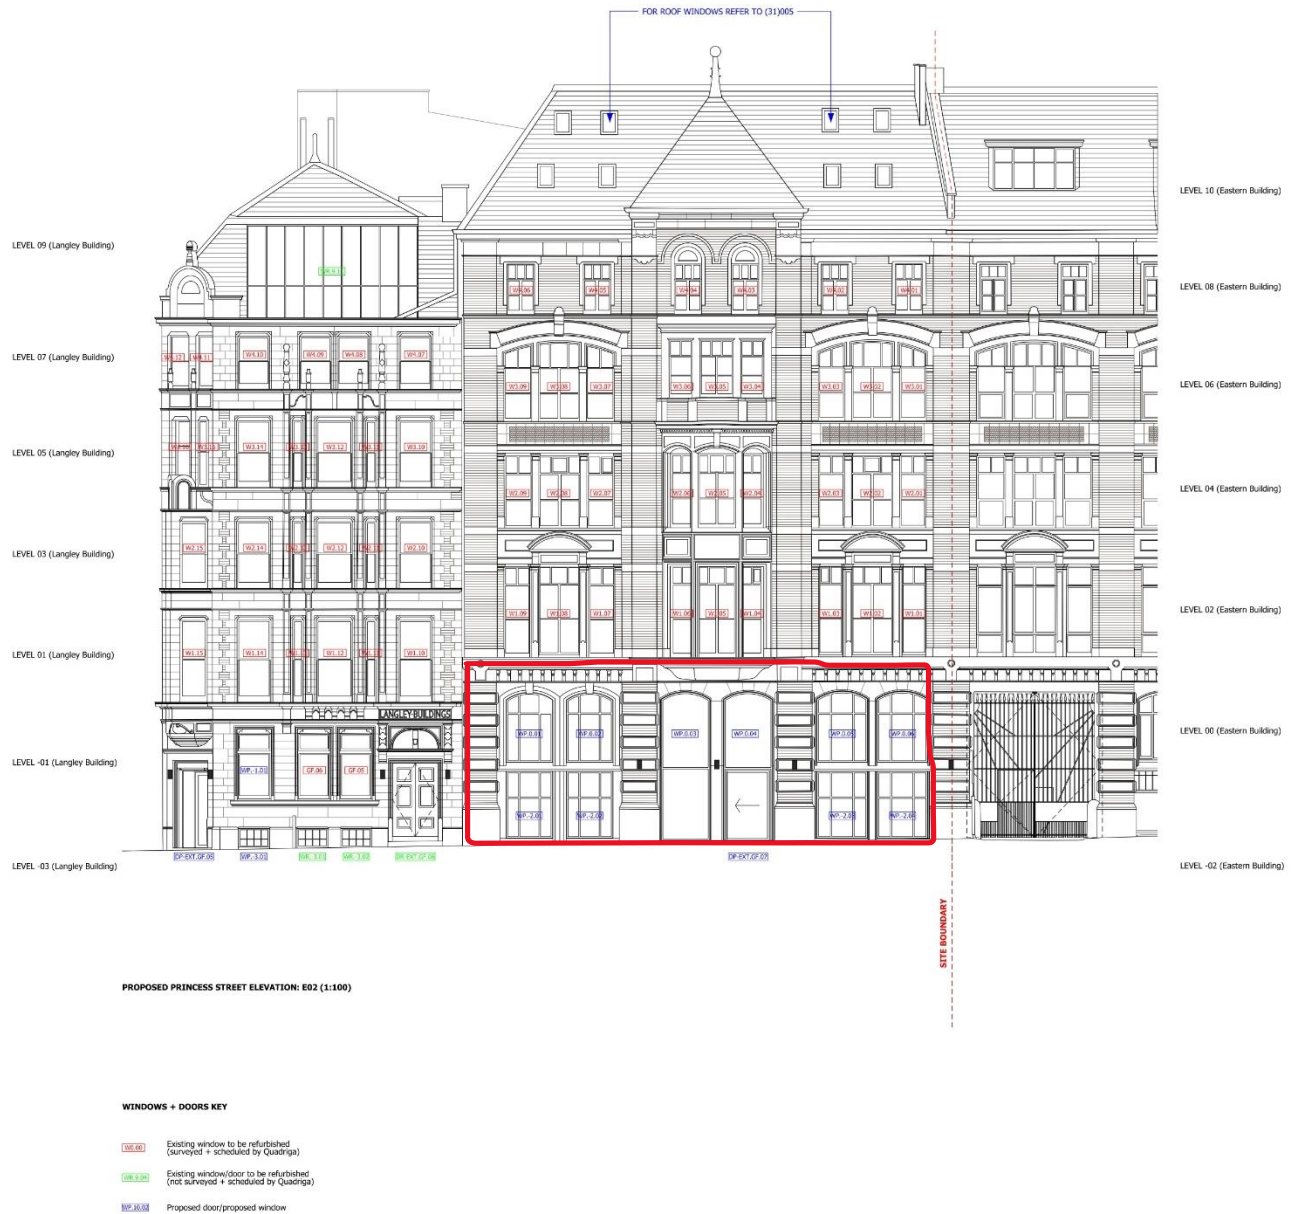
Figure 67: Location of Windows replaced on the Princess Street Elevation (Credit Bridge Architects 2021)

Figure 66 below shows the highlighted windows that have all been replaced as they were beyond repair.

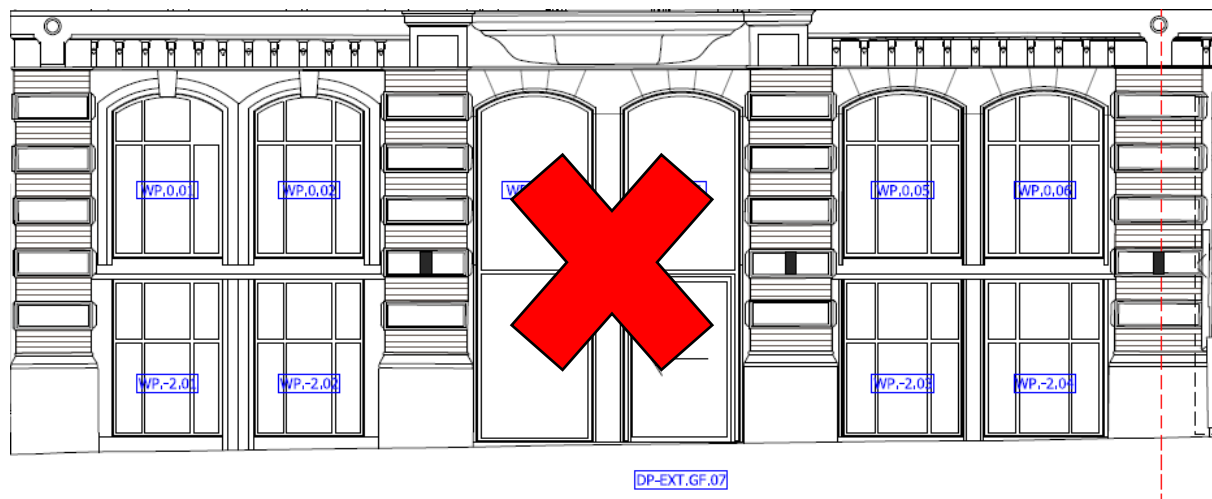
Figure 68: Close up of entrance windows and door (Credit Bridge Architects 2021)

As shown in the figures below taken in mid-2022 the condition of the were beyond repair and were required to be replaced making sure that the replacement windows were within the planning condition 3 set out by Manchester City Council:-

It is important to note the Windows are of historical interest and have be made good with an accurate like for like replacement in line within the listed building conditions, carefully ensuring a match to the original item carried out by the chosen heritage contractor.

In this case the windows that are beyond repair are replica timber casement alternatives has been chosen true to the original heritage.

All windows are constructed using soft pinewood (Pine or Douglas fir) and are finished in an oil based paint. These are glazed with a 3-4 mm hand drawn cylinder or crown glass, and float glass.

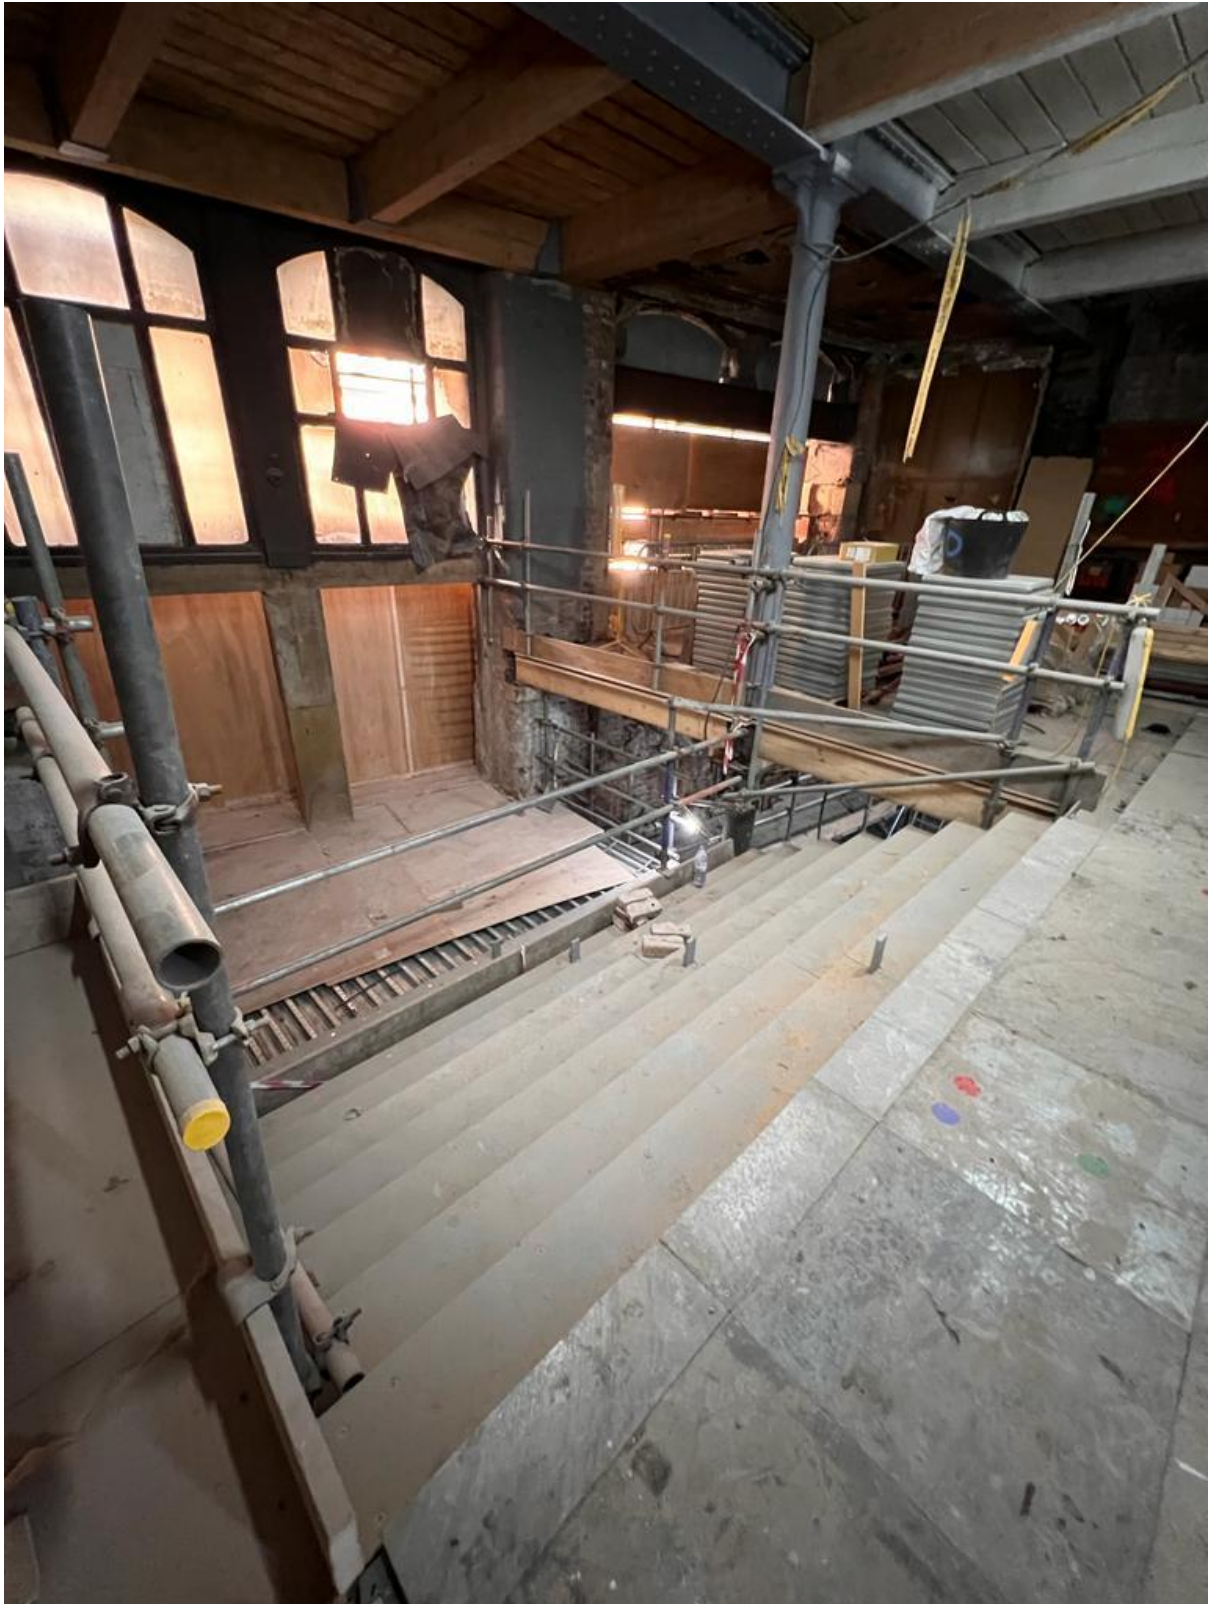
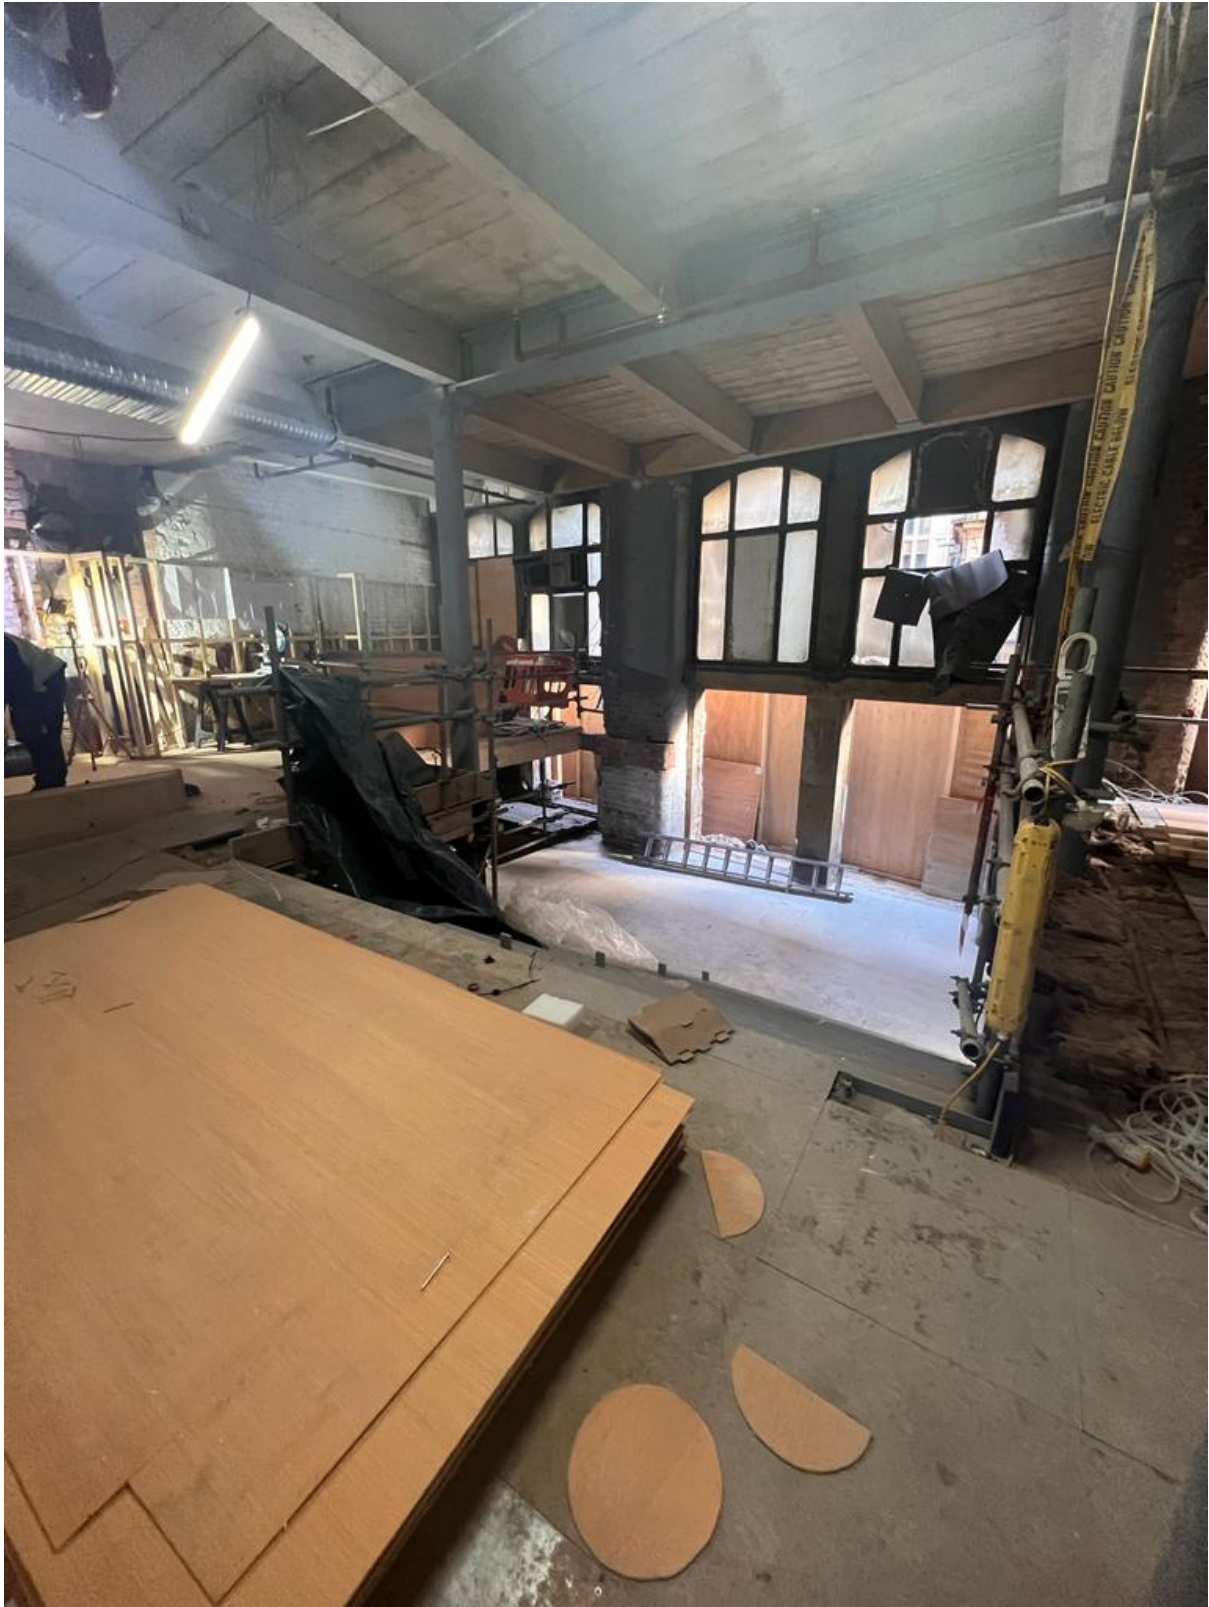
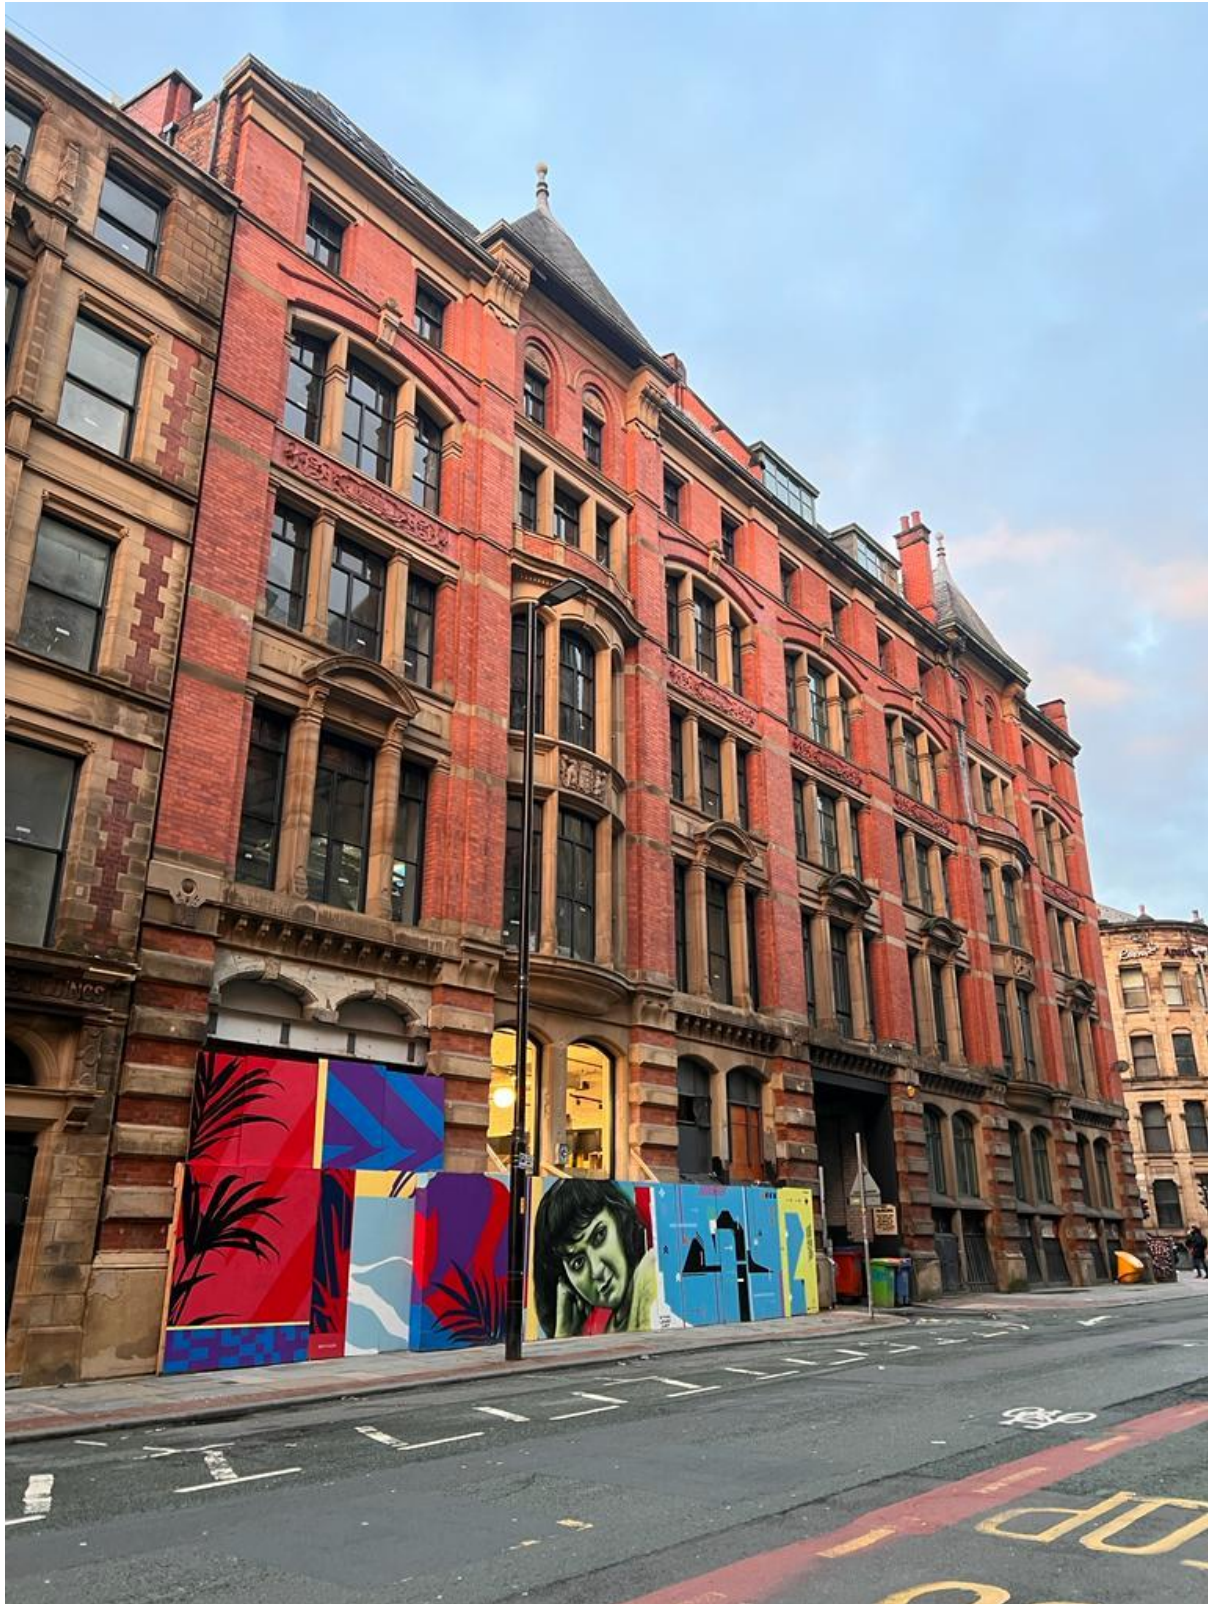
Figure 69: Internal View of the reception windows (Credit CubicWorks 2022)

Figure 70: Internal View of the Reception Windows (Credit CubicWorks 2022)

Figure 71: External View of the Reception Windows (Credit Cubic Works 2023)

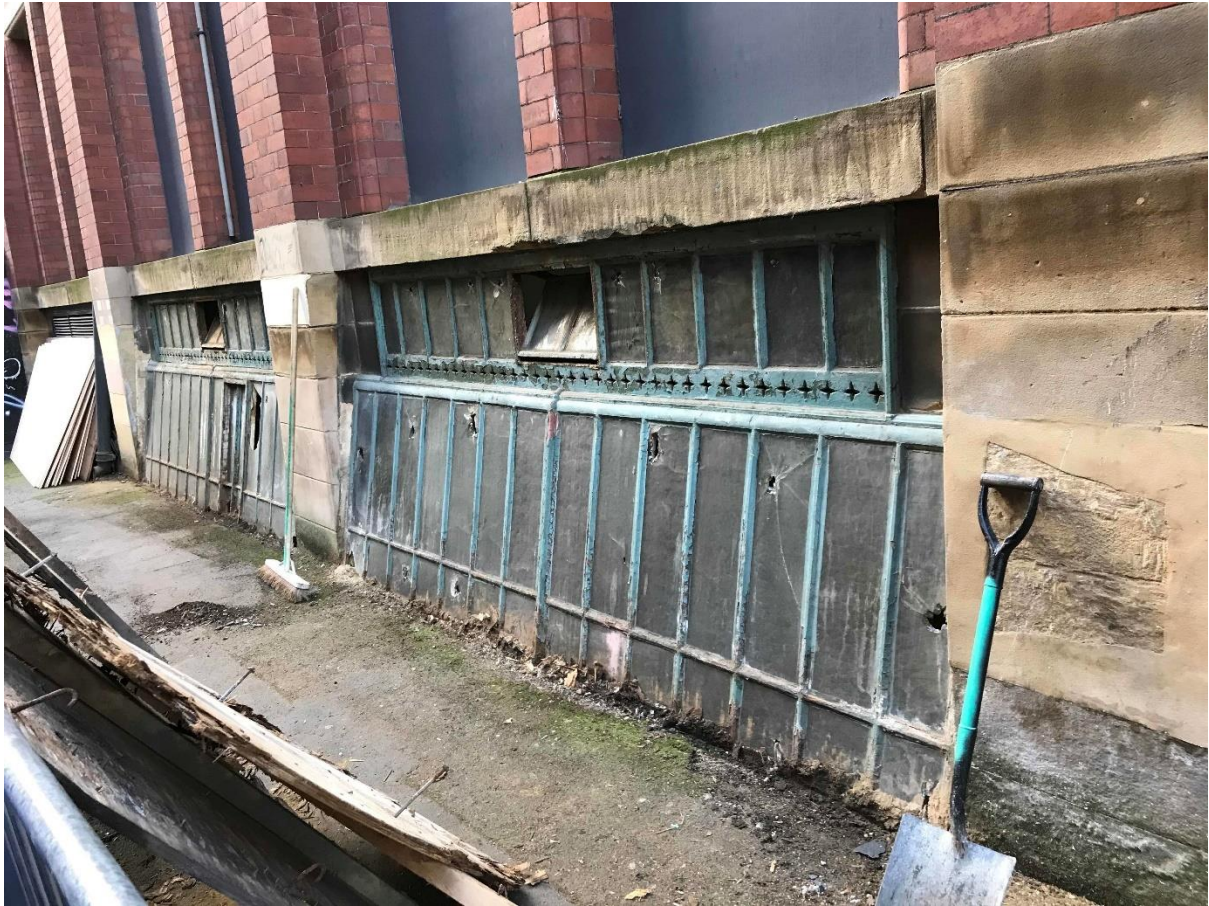
Figure 97: W1-10 & W1-11 (Credit Bridge 2021)

This section of the report highlights the condition of the basement windows on the Harter Street elevation in late 2021 and the work undertaken to restore them to their former glory.
