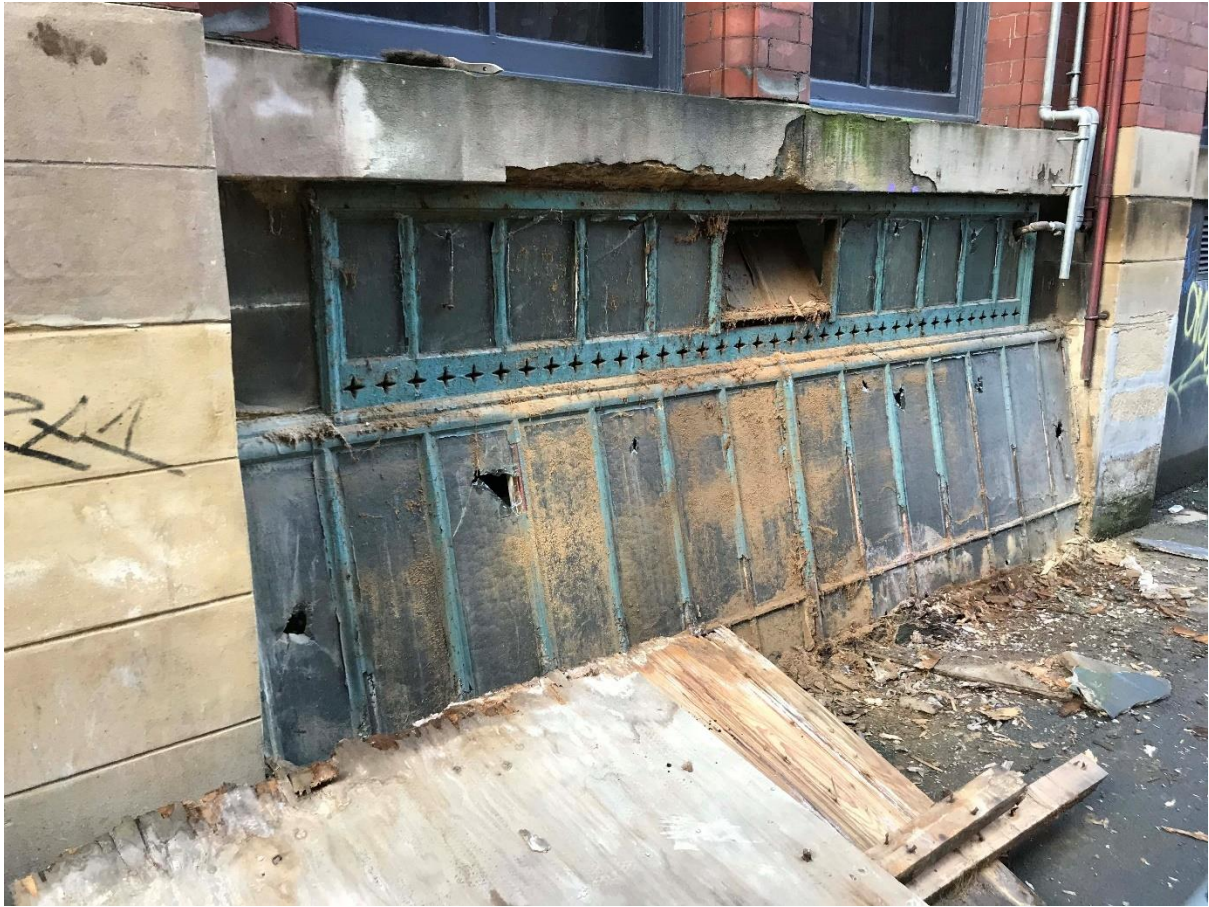
Figure 99: W-1 06 & W1-07 (Credit Bridge 2021)

This section of the report highlights the condition of the basement windows on the Harter Street elevation in late 2021 and the work undertaken to restore them to their former glory.
