**Project Name:** 2023\_07\_17 Echo Street Murrywood

**Project Date:** 17/07/2023

**Inspection Standard:** MSCC5 Sewers & Drainage GB (SRM5 Scoring)

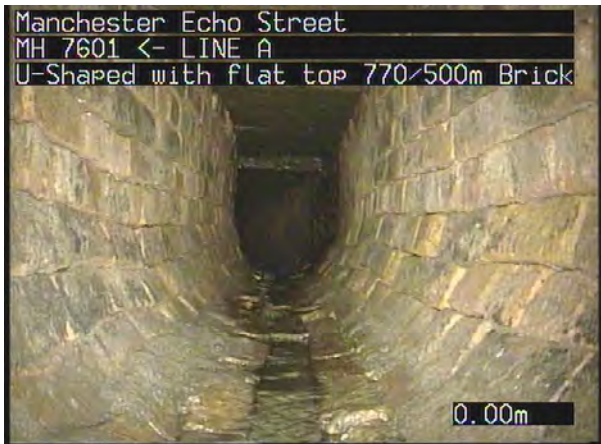
LINE A  
 X\_7a4f4d6f-752e-4a82-bda1-a23080269cca\_20230717\_1047  
 07\_080.jpg, 00:00:03, 0.00 m  
 Water level, 5% of the vertical dimension

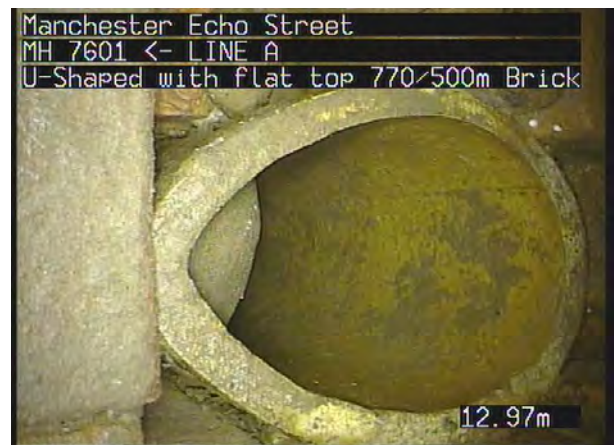
LINE A  
 X\_d595bc20-4e77-4bfa-853e-304072921cc7\_20230717\_1050  
 31\_964.jpg, 00:02:13, 12.97 m  
 Connection other than junction at 10 o'clock, 225mm dia, VC  
 EGG

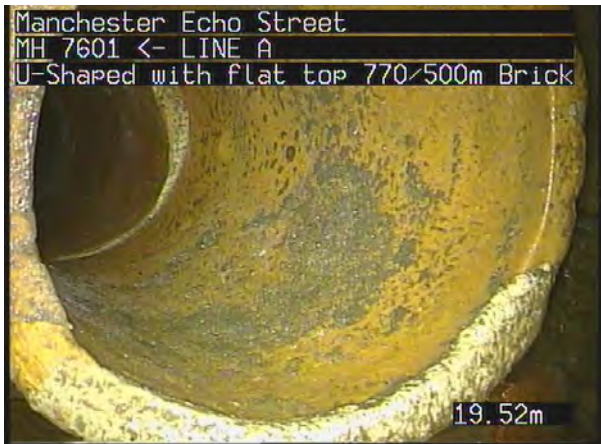
LINE A  
 X\_1f4c68be-4d7f-46d6-a618-db3a4450f03e\_20230717\_10513  
 2\_599.jpg, 00:03:02, 19.52 m  
 Connection other than junction at 10 o'clock, 225mm dia

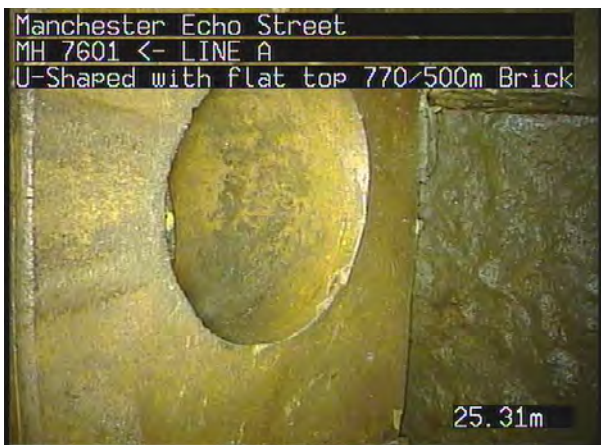
LINE A  
 X\_3f42fa24-4b32-4baf-ac52-75a5ba51614b\_20230717\_10542  
 7\_629.jpg, 00:05:33, 25.31 m  
 Connection other than junction at 11 o'clock, 150mm dia

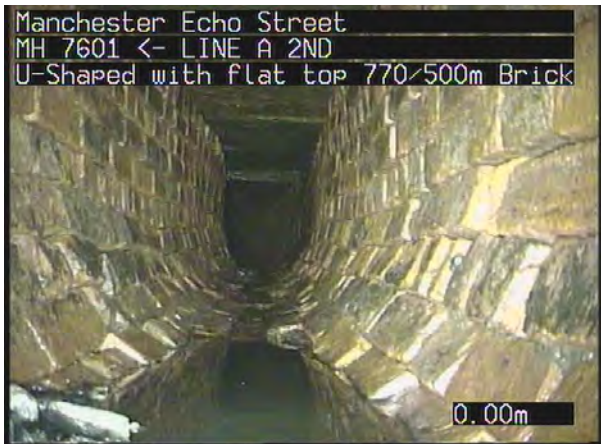
LINE A  
 2NDX\_4e5e1bfd-56a2-4a5f-9853-9e0d99b1fb99\_20230717\_1  
 24118\_824.jpg, 00:00:03, 0.00 m  
 Water level, 5% of the vertical dimension

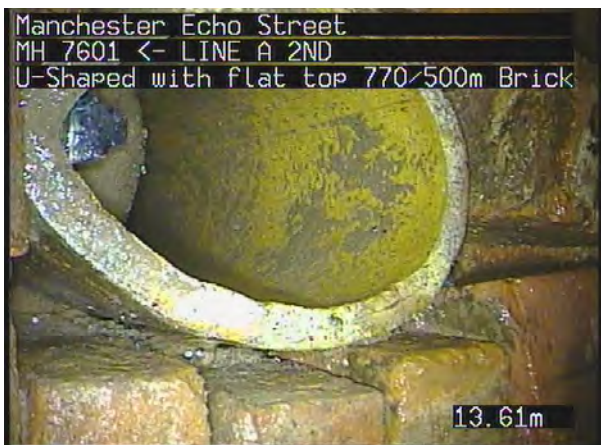
LINE A  
 2NDX\_4c24f6c7-ffb6-411c-abb9-565782ae4efc\_20230717\_12  
 4329\_034.jpg, 00:01:36, 13.61 m  
 Connection other than junction at 10 o'clock, 225mm dia, EGG  
 VC

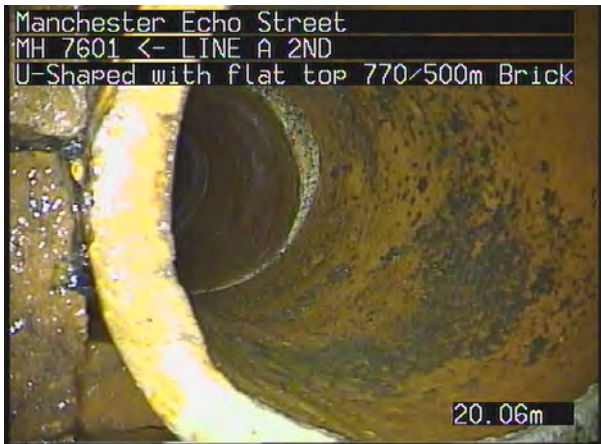
LINE A  
 2NDX\_8f6a7a56-df09-4f09-a727-39e1557c3611\_20230717\_1  
 24528\_952.jpg, 00:02:45, 20.06 m  
 Connection other than junction at 10 o'clock, 225mm dia

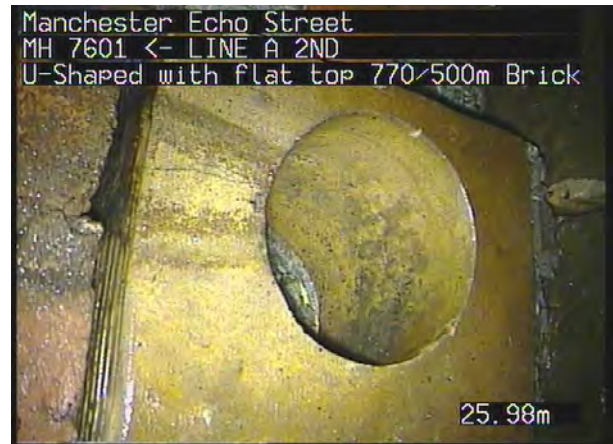
LINE A  
 2NDX\_6abe0f08-0129-4271-9e56-47bc61c8b2ab\_20230717\_  
 124631\_366.jpg, 00:03:39, 25.98 m  
 Connection other than junction at 11 o'clock, 150mm dia

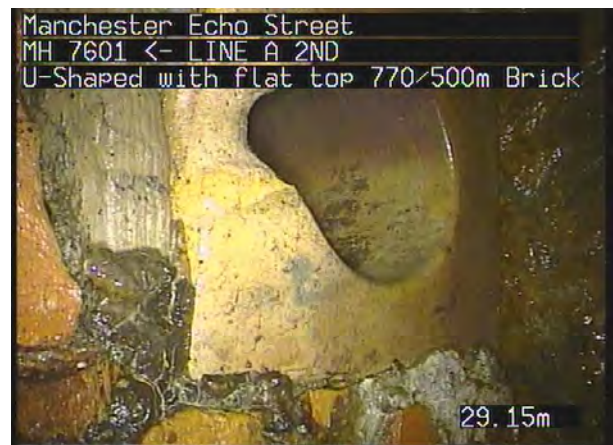
LINE A  
 2NDX\_6a6d3177-ca9d-4338-b095-2fee5614ffd7\_20230717\_1  
 24902\_822.jpg, 00:05:45, 29.15 m  
 Connection other than junction at 11 o'clock, 150mm dia

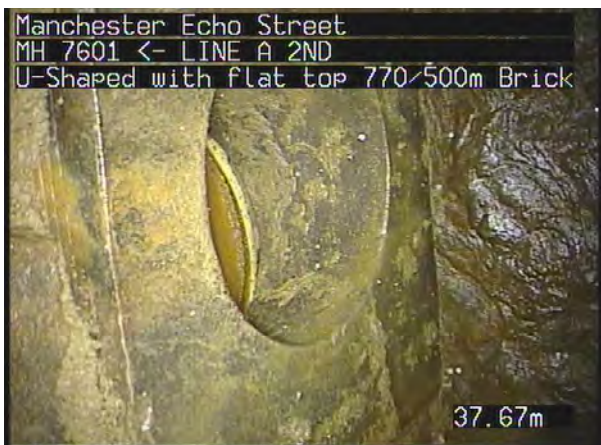
LINE A  
 2NDX\_672b2ed2-a908-4c38-8c6b-618fc1ecfb66\_20230717\_125454\_647.jpg, 00:10:47, 37.67 m  
 Connection other than junction at 11 o'clock, 150mm dia

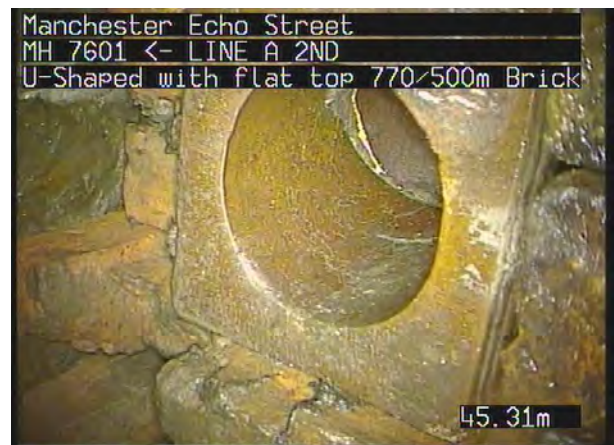
LINE A  
 2NDX\_b5cbccc8-cd79-4971-8270-115101e578cc\_20230717\_125551\_650.jpg, 00:11:37, 45.31 m  
 Connection other than junction at 02 o'clock, 150mm dia

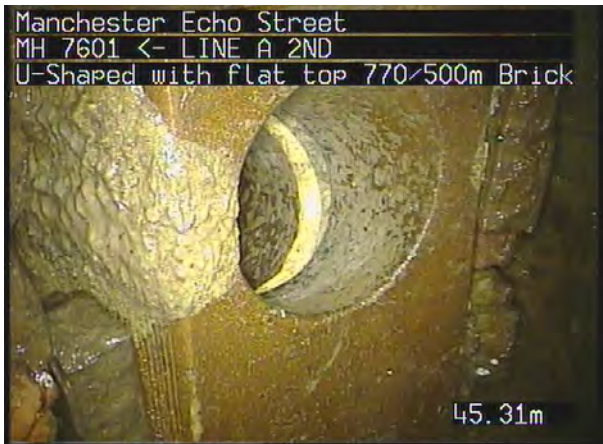
LINE A  
 2NDX\_be57e9d6-ea52-4e9a-86f1-f9aa1cefe8f1\_20230717\_1  
 25606\_134.jpg, 00:11:45, 45.31 m  
 Connection other than junction at 11 o'clock, 150mm dia

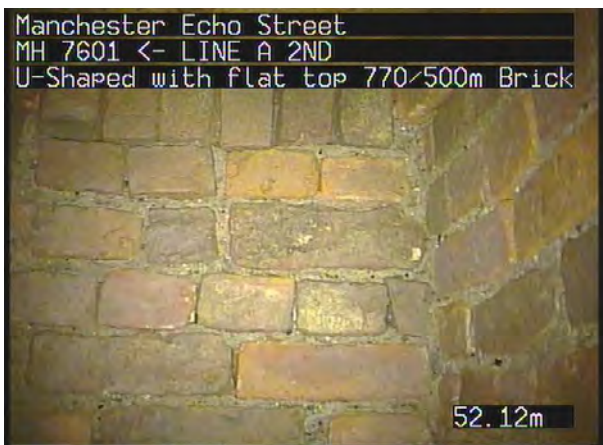
LINE A  
 2NDX\_ac6685d6-facc-4cc7-843f-db48eacf1117\_20230717\_1  
 30916\_805.jpg, 00:24:37, 52.12 m  
 Finish node, other special chamber, reference: LINE A 2ND,  
 CAPPED END

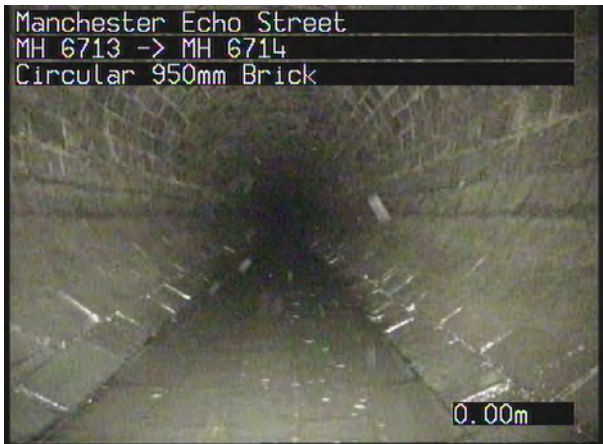
MH  
 6713X\_ab701b4e-8436-4255-a2c0-0e9bc589ab84\_20230717\_140857\_586.jpg, 00:00:04, 0.00 m  
 Water level, 20% of the vertical dimension

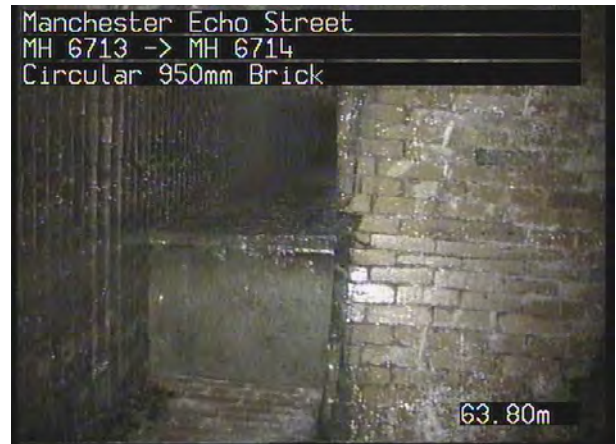
MH  
 6713X\_9ce91352-b92b-42e0-80f4-d611e9deeb8e\_20230717\_141718\_632.jpg, 00:07:05, 63.80 m  
 Finish node, manhole, reference: MH 6714

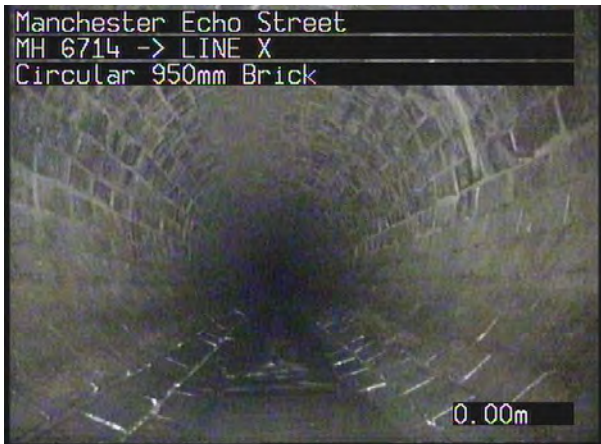
MH  
 6714X\_a527af0a-b09e-46ec-98d4-a8c2dfa3826c\_20230717\_141915\_249.jpg, 00:00:03, 0.00 m  
 Water level, 10% of the vertical dimension

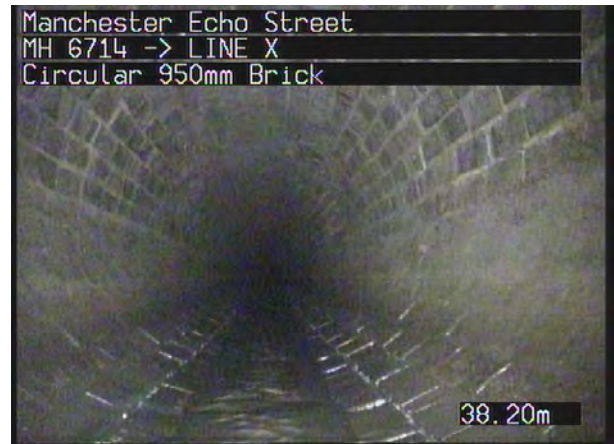
MH  
 6714X\_b2d108cc-3c43-4efa-bb00-41c72b0d2543\_20230717\_142206\_134.jpg, 00:02:37, 38.20 m  
 Survey abandoned, OFF BOUNDARY LINE

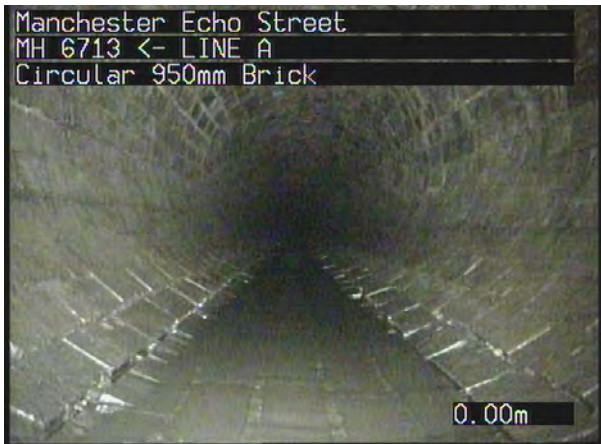
X\_01c33be5-eabc-4e22-a986-1e5e502cf143\_20230717\_1440  
 14\_262.jpg, 00:00:03, 0.00 m  
 Water level, 20% of the vertical dimension

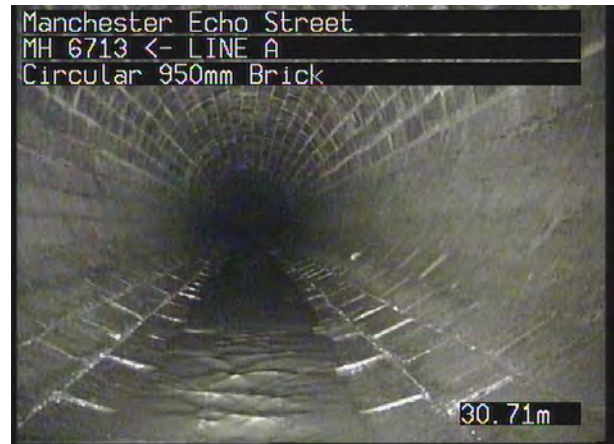
X\_19a71d37-7c20-4af1-baeb-885d4d70f085\_20230717\_1442  
 45\_222.jpg, 00:02:19, 30.71 m  
 Survey abandoned, OFF BOUNDARY LINE

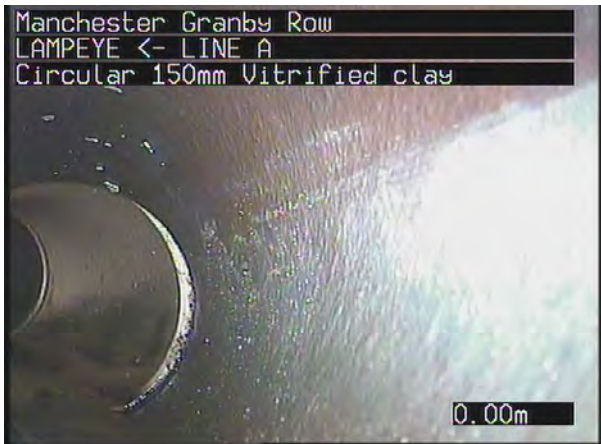
LINE A  
 X\_8f9a27bb-62ca-4cf3-85bf-7fc34367e498\_20230718\_10263  
 7\_718.jpg, 00:00:03, 0.00 m  
 Water level, 5% of the vertical dimension

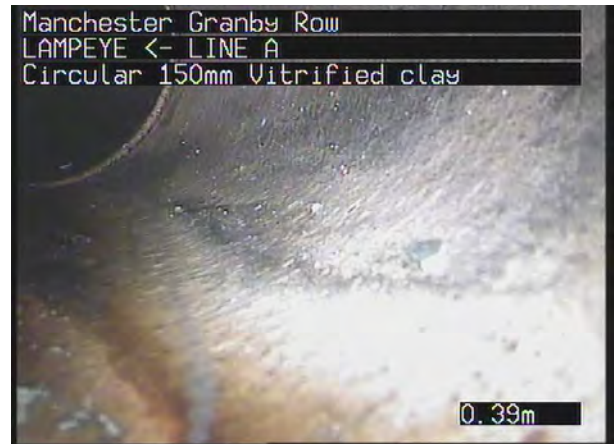
LINE A  
 X\_83d8cf41-2026-4e8f-abae-7f84a1be78ba\_20230718\_10265  
 4\_487.jpg, 00:00:15, 0.39 m  
 Line deviates left

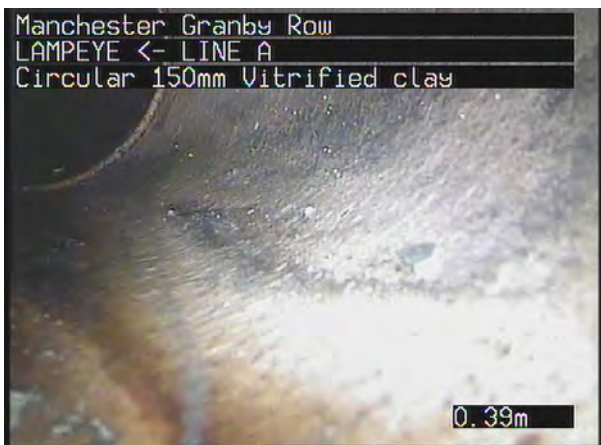
LINE A  
 X\_cd60ad08-4552-4b50-a58e-7e1d777acc8a\_20230718\_102  
 653\_269.jpg, 00:00:16, 0.39 m  
 Line deviates up

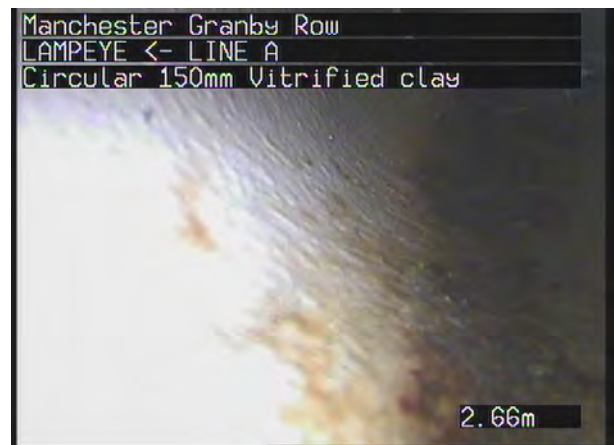
LINE A  
 X\_85c09618-66b1-4316-b75e-7aa76ab088d5\_20230718\_102  
 713\_325.jpg, 00:00:28, 2.66 m  
 Line deviates up

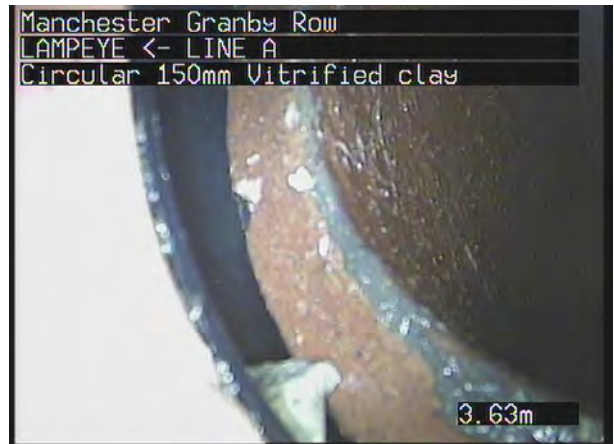
LINE A  
 X\_9b2ea69f-8408-4bd3-a7da-bb8931d14aa4\_20230718\_102  
 730\_868.jpg, 00:00:45, 3.63 m  
 Line deviates right

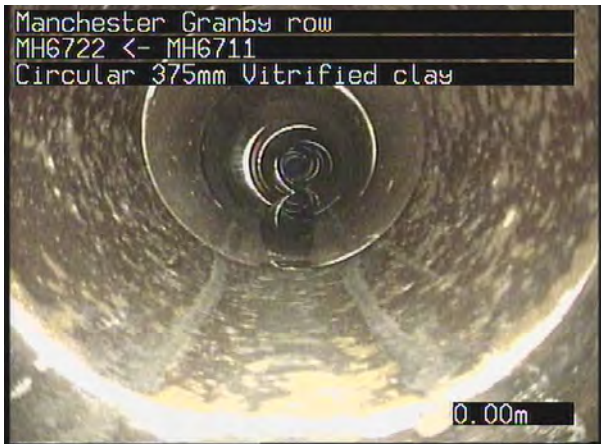
MH6711X\_665136cc-919f-4a2c-8dd5-025d4d30ea0d\_202307  
 18\_115011\_487.jpg, 00:00:02, 0.00 m  
 Water level, 5% of the vertical dimension

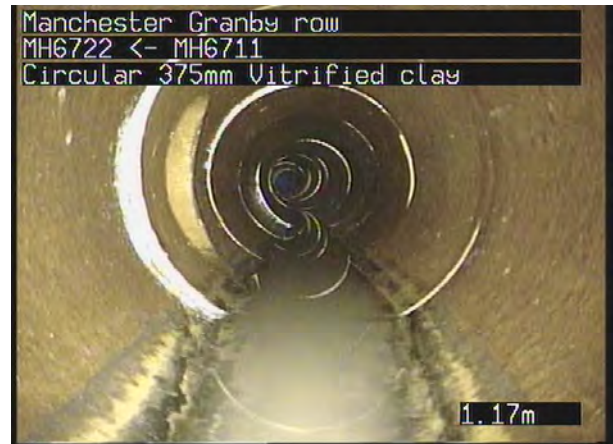
MH6711X\_48877146-9bc1-418d-a4c0-126d9dfa3414\_202307  
 18\_115027\_501.jpg, 00:00:17, 1.17 m  
 Water level, 10% of the vertical dimension

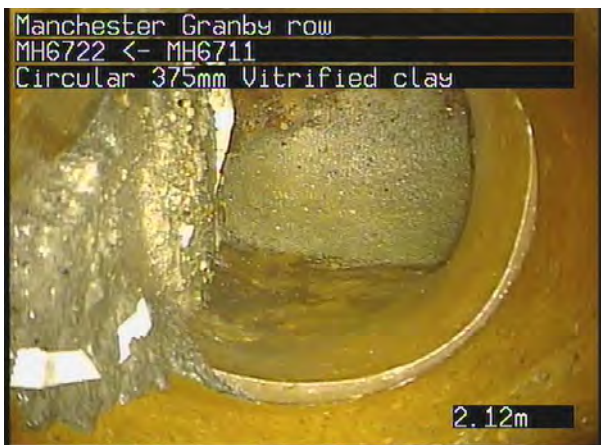
MH6711X\_e4dfaa13-8daa-4022-b960-b2f4b1205e42\_202307  
 18\_115046\_229.jpg, 00:00:29, 2.12 m  
 Junction at 09 o'clock, 150mm dia

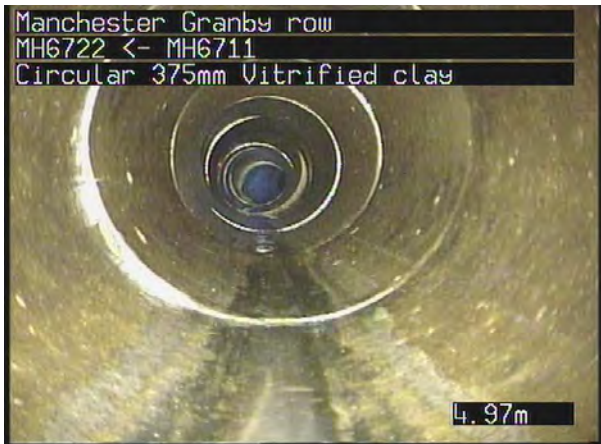
MH6711X\_2bbe285a-c8cb-437b-a62b-d3c48068656a\_20230718\_115132\_087.jpg, 00:01:05, 4.97 m  
 Water level, 5% of the vertical dimension

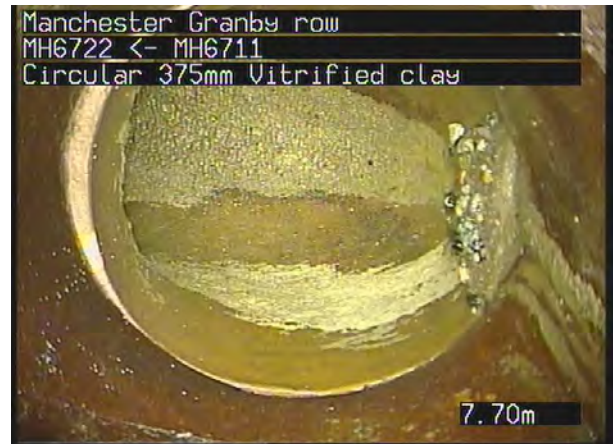
MH6711X\_ee74eb02-5856-4f5e-ba34-1166509d1127\_20230718\_115156\_785.jpg, 00:01:24, 7.70 m  
 Junction at 03 o'clock, 150mm dia

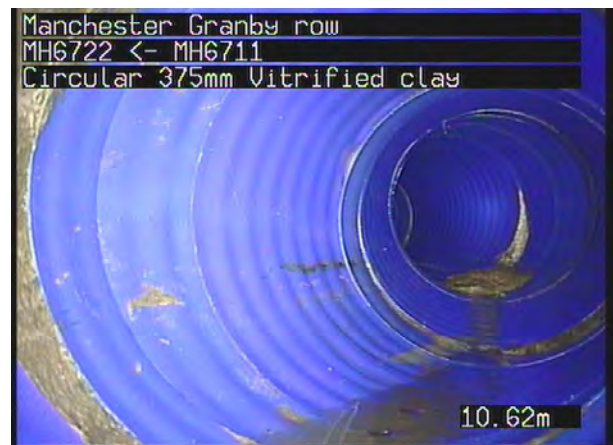
MH6711X\_beefbb52-6744-4688-80d0-1fd9b7b21494\_20230718\_115415\_508.jpg, 00:02:55, 10.62 m  
 Pipe material changes to polyvinyl chloride at this point

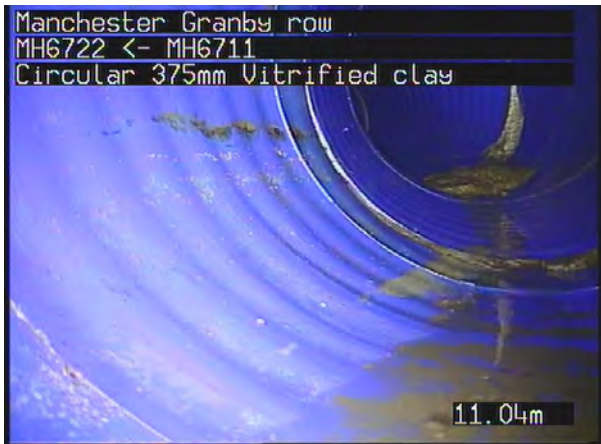
MH6711X\_4480029e-3ef1-42c4-8b16-6c9c30b20e4c\_20230718\_115425\_171.jpg, 00:03:02, 11.04 m  
 Line deviates right

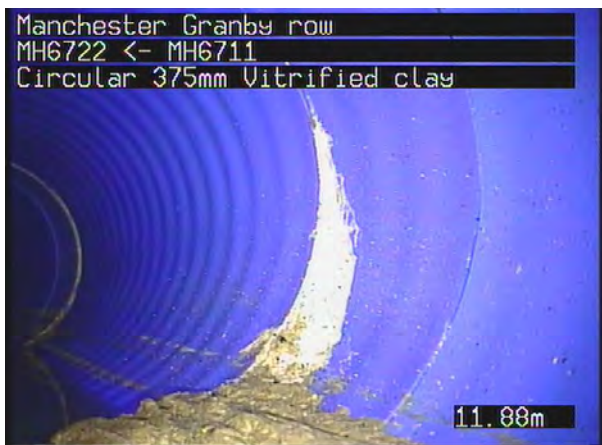
MH6711X\_d0cd7441-7a70-40d8-9414-5019e0961be7\_20230718\_115551\_290.jpg, 00:03:16, 11.88 m  
 Line deviates left

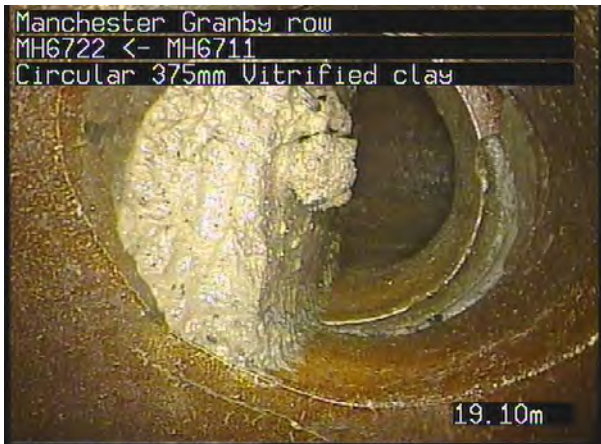
MH6711X\_fa476d7c-e33d-4136-9587-b13d9317a760\_20230718\_115915\_685.jpg, 00:05:45, 19.10 m  
 Junction at 09 o'clock, 150mm dia

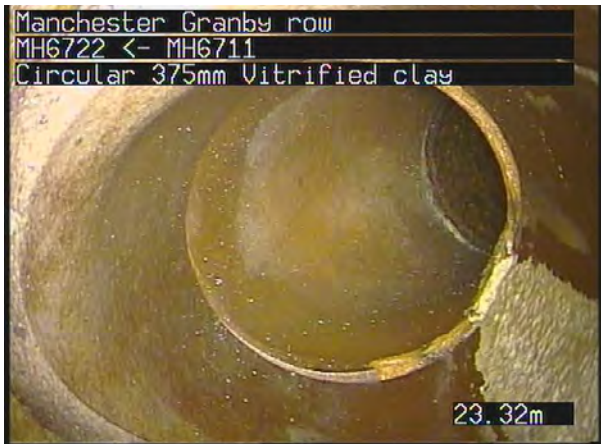
MH6711X\_7201a499-521a-46db-af01-6402e3fec686\_20230718\_120219\_418.jpg, 00:07:19, 23.32 m  
 Connection other than junction at 02 o'clock, 225mm dia

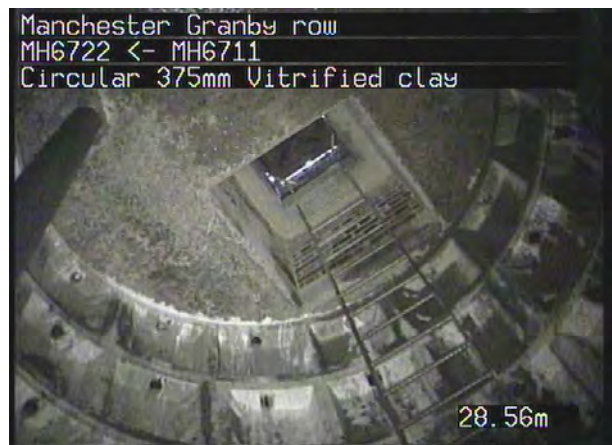
MH6711X\_f5eb8ef0-e23a-47c7-a54e-6493bf9cd807\_20230718\_120421\_809.jpg, 00:08:21, 28.56 m  
 Finish node, manhole, reference: MH6711

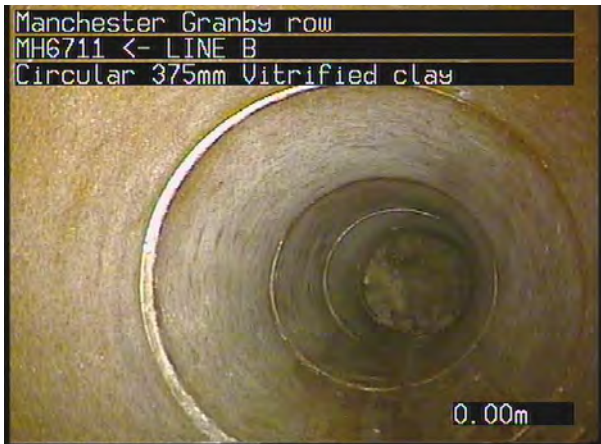
X\_5b41694c-3e60-4972-a635-b80a3dbac6ad\_20230718\_120  
 614\_060.jpg, 00:00:02, 0.00 m  
 Water level, 5% of the vertical dimension

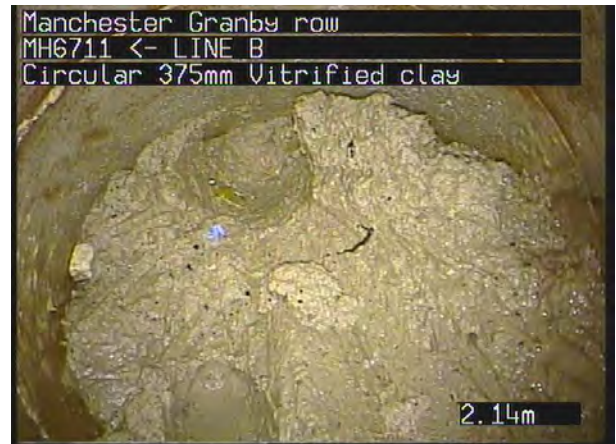
X\_7196bd35-6026-475a-9265-815fdb7a4472\_20230718\_120  
 640\_878.jpg, 00:00:18, 2.14 m  
 Survey abandoned, CAPPED OFF
