**Project:** Abraham Moss Leisure Centre

# LAND QUALITY TECHNICAL NOTE 02: WATCHING BRIEF DURING EXCAVATION

| Job | <b>Abraham Moss Library and Leisure Centre, Manchester</b> |
| Report Ref: | <b>LP44107-RAM-ZZZ-XX-RP-Y-00009 P01 Technical Note 02</b> |

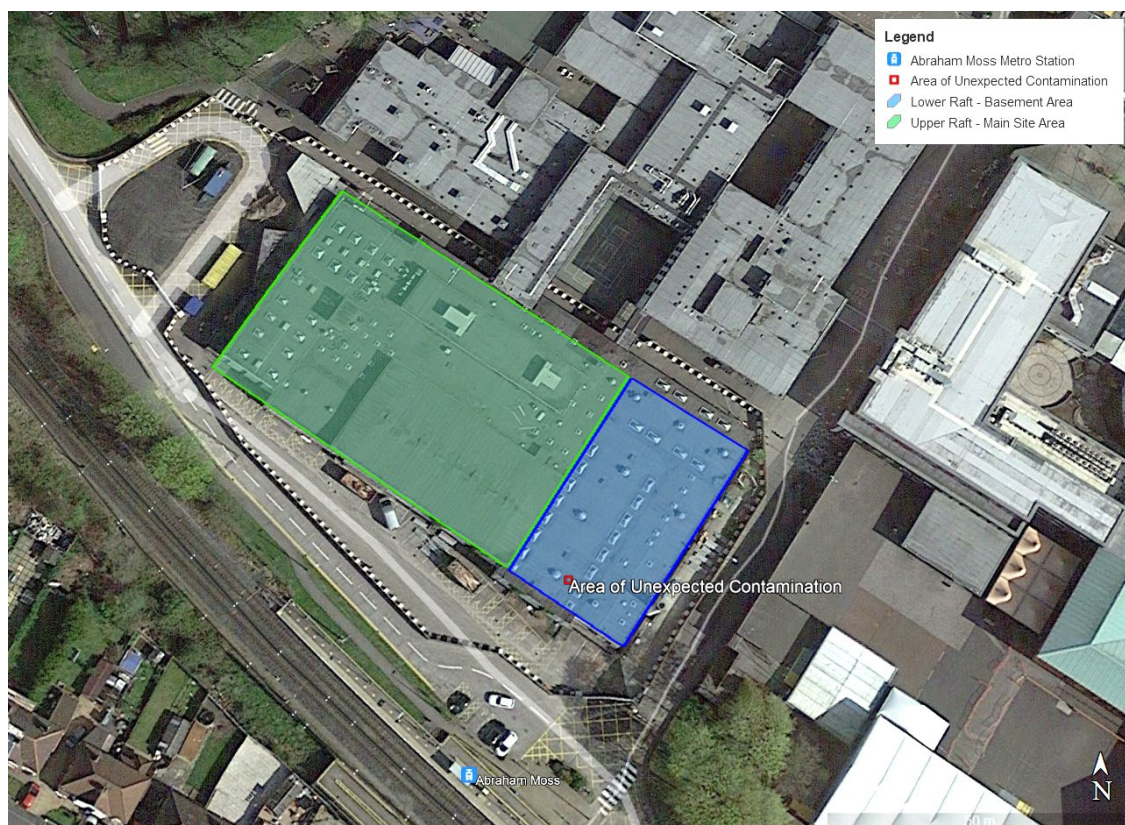
**Figure 1:** Indicative Site Layout Plan (shown prior to demolition)

The site is divided into two areas; the Upper Raft generally occupying centre and west of the site, and the Basement Area (or 'Lower Raft') generally occupying the east of the site. Figure 1 below highlights these areas respectively.
