## **DESIGN, ACCESS & HERITAGE STATEMENT**

### Broomcroft Hall Boundary Wall, Didsbury, Manchester, M20 2RU

## PN 8529 BOUNDARY WALLS, REPLACEMENT OF SECTION OF BOUNDARY WALL WITH HEDGE, BROOMCROFT HALL, DIDSBURY, UNIVERSITY OF MANCHESTER.

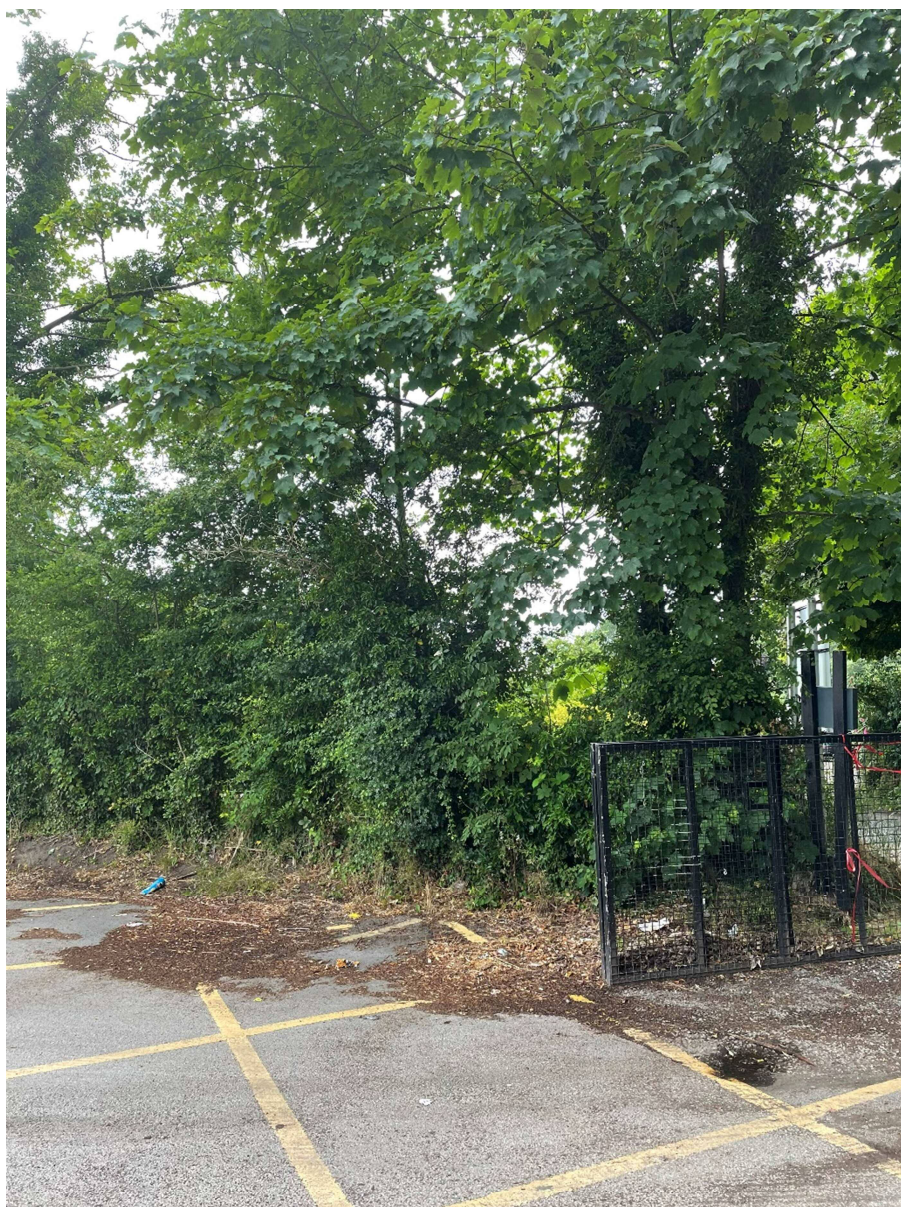
- 2.21 The 4-metre section of wall has suffered structural movement, with cracking in several areas and displacement of bricks at the base of the pier. The University has taken advice from a Structural Engineer who has advised that the movement is progressive, and the wall is unstable and needs rebuilding. Appendix 1, Email 1.

- 2.23 Immediately behind the section of damaged wall is a lime tree, approximately 80 years old. It is likely that the close proximity of the tree to the wall has caused the wall to move and become unstable. The University has been advised by a tree consultant that we cannot rebuild the wall without having significant implications to the health of the tree. Appendix 1, Email 2. It is therefore proposed to remove the wall and to replace it with a hedge in order to retain the tree. Photos 3 and 4 in Appendix 1 show the damaged wall section that we propose to remove.

**Photo 4.** Red outline shows the proposed wall section to be removed

- 2.11 Planning permission is sought to replace a 4-metre section of Broomcroft Hall's brick boundary wall with a hawthorn hedge.

The works to remove the damaged wall sections would be carried out under supervision of the tree consultant, to ensure that the works are undertaken with due care and attention to avoid any damage to the tree as far as possible.
