# **Land at Victoria Avenue East, New Moston**

## **Proposed Retail Development**

### **Flood Risk Assessment & Outline Drainage Strategy**

For: Aldi Stores Ltd.

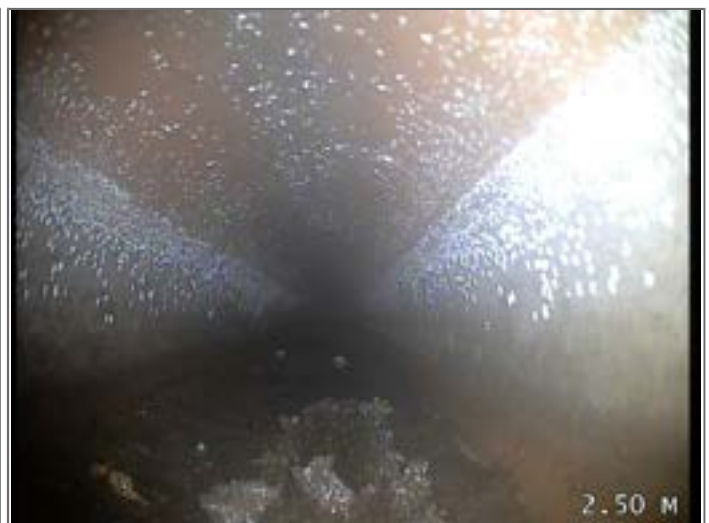
Settled deposits fine 5% cross-sectional area loss

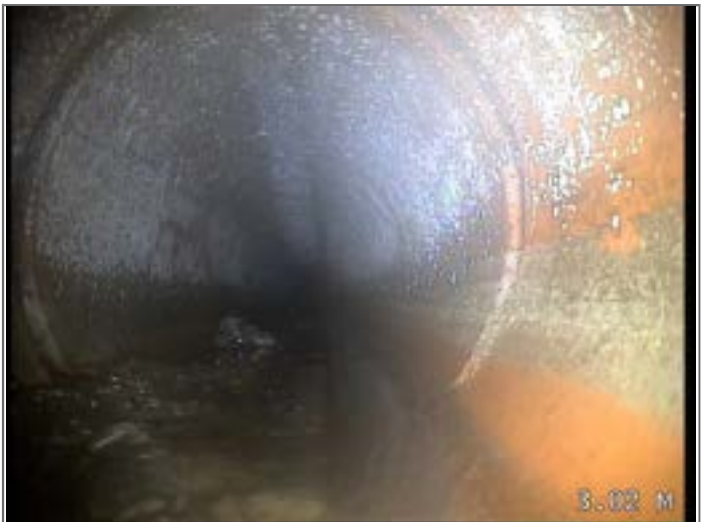
Settled deposits fine 5% cross-sectional area loss

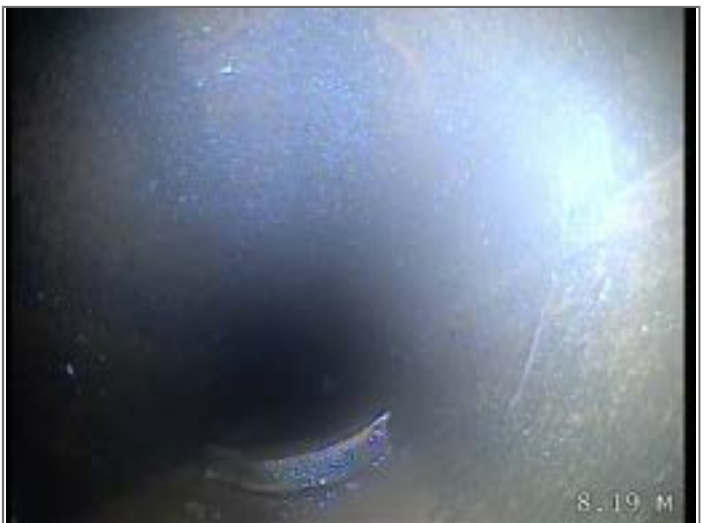
Settled deposits coarse 5% cross-sectional area loss - Remark: PIECE OF PIPE

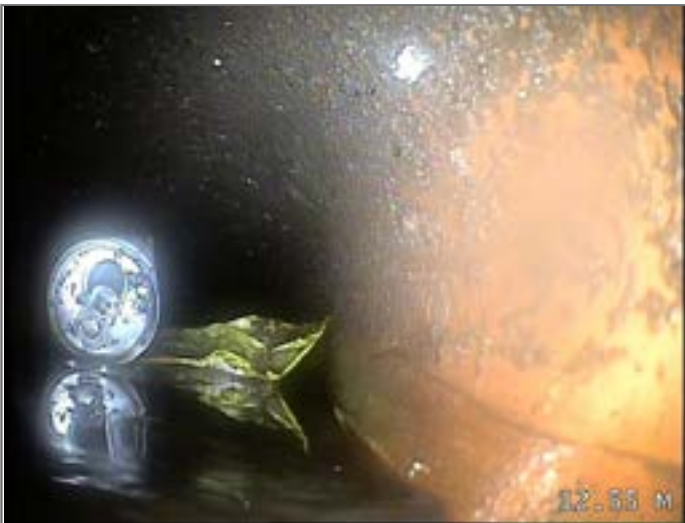
Other settled deposits 25% cross-sectional area loss - Remark: DEBRIS

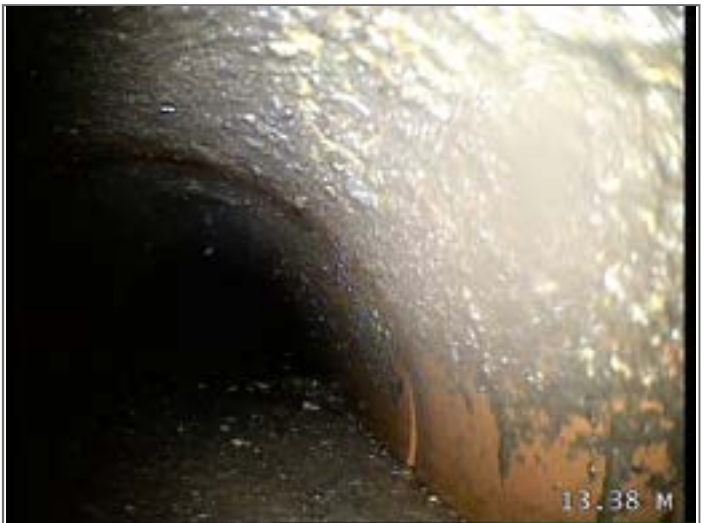
Settled deposits fine 25% cross-sectional area loss

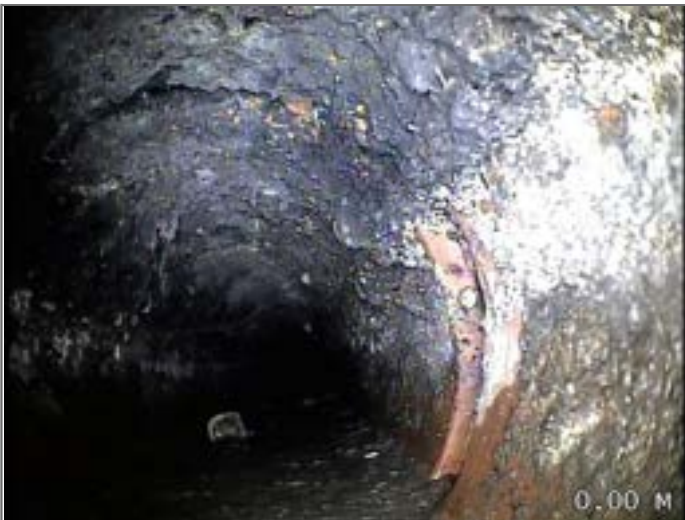
Settled deposits fine 10% cross-sectional area loss

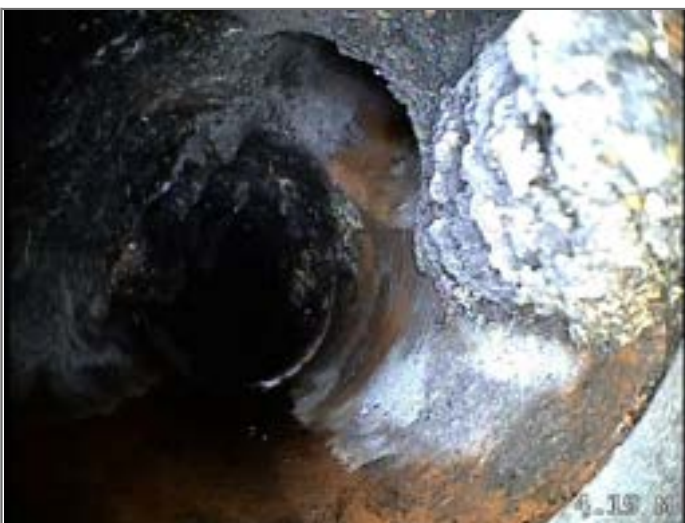
Junction at 1 o'clock, diameter 100mm

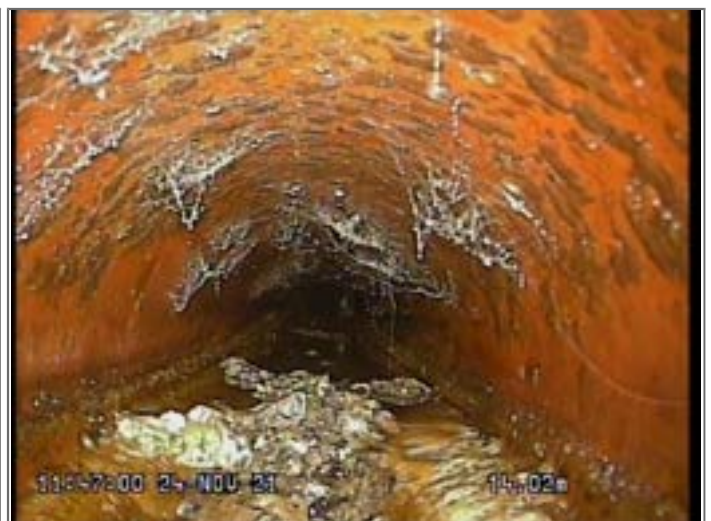
Attached deposits, fouling from 5 to 7 o'clock 10% cross-sectional area loss

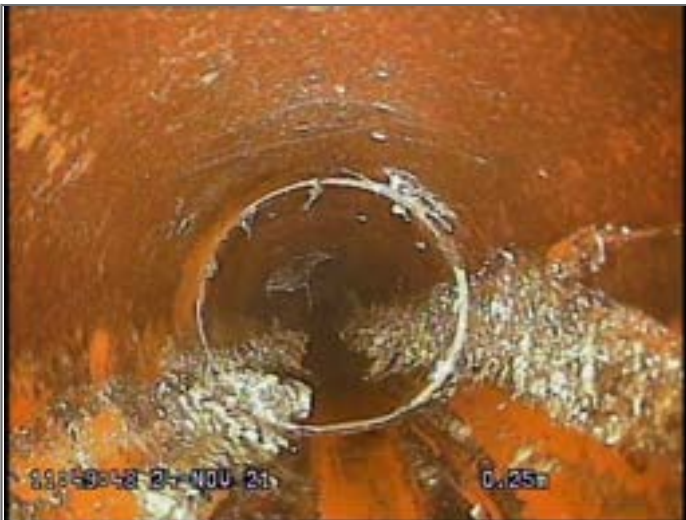
Attached deposits, fouling at 7 o'clock 5% cross-sectional area loss

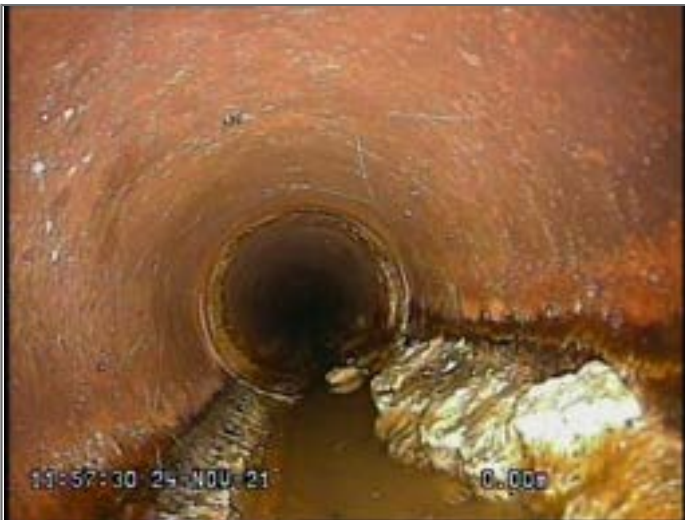
Attached deposits, fouling at 4 o'clock 10% cross-sectional area loss

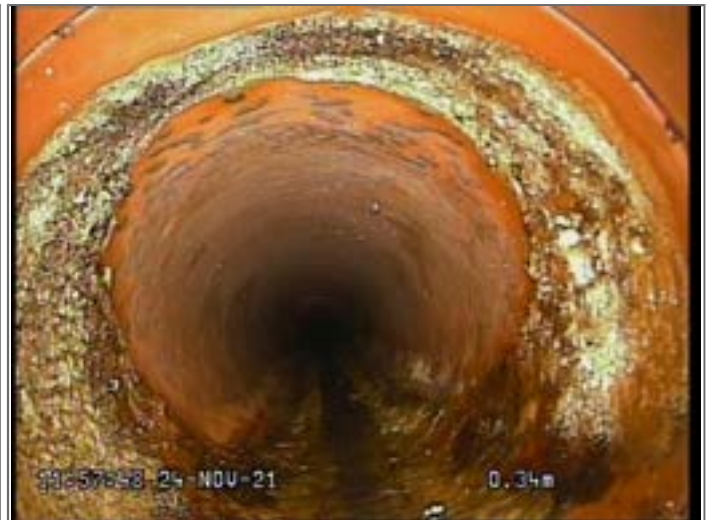
Attached deposits, encrustation from 7 to 5 o'clock 5% cross-sectional area loss

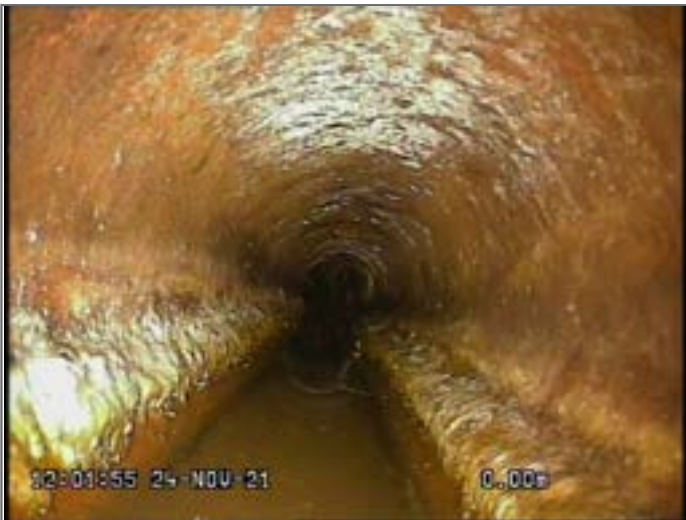
Attached deposits, fouling at 5 o'clock 5% cross-sectional area loss

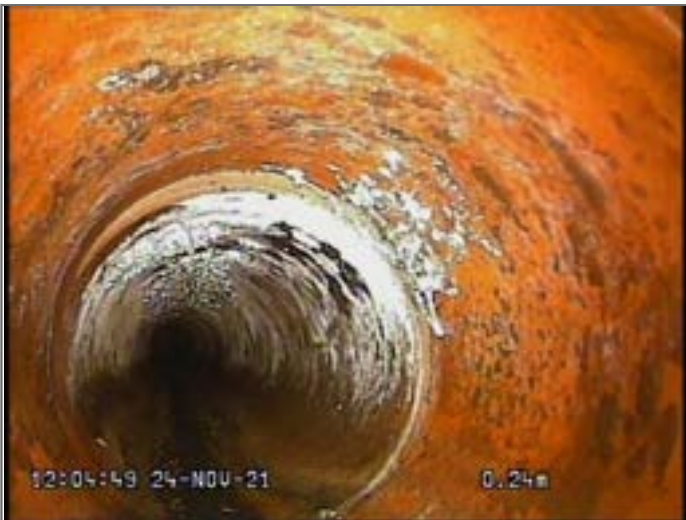
Line of drain/sewer deviates left

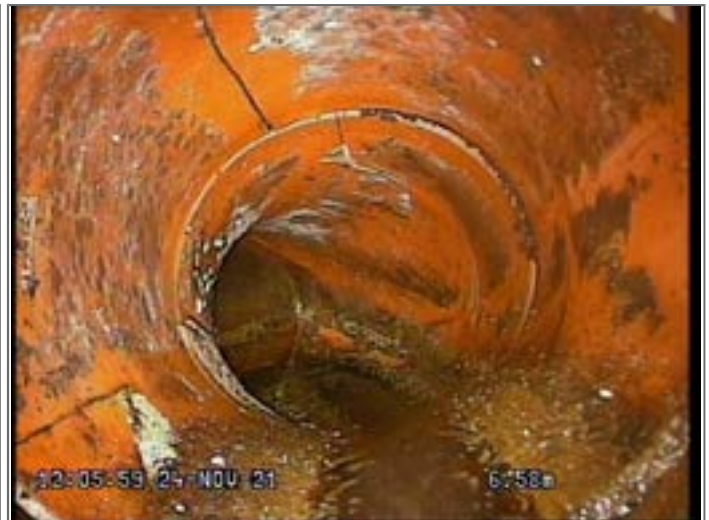
Line of drain/sewer deviates down

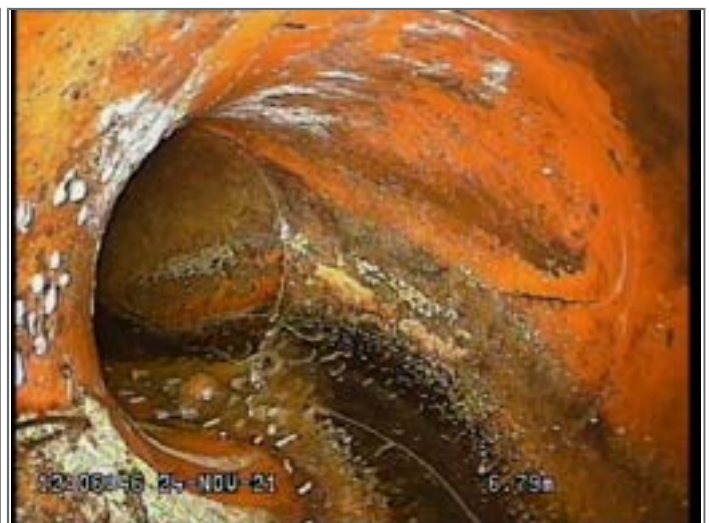
Line of drain/sewer deviates left

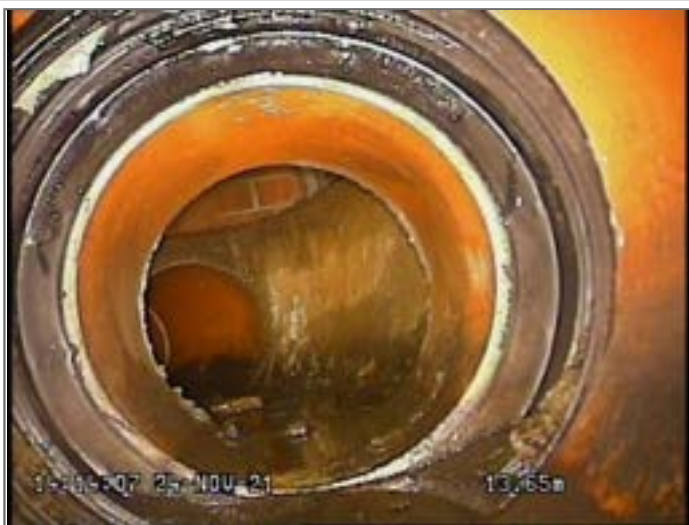
Open joint large

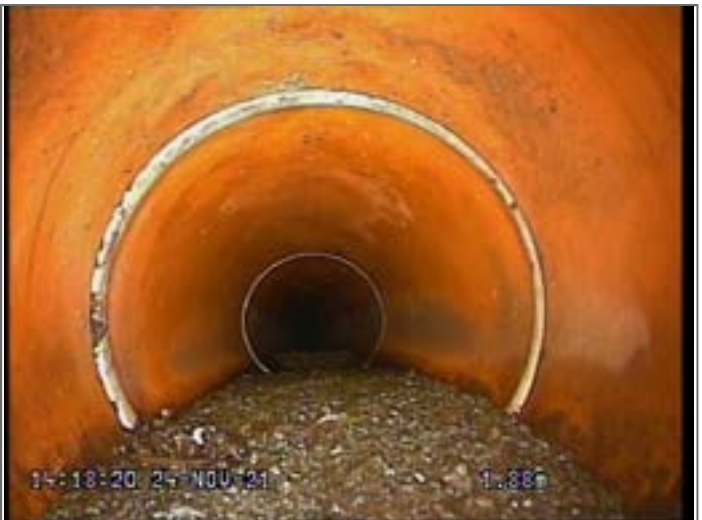
Settled deposits fine 20% cross-sectional area loss

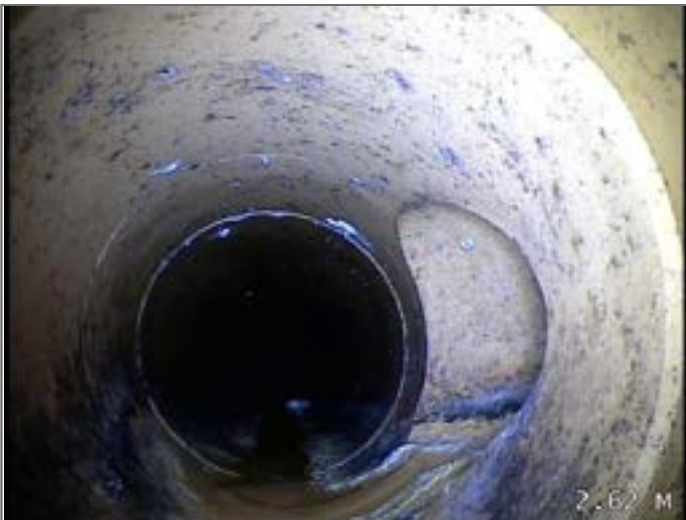
Junction at 3 o'clock, diameter 100mm

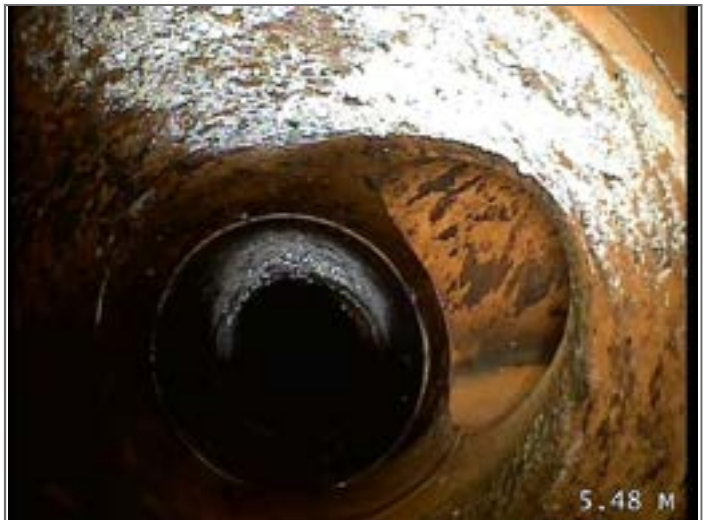
Junction at 3 o'clock, diameter 100mm

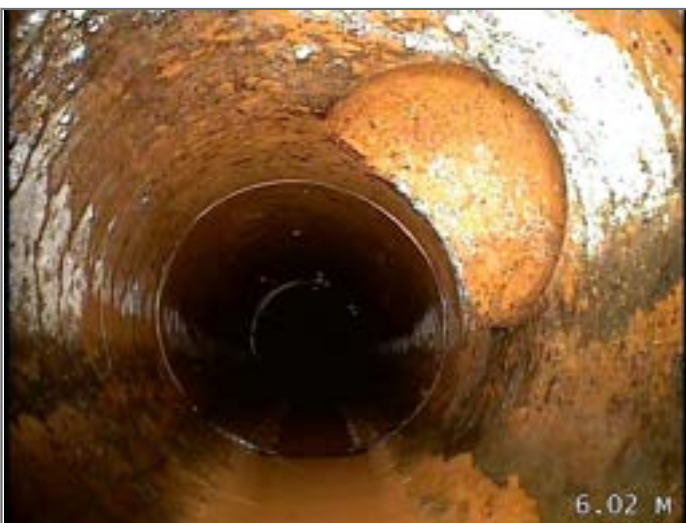
Junction at 2 o'clock, diameter 100mm

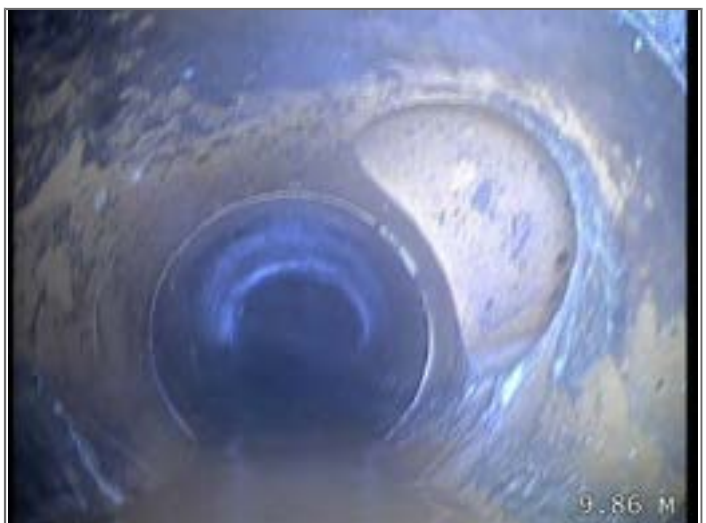
Junction at 2 o'clock, diameter 100mm

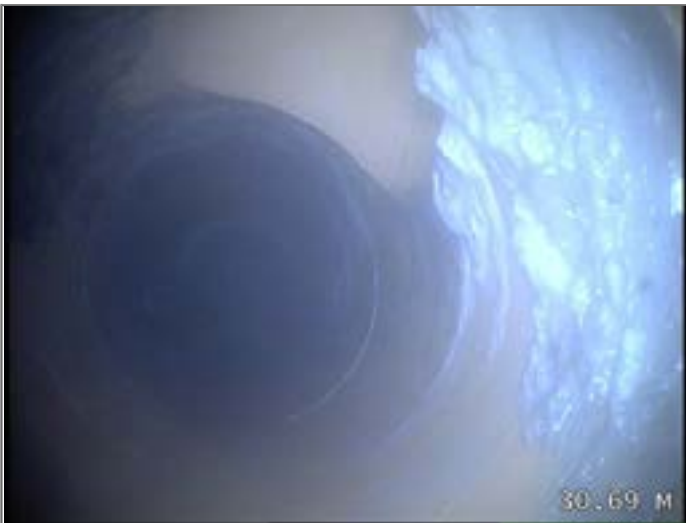
Junction at 1 o'clock, diameter 100mm

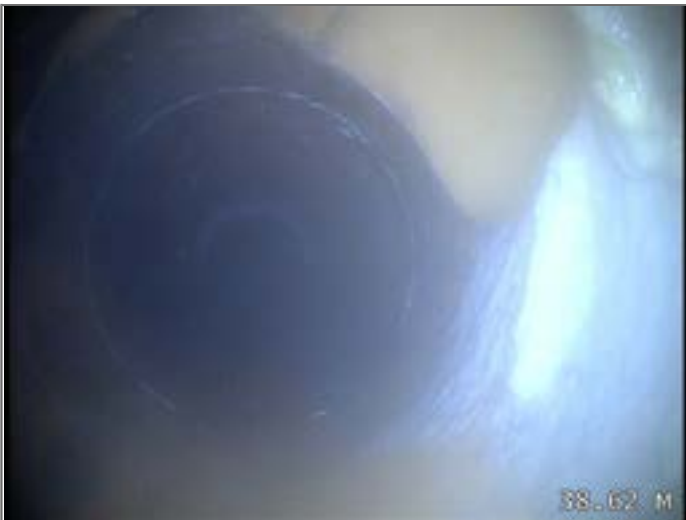
Junction at 1 o'clock, diameter 100mm

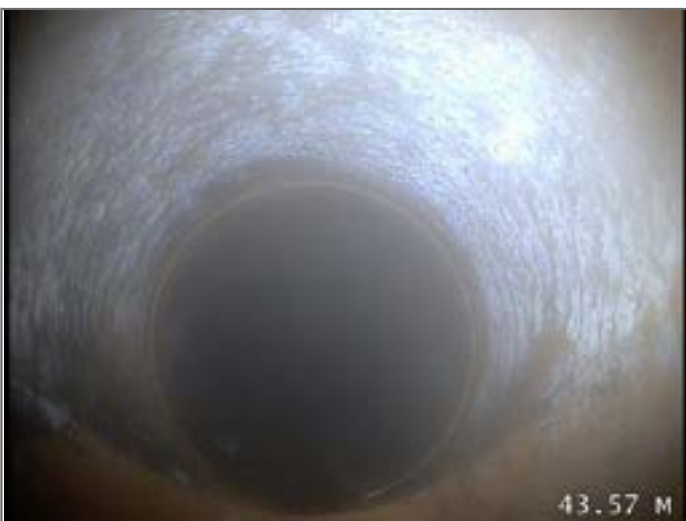
Line of drain/sewer deviates down - Remark: BACK DROP

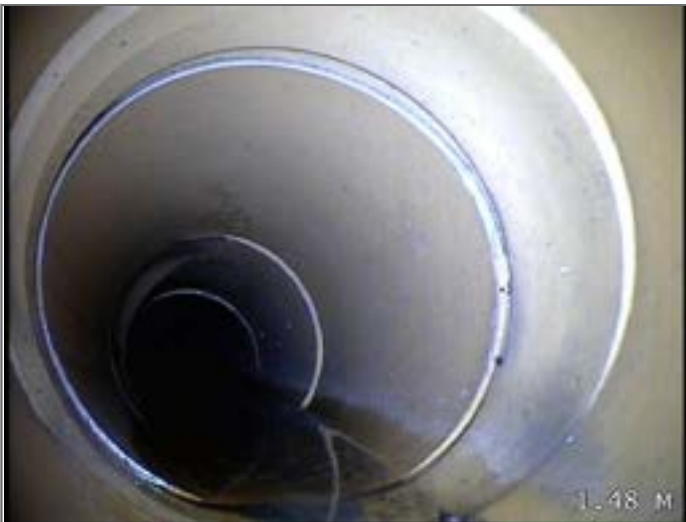
Line of drain/sewer deviates left

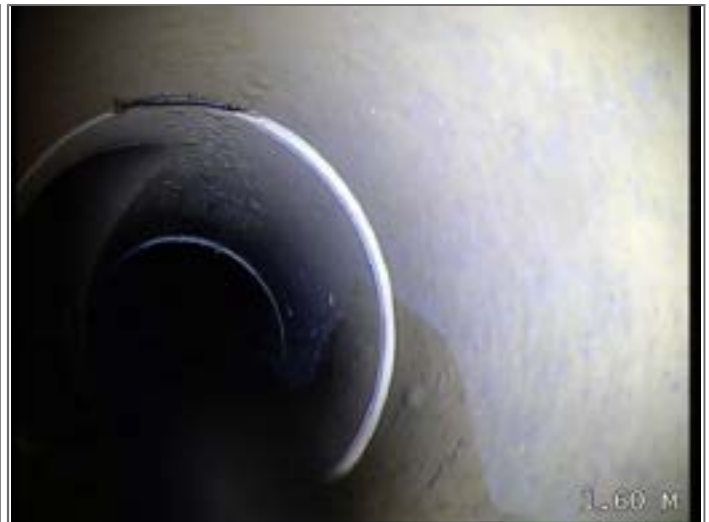
Junction at 9 o'clock, diameter 100mm

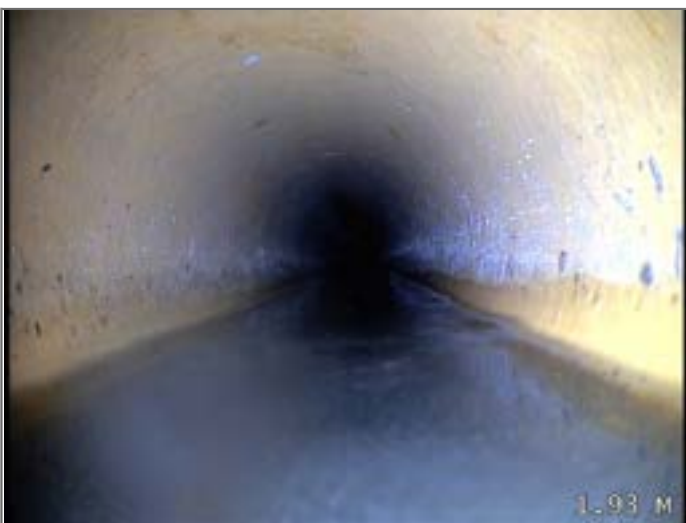
Settled deposits fine 5% cross-sectional area loss

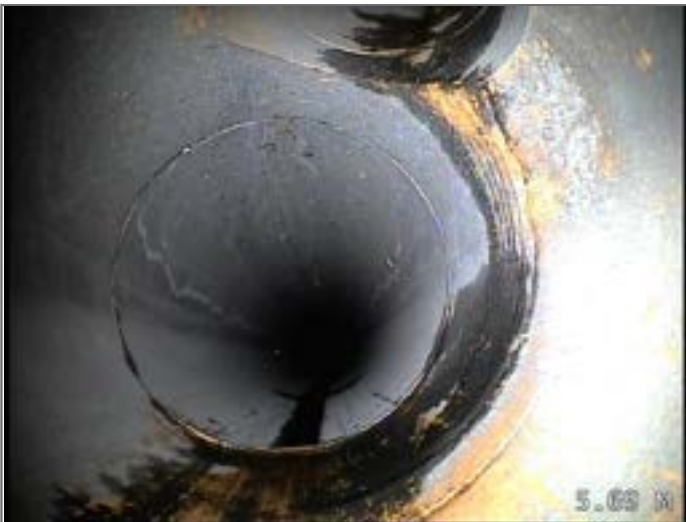
Junction at 1 o'clock, diameter 100mm

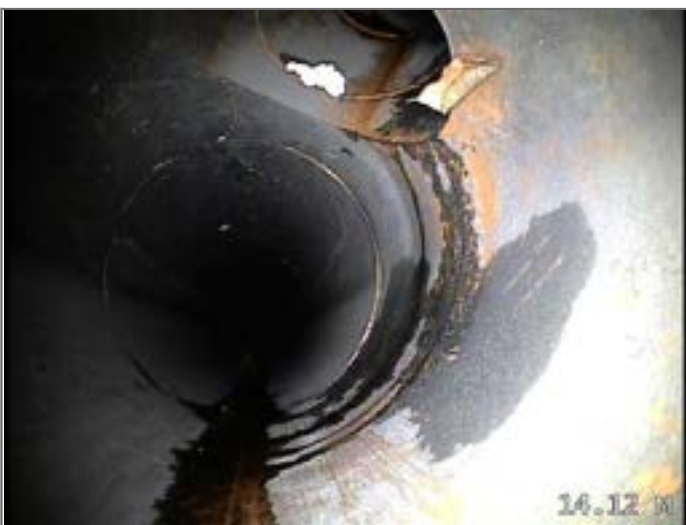
Junction at 1 o'clock, diameter 100mm

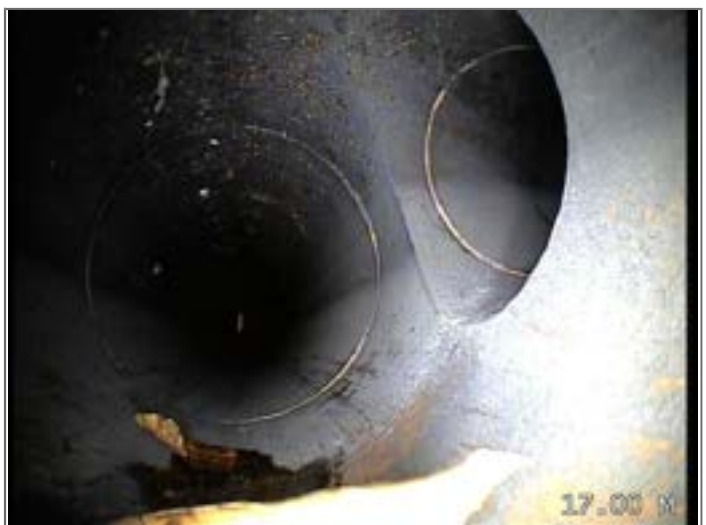
Junction at 2 o'clock, diameter 100mm

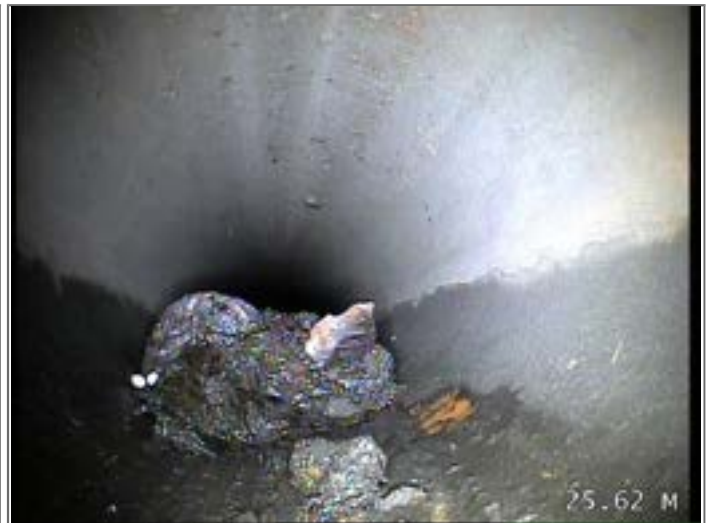
Settled deposits fine 10% cross-sectional area loss

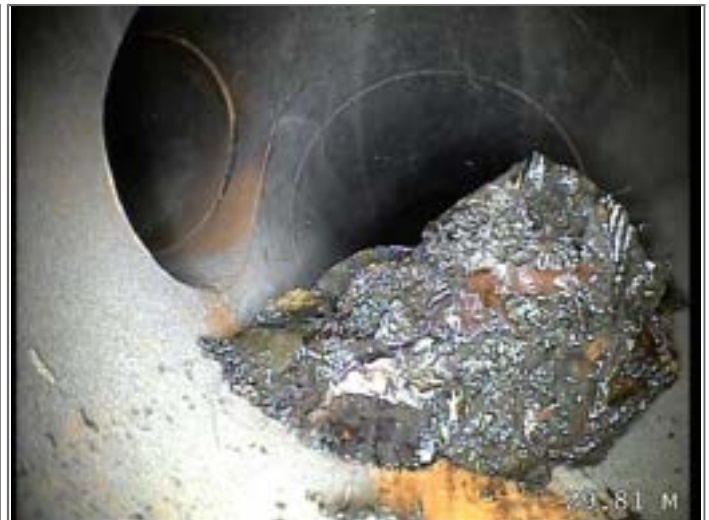
Junction at 10 o'clock, diameter 100mm

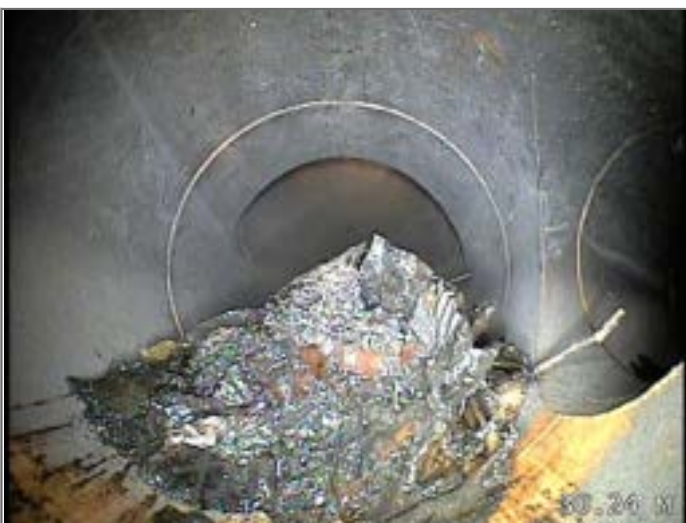
Junction at 3 o'clock, diameter 100mm

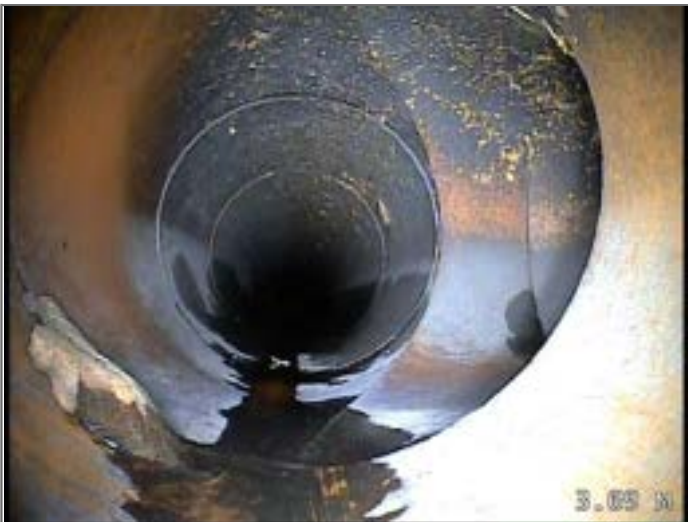
Junction at 3 o'clock, diameter 150mm

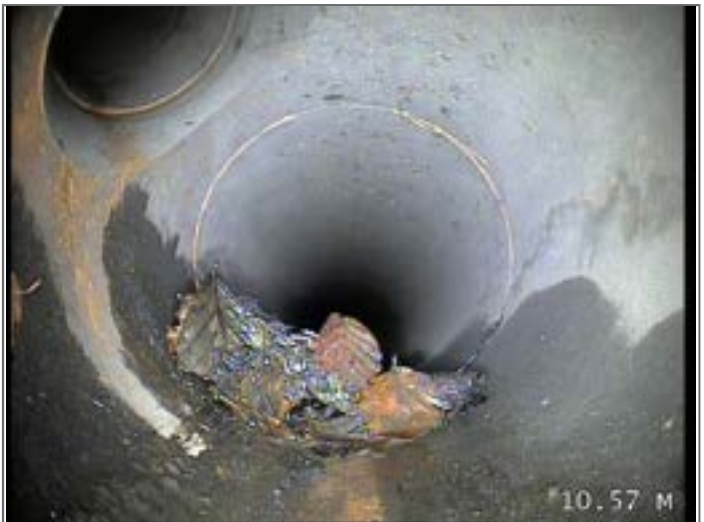
Junction at 11 o'clock, diameter 100mm

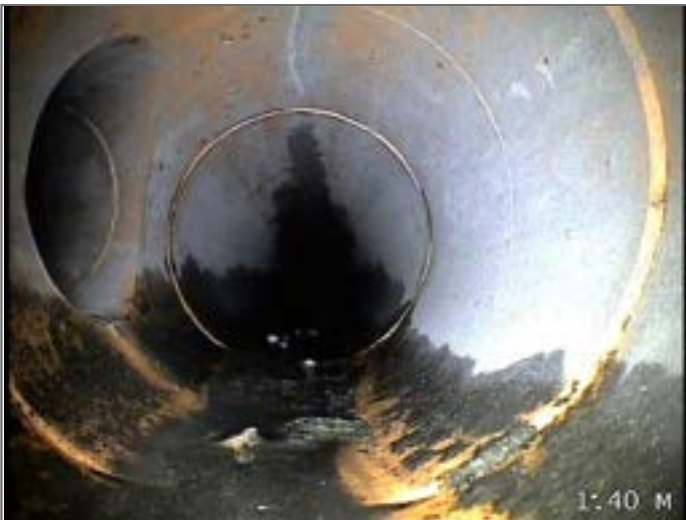
Junction at 9 o'clock, diameter 100mm

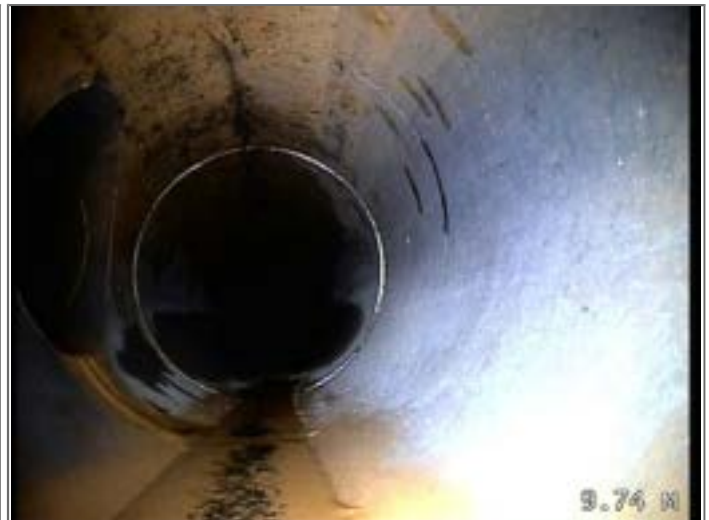
Junction at 9 o'clock, diameter 100mm

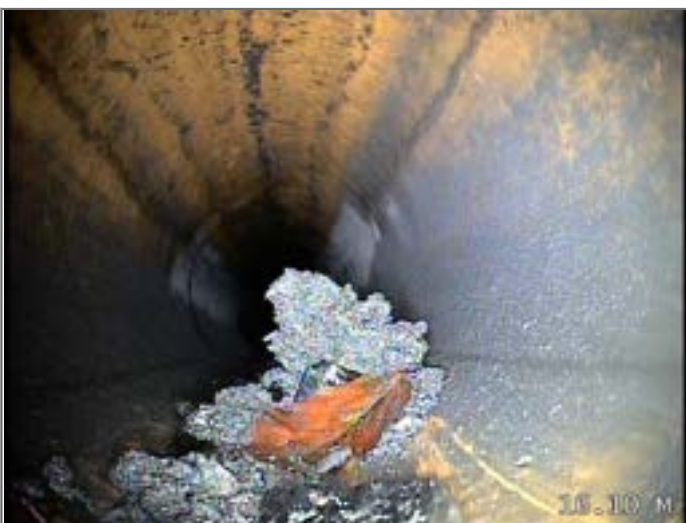
Settled deposits fine 5% cross-sectional area loss

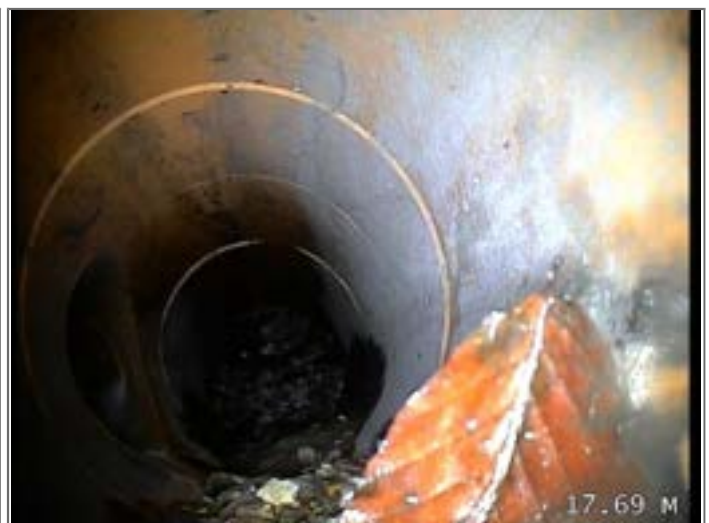
Junction at 9 o'clock, diameter 100mm

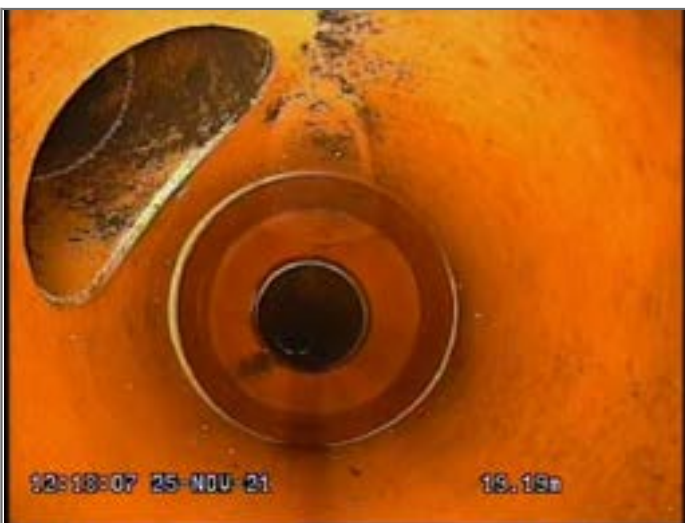
Junction at 10 o'clock, diameter 100mm

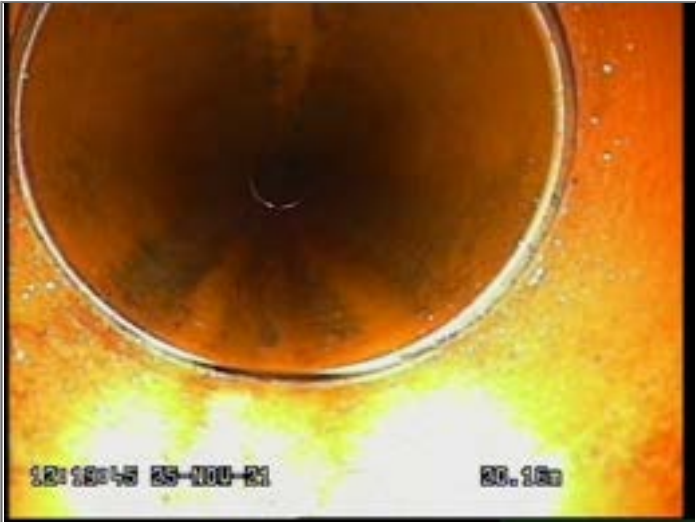
Finish node type, gully, reference UNABLE TO PASS DUE TO CHANGE OF PIPE SIZE - REST BEND IN VIEW A FEW METERS U/S

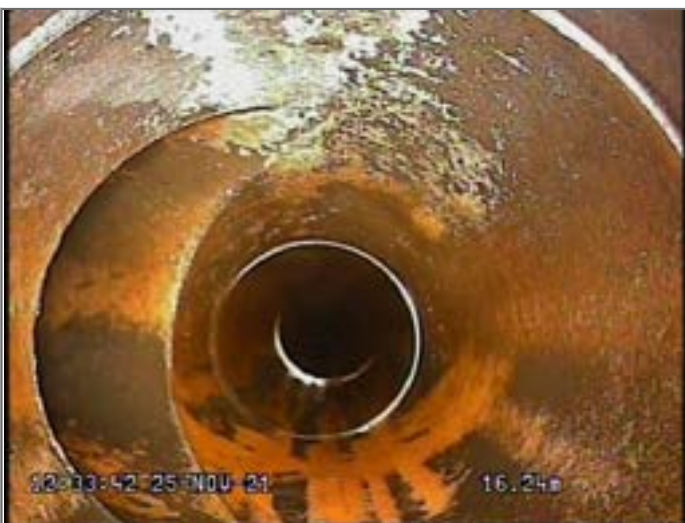
Junction at 9 o'clock, diameter 150mm

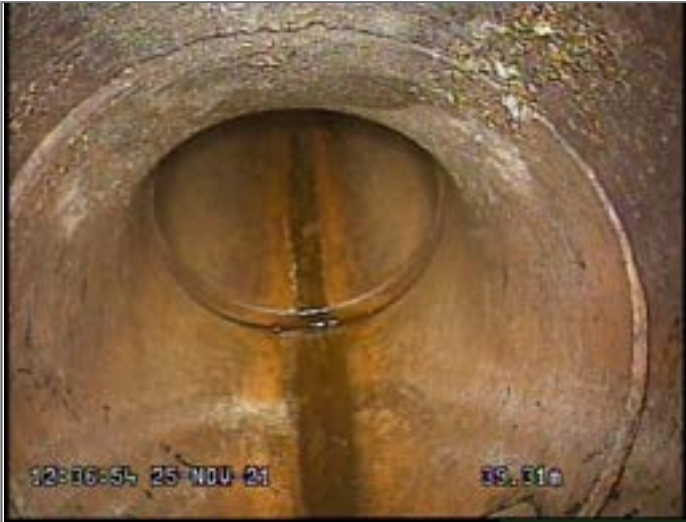
Line of drain/sewer deviates up

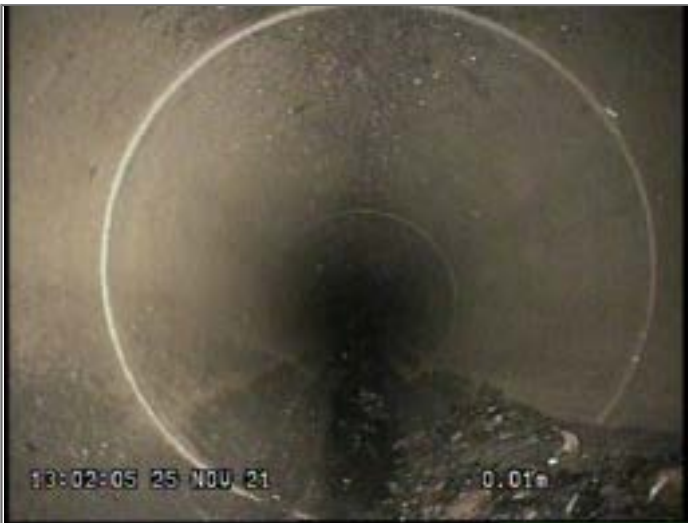
Start node type, manhole, reference MH S12

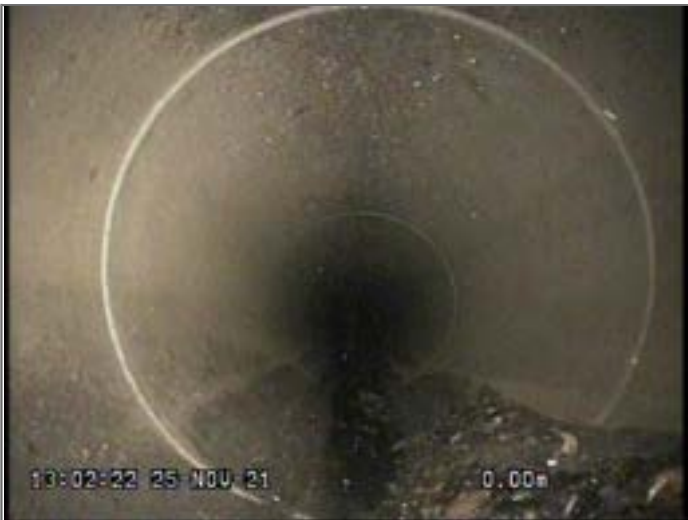
Settled deposits fine 5% cross-sectional area loss

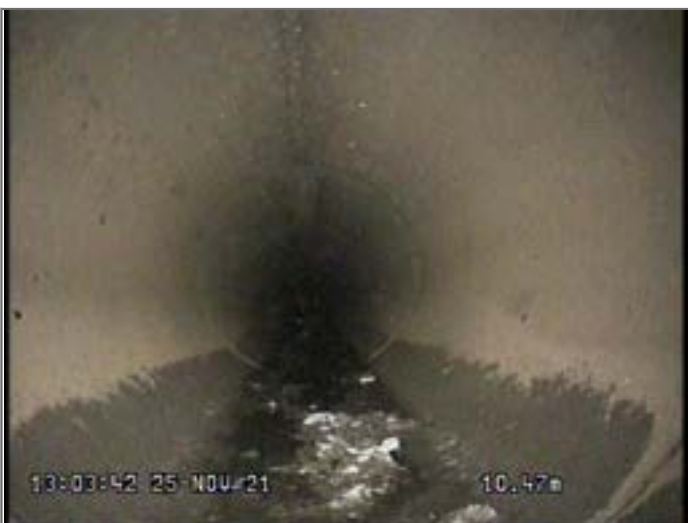
Settled deposits fine 5% cross-sectional area loss

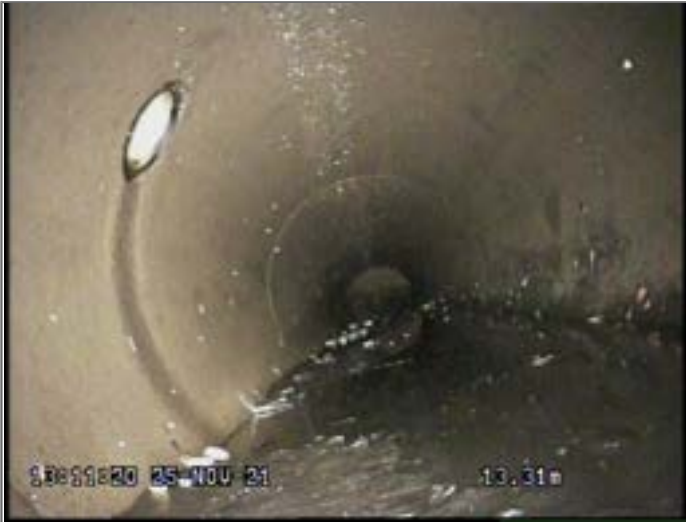
Settled deposits fine 10% cross-sectional area loss, Finished

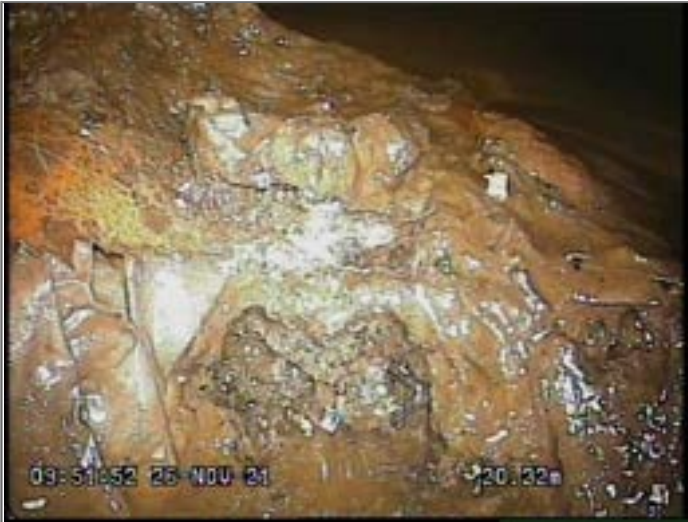
Settled deposits coarse 15% cross-sectional area loss

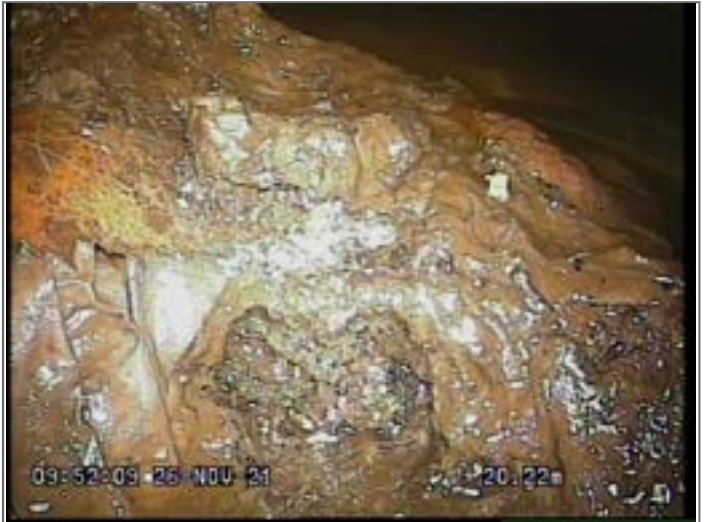
Survey abandoned - Remark: OBSTRUCTION - UNABLE TO PASS DUE TO FOUL AND COARSE DEPOSITS

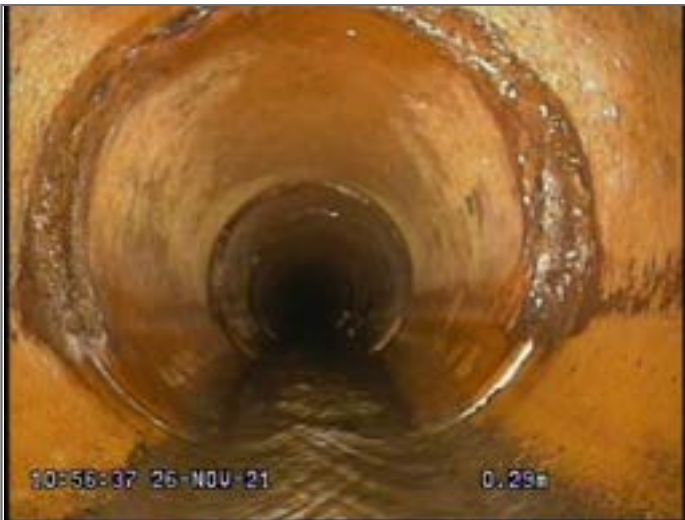
Attached deposits, encrustation from 8 to 4 o'clock 5% cross-sectional area loss

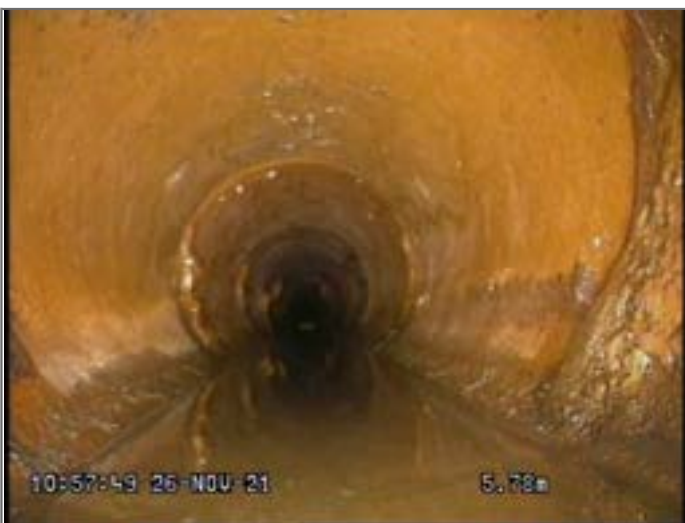
Settled deposits fine 5% cross-sectional area loss

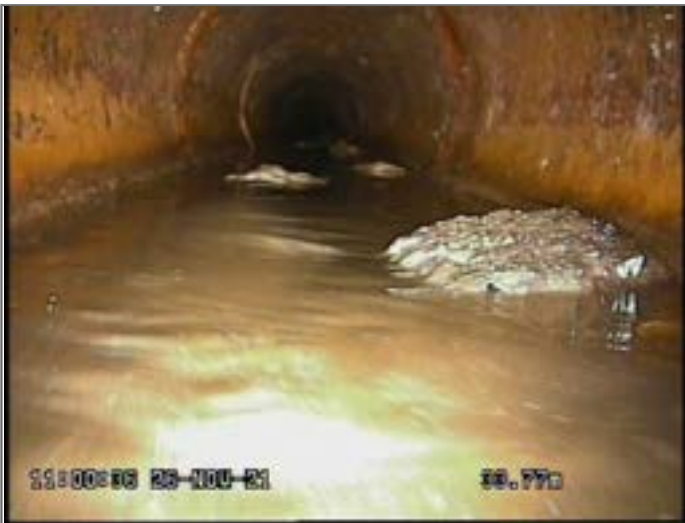
Settled deposits coarse 5% cross-sectional area loss
